The restoration of San Paolo Church in Pisa: geotechnical aspects

Nunziante Squeglia,* Stefano Stacul,* Elena Diddi**

Summary

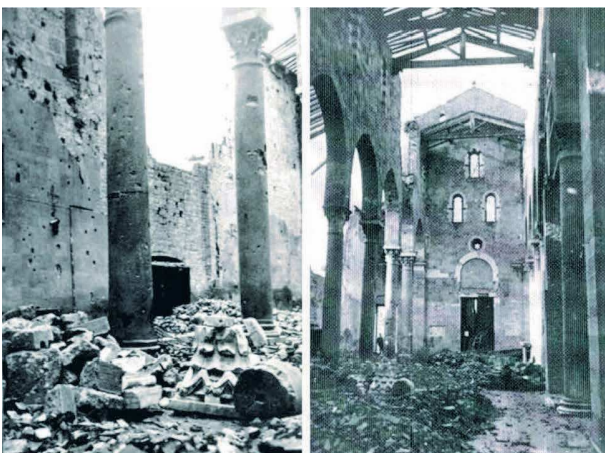
On August 31st, 1943 the southern side of Pisa was intensely bombed and the Church was heavily damaged (Fig. 2), with the destruction of the wooden roof and the partial collapse of the southern wall. The reconstruction, which lasted 16 years, took place between 1944 and 1960.

Fig. 2 – Damages due to bombing of 1943.

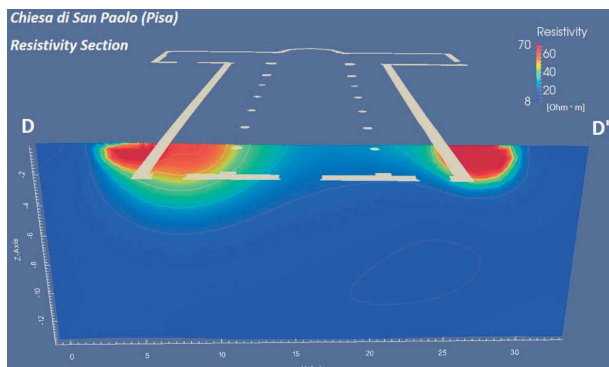
sent case an increment of resistivity has been associated to the occurrence of masonry; in figure 16 the foundation seems 2.5 m deep and some meters wide. As reported in figure 15, information about foundation of columns is not available. Such lack of information is due to presence of a metallic grid below internal pavement, discovered after ERT execution.

An accurate analysis of electric tomography and a comparison with direct inspection (say excavation) revealed that the information deduced by means of ERT is not reliable. The reasons of such unreliability are probably connected to the small difference in resistivity between the foundation walls and the ground, rather than the presence of the metallic grid. In fact, similar results have been obtained at the Baptistery in Piazza dei Miracoli, in which the metallic grid below the internal pavement is not present, while the material of foundation masonry is similar (Fig. 17). Further investigation revealed that the foundation were deeper than 2.5 m and the ERT tests have been discarded since the technique was evidently unable to discriminate the masonry from the ground.

Fig. 16 – Results of electrical tomography.
Fig. 16 – Risultati delle tomografie elettriche per le fondazioni della Chiesa di San Paolo.

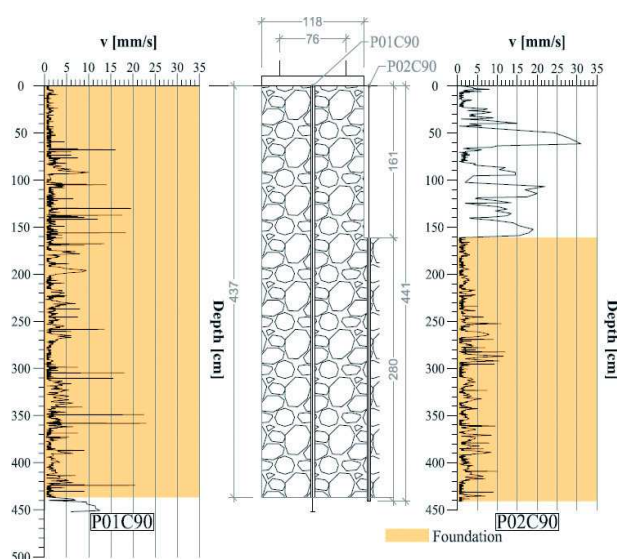
er samples of masonry. As matter of fact, the possibility to retrieve good quality samples from masonry is connected to the quality of masonry itself and the diameter of borehole. In the case of very small diameter, say 35 ÷ 40 mm, only a very good masonry or large stones allow the retrieval of intact cores. The recorded parameters, therefore, are the only data available to judge the quality of masonry and to deduce its geometry. At present, it is not yet possible to directly relate the recorded parameters to the masonry characteristics; as a consequence, the identification of masonry is deduced by comparison. Figure 20 shows an example of the results in terms of rate of penetration versus depth. In the figure is evident the role of rate of penetration in defining the geometry of the foundation.

Fig. 20 – Results of instrumented coring.

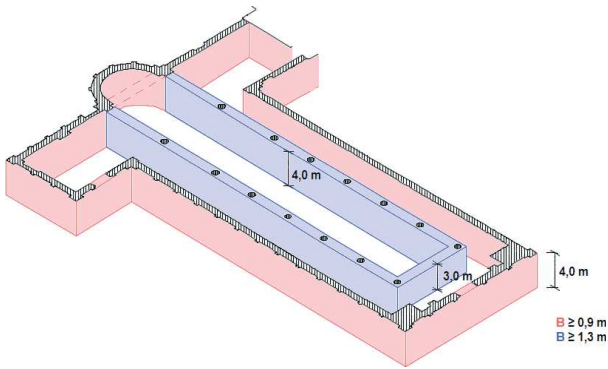
- columns rest on a masonry wall 4 m deep with a base at least 1 m wide. This wall connects all columns in E-W direction. The columns are not connected in N-S direction with the exception of western columns, where a masonry wall based at 3m depth has been found. This system probably coincides with the foundation of the smaller church built at the beginning of X century;
- all walls foundations are 4 m deep, with a base no more than one meter wide.

This information, summarised in figure 21, is somewhat unexpected. There is about a century between the two part of the construction, but the depth of the foundations of the different portion is quite the same and rather large.

Fig. 21 – Scheme of foundation system deduced by the whole investigations.

A hand excavation down to 4 m depth and under water does not appear credible. In an alternative hypothesis, the original foundations were shallower, and then the ground level has been risen by natural sedimentation or artificial infill to protect the church by the Arno river floods.
