Rapid assessment of geo-hydrological hazards in Antananarivo (Madagascar) historical centre for damage prevention

Andrea Ciampalini, William Frodella, Claudio Margottini & Nicola Casagli

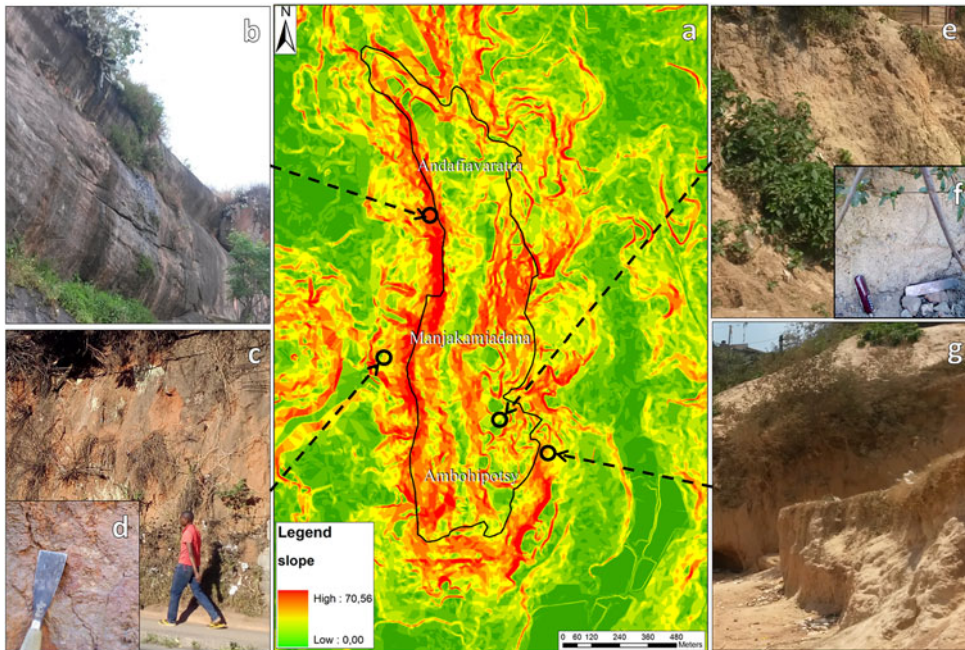
Figure 7. Analamanga hill DEM slope map (a), and the related geology (arrows show the outcrops): (b) granite western slope rock wall; (c) laterite soils (d: detail); (e) slope eluvial-colluvial deposits (f: detail); (g) alluvial deposits. Source: Author

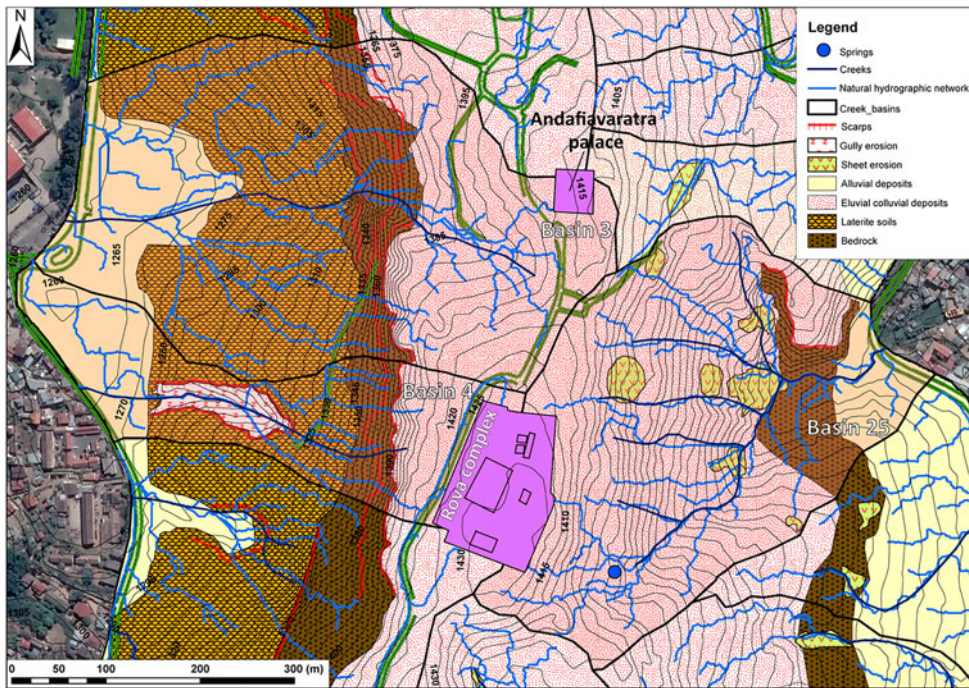
Figure 11. Maps of Basins 3–4 and 25. Green lines mark the roadways and paths. Source: Author

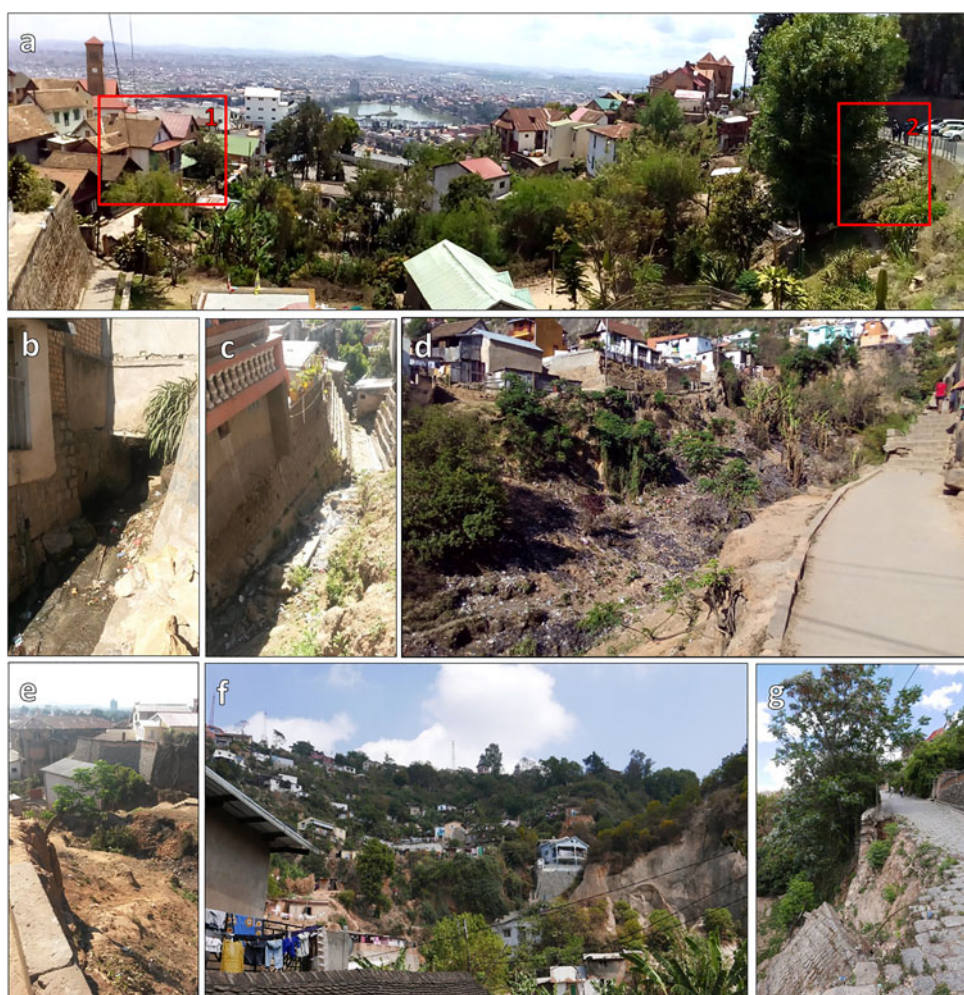
These two basins are located along the hill western slope, and their profile, from ridge to toe slope is characterized by an upper moderately low energy surface, passing downslope to a steep scarp and subsequently to low energy mid-slope-colluvial foot-slope surfaces ([Figures 7–9](#)). Their cover consists of eluvial-colluvial deposits in their upper sectors, while granite outcrops along the scarp. Thick laterite soils form the downslope sector, which links with the river plain alluvial deposits in the toe-slope sector ([Table 1](#); [Figure 11](#)). Both the basins natural hydrographic networks are characterized by a single straight channel (first order), on the contrary, the anthropic hydrographic network is well-developed due to the intense urbanization of the area ([Figures 10](#)). Creek no 3 develops from a small hanging-like valley, located over the scarp between the Rova complex and the Andafiavaratra Palace ([Figures 11](#) and [12\(a\)](#)). This valley is intensely urbanized and characterized by waterlogging areas (partially buried under the road paving); structural damages (cracks and fissures) affect the buildings located along its southern flank, while

retaining sand bags placed at the foot of the roadway indicate that the whole valley is affected by instability problems. The basin area, downslope of the scarp, is characterized by narrowing of the creek channel (Figure 12(b,c)), and by the partial burial of the water course beneath the street level. Furthermore, the obstruction provoked by illegal garbage dumping leads the water flow out from the sewer cover or from holes in the road pavement. The creek basin no 4 presents a critical situation in the lower part of the slope: here the creek deeply cuts the laterites forming a gully lavaka-like feature (Figures 11 and 12(d,e)). This erosional morphology, led to the instability of the valley flanks and the intense damaging of the surrounding pathways. The final part of the creek becomes very narrow and it is buried beneath the street level (Figure 12(e)). The geo-hydrological problems of this creek are exacerbated by the burning of the vegetation along the slopes, by several hovels and some concrete building located inside the creek course, and by the presence of abundant garbage obstructing the sewer system.

Basin no 25 is located in the Analamanga hill eastern slope and is characterized by a more gentle and regular morphology with respect to basins 3–4, except for a scarp located in the north lower sector (Figures 6, 8 and 10). In its upper sector, the basin cover is mainly formed by eluvial-colluvial deposits (up to a few metres of thickness) overlapping the intensively weathered bedrock, while alluvial deposits characterize the toe slope (Figure 12(f)). Sheet erosion phenomena are common and widespread within the eluvial-colluvial deposits (Figure 8). The basin hydrographic network is the most complex of the area, showing a dendritic-like pattern with a high drainage density (Figure 10). Despite the road system within the basin area is well developed, the artificial drainage network for the collection of rain water is totally or partially lacking, thus rain water flows mainly along the roads, and the sewer system, when present, is often obstructed by garbage. This area corresponds with one of the most prone to landslide zone due to the drainage network density, and to the presence of both granular eluvial-colluvial deposits and intensively weathered granite lacking vegetation cover. The basin is also characterized by the presence of running water within the hydrographic network and by springs (Figure 8). The reduction of the vegetation cover due to the increase of the population represents a real threat for this basin; furthermore, in order to create spaces for the construction of new hovels, the slope gentle morphology has been strongly modified by undercuts artificial terraces (Figure 12(f)). In fact, as a consequence of the 2015 cyclone event, part of the main road passing through this basin collapsed due to a small landslide (Figure 12(g)).

Figure 12. Geomorphological-erosional problems in basins 3–4. Hanging-like valley (a); damaged buildings (red square 1), retained roadway slope (red square 2). Creek 3 hydraulic narrowing (b). Creek 4 lavaka-like gully erosion (c) and hovels built within the creek bed (d). Basin 25 urbanization (e). Source: Author
