In situ measured cross section geometry of old timber structures and its influence on structural safety

Paulo B. Lourenço¹, Helder S. Sousa², Ricardo D. Brites³, Luís C. Neves⁴

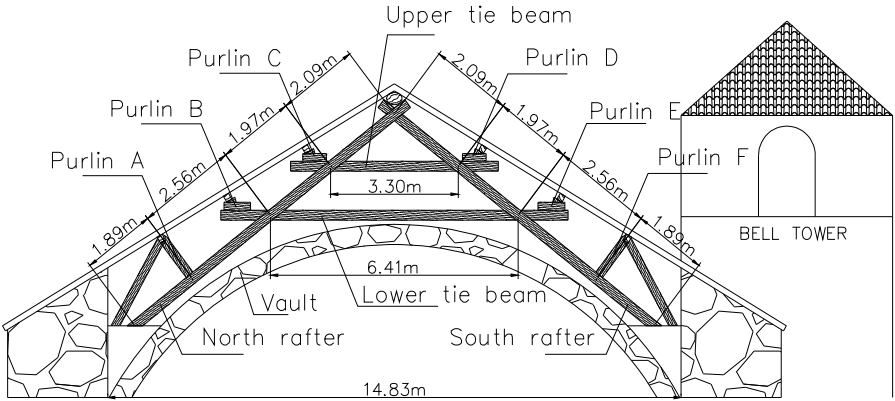
a)

The studied roof was built in the 17th century and is composed by eight timber trusses with two parallel high tie beams, without any post, see Figure 1a. The trusses and the ridge beam have round cross sections and non-straight axis, while the purlins are more recent and present rectangular cross sections and straight axis. The results of the measurements are presented in Table 2, where E is the average dimension and CoV is the coefficient of variation. It is noted that the deterioration of the rafters is often asymmetric due to localized water infiltrations or different neighbouring bodies to the roof under consideration. For this reason, the north and south rafters are considered in independent groups. The results indicate that the coefficients of variation of the dimensions of the round cross section are much larger than the coefficients of variation of the rectangular cross sections (11% on average for the purlins vs. 17% on average

for the rest of the members). The lower tie beam has a larger coefficient of variation because the ends have a lower cross section than the central part of the element. The coefficient of variation of the purlins is within the expected range according to JCSS (2001).

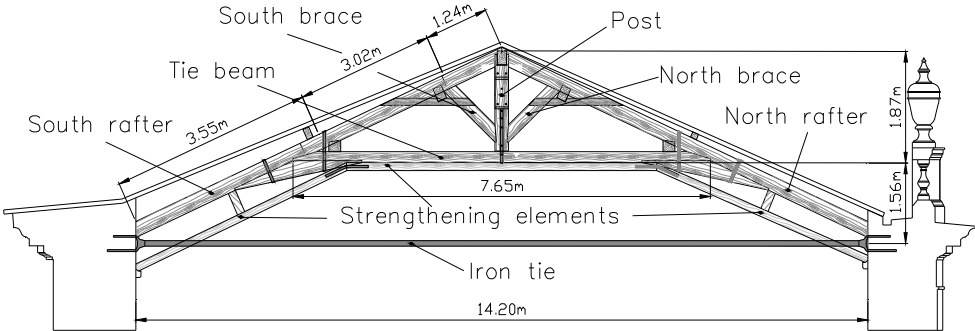
b)

This roof was built between 1773 and 1775, and the building was used as a chemical laboratory and classroom until 1998. The survey focuses on the roof of Wing 1, which was heavily deteriorated due to wood-boring beetles and fungi attack. It is assumed that the roof trusses are original, even if there are later additions and strengthening. The roof structure is composed by four trusses with an iron tie at the base and a timber tie beam at mid-height, see Figure 1b, where the post and braces are connected. The added strengthening elements (only in two of the trusses) are also shown in the figure under the rafters. The date of this intervention is not known but the wood is in better condition. The results from the geometrical survey (Table 2) indicate that the severe biological degradation provides very large coefficients of variation for the rafters and tie beam, particularly along the height of the members. The average coefficient of variation of the dimensions in these members is 18%, whereas the average coefficient of variation for the height alone is 25%. For the post and braces, the average coefficient of variation of the dimensions is 5%.

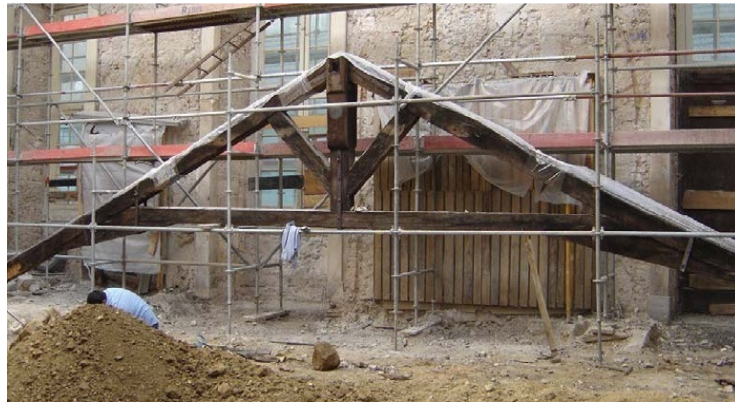
b)

Roof A1 from the laboratory is three pitched, including four trusses with a span of 14.2 m, see Figure 3. As a consequence of the large deterioration and damage, the trusses were brought down and a detailed survey of the condition was made. In order to identify and locate the damage during the inspection, a detailed inspection was considered for each timber member (rafters, tie-beam, braces, post and wedges) of each truss, using traditional and advanced techniques, namely controlled drilling Resistograph to obtain density profiles (Rinn and Schweingruber, 1996) and impact hammer Pilodyn for surface fungi deterioration measurement (Görlacher, 1987). To calibrate these methods, tests in areas that apparently were in good condition were carried out as reference. The combination of the above techniques allowed the definition of deterioration and damage maps, see Figure 4. The four trusses were in poor condition and, based on the inspection only, it was concluded that they were unfit for use without extensive repair and strengthening.

Figure 3: Wing 1 from Chimico laboratory: (a) plan with location of trusses; (b) photograph of truss #4 once it was moved down

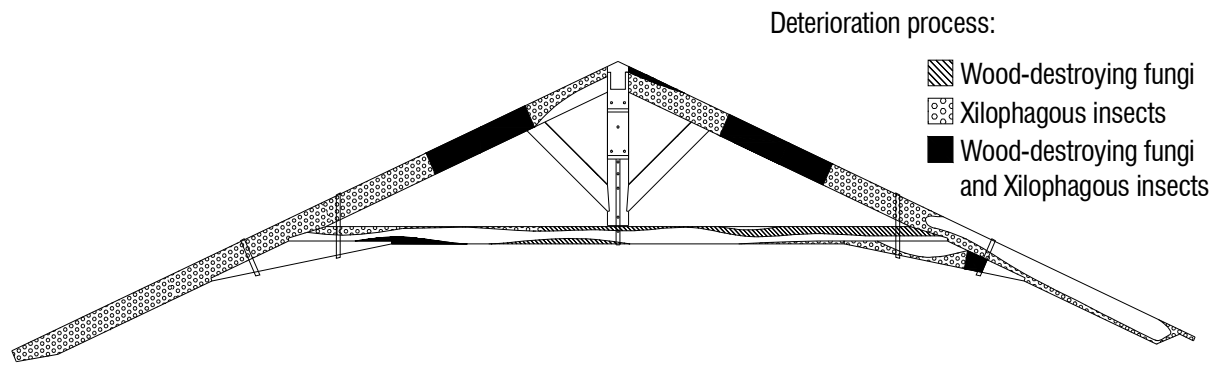
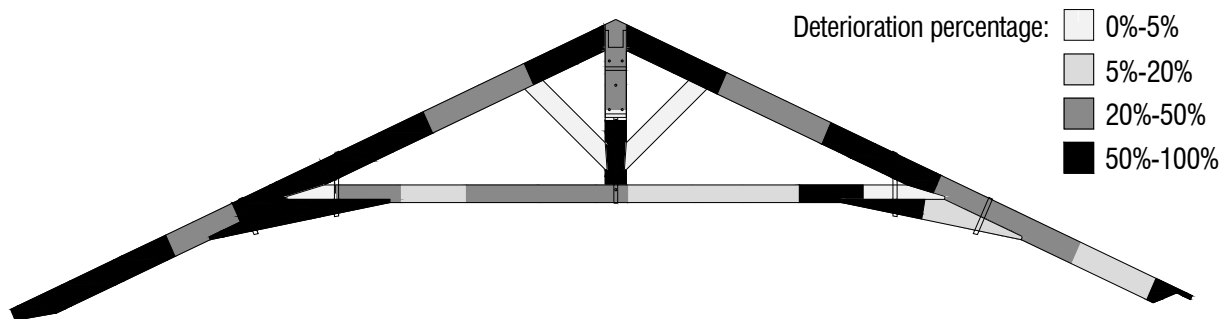
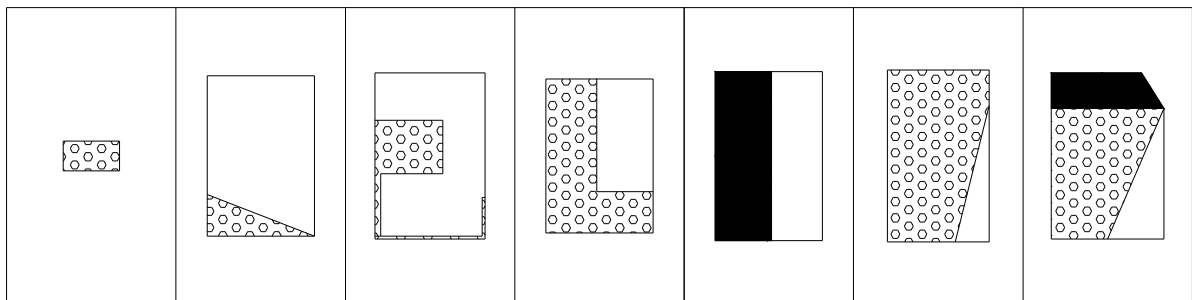
Figure 4: Results obtained for each truss (truss #1 is shown): a) deterioration and damage map; b) percentage of deterioration in terms of cross section; c) detailed information along a member about deterioration and damage.
