Technical Inspection and Intervention Proposals for The Rehabilitation of a Multifamily Housing Building of the Decade of 60 of Last Century in Portugal

Ines I. G. Marcelino ¹, Joao C. G. Lanzinha ²

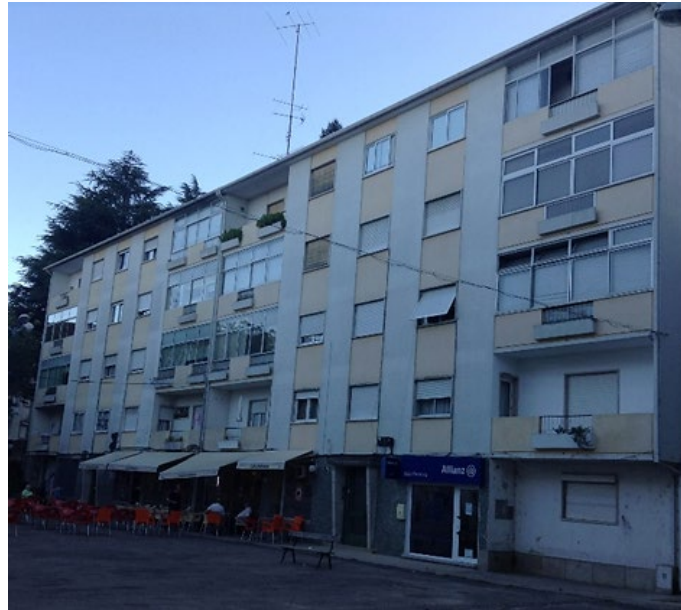
It can be concluded that the building under study has been poorly maintained over the years. Taking into account all the analysis performed, it is verified that the thermal discomfort is the most serious problem and that it is urgent to solve.

Figure 2. Main facade of the building under study

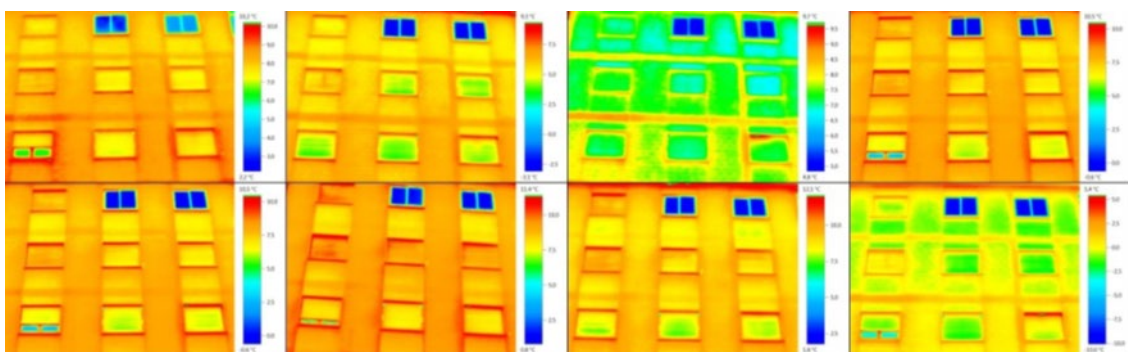
The thermographic analysis allowed us to prove the main constructive weaknesses of the external envelope, namely the flat thermal bridges (beams, pillars and shutters), the linear thermal bridges in the glazed spans, mainly sill and lintel, roofing slab and intermediate floor slabs. In Figure 3 some examples of the thermograms are shown where the fragilities previously mentioned are detected.

Figure 3. Examples of thermograms - Main facade

- The fraction which is a coffee shop presents temperatures superior to the rest of the façade, and thus transmits it to the ground floor;
- The rear façade is warmer when measured at night, due to the use of the kitchen;
- In the case of sanitary facilities, they are warmer during the morning;
- During interviews with residents it was found that people only warm up some compartments, especially at night, which have been proven by thermography;
- It was verified that some apartments are not occupied, allowing to confirm the occupancy rate.

In the first phase, it is a priority to isolate the exterior envelope of the building (walls, roofing slab and floor), change the glazed spans and their respective solar protections (Figure 5). In order to improve the ventilation, it is intended to install mechanical extractors that work in the chimney on the stove and in the sanitary installations. In addition, implement the first phase of improvement of accessibility, which corresponds to the placement of two ramps at the entrance and another in the main lobby of the building.

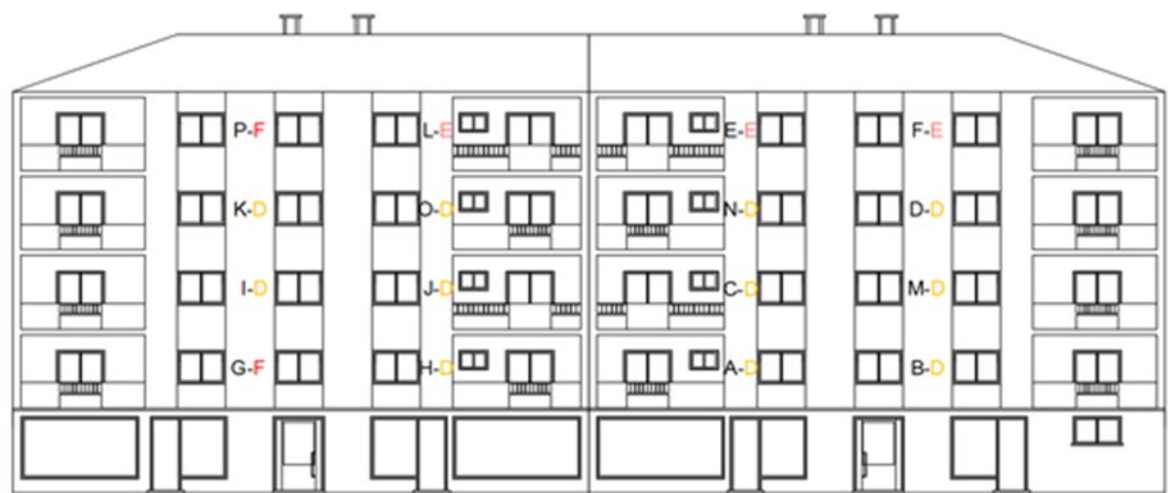
Figure 4. Energy classes of the fractions (Example Fraction A - Energetic Class D)

As can be observed, the heaviest energy classes are located on the top floor (Table 1), because they are in contact with the attic, heavily ventilated and without thermal insulation. On the ground floor, the apartments with the lowest rating are in contact with non-useful space (ENU), namely the coffee shop, support store and a shop.

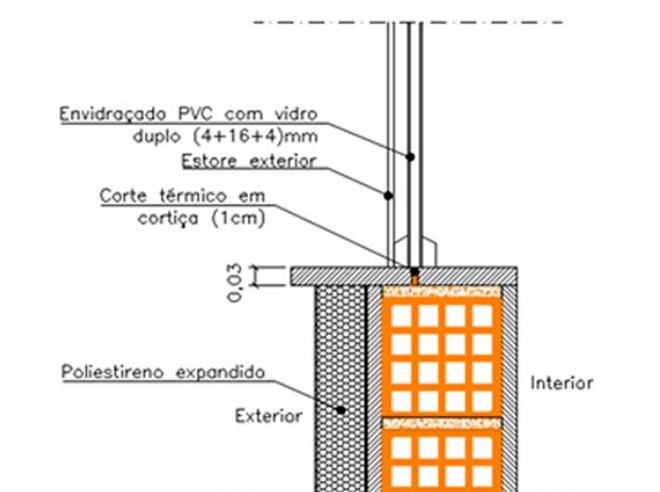
Figure 5. Constructive wall detail with ETICS system, sill and glazing [1]
