Seismic performance of bridges during the 2016 Central Italy earthquakes

Di Sarno L., da Porto, F. , Guerrini, G., Calvi, P.M., Camata, G. and Prota, A.

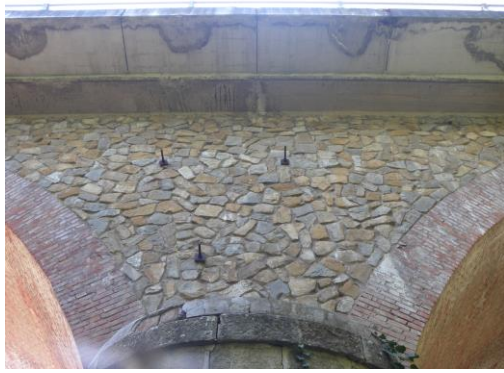
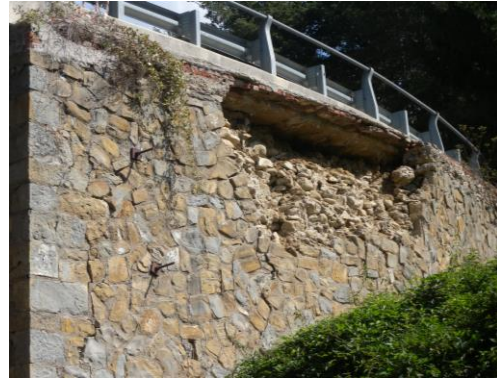
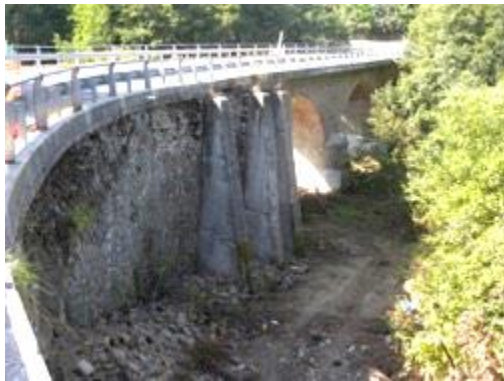
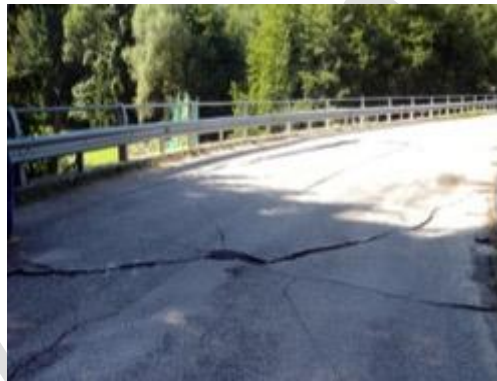
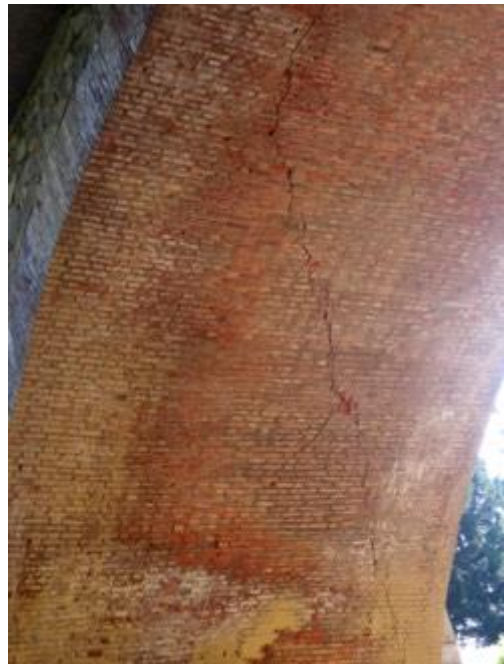
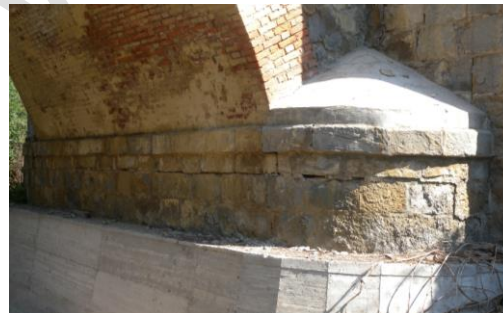
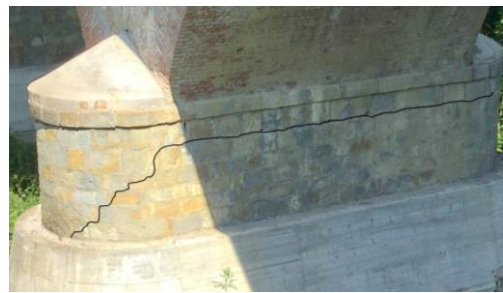
322 During the earthquakes, several sections of the external stone masonry layers collapsed out of
323 plane. This occurred particularly in some areas of the abutment walls (Figures 10b and 10c),
324 where ties were not placed. Moreover, wide horizontal cracks opened across the construction cold
325 joints in the buttresses retaining the North-East wing wall (Figure 10c), with residual widths of
326 the order of 10 mm. In addition, sliding occurred along these cracks, with permanent
327 displacements ranging from 10 to 50 mm.

328 This resulted in a lack of confinement of the interior uncemented cobbles and infill material,
329 causing lateral relaxation and settlement that was visible on the roadway surface above the
330 abutment (Figure 10d): major longitudinal and transverse cracks were observed along the road
331 surface, with maximum widths of about 60 mm vertically and 30 mm horizontally. A widespread
332 deformation pattern had already developed before the earthquake sequence, due to slope
333 instability in the eastern approach embankment: this was the cause of pre-existing cracks on the
334 road pavement mainly above the embankment and at the embankment-abutment joint, but only
335 marginally above the abutment.

336 Cracks were observed on the intrados of all the arches of the bridge, originating from the pier and
337 propagating diagonally along the arch intrados. The widest cracks were found on the East arch,
338 forming an X-shape pattern between the East abutment and mid-span (Figure 10e). This probably
339 occurred due to the restraining effect of the East abutment against transverse displacement of the
340 deck, which also caused horizontal cracking at the East arch springings at abutment and pier
341 (Figure 10f and 10g).

354 Figure 10 - “Tre Occhi” masonry bridge (42.620668 N, 13.290176 E): (a) partial collapse of the South-East
 355 wing wall; (b) buttresses and partial collapse of the North-East wing wall; (c) roadway settlement and cracks
 356 above the East abutment; (d) pre-existing cracks on the roadway at the East embankment-abutment joint
 357 (from Google Maps); (e) cracks on the East arch intrados; (f) cracks on the East arch springing at the
 358 abutment; (g) cracks on the East arch springing at the pier.

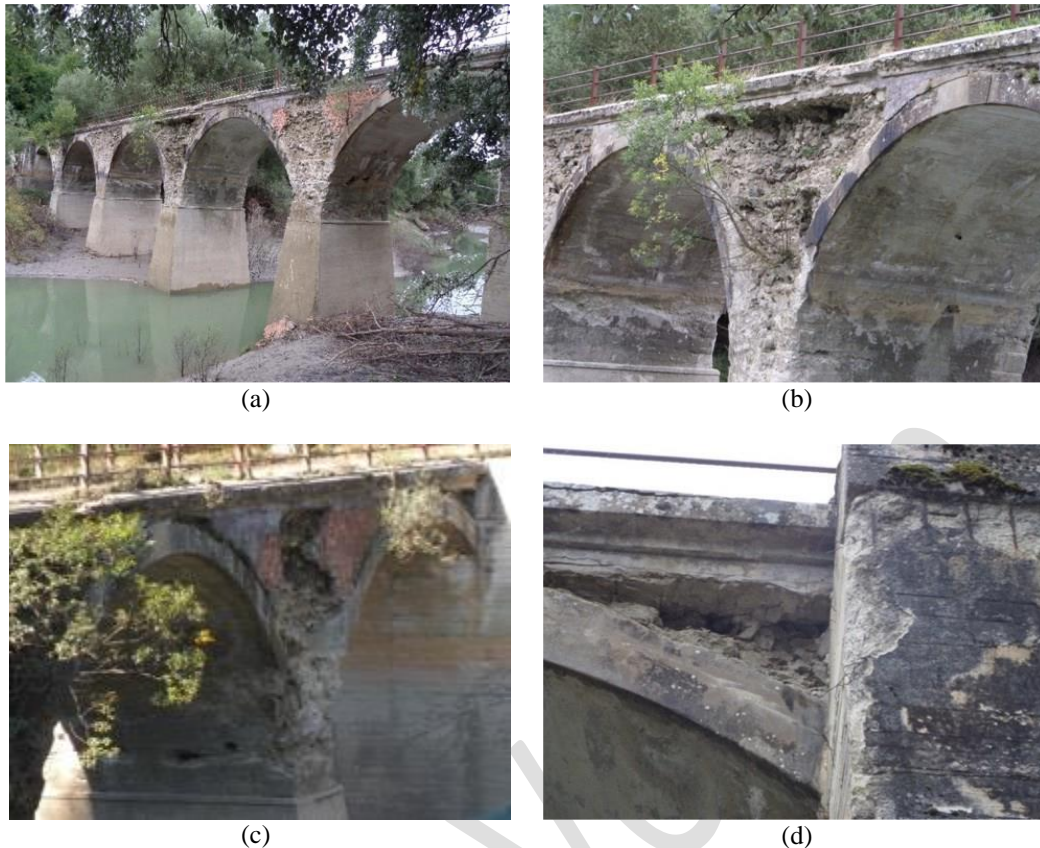
361 Figure 11 - “Cinque Occhi” masonry bridge (42.623178 N, 13.250428 E): (a) elevation view of the bridge;
 362 (b, c) partial collapse of masonry spandrel walls and loss of material at the arch springings, with evidence
 363 of previous retrofit and pre-existing damage; (d) collapse of a spandrel wall in proximity of the South
 364 abutment, with evidence of pre-existing damage to the reinforced concrete structure.
 365

375 The August 24 earthquake worsened the pre-existing damage pattern of the bridge, causing
 376 diffused out-of-plane failure of the spandrel walls (Figures 11a through 11d), due to low quality
 377 of the masonry and lack of ties. Localized losses of concrete cover and masonry units can be
 378 observed at the pier springing (Figures 9b and 11c): this can be associated with the development
 379 of horizontal hinges, as part of a longitudinal global mechanism facilitated by the pier slenderness
 380 and by the limited arch thickness-to-span ratio. Some damage was also observed on the spandrels
 381 close to the South abutment (Figure 11d). The bridge deck was not cracked along the roadway
 382 surface nor at the abutments: thus, structural safety was judged as not compromised by the
 383 earthquake and no traffic restrictions were applied.

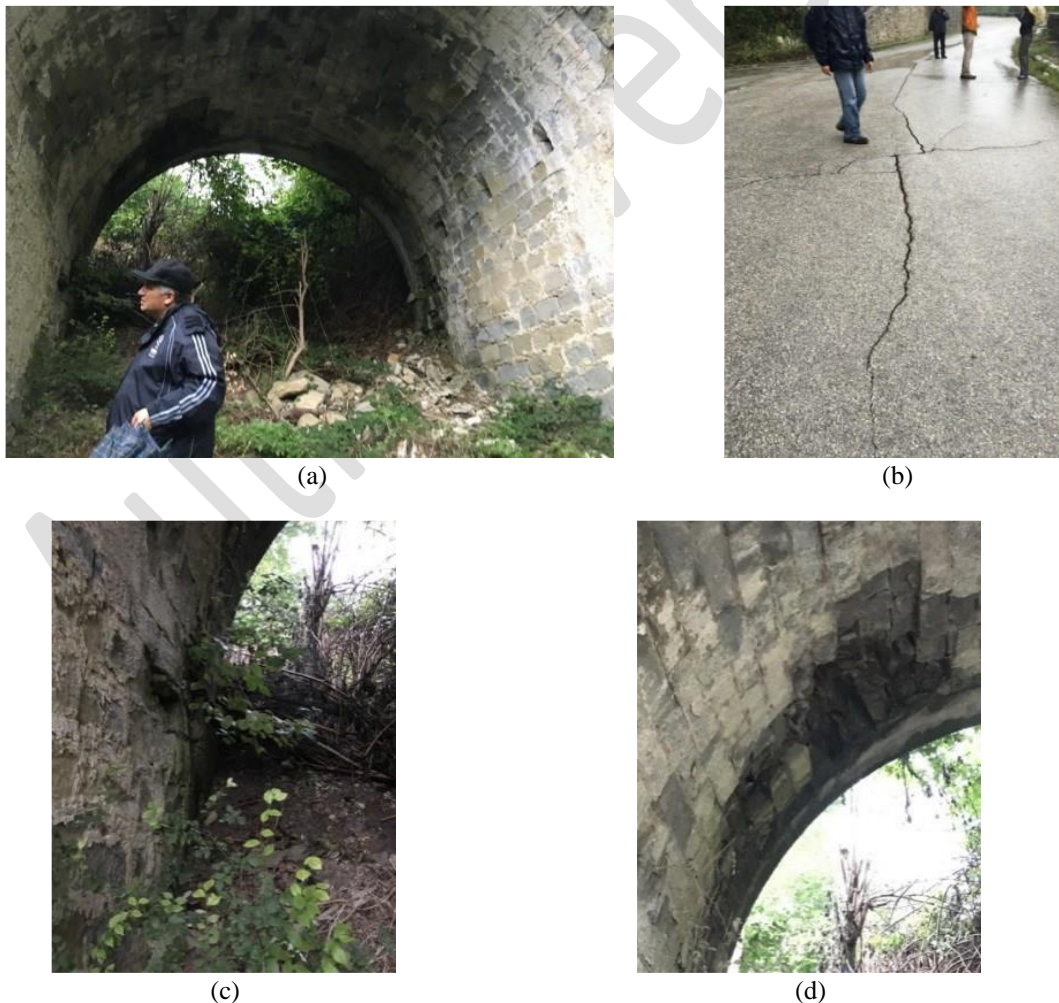
384 Two arch bridges have been inspected along the “Trisungo-Tufo” road, in the locality of Tufo.
 385 The first one is a single-span arch stone masonry bridge (Figure 12), made with stone voussoirs
 386 of variable thickness. The bridge is oriented along the NEE-SWW direction, so it was subjected
 387 to higher PGA values along its longitudinal (partially inclined) direction. Cracks on the road
 388 surface over the abutments (Figure 12b) were caused by seismically induced infill settlements,
 389 related to displacements of the earth-retaining wing walls. Local cracking within load-bearing

390 masonry elements, and spalling of the external leaf of the abutments and of the vault intrados
391 (Figure 12c and 12d) were also observed.

406 Both the bridges in the locality of Tufo showed evidence of damage on the road surface (Figure
407 12b), as a result of abutment infill settlements. These effects induced local officials to limit traffic
408 on the SP129 bridges.
409
410

411 Figure 12 - Single-span masonry bridge along the “Trisungo-Tufo” route (42.735981 N, 13.254862 E): (a)
412 view of the bridge; (b) damage on the road pavement; (c) spalling of the outer leaf of the abutment; (d)
413 spalling of the intrados of the vault.

For the single-span “Trisungo-Tufo” bridge, the weaker mechanism according to the simplified approach would be the spandrel wall transverse failure (SW-T). The local masonry spalling at various heights on the vault intrados, although not clearly related to the formation of hinges, may be compatible with an initial triggering of a local arch mechanism in the longitudinal direction (A-L), which the second possible mechanism according to this procedure.

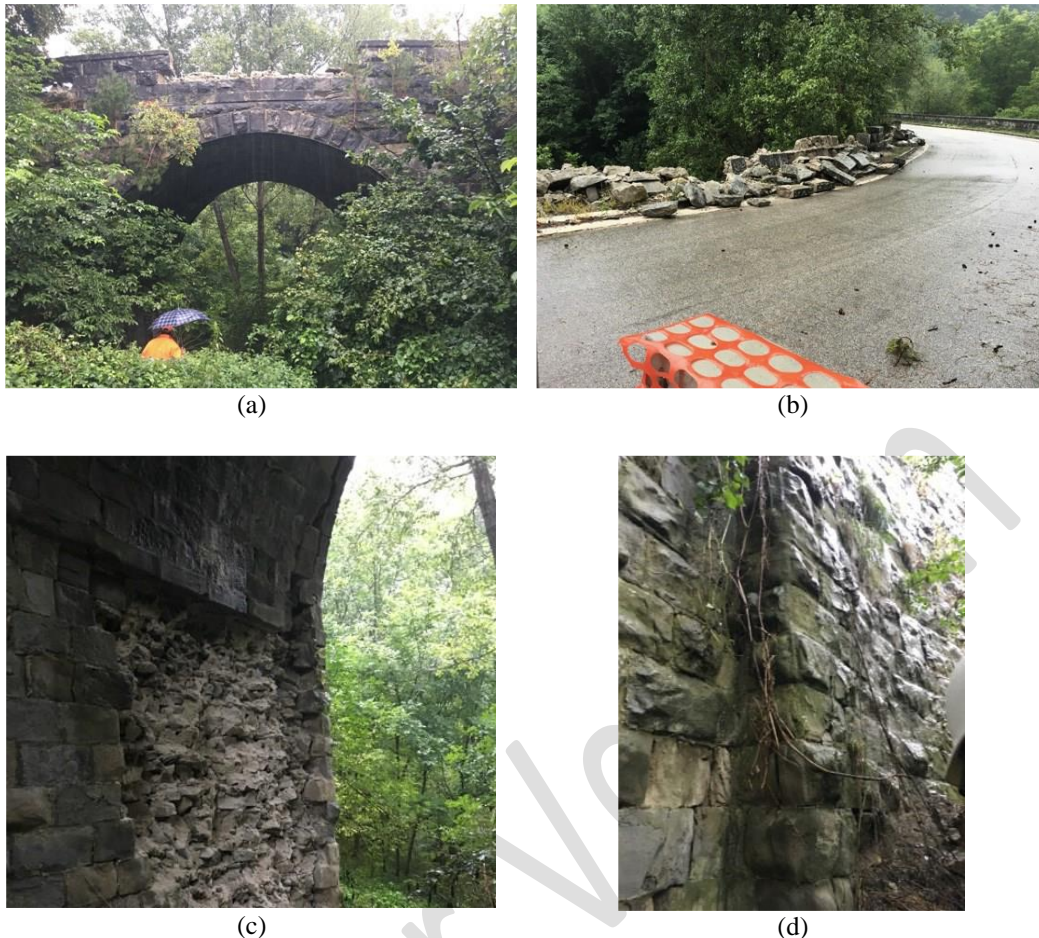
392 Similar effects were observed for the second arch bridge along the “Trisungo-Tufo” route (Figure
393 13), a three-span arch structure made of stone masonry. The abutments and the piers are made of
394 stone masonry, with an external leaf made of larger blocks, and an internal infill made of smaller
395 stones, laid with mortar of poor characteristics and some loose material. This bridge has a curved
396 longitudinal axis, with the mid-span radius oriented along the East-West direction, which was
397 subjected to the highest PGA during all the main events.

398 In this case, out-of-plane overturning of the masonry parapets above the central span of the bridge
399 occurred (Figure 13a and 13b). Moreover, the bridge comprises an older part and an adjacent
400 relatively recent parallel extension; the latter behaved poorly during the earthquake, and
401 experienced spalling of the external masonry leaf in the North abutment (Figure 13c) and cracks
402 of one masonry pier (Figure 13d). These local effects were primarily due to the poor connection
403 between the stone blocks, which led to loss not only of single units, but also of entire portions of
404 the abutment walls. Horizontal cracks at the haunches can be compatible with an initial formation
405 of plastic hinges.

414 Figure 13 - Three-span masonry bridge along the “Trisungo-Tufo” route (42.73538 N, 13.253655 E): (a, b)
 415 out-of-plane collapse of the parapet over the central arch; (c) spalling and (d) cracking of some masonry
 416 elements.

For the three-span “Trisungo-Tufo” bridge, the first expected mechanism, according to the simplified approach, is the spandrel wall transverse failure (SW-T): consistently, the actual and most severe damage was the out-of-plane overturning of the masonry parapets. Horizontal cracks at the southern haunches are also visible: this damage is compatible with the initial formation of hinges and the triggering of a global longitudinal mechanism (AP-L), which is the second most likely mechanism identified by the simplified analysis.

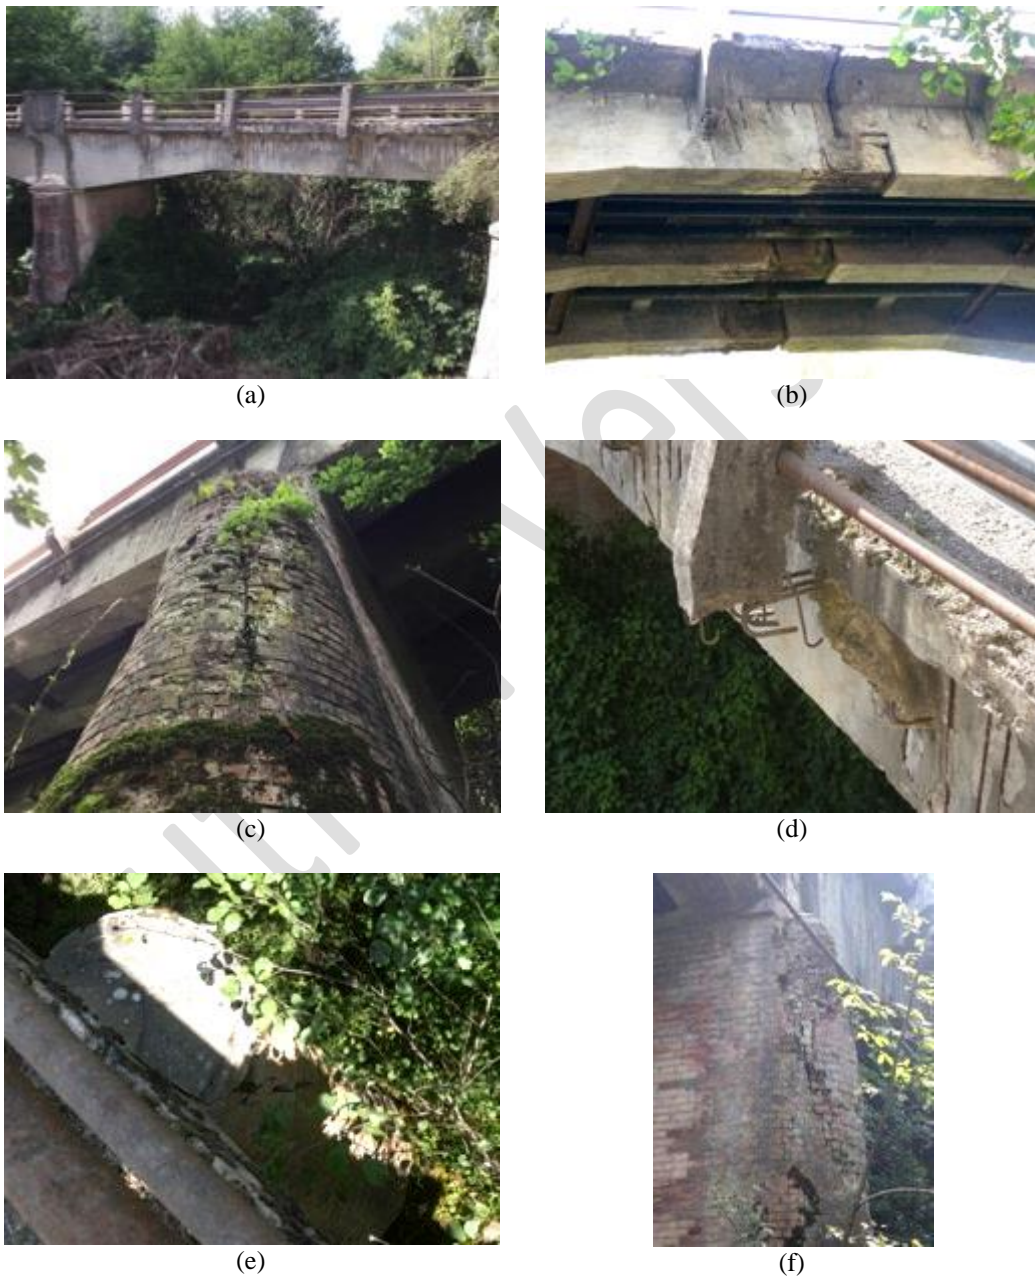
440 As shown in Figure 14, the bridge was poorly maintained, with severe signs of degradation and
 441 pre-existing damage. In particular, the concrete girders showed widespread loss of concrete cover,
 442 steel reinforcement exposure and advanced corrosion (Figure 14a), especially at the Gerber beam
 443 joints (Figure 14b). Masonry piers showed degradation mainly related to erosion, loss of mortar
 444 joints, and vegetation growth (Figure 14c). In addition, the connections between parapets and
 445 deck were poorly designed: at some locations the parapet posts were torn from the deck (Figure
 446 14d), probably after vehicle collision, and were precariously suspended.
 447
 448
 449

450 Figure 14 - “Rosa” reinforced concrete and masonry bridge (42.623178 N, 13.250428 E): (a) elevation view
 451 of the North-East bay; (b) degradation of the reinforced concrete Gerber girders; (c) degradation of the
 452 masonry piers; (d) pre-existing damage of a parapet connection to the deck; (e, f) cracking and partial
 453 collapse of the exterior brick leaf of the piers.
 454
 455

456 After the August 24 event traffic restrictions were imposed on the “Rosa” bridge, with maximum
457 vehicle weight limited to 3.5 t; a Bailey bridge bypass was built for heavier traffic. The earthquake
458 caused local damage to the substructures (Figures 14e and 14f), with vertical cracks at the top of
459 the masonry piers starting from the external girder support and local collapse of the exterior brick
460 leaf. The poor quality of the masonry, combined with the weakening of the shear-friction transfer
461 between girders and piers due to material degradation and significant vertical earthquake
462 accelerations, appear to be the main causes of the observed damage.
463 The SS685 and the SS4 are two important state roads. These roads run predominantly East-West
464 and represent major connections between the two Italian coasts. In the surroundings of Amatrice,
465 a number of RC viaducts are part of this network, and were therefore inspected during the

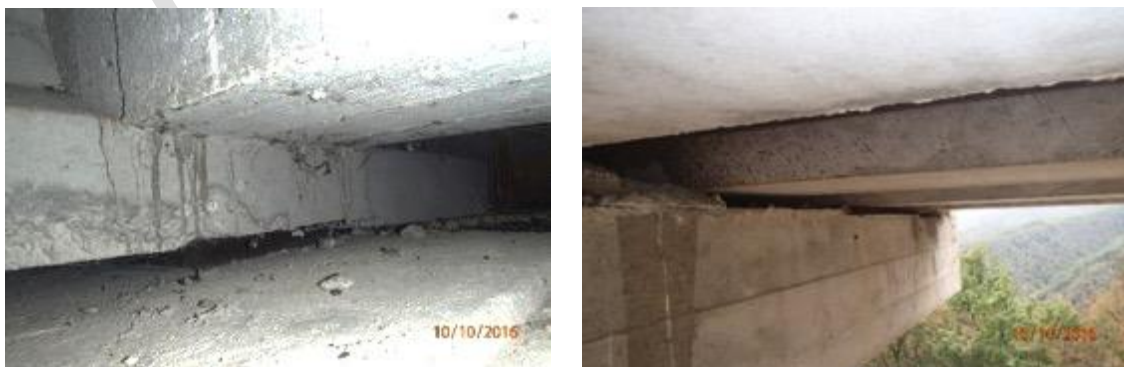
Even though no unseating was documented, some damage was observed due to excessive longitudinal displacements of the superstructure. These uncontrolled displacements often induced pounding effects which, in turn, caused damage (i.e. visible cracking and spalling) to elements such as bent-caps, transverse diaphragms, and abutments, as shown in Figure 18, sometimes worsening pre-existing damage due to material deterioration.

Figure 17 - Bearing pads of a viaduct investigated along SS685 (courtesy of Totaro).

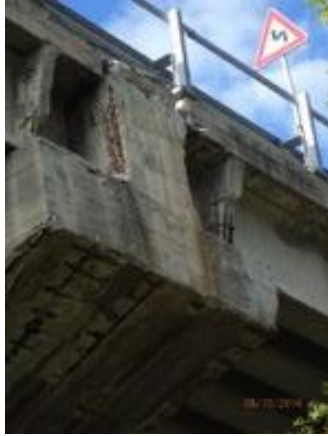
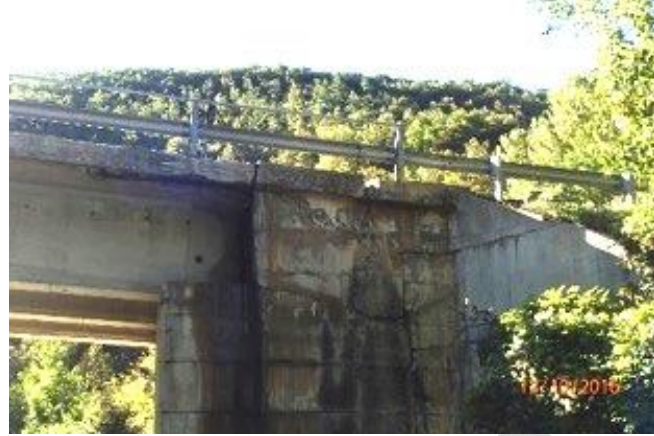
Figure 18 - (a) Damage to bent cap and transverse diaphragms along SS685 (42.756556 N, 13.277111 E);
 (b) Damage to an abutment along SS4 (42.699565 N, 13.251978 E; courtesy of Totaro).

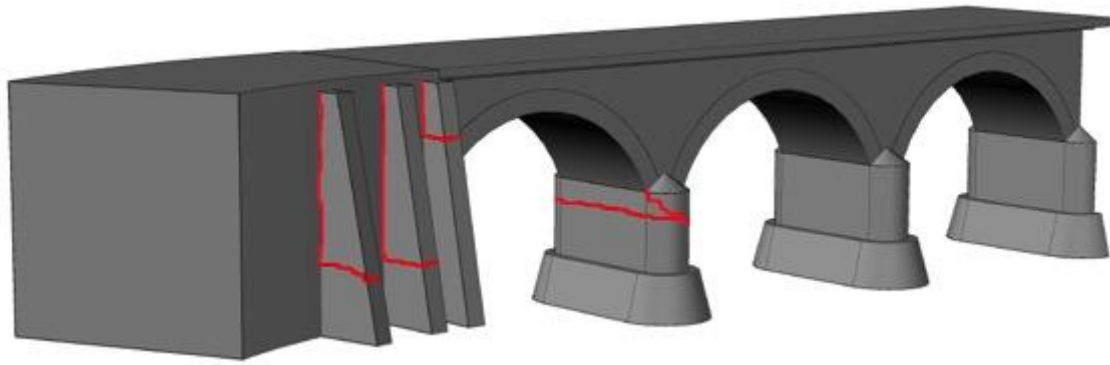
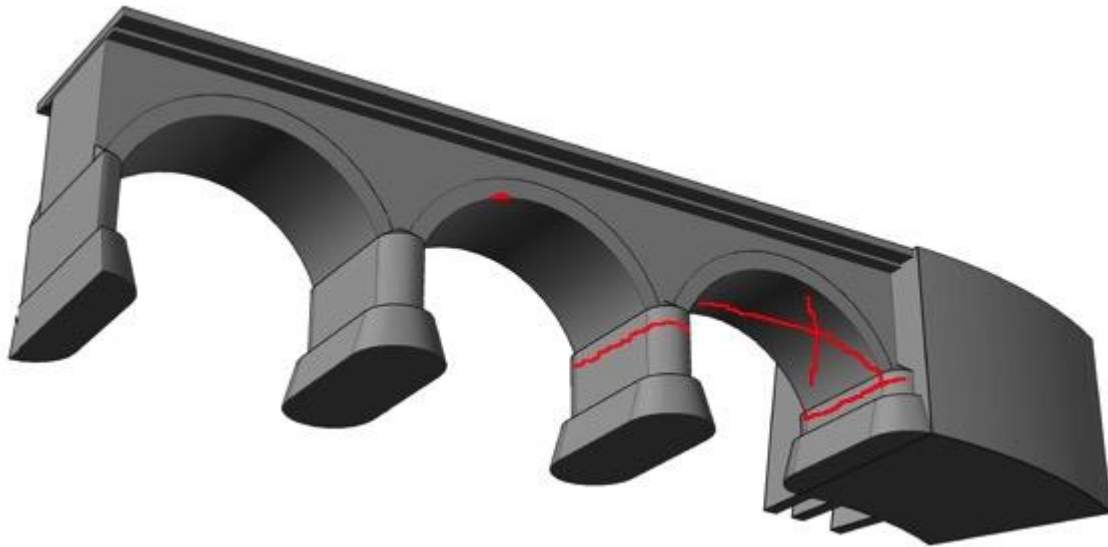
Further analyses have been carried out on a model of the “Tre Occhi” bridge to understand the actual transverse collapse mechanism, with the overturning of the abutment retaining buttresses, and diffused cracking of the East abutment, pier and span, as represented in Figure 19.

625 Figure 19 - Actual crack pattern of “Tre Occhi” bridge: views from (a) North and (b) South.
