Failure analysis of a degraded 1.2 kV SiC MOSFET after short circuit at high temperature

Failure Analysis of a Degraded 1.2 kV SiC MOSFET after Short Circuit at High Temperature

Paula Diaz Reigosa, Francesco Iannuzzo, Lorenzo Ceccarelli

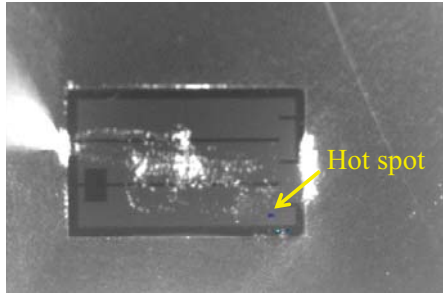
In this section, the electrical behaviour will be correlated with the physical failure analysis of the 1.2-kV/ 90-A SiC MOSFET. To do so, a thermal analysis followed by a Focused Ion Beam (FIB) cut have been performed on the degraded SiC MOSFET in order to find possible damages on the gate oxide. First, the package material has been removed by high-temperature etching, and then, an Indium Gallium Arsenide (InGaAs) infra-red camera has been used to find possible hot spots. The principle is to apply a voltage on the drain terminal, for example up to 150 V, and connect the gate and the source terminals to ground. If the SiC MOSFET has a defect, a leakage current will appear from drain to source or drain to gate, which it can be detected with a very sensitive infrared camera. The infra-red camera can penetrate to the device with a certain depth, so it is possible to observe the chip surface and the structure underneath. The results can be observed in Fig. 3, where two hot spots can be identified. The hot-spot analysed in this paper is the one localized in the active region, which is highlighted in in Fig 3.

Fig. 3. InGaAs infra-red image of the degraded SiC MOSFET.

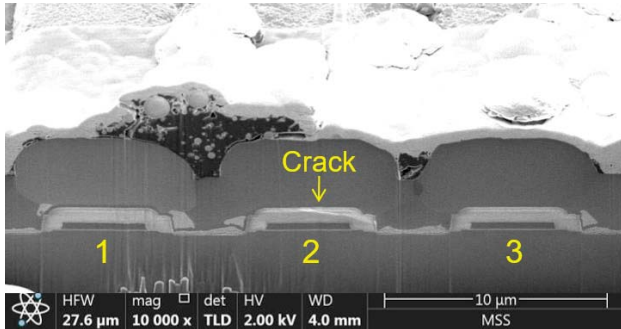
A Focused Ion Beam (FIB) at the hot spot location is used to obtain the vertical cross-section of the SiC MOSFET structure, whose image is revealed in Fig. 4. The image shows the physical structure corresponding to three cells, where one of the cells appears to be cracked on the field-oxide region. This cell in particular is further magnified in Fig. 5, where the crack between the poly-silicon gate and the aluminum source is clearly observed. On the other hand, the thin gate-oxide layer appears to be intact, concluding that the field oxide is the weakest part when the device is stressed under short circuit. These results are in agreement with the literature, since cracks

Fig. 4. Focused Ion Beam (FIB) cross-section of three cells at the hot spot location, where one of the cells presents a crack.

have also been observed in the field oxide region in [15]. A more in-depth analysis has been performed on adjacent cells, showing that not only one cell but several ones have cracks on the field oxide region.

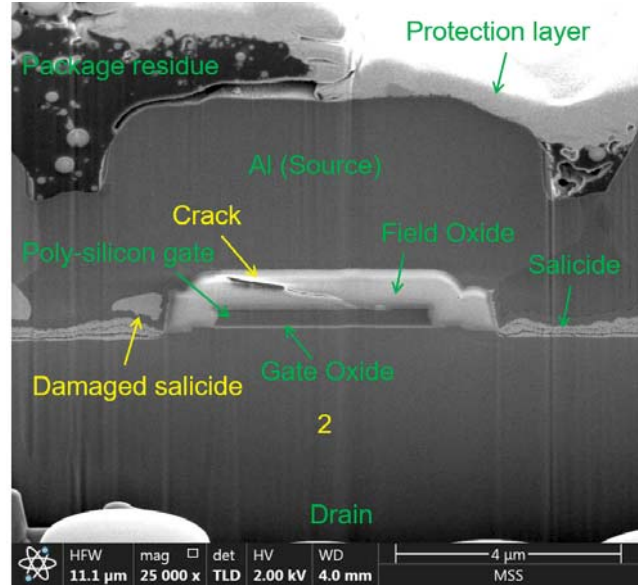
Furthermore, the salicide which is the technology that is used to form the electrical contact between the semiconductor substrate and the source terminal appears severely degraded, as pointed out in Fig. 5. This region is further magnified in Fig. 6, where it can be observed that solid particles accumulate in the aluminium source region between the salicide and the gate oxide. So far, the origin of these particles is not clear and it is not possible to provide the relevant information about the failure mechanism due to the short circuit stress. To better understand whether these particles may come from a process defect or could have originated after the applied short circuit stress, a cross-section of a new 1.2-kV/90-A SiC MOSFET will be presented in the next section.

Fig. 5. Magnified Focused Ion Beam (FIB) cross-section of the damaged cell.

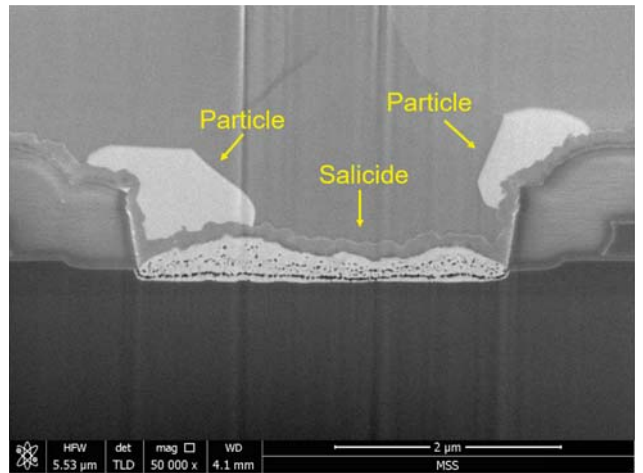
Fig. 6. Magnified Focused Ion Beam (FIB) of the salicide region of the degraded SiC MOSFET.
