## **Effect of short-circuit stress on the degradation of the SiO<sub>2</sub> dielectric in SiC power MOSFETs**

*Published in:*  
Microelectronics Reliability

# Effect of Short-Circuit Stress on the Degradation of the SiO<sub>2</sub> Dielectric in SiC power MOSFETs

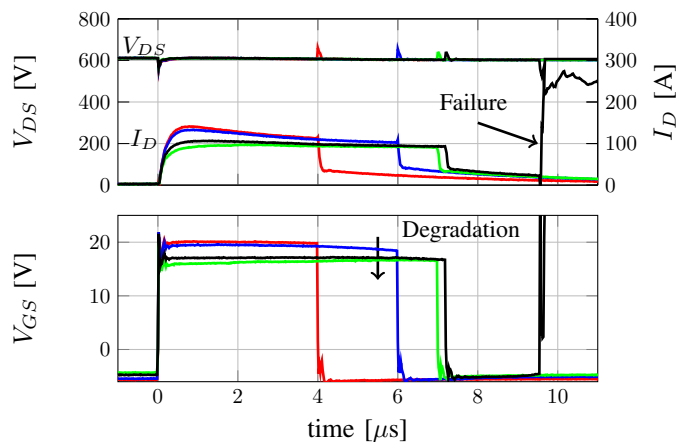
In SiC MOSFETs, the most common failure mechanism seems to be the gate-oxide breakdown, as the experimental results in Fig. 1 demonstrate so. Two degradation mechanisms are typically observed: (1) gate-voltage reduction at the end of the short circuit pulse, for example, the short circuit waveforms in Fig. 1 when the device is tested up to 6  $\mu$ s, and (2) permanent gate-voltage reduction, for example, the short

Fig. 1: Short-circuit tests with increasing time of a 1.2-kV/36-A SiC MOSFET:  $V_{DC} = 600$  V  $T_j = 150^\circ\text{C}$ .

circuit waveforms in Fig. 1 when the device is tested up to 7  $\mu$ s. Therefore, it is worth to note that the failure indicator is the on-state gate-source voltage reduction due to the increase in the gate leakage current, which eventually causes a permanent gate damage and ends up in a gate-oxide breakdown failure. This failure mode has been attributed to the high temperature and high electric field withstood across the thin gate oxide [7], [15], [16], combined with the much higher defect density of SiC MOSFET structures (i.e., substrate defects, particles and metallic contaminations). Recently, it has been discussed that robust short-circuit devices can be designed if the thickness of the oxide is increased or the cell pitch is increased, while on the other hand, the on-state resistance becomes compromised leading to greater power losses [17], [18]. Despite of this trade-off curve, cracks across the thin gate-oxide have not been reported in the literature, as discussed in [19], therefore this assumption needs to be further validated.

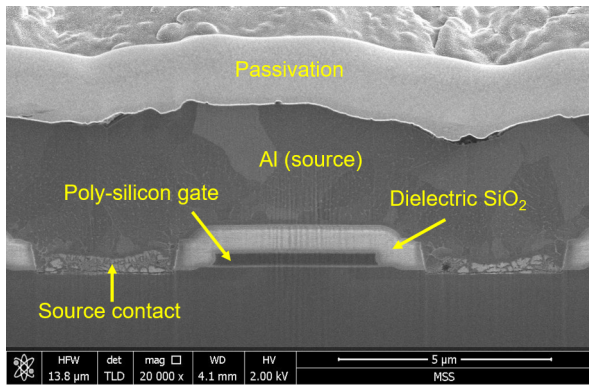
Fig. 2: Focused Ion Beam (FIB) cross section of the new 1.2-kV/90-A SiC MOSFET showing one cell.

The experimental investigations have been conducted on a commercial 1.2-kV/ 90-A SiC MOSFET having a TO-247 package and a planar technology (C2M0025120D). A Focused-Ion Beam (FIB) cut has been performed on the new SiC MOSFET first, which serves as a reference for later comparing the cell differences between the new and the degraded SiC MOSFET after applying the short circuit stress. The vertical cross section of the new device is presented in Fig. 2, where the gate structure of a single cell is observed. The cut has been performed on an arbitrary region of the device active area, showing no abnormalities or process defects.

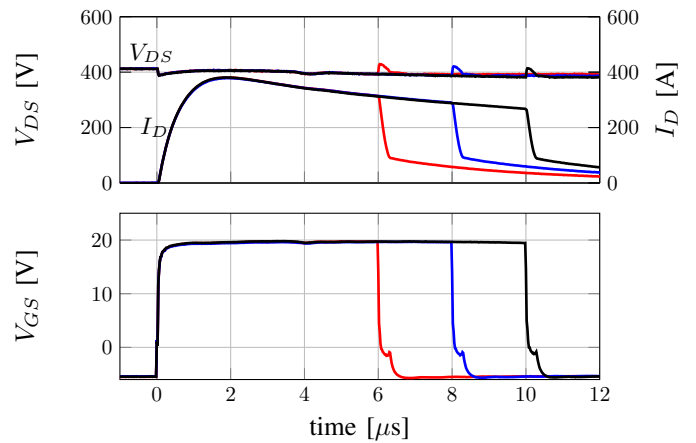
Fig. 3: Short-circuit tests with increasing time of a 1.2-kV/90-A SiC MOSFET:  $V_{DC} = 400\text{ V}$   $T_j = 150^\circ\text{C}$ .

results at low bias voltage and high temperature do not show any degradation on the gate voltage, and therefore, it can be concluded that the SiC MOSFET is able to survive this condition.

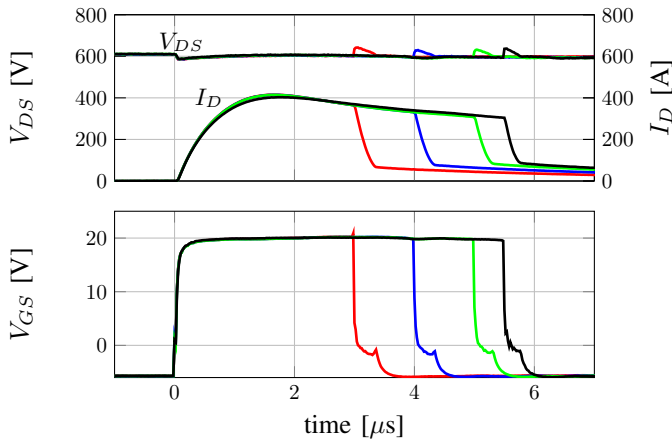
Finally, it is also worth to note that the gate voltage shows a voltage decay with increasing short circuit pulses. In Fig. 4, the  $V_{GS}$  reduces from 19.8 V to 19.4 V when the applied short circuit pulse is increased from  $3\ \mu\text{s}$  to  $5.5\ \mu\text{s}$  at  $T_j = 25^\circ\text{C}$ . This leads to a  $\Delta V_{GS} = 0.36\text{ V}$ , which means that the gate leakage current is only 36 mA, and therefore, the device

Fig. 4: Short-circuit tests with increasing time of a 1.2-kV/90-A SiC MOSFET:  $V_{DC} = 600$  V  $T_j = 25^\circ\text{C}$ .

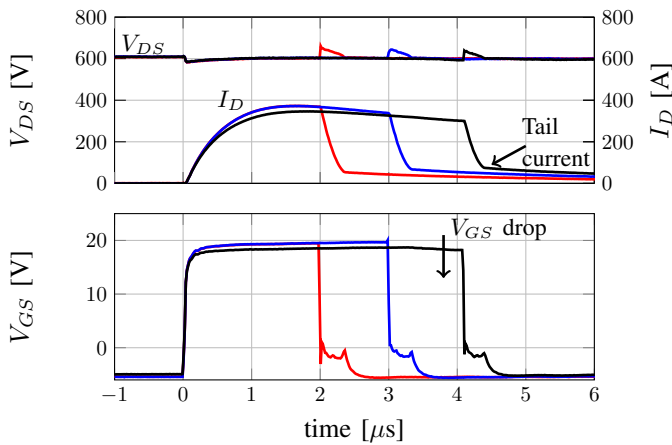
Fig. 4 shows the short-circuit voltage and current waveforms of the 1.2-kV/ 90-A SiC MOSFET for a bias voltage of 600 V and initial junction temperature  $T_j = 25^\circ\text{C}$ . Furthermore, Fig. 5 shows the same waveforms for a bias voltage of 600 V and  $T_j = 150^\circ\text{C}$ . In this work it has been assumed a 600 V application to be the nominal. The results at high temperature and nominal voltage show a significant reduction of the gate-source voltage  $V_{GS}$ , while the results at room temperature do not show such a degradation. In Fig. 5, the  $V_{GS}$  reduces from 19.7 V to 18.7 V while the short circuit pulse has been increased from  $3\ \mu\text{s}$  to  $4\ \mu\text{s}$ . This leads to a  $\Delta V_{GS} = 1\text{ V}$ , which means that the gate current increases 100 mA ( $R_g = 10\ \Omega$ ). The gate leakage current for a fresh device is in the nA-level, and then gradually increases with the short circuit pulse duration up to 100 mA, which is considered as the critical point. The gate leakage current now flows through a new path between gate and source, which demonstrates that the gate electrode is no longer isolated.

After the last test, the damage on the gate side is permanent but the device is still able to turn-on/turn-off. With the aim of performing a physical structural analysis of the device, the short-circuit experiments are stopped before observing a gate breakdown failure, as pointed out in Fig. 1. Thanks to the physical analysis, the assumption that a new resistive path has been originated will be validated.

Fig. 5: Short-circuit tests with increasing time of a 1.2-kV/90-A SiC MOSFET:  $V_{DC} = 600$  V  $T_j = 150^\circ\text{C}$ .

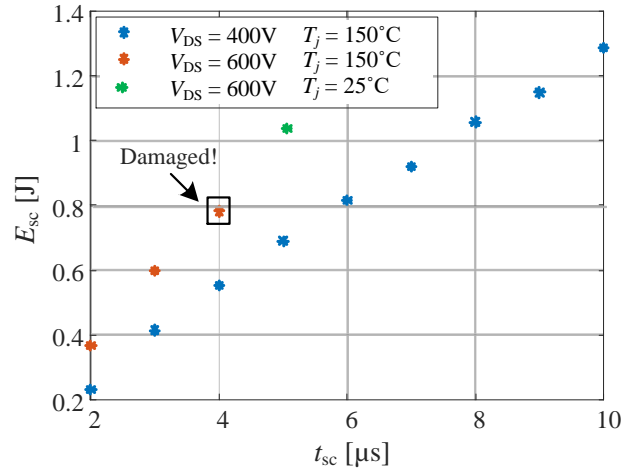
The calculated short-circuit energies from the short circuit current and drain-source voltage waveforms have been plotted in Fig. 6. The short-circuit energy causing a permanent damage on the SiC MOSFET is 0.8 J, which can be considered as the critical energy when the device is tested at  $T_j = 150^\circ\text{C}$  and  $V_{DC} = 600$  V. Furthermore, the calculated short-circuit energy for a bias voltage of 600 V and  $T_j = 25^\circ\text{C}$  is about 1.14 J, which is above the one that lead to a permanent degradation in the previous case. The calculated short-circuit energies when the device is tested under a bias voltage of 400 V and  $T_j = 150^\circ\text{C}$  show that the value is also above the one leading to the permanent damage of the device, even though the initial junction temperature was the same ( $T_j = 150^\circ\text{C}$ ). These results prove that in planar SiC MOSFETs, the gate reliability

is not only related to the critical energy, but bias voltage plays a significant role, too.

Fig. 6: Calculated short-circuit energy for two bias voltage ( $V_{DC} = 400$  V and 600 V) and initial junction temperatures ( $T_j = 25^\circ\text{C}$  and  $150^\circ\text{C}$ ).

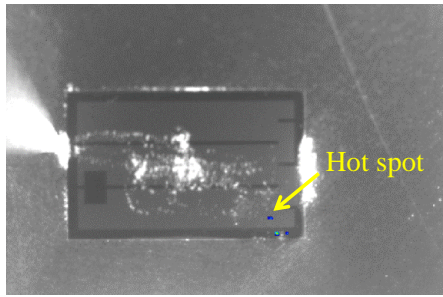
After the last short circuit test under bias voltage of 600 V and initial junction temperature  $T_j = 150^\circ\text{C}$ , where we have observed a clear damage on the gate side (Fig. 5), a physical failure analysis on the 1.2-kV/ 90-A SiC MOSFET has been performed. First, the package material has been removed by high-temperature etching, and then, an Indium Gallium Arsenide (InGaAs) infra-red camera has been used to find possible hot spots. The principle is to apply a voltage on the drain terminal and connect the gate and the source terminals to ground. If the SiC MOSFET has a damage, a leakage current will appear from drain to source or drain to gate, which can be detected with a very sensitive infra-red camera. The results can be observed in Fig. 7, where a hot spot in the device active area is revealed. The location of the hot-spot is highlighted in Fig. 7.

Fig. 7: InGaAs infra-red image of the degraded 1.2-kV/ 90-A SiC MOSFET under short circuit.

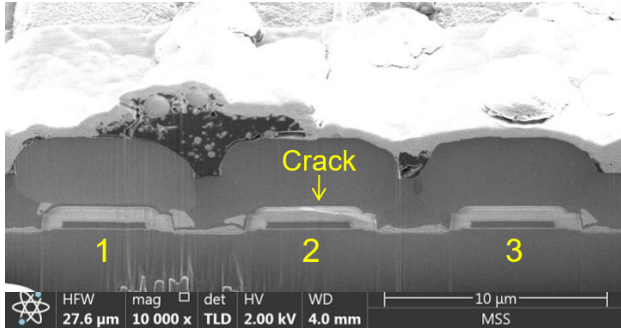
A Focused Ion Beam (FIB) micro-section at the hot spot location is applied to find possible damages on the gate oxide. Fig. 8 reveals the image of the FIB cut, where the vertical structure corresponding to three cells is observed. It is worth to note that one of the cells appears to be cracked, therefore, this particular cell is further magnified in Fig. 9. It is interesting to compare the image between the new (Fig. 2) and the degraded SiC MOSFET (Fig. 9), which proves that three major degradations have been found:

- 1) A crack in the dielectric between the poly-silicon gate and the aluminium source.
- 2) Metal particles accumulated near the source contact (salicide).

Fig. 8: Focused Ion Beam (FIB) cross-section of three cells at the hot spot location, where one of the cells presents a crack.

3) Alterations in the top surface of the aluminium source.

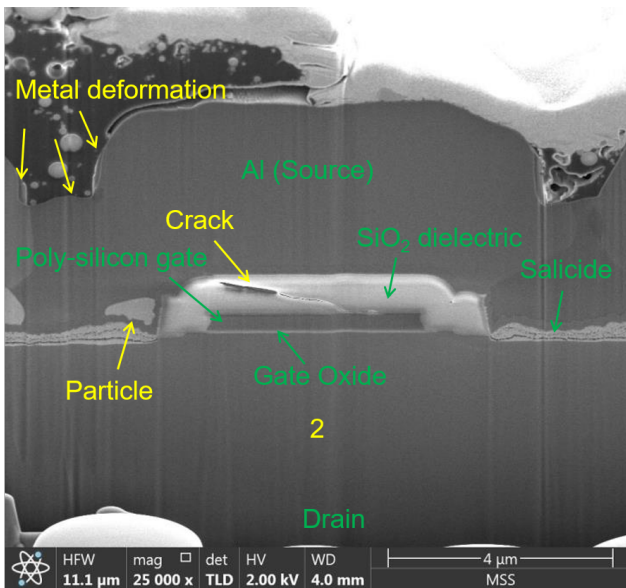
Each of the three degradations are analysed in more detail in the following. First, the cracks found in the degraded device between the poly-silicon gate and the aluminium source cannot be found for the new device, which proves that have been

Fig. 9: Magnified Focused Ion Beam (FIB) cross-section of the damaged cell.

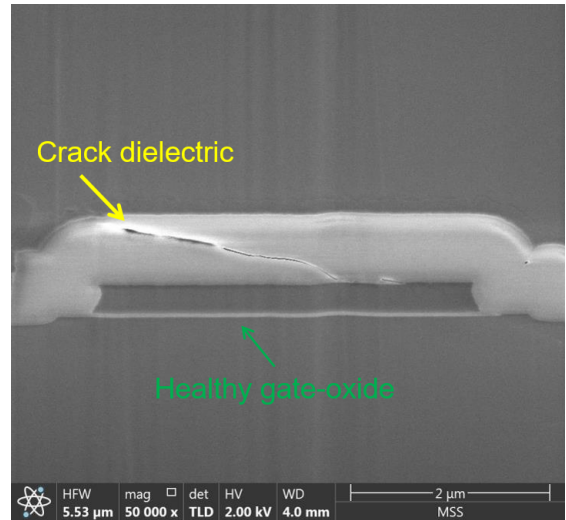
Fig. 10: Image of the gate-oxide region.

formed after the short circuit stress. Furthermore, Fig. 10 shows a magnified image where the gate-oxide layer appears to be intact in this cell. This observation demonstrates that the high electric field and high temperature sustained across the thin gate-oxide was not the root cause of the gate damage. A more in-depth analysis has been performed on adjacent cells, showing that not only one cell but several ones have cracks on the inter-level dielectric (between poly-silicon gate and aluminium source).

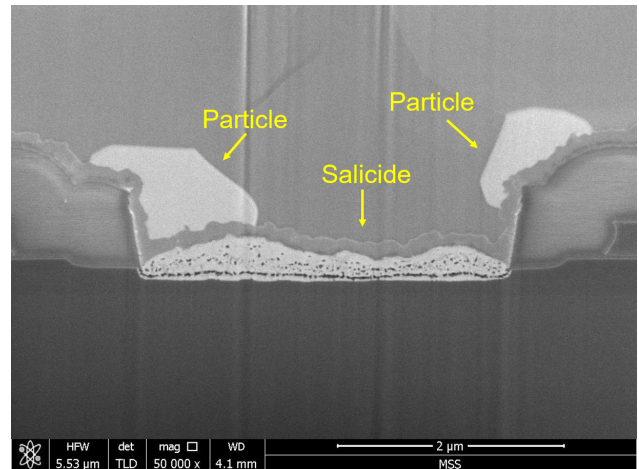
Fig. 11: Magnified Focused Ion Beam (FIB) of the salicide region of the degraded SiC MOSFET.

The salicide which is the technology that is used to form the electrical contact between the semiconductor substrate and the source terminal appears to be severely degraded, which can be observed in Fig. 11. First, the source contact thickness is not homogeneous and second, particles can be observed near the salicide which are not seen for the new device. This indicates that they could have originated as a consequence of the short-circuit stress and not from device process defects. Although a material analysis has not been performed on the particle itself,

it can be said that the material must be a metal because of the image light color.

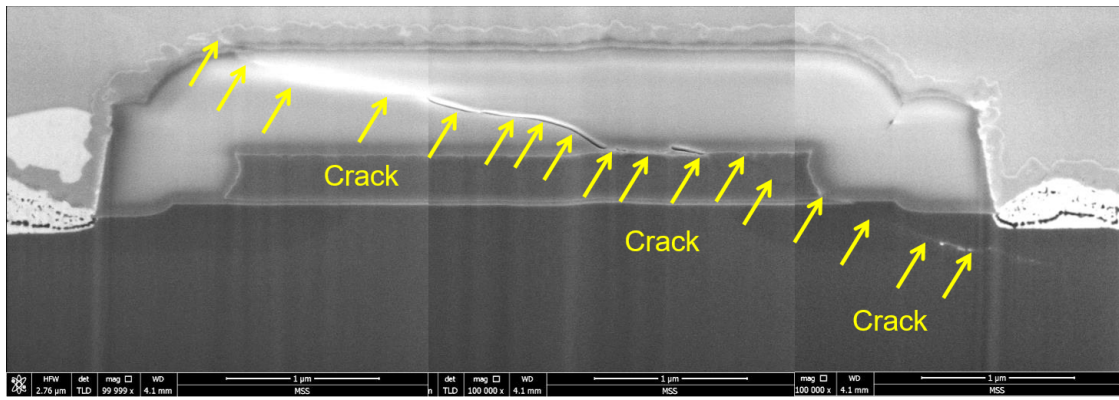
Fig. 12: Focused Ion Beam (FIB) microsection showing a crack between the source metallization and the SiC substrate.

The damaged SiC MOSFET die has been further analysed with the aim of finding defects that could explain the drain leakage current increase. A FIB micro-section has been performed at different locations in the vicinity of the hot spot. In Fig. 12, it can be recognized that the crack between the poly-silicon gate and the aluminum source has propagated towards the SiC substrate through the poly-silicon gate and gate-oxide probably in the third dimension and therefore not clearly visible in Fig. 12. This crack allows for a conductive path between the drain and source generating a drain leakage increase consequently.

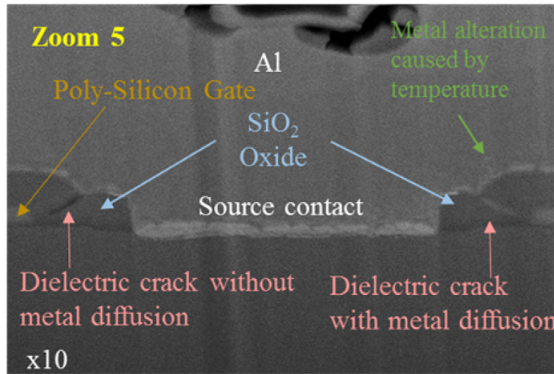
(a) Scanning Electron Microscope (SEM) image showing cracks in the dielectric around the poly-silicon gate electrode of a 1.2 kV/ 36 A SiC MOSFET [20].

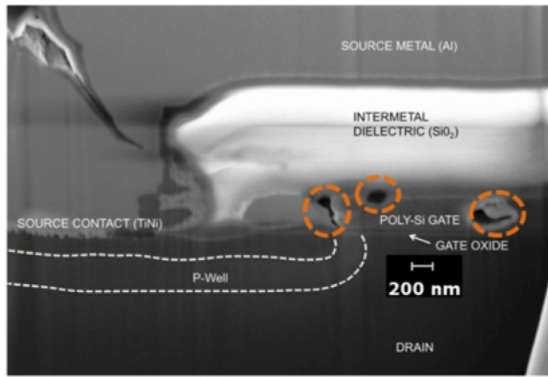
(b) SEM image showing defects in the poly-silicon gate electrode of a 1.2 kV SiC MOSFET [21].

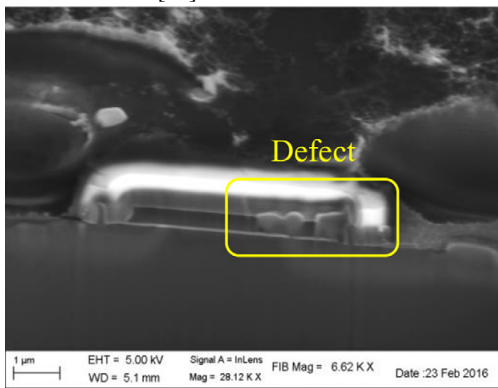
(c) SEM image of the degraded 1.2 kV/ 24 A SiC MOSFET cell showing defects in the poly-silicon gate electrode [4].

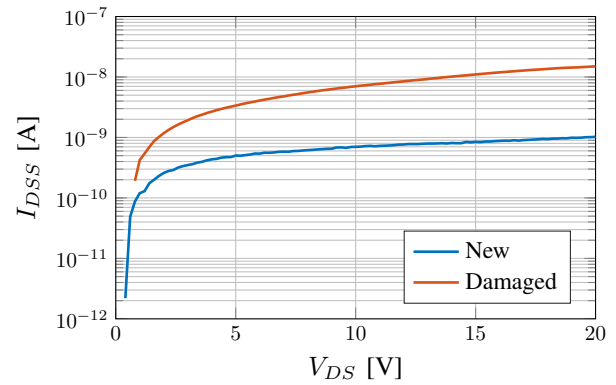
The degradation of the 1.2-kV/ 90-A SiC MOSFET has been attributed to the change in gate leakage current and gate damage due to the formation of cracks in the SiO<sub>2</sub> dielectric. Nevertheless, it is worth to discuss that the drain leakage current significantly increases between the fresh and the damaged device, as observed in Fig. 14, where the typical  $I - V$  curve is presented. The aim is now to find out through the physical inspection of the device, whether there are further cracks or defects that allow the drain leakage current to flow from drain to source through a new path.

Fig. 14: Short-circuit tests with increasing time of a new and a degraded 1.2-kV/90-A SiC MOSFET:  $V_{DC} = 600$  V  $T_j = 150^\circ\text{C}$ .
