Detailed Inspection of Metal Implants

Hothi, Harry, Berber, R, Whittaker, Robert, Bills, Paul J., Skinner, John and Hart, A. J. (2015) Detailed Inspection of Metal Implants. *Hip International*, 25 (3). pp. 227-231. ISSN 1120-7000

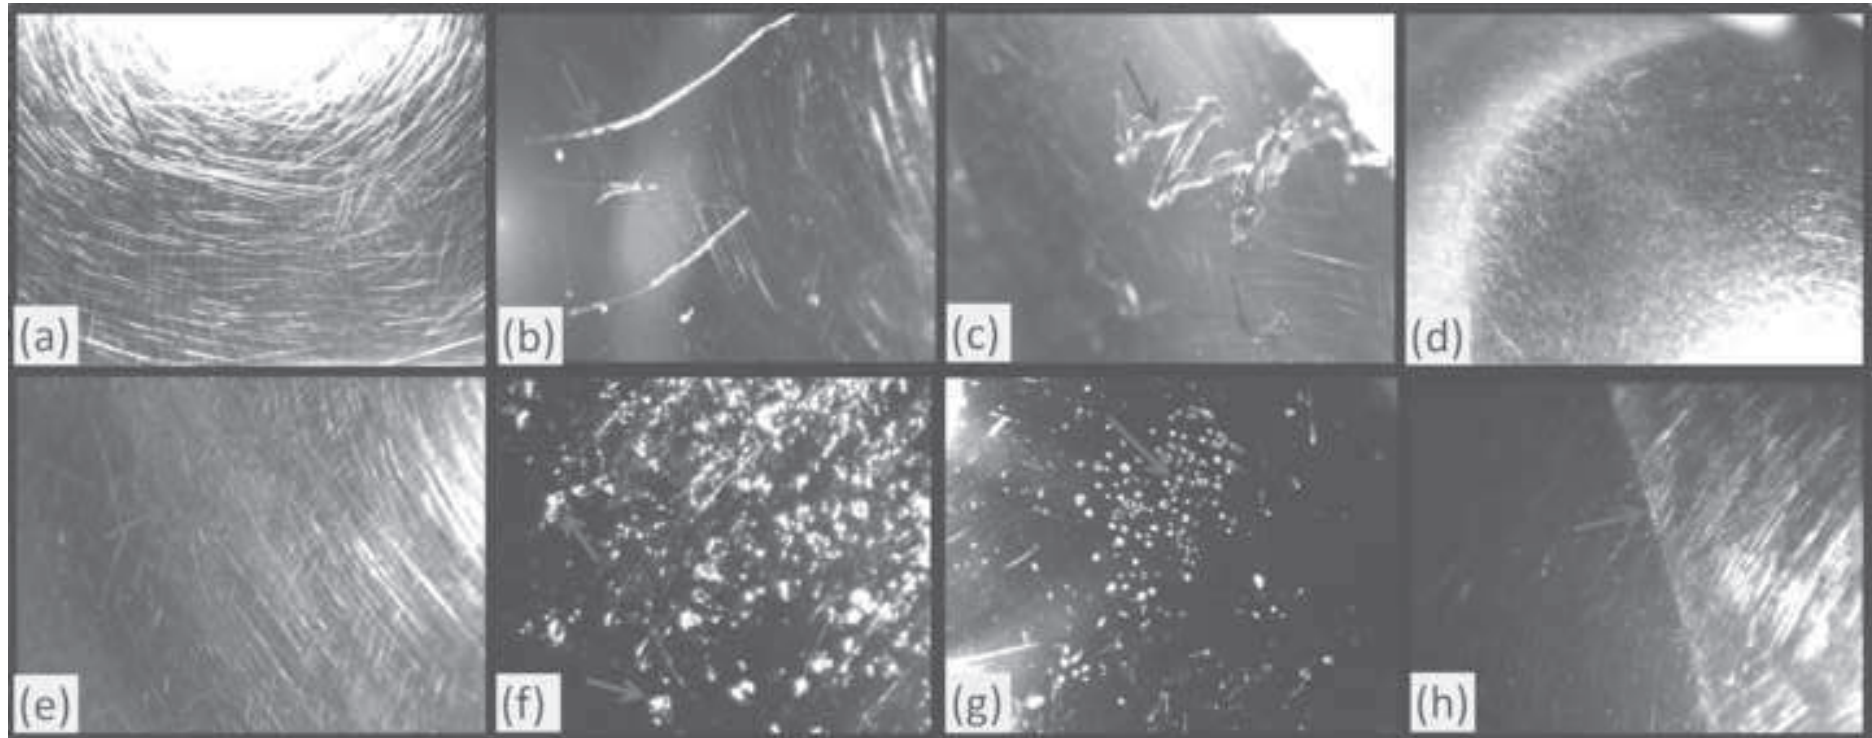
Figure 1
[Click here to download high resolution image](#)

The presence of 8 specific features relating to changes in the visual appearance of the surfaces was recorded. In this study these features are referred to as: (1) light scratches; (2) moderate scratches; (3) heavy scratches; (4) haziness; (5) discolouration; (6) embedded particles; (7) pitting; (8) presence of a visible wear scar, Figures 1. Table 1 describes the criteria used to define each feature.

Figure 1: Examples of bearing surface features observed microscopically: **(a)** Light scratches, **(b)** Moderate scratches, **(c)** Heavy scratches, **(d)** Haziness, **(e)** Discolouration, **(f)** Embedded particles, **(g)** Pitting and **(h)** Clear wear scar
