Case Studies in Engineering Failure Analysis

Failure analysis of the fasten system of wheels used in mining pickup trucks

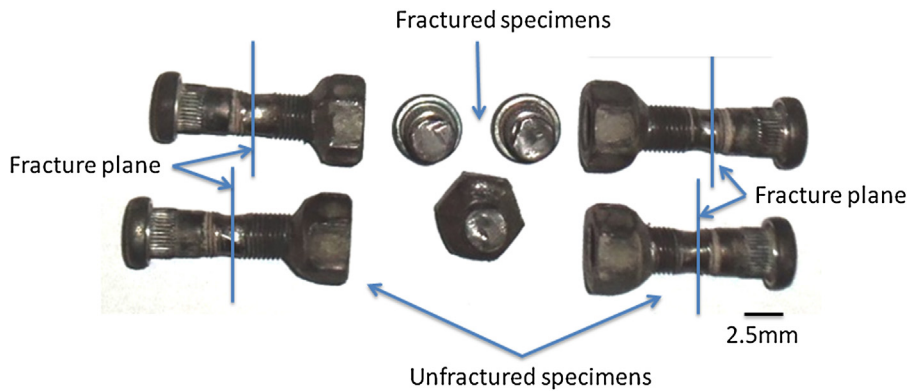
Fig. 1. Photographs of the machines elements before and after failure.

Fig. 1 shows photographs taken from specimens removed from a wheel before and after failure which is expressed by fracture of body of the bolts. It is worth mentioning that the thread of the lug-nuts did not present fracture but exhibited a considerable amount of plastic deformation. The chemical composition (%wt) and measured hardness values of the lug nuts and bolts taken from the vehicles are presented in Table 1. This table also includes the hardness values and chemical composition of steels that are suggested for machine elements used in this application according to SAE standards [9]. Comparison of the data allows to identify that the chemical composition of the faulty bolts does not vary much from the materials suggested by the standard however, a considerable variation of the chemical composition of the lug-nuts can be observed.

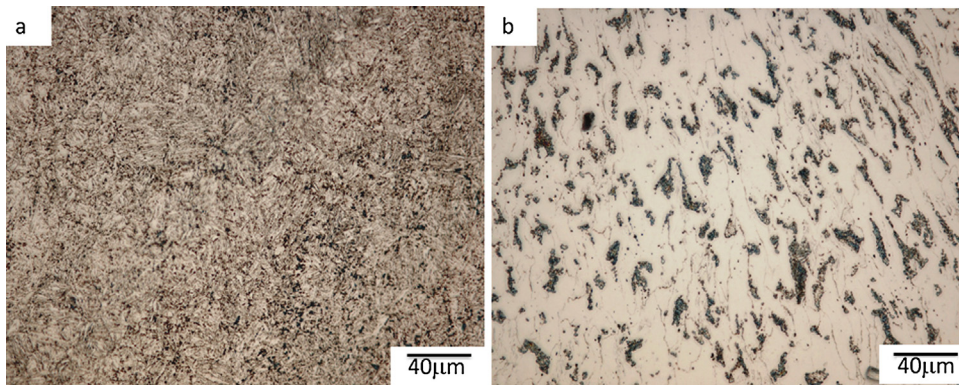
Regarding the metallographic inspection of the specimens, Fig. 2 shows the microstructure that was revealed after etching the polished specimens. From this picture, it is possible to identify that the bolts (Fig. 2a) present a tempered

Fig. 2. Microstructures of the machine elements. a) bolts. b) lug-nuts.

martensite matrix that is typical of high resistance machine elements for this application [9,10]. Contrarily, the lug-nuts (Fig. 2b) presented a matrix comprised by ferrite grains with dispersed pearlite islands.

As a first premise and by means of the metallographic analysis, it was determined that the lug-nuts of specimens that presented failure presented a ferritic-pearlitic microstructure. From the point of view of the theory of mechanical design and defined standards that apply to machine elements for automotive applications [9,10], the combination of these materials particularly for this application is not suitable given that bolts of high strength steel must be coupled with lug-nuts of similar metallurgical characteristics; this of course was not the case and lug nuts similar to an AISI 1020 steel were used [11]. In addition, during this inspection, it was also found that severe plastic deformation was experienced by the lug-nuts as it shown in Figs. 5 and 6. The deformation experienced by these machine elements in faulty specimens can be associated with the overtorque applied every time that the lug-nuts where tightened when they became loose. Certainly this action exerted a stress state that clearly exceeded the yield strength of these elements and caused plastic deformation by cold working which can be proven by the microhardness values taken at these zones which are shown in Fig. 8. These values where obtained after the development of tightening experiments in pair of new machine elements with a digital torque wrench which prove that, when the torque exceeds a value of 167.5 N-m (which is the value of torque suggested for this vehicle according to the manufacturer), plastic deformation occurred.

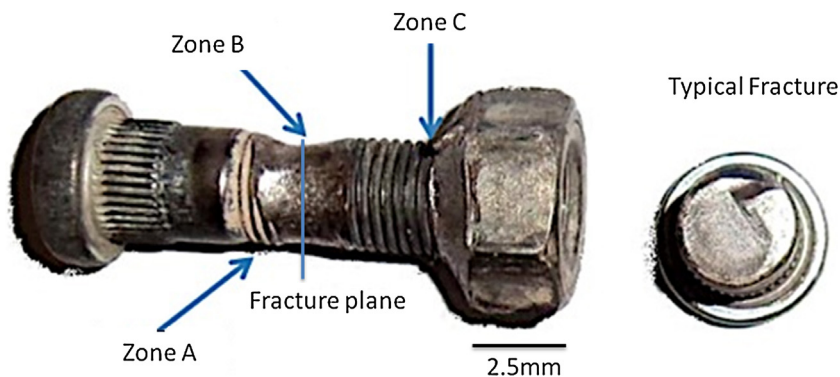
Fig. 3. Characteristic zones formed on the lug nut before failure by fracture.

Alternatively, the visual aspect of near-to-failure specimens taken from a wheel that was not ejected is presented in Fig. 3. From this figure it is possible to note the presence of three characteristic zones. The first of these corresponds to damage of the original limit of the thread of the bolt (zone A) together with two zones that denote severe plastic deformation of the threads of the bolt and the lug-nut (zones B and C respectively). In addition, the wheels that failed during operation of the vehicle exhibited fracture of at least 4 bolts. The results of a greater detail inspection of these specimens conducted with a stereoscope allows to suggest that all of them presented the same distinctive namely beach marks, cracks that propagate from the surface to the centre in the radial direction of the bolt and necking (Fig. 4a–c). Apart from these morphological features, most of the machine elements that presented exhibited a considerable amount of oxide on the fracture surface as it is clearly shown in Fig. 4a.

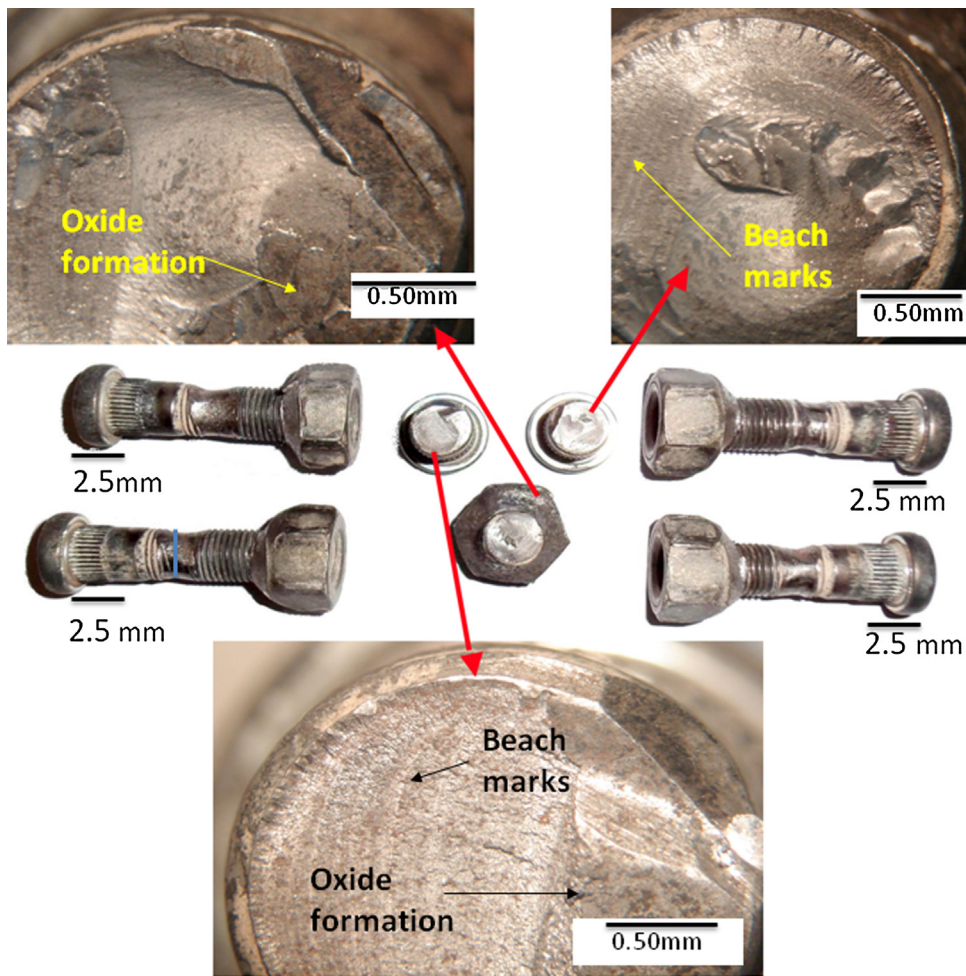
Fig. 4. Characteristic zones formed in fractured specimens.

Upon the deformation of lug-nuts, gaps were created at different zones between the lug-nuts and bolts that promoted the formation as non conformal contact surfaces as it was shown in Figs. 6 and 7. Given the harsh conditions of the roads where these vehicles transit, undoubtedly, a vast amount of cyclic loads acted on the bolts (as it was suggested by the shear pattern that can be clearly appreciated in Fig. 5) and, as these elements were not properly fixed the tension applied to them was lost, they entered into a fatigue state. The nucleation and propagation of cracks from the surface of the bolts to their geometrical centre shown in Fig. 7 can be considered as the main evidence that supports this phenomenon. Once a considerable amount of cracks were developed, fracture of the bolts occurred (Fig. 4) and with this, the detachment of the wheels from the vehicle.

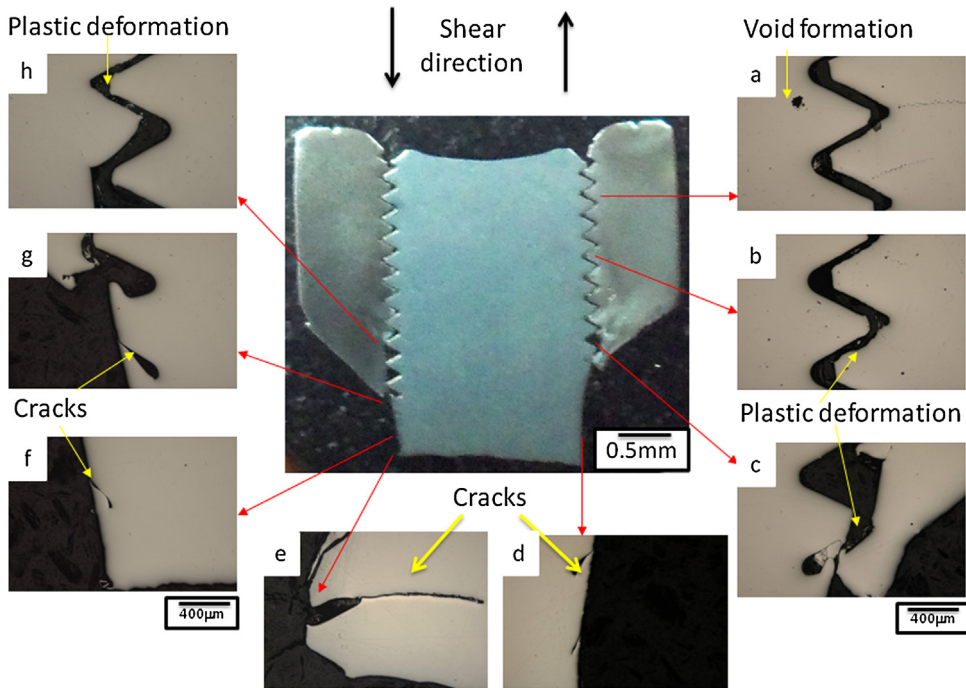
After the visual inspection of the fractured specimens a metallographic analysis was also conducted for a pair of machine elements before the possible failure of a wheel, i.e. just before tightening practices. The results from this analysis are presented in Fig. 5 where it can be appreciated that, after one week of operation, the lug nuts and bolts are severely deformed judging by the shear pattern that is established in the vertical direction. In addition, void nucleation and crack propagation in the radial direction were frequently observed for both machine elements together with plastic deformation of the crests. In some zones plastic deformation was quite severe that fragments from the lug-nuts were removed and trapped at the interface formed between the machine elements (Fig. 6). Furthermore the lug-nuts also presented a severe overretching this phenomena being only observed particularly at the crests of the thread (Fig. 7) where also, a concentration of plastic deformation and a crack were also found.

Fig. 5. Severe plastic deformation of lug-nuts and bolts, and phenomena that comprise this degradation mechanism.

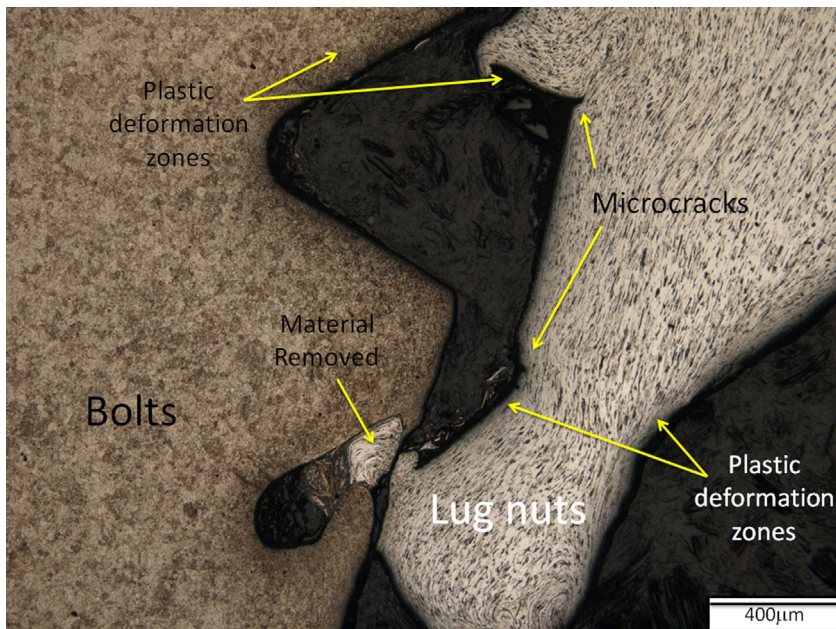
Fig. 6. Greater detail optical micrograph showing localized plastic deformation of lug-nuts and bolts.

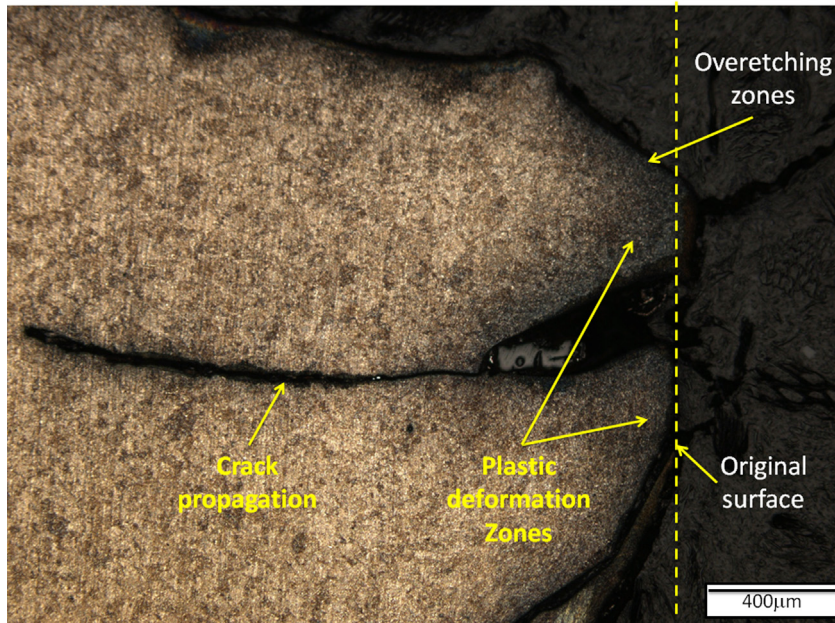
Another important aspect that was found during the metallographic inspection of a particular set of faulty specimens, was the formation zones (revealed by means of overetching of the samples during metallographic preparation) localized at the top of the crests of the thread, in fact, some of these zones also presented some degree of plastic deformation as it can be appreciated in Fig. 7 and with greater detail in the backscattered electron micrograph shown in Fig. 9. This micrograph suggests the existence of a phase transformation from martensite to ferrite where the plastic deformation of the latter phase is also observed. This phenomenon can be associated with various mechanisms the most common among these, decarburization during heat treatment practices [12]. This was probably the case because the carbon content %wt that

Fig. 7. Localized overetching, plastic deformation at crests and fracture propagation in a bolt.

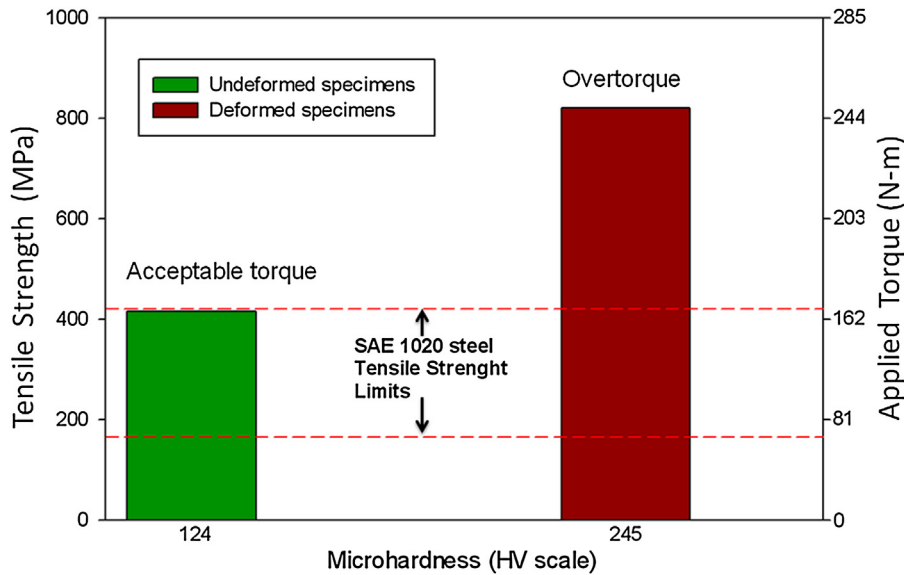
Fig. 8. Tensile strength equivalent to their Vickers hardness number of the bolts after the application of different torque values.

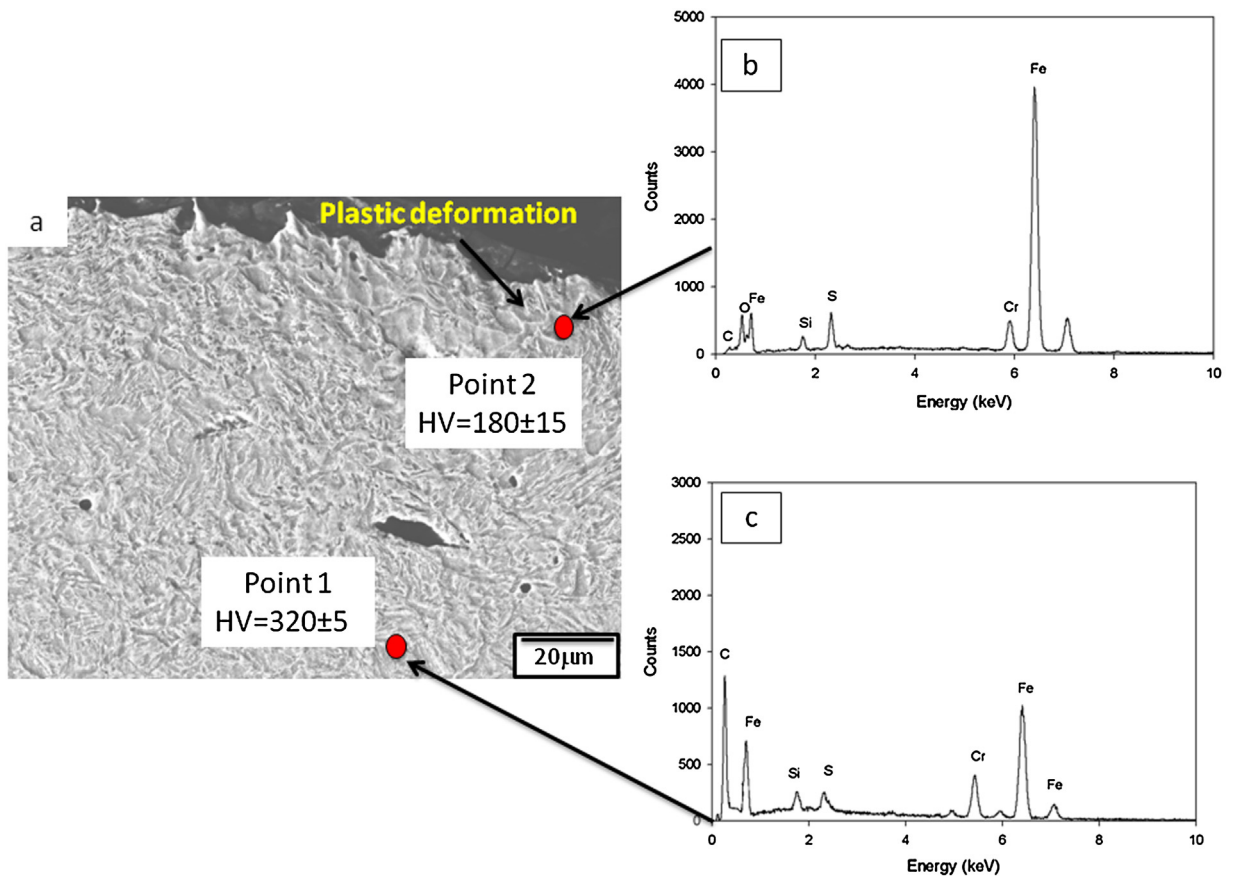
the carbon content measured at point 1 in Fig. 9a) in the martensite region, is greater (0.25%wt) than the carbon content in ferrite that resulted (0.09%) (marked as point 2 in Fig. 9b), suggesting that a phase transformation could occur at this location. However, as EDX analyses have only a semi-quantitative character, micro-hardness measurements were taken using the Vickers scale showing that the hardness values taken in the ferrite region ($HV = 150 \pm 15$) are effectively lower if compared with the values of hardness taken in the martensitic matrix ($HV = 320 \pm 5$) proving that a different phase composition exists at these regions.

Ofier et al. [12] suggested that local decarburization of tool steel machine elements promotes failure by crack formation due to phase mismatch hence; the differences in the elastic properties between ferrite and martensite at the crests of the thread and the strain accumulated due to cold working are enough reasons to promote crack nucleation and further

Fig. 9. Scanning electron micrographs and energy dispersive X-Ray analyses of characteristics zones formed in the bolts.
