Investigation of High Energy Arcing Fault Events in Nuclear Power Plants

Heinz Peter Berg¹ and Marina Röwekamp²

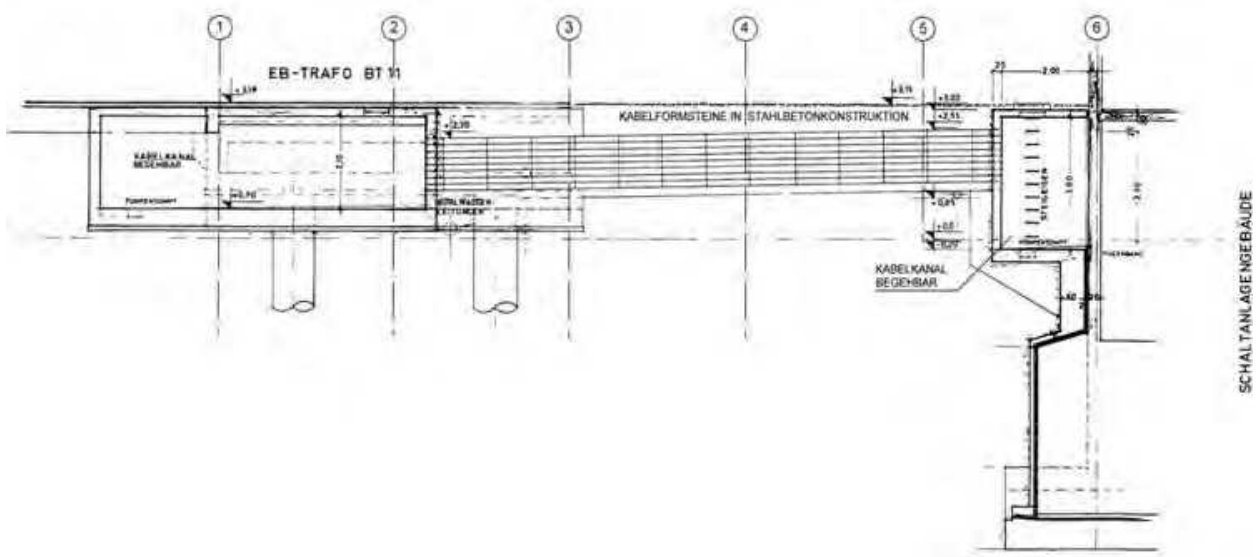
Due to the conditions in the ground, cables were partly imbedded in so-called 'cable cylinder blocks' manufactured from concrete (see Figure 2).

Fig. 2. Cross section of the cable tray inside the cable cylinder blocks inside ground between the buildings

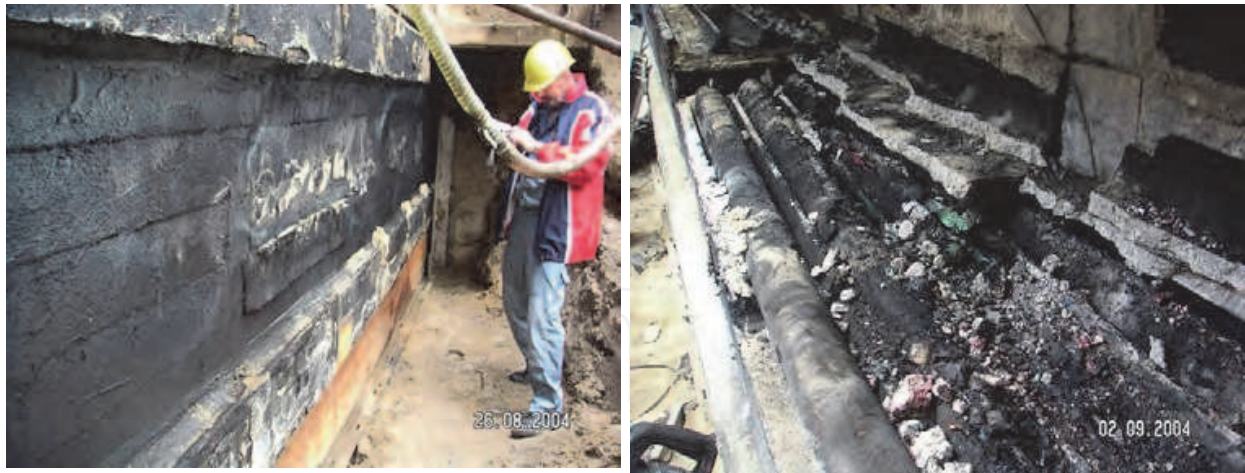
Fig. 3. Photos of the cable damage; left: location of the damaged cable, right: damage by the cable fire/evaporation

The detailed analysis led to the definite result that the event was mainly caused by ageing of the 10 kV cables. The ageing process was accelerated by the insufficient heat release inside the cable cylinder blocks.

As a corrective action, all high voltage (mainly 10 kV) cables with PVC shielding being older than 30 years were replaced by new ones.

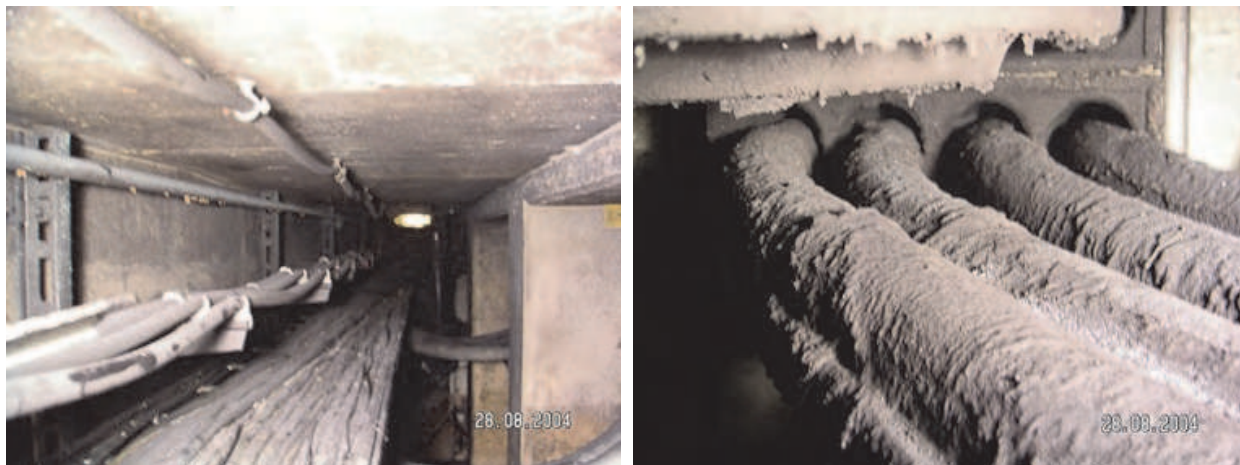
Fig. 4. Cables with protection by intumescent coating; left: photo of the cable channel, right: photo of the coating

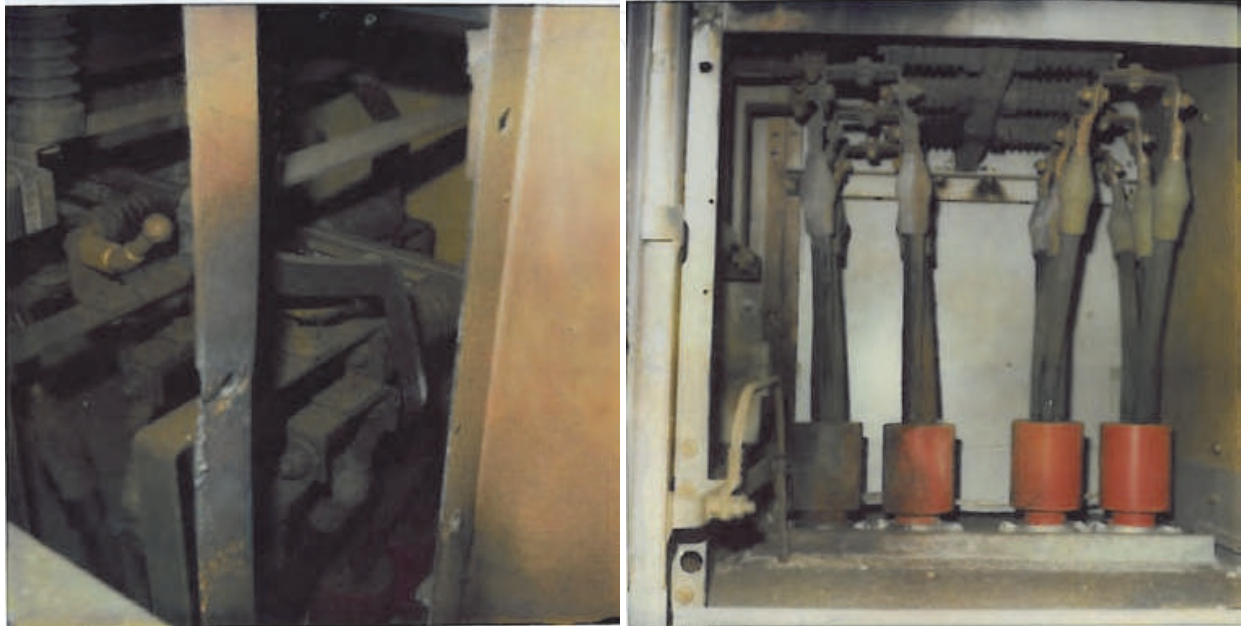
Fig. 5. Photographs: a) view into the exciter cabinet, in the foreground location where the screw loosened and b) view into the cabinet

Performing a load test during a regular in-service inspection (usually at an interval of four weeks) of the emergency diesel generator, an arcing fault with a short-to-ground took place in the electrical cabinet of the exciter system of the emergency diesel generator (cf. Figure 5 above).

The ground fault is assumed to be caused by a loose screw. The ionization of air by the arc developed to a short circuit within approximately four seconds.

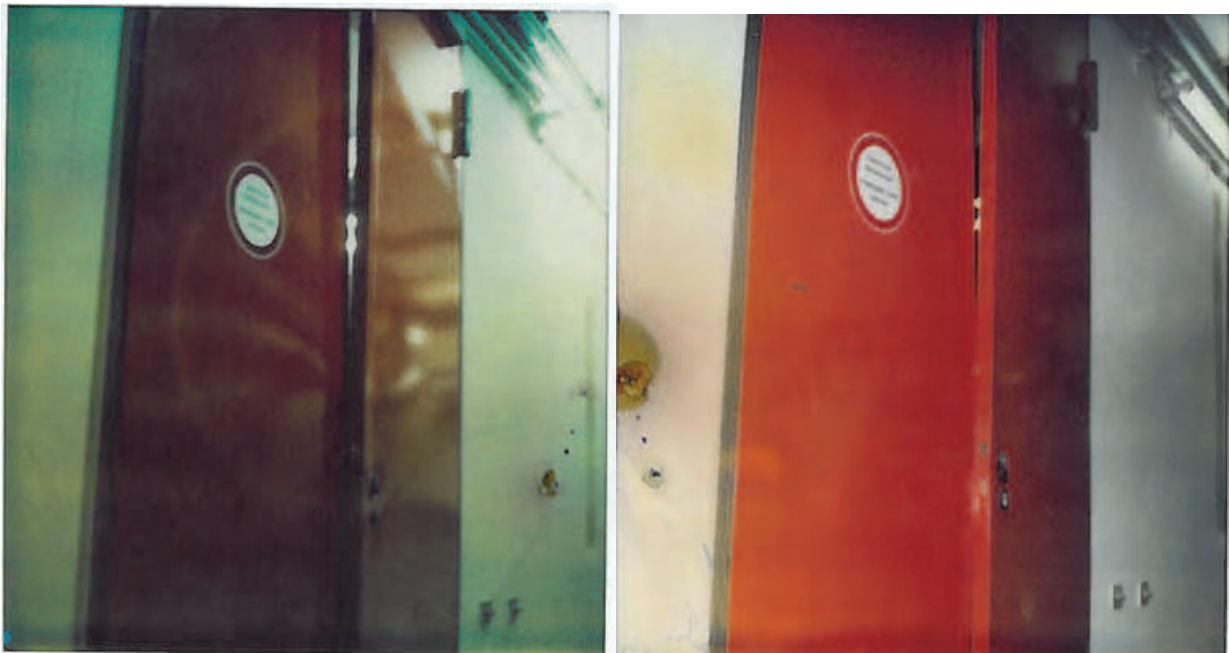
Fig. 6. Photographs of the damaged fire door from outside the room

Due to the high energy electric arcing fault a sudden pressure rise occurred in the room (room dimensions are approximately 3.6 m x 5.5 m x 5 m) that damaged the double-winged fire door.

Photographs of the damaged fire door from outside the room are shown in Figure 6 above.

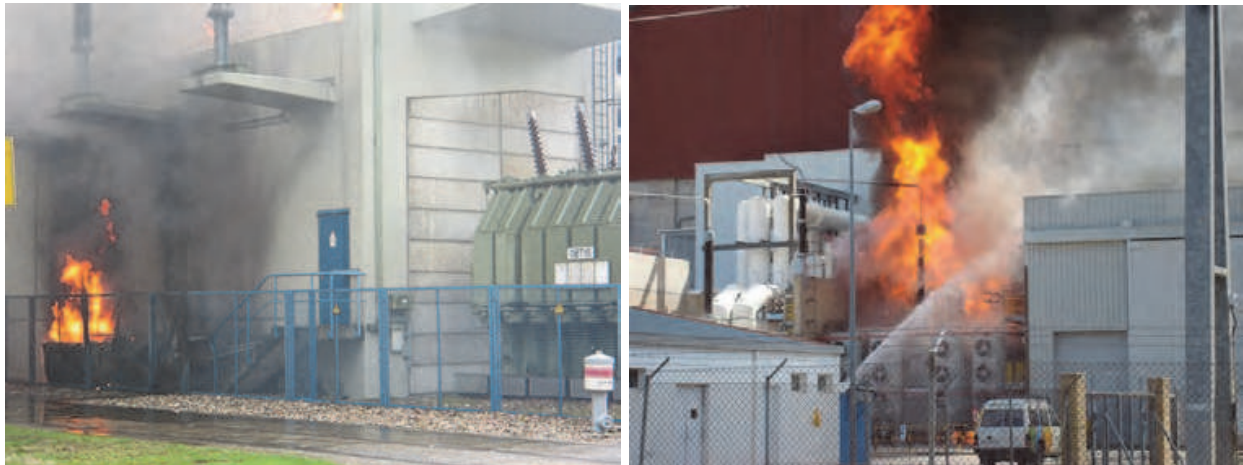
Due to the damage caused by the fire in the transformer, the plant was shut down. The fire of the transformer showed the normal behaviour of a big oil-filled transformer housing, the fire lacks combustion air and produces a large amount of smoke (see Figure 8).

A detailed root cause analysis regarding the different deviations from the expected event sequence was carried out. The cause of the fire was a short circuit in the windings of the generator transformer. Due to the damages to the transformer it was not possible to resolve the failure mechanisms in all details.

Fig. 8. Flame and smoke occurring at the generator transformer; the photo on the right hand shows the fire extinguishing activities

As a consequence of these indications, improvements concerning the fire protection of transformers are intended in Germany (Berg et al., 2010).

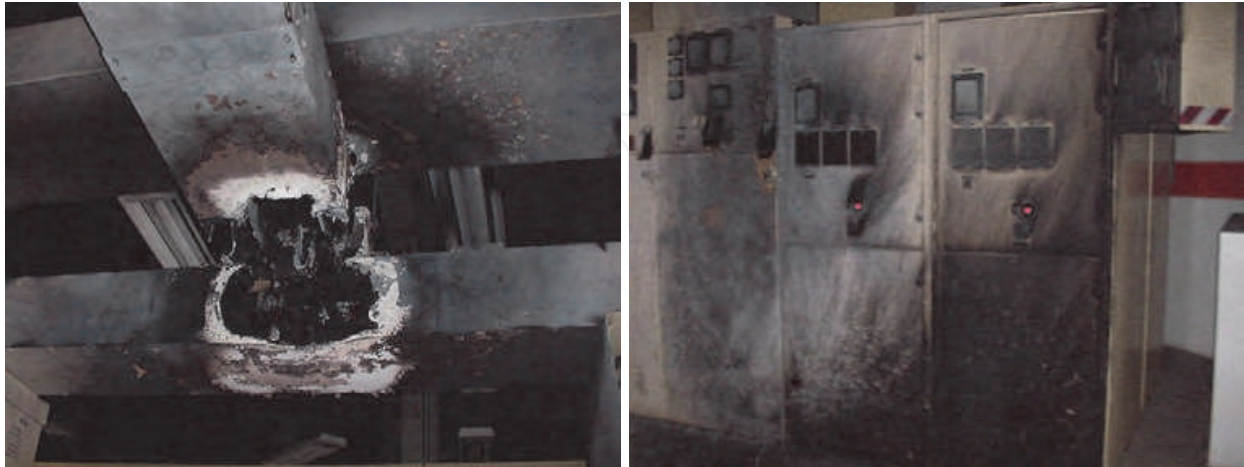
This event was initiated due to the centre bus overheating causing the polyvinyl chloride (PVC) insulation to smoke, which lead to a failure of the adjacent bus insulation. Having only a thin layer of silver plating on the electrodes, noticeably flaking off in areas not directly affected by the arc, contributed to the high-energetic arcing fault event.

Other factors that caused the failure were heavy bus loading and splice joint configurations, torque relaxation, and undetected damage from a 1995 transformer explosion. Two photos of this failure are shown in Figure 9. More photos are provided in (Brown et al, 2009).

Fig. 9. Photographs of the damages at the Diablo Canyon nuclear power plant (from Brown et al., 2009)

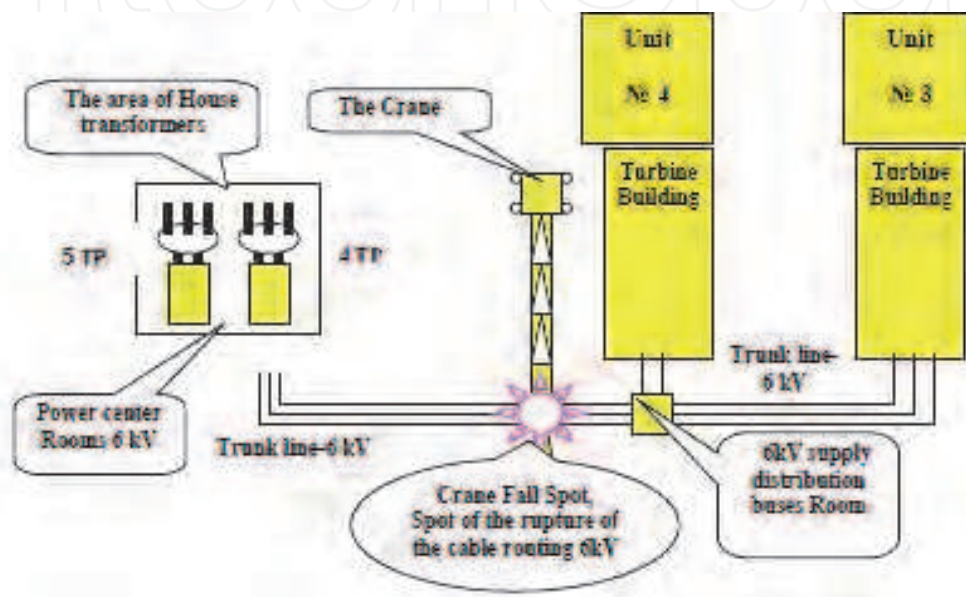
The long-term exposure of this earth fault (1 min and 36 sec.) caused a high earth fault currents which burn the cables. This led to a fire spread to the 6 kV supply distribution buses and 6 kV metal clad switchgear rooms resulting inside these rooms in high temperature and release of the toxic substance. Also the equipment of the transformers TP 4 and TP 5 was damaged.

Fig. 10. Diagram of the situation after the event (from IAEA, 2004)
