# Lessons Learned from Recent Earthquakes – Geoscience and Geotechnical Perspectives

Robert C. Lo<sup>1</sup> and Yumei Wang<sup>2</sup>

<sup>1</sup>*Klohn Crippen Berger Ltd., Vancouver, B.C.*

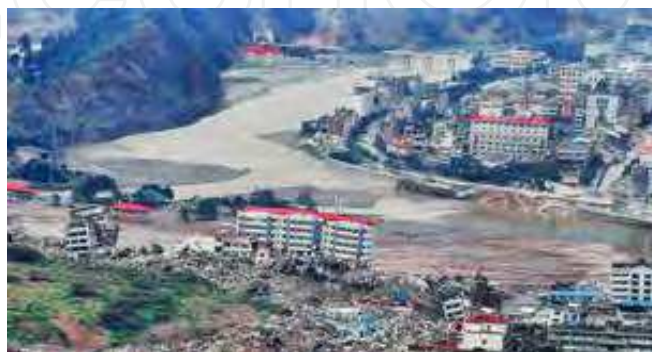
Fig. 8. Old Beichuan Town After Earthquake. <http://www.eeri.org/site/meetings/us-china-us-china-symposium>

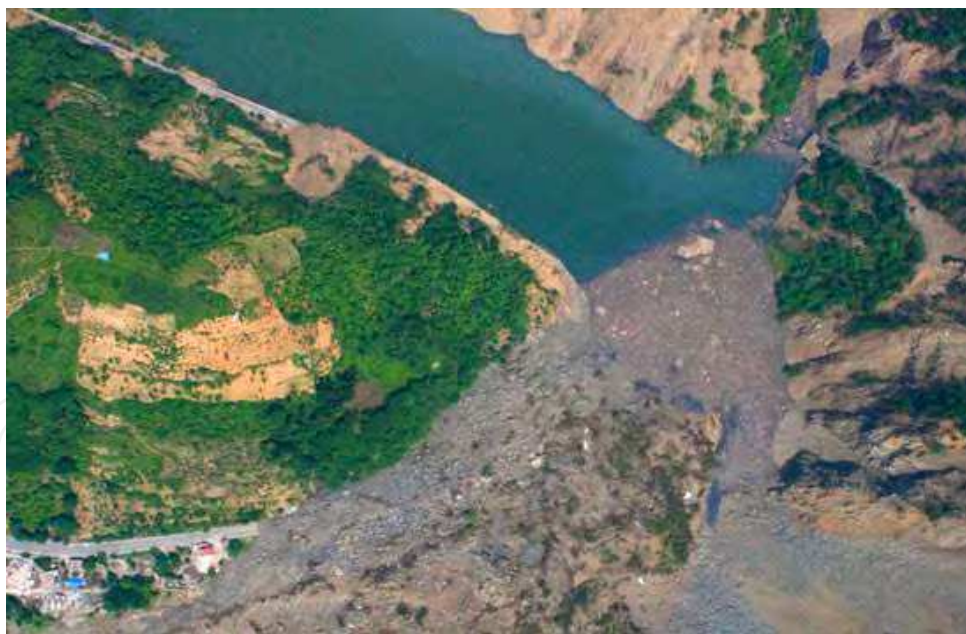
Up to 34 landslide lakes were formed in Sichuan and one in Gansu provinces, threatening about 700,000 people living downstream. The largest one was located in Tangjiashan, Beichuan County (see Fig. 11), with a 71-m high debris dam blocking the Shitingjian river forming a lake about 800 m long and 600 m wide. The downstream flood-threatened area had to be evacuated, and the debris dam breached by excavation and blasting to remove the secondary flood hazard.

Fig. 11. Landslide Lake at Tangjiashan Landslide. Engineering Resilient Cities - Mahin - Oct 2008

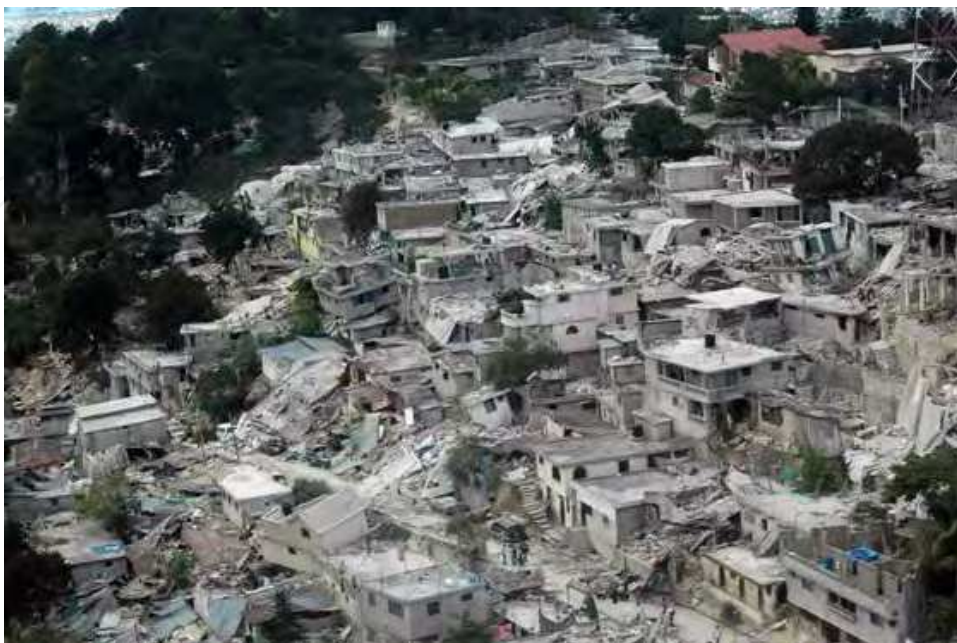
Fig. 19. Damaged Buildings Located on Hill Slope. <http://www.worldcatastrophe.com>

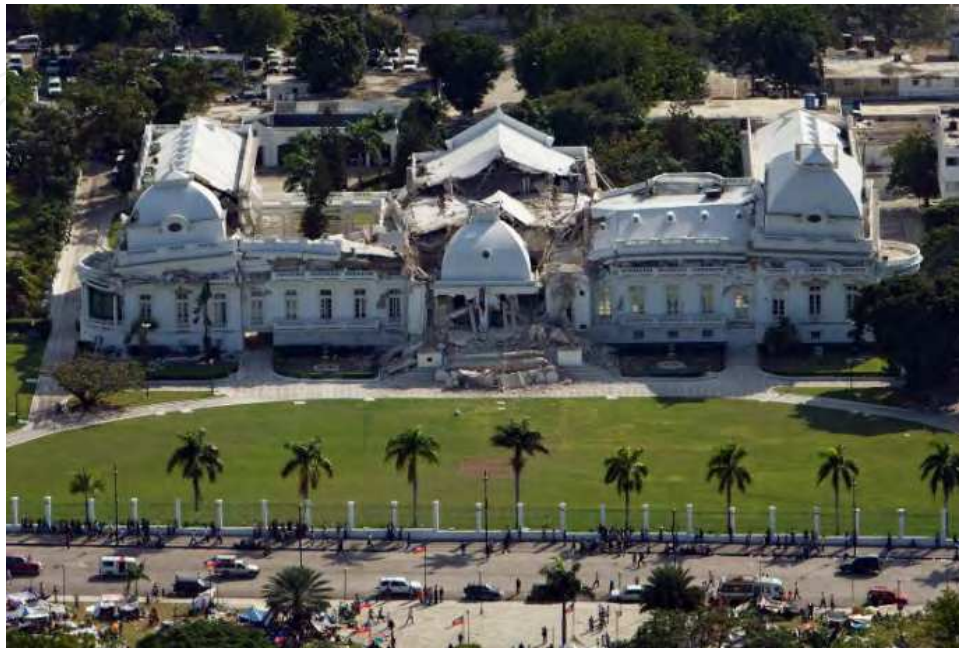
Fig. 20. Damaged Presidential Palace in Port-au-Prince. <http://alanrdennis.wordpress.com>

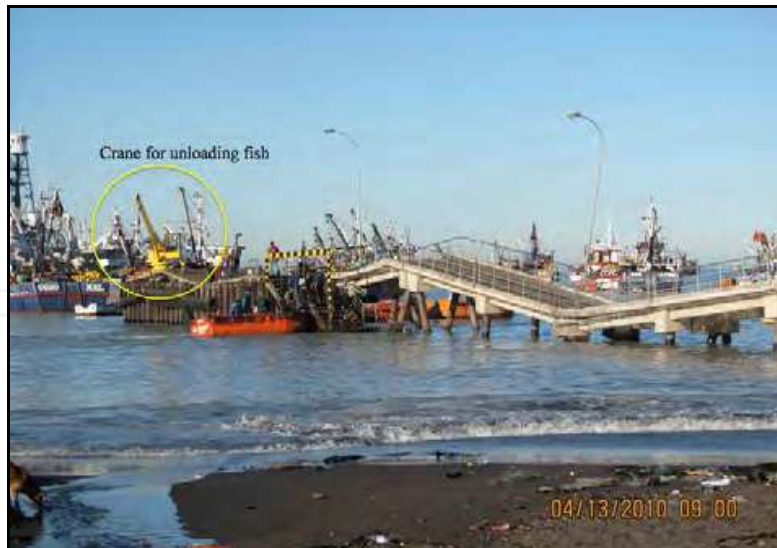
Fig. 22. Distorted Fish-Unloading Concrete Pier at Coronel Port, Chile. (TCLEE 2010)

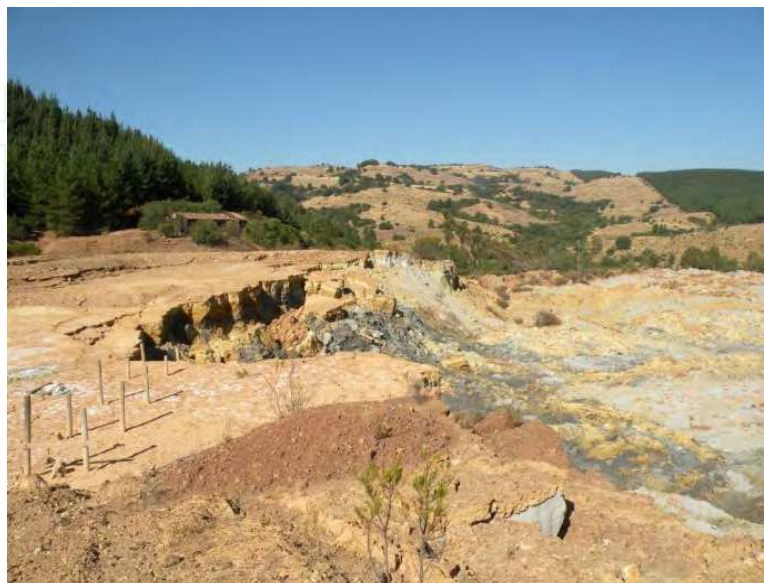
The flow failure of a tailings dam triggered by the earthquake is shown in Figs. 23 and 24 (GEER 2010). Compared with a large number of tailings dam failures in the 1965 La Ligua earthquake and two failures in the 1985 Santiago earthquake, tailings dam performance in this event seems to show some improvement. Compacted engineering fills and structures supported by improved ground using stone columns and micro-piles were reported to perform well.

Fig. 24. Upper Scarp of Failed Tailings Impoundment. (GEER 2010)

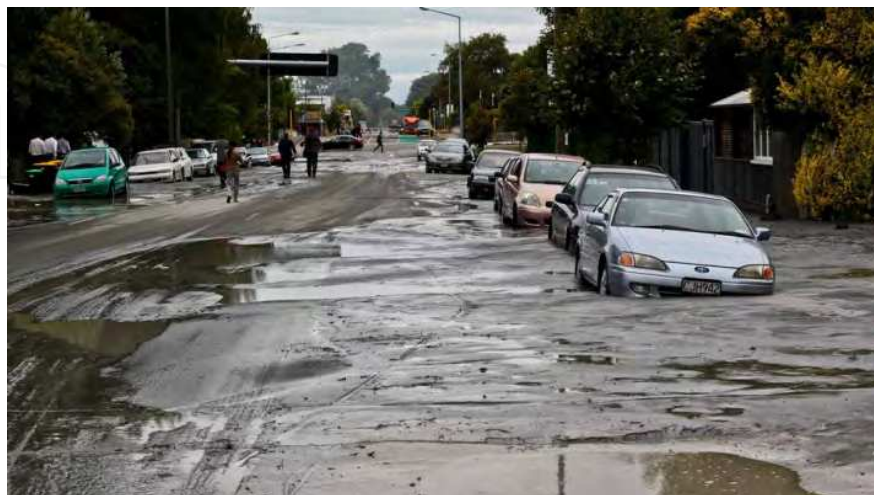
Fig. 26. Liquefied Sand Deposited on Street, 2011. <http://otilya.com/view/News/Asia-Pacific/New-Zealand>

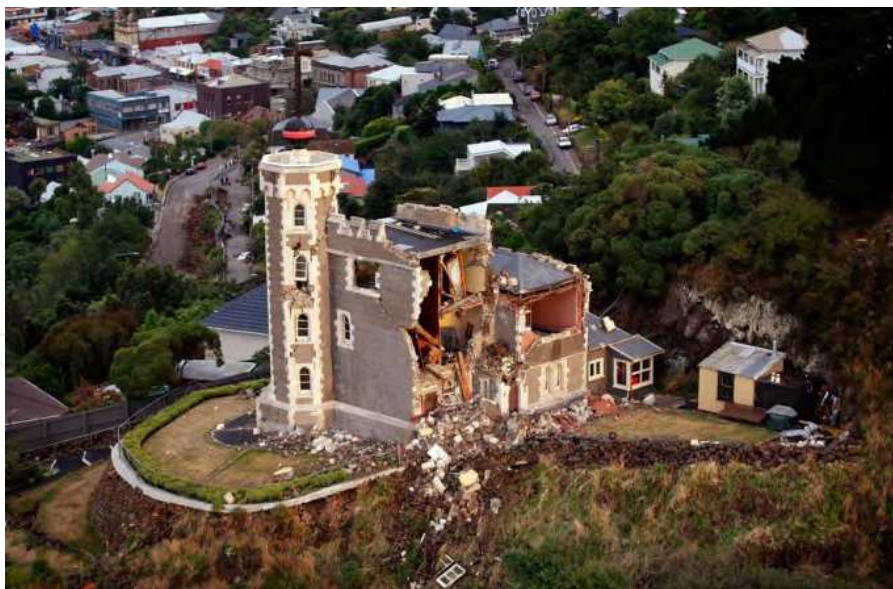
Unreinforced masonry and non-ductile reinforced concrete buildings suffered most structural damages, while liquefaction and lateral spreading contributed to foundation failures or differential settlement of buildings and pipeline breaks. Non-structural damages to building components and content caused food-supply shortage and slowed down business recovery. Other damages were caused by rock falls in the Port Hills area.

Fig. 30. Topographic Amplification May Play a Role in Damaging an Unreinforced Masonry Building, 2011. <http://otilya.com/view/NewsAsia-Pacific/New-Zealand>

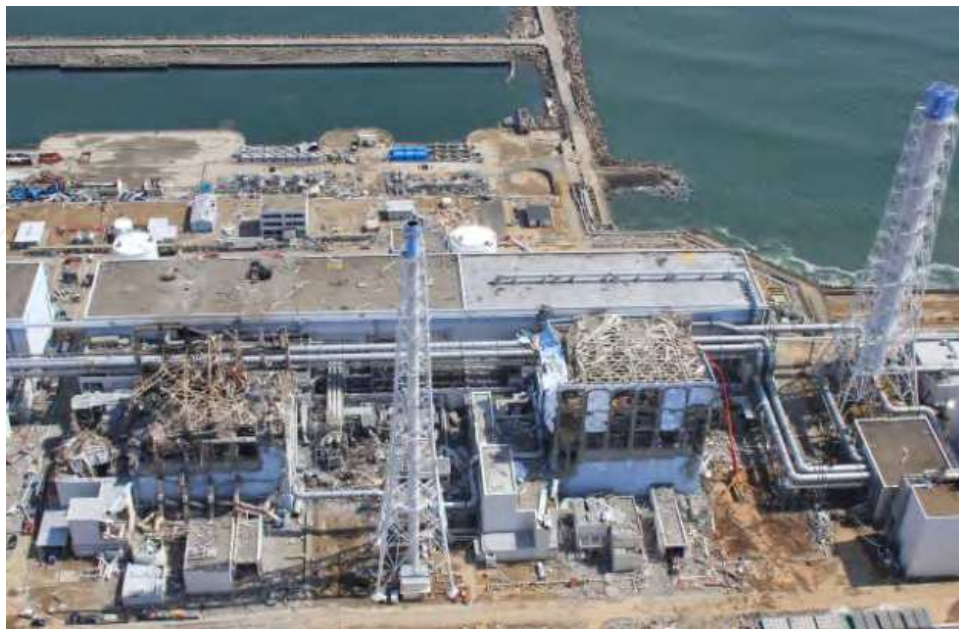
revealed another relatively modern threat, i.e., the trigger of a long-lasting and potentially deadly nuclear incident. Salt water intrusion into pumping systems resulting in equipment failures has been reported earlier such as in the 1993 Hokkaido and 2004 Sumatra events. This relatively minor problem usually only led to delay in the restoration of the water and sewer systems. Nevertheless, at the Fukushima Dai-Ichi nuclear generating station (see Fig. 34), the disruption of the cooling systems of nuclear reactors and power failure resulted in the meltdown of reactor fuel rods.

Fig. 34. Blast-Damaged Fukushima Dai-Ichi Nuclear Power Plant Unit 3 (left) and Unit 4 (right). <http://pinktentacle.com/>

The current solution is to abandon the power station, and to eventually entomb the damaged reactors in concrete after their cool-down, even though ongoing radiation leak continues to contaminate the plant site, its surrounding land and sea five months after the earthquake (August 2011).

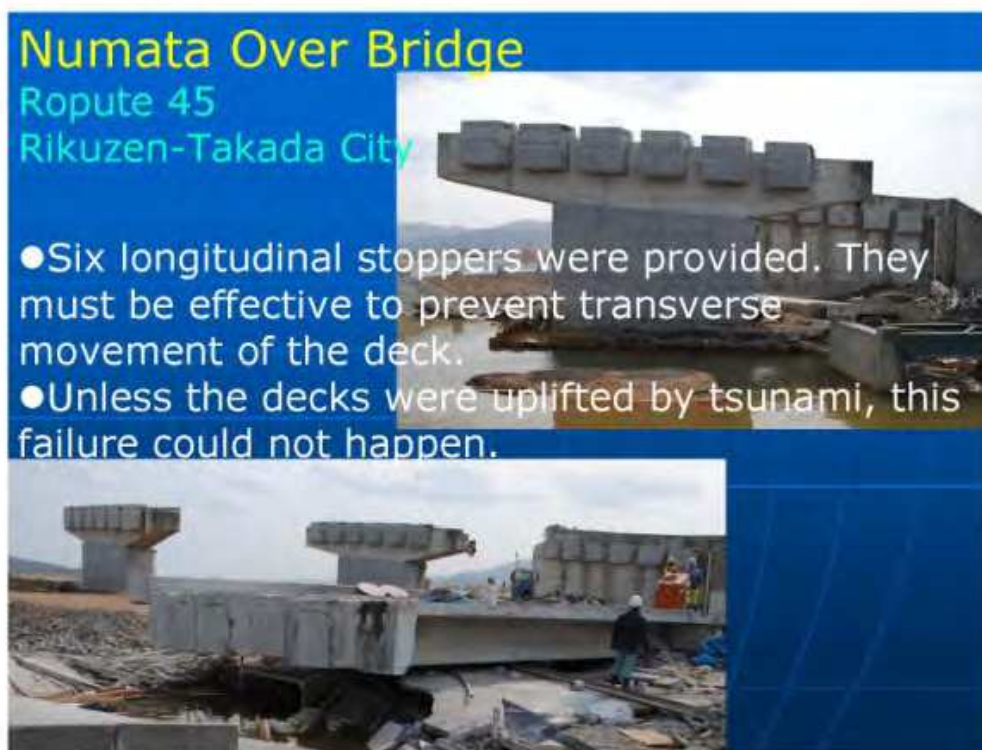
- The important impact of tsunami hydrodynamic pressure on the performance of port facilities and bridges have been recognized for some time, vertical restrainers to counteract the tsunami uplift force against bridge decks such as experienced in the Maule and Tohoku earthquakes are proposed by Kawashima (2011). Policy to require vessels leaving the ports and sailing to the sea upon receiving tsunami warning would prevent damage to the vessels as well as port infrastructures from vessel impact.

Fig. 37. Uplift of Bridge Deck In Spite of Longitudinal Stoppers – Tohoku Earthquake. (Kawashima 2011)

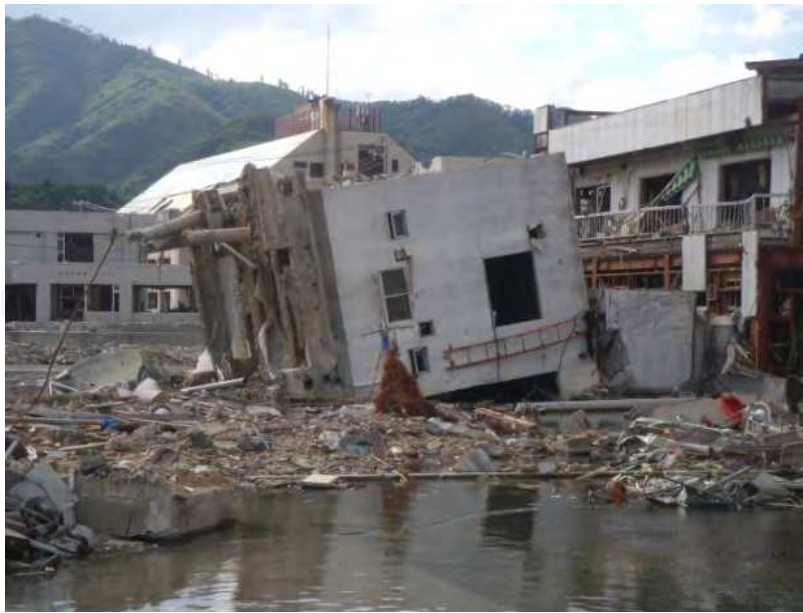
Fig. 38. Overturned Police Station, Onagawa, Japan, 2011.

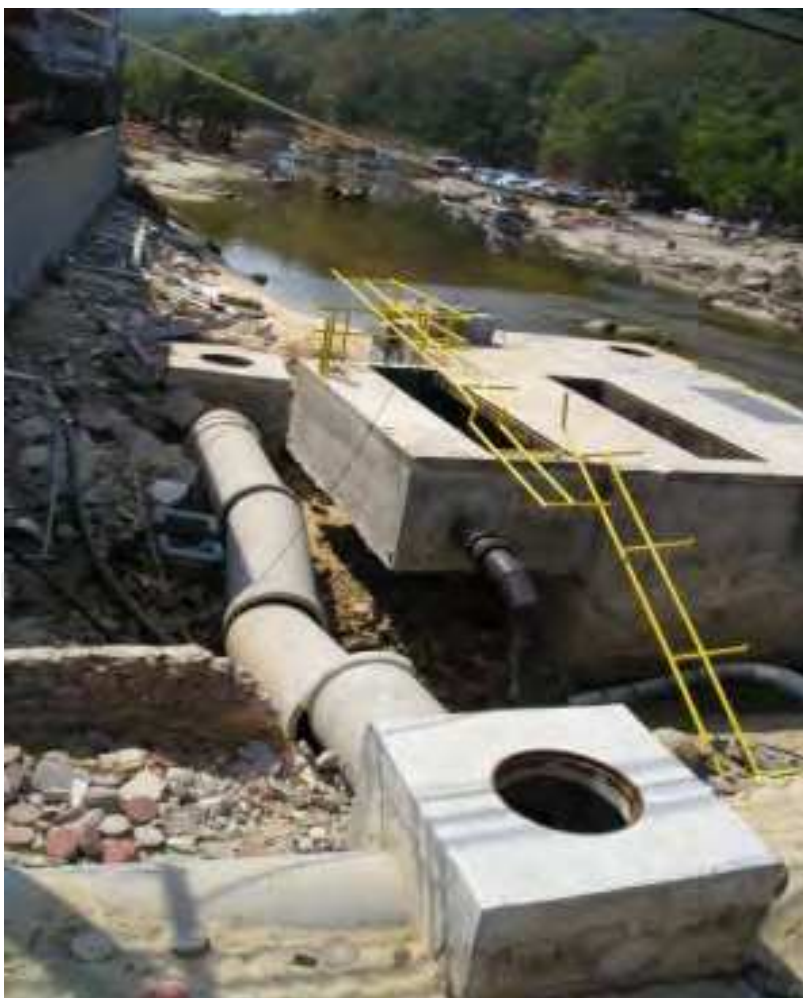
Fig. 39. Pump Station Damaged by Wave Scour, Patong Beach, Phuket Province, Thailand, 2004.

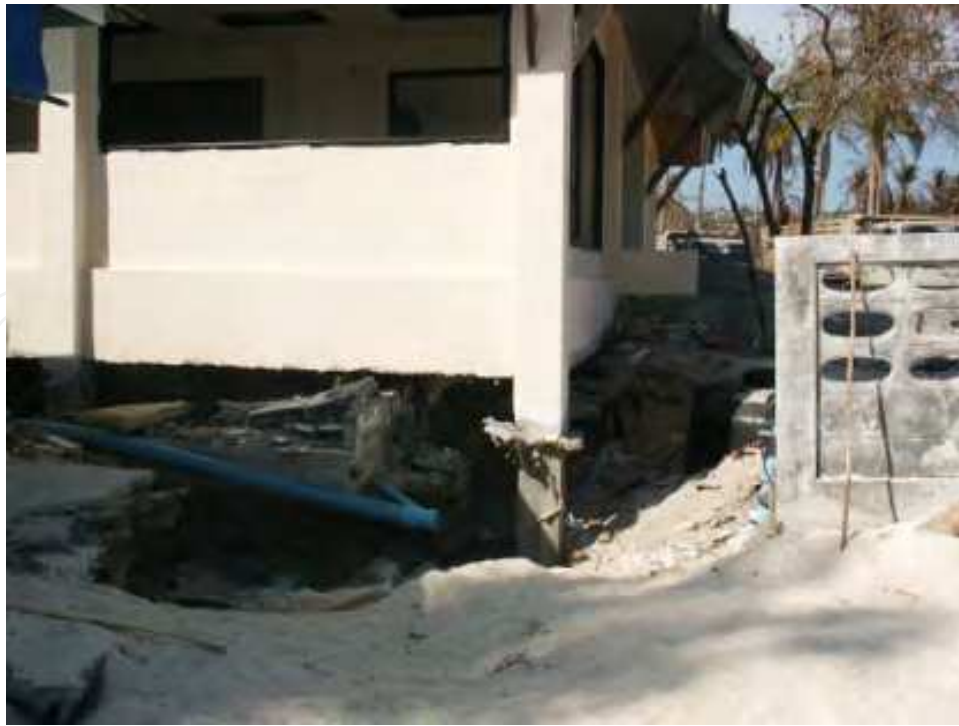
Fig. 40. Scouring of Foundation Soils and Severing of Building's Utility Lines, Phi Phi Island Hospital, Thailand, 2004.

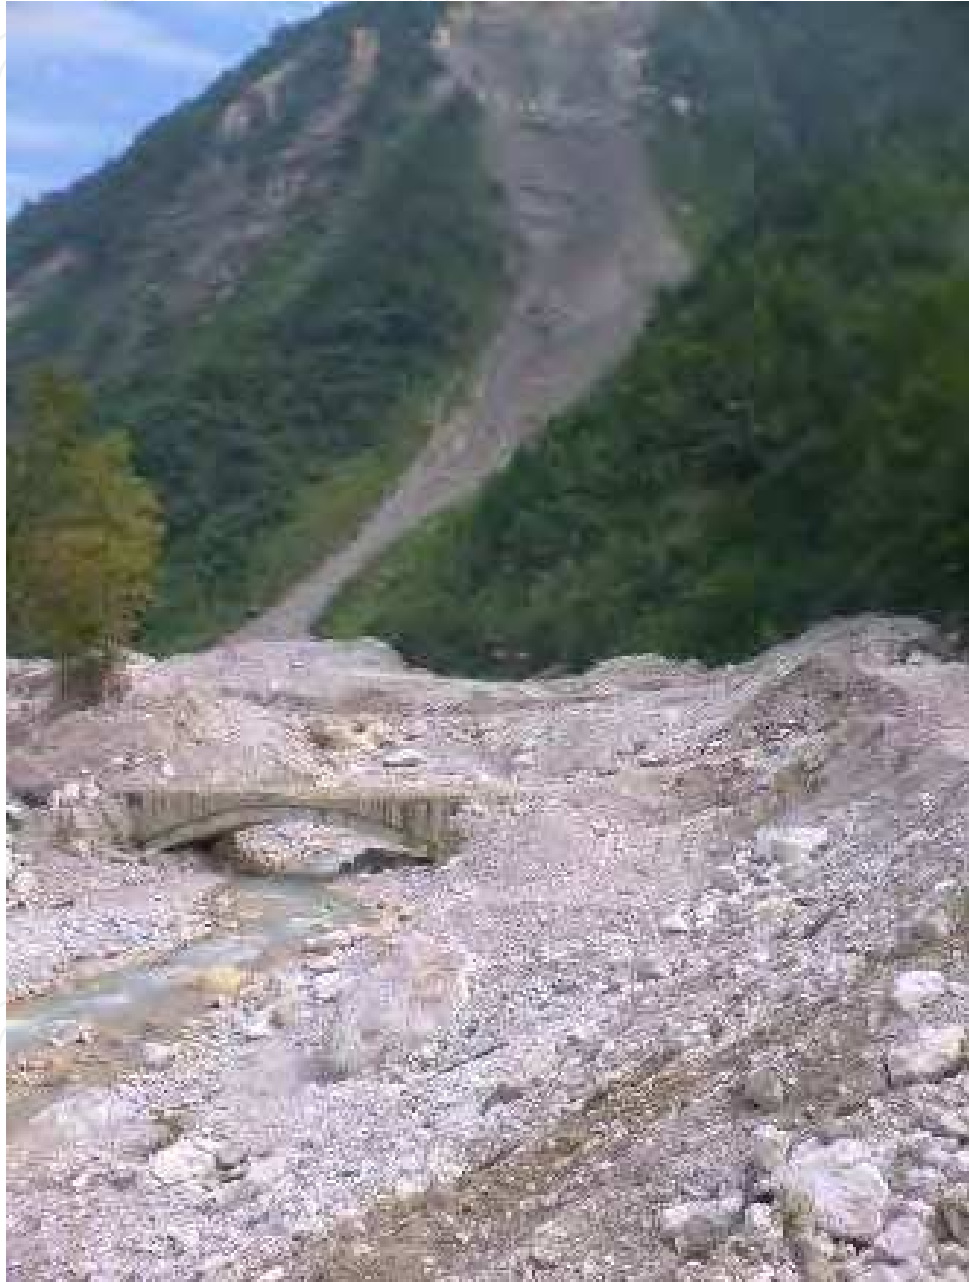
moving sliding debris (see Fig. 43). The presence of water in the soil mass, as reflected in its degree of saturation, increases the probability of triggering a slide during an earthquake. Thus, whether the occurrence of earthquake is in dry or wet season could have significant difference in its impact. Heavy precipitation in earthquake stricken area could trigger post-earthquake landslides, debris flows and/or lahars (mudflows of volcanic debris). Moreover, the amount of water within the sliding mass and/or being entrained along its moving path increases its run-out distance and, hence, downstream impact. The local topographical detail along the debris travel path dictates the area being buried by the slide debris. The formation of a landslide lake, caused by temporary blockage of river by unstable slide debris, poses a special flood hazard. Timely construction of a spillway to drain the lake is required to ameliorate the downstream flood hazard such as the case with the Tangjiashan Landslide-Lake after Wenchuan 2008 earthquake (see Fig. 11).

Fig. 43. Debris Flow at Huosigou, Chongzhou, China, 2008.

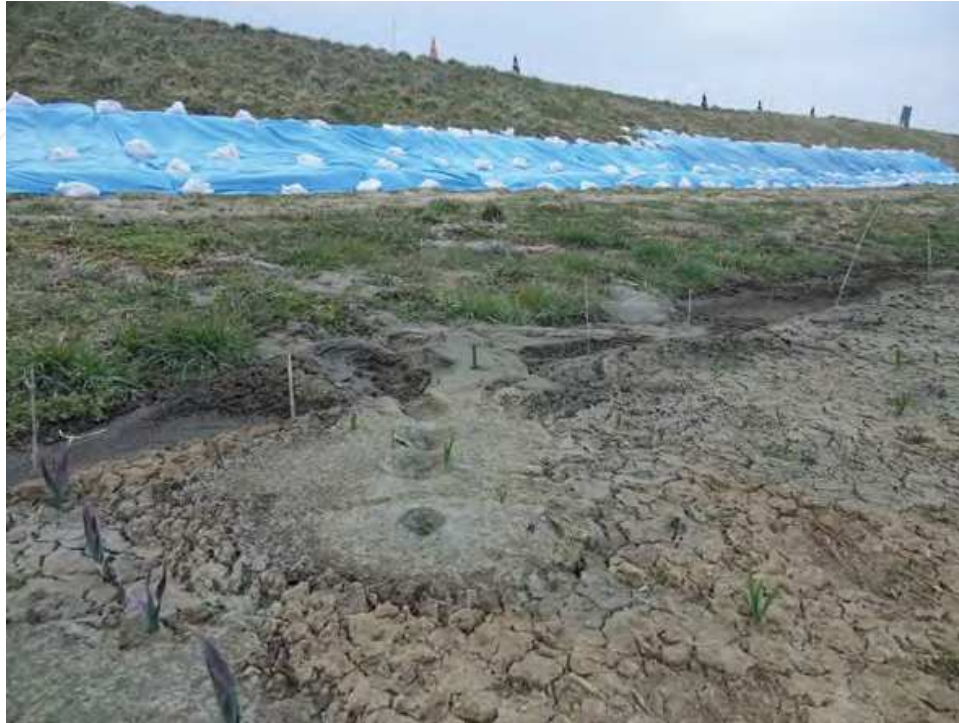
Fig. 44. Levee Slope Repair and Sand Boils at Toe, Japan. (JSCE 2011)

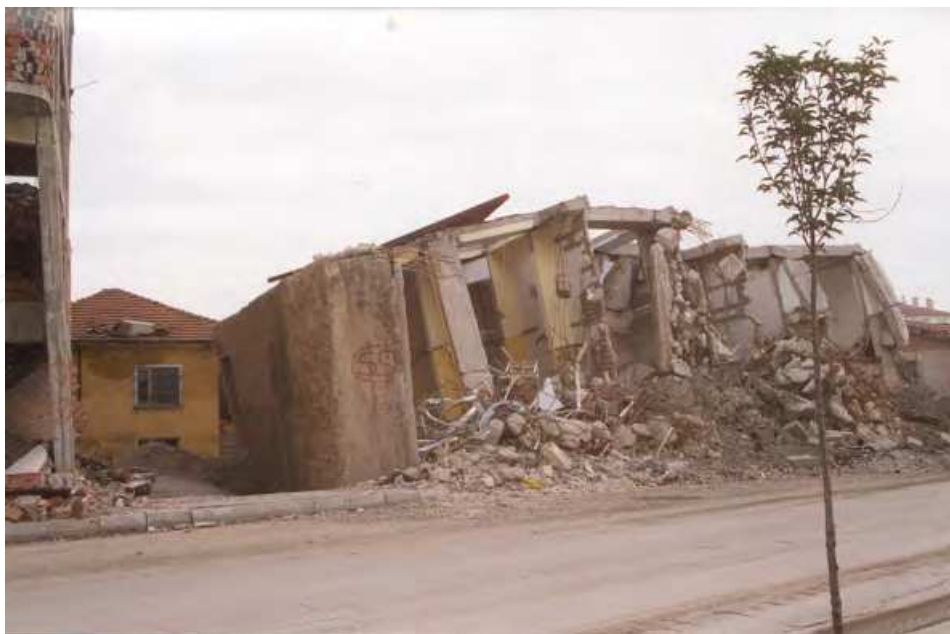
overturning of the building (see Fig. 45). This type of foundation behavior was observed in Mexico City due to the presence of sensitive Mexico City clay during the 1985 Michoacan earthquake, and again in Adapazari City due to the presence of Holocene alluvium during the 1999 Kocaeli earthquake.

Fig. 45. Overturned Building of High Aspect Ratio in Adapazari City, Turkey, 1999.

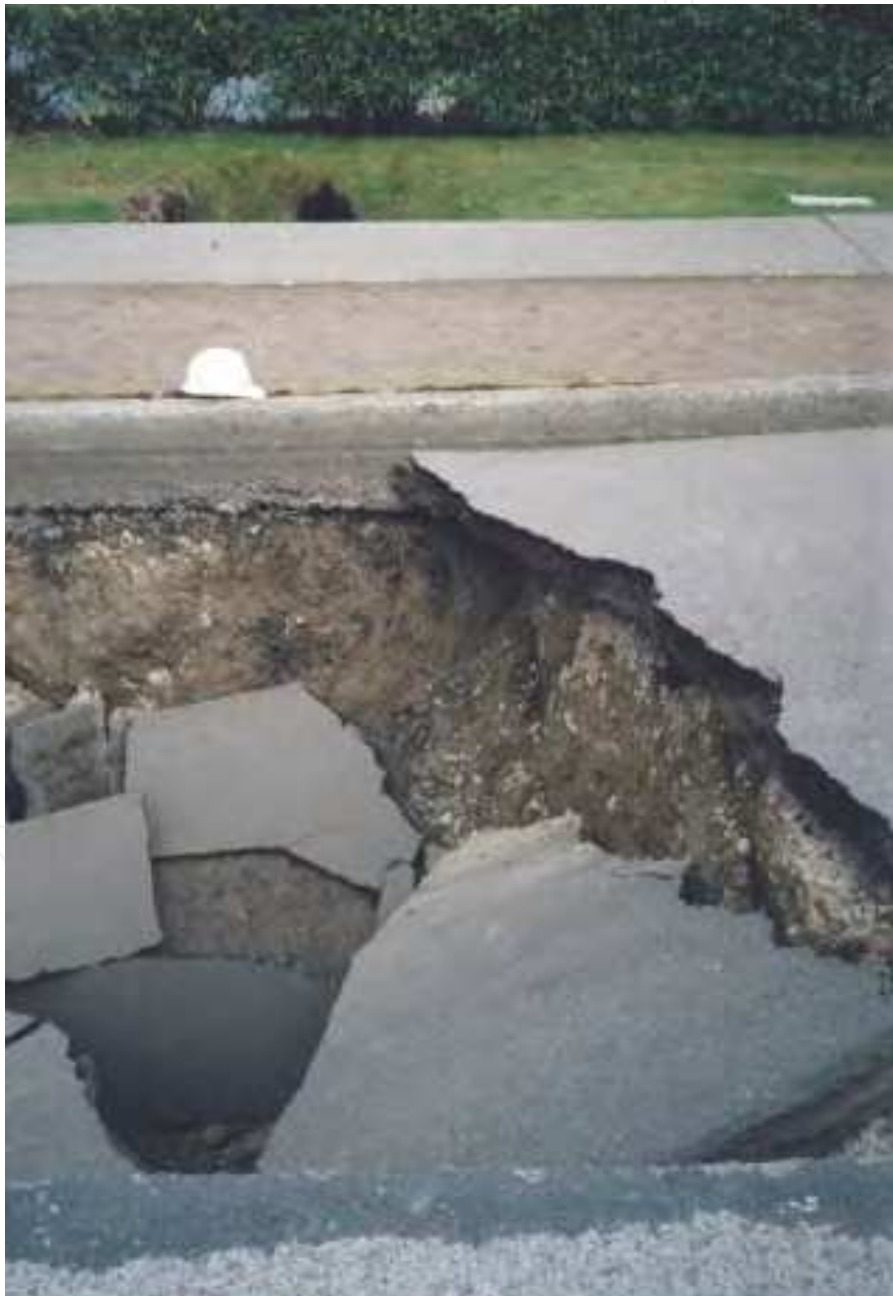
- Surface expression of underground failure – Sinkhole may occur during an earthquake. The phenomenon appears to be puzzling until the cause is identified. Usually, sinkhole

Fig. 46. Sinkhole Formed by Collapse of Roadway During Earthquake, Washington, 2001.

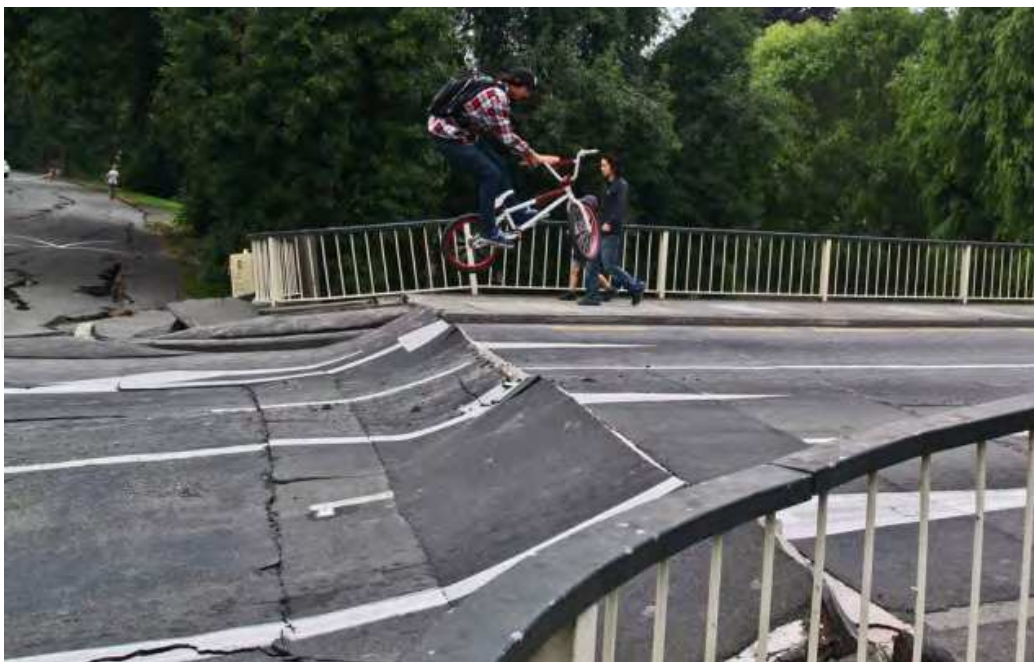
Fig. 47. Settlement of Approach Fill at Bridge Abutment Formed a Bike-Jump for a Youngster. <http://otilya.com/view/News/Asia-Pacific/New-Zealand>
