Recent Landslide Damming Events and Their Hazard Mitigation Strategies

Ahsan Sattar and Kazuo Konagai Institute of Industrial Science, University of Tokyo Japan

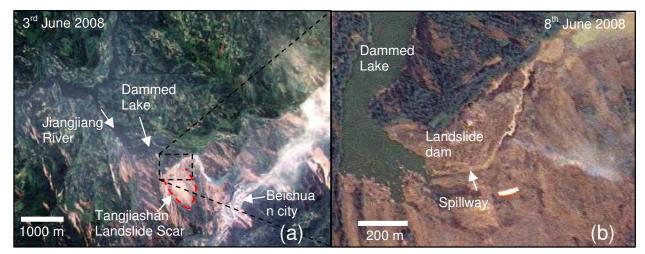
Fig. 1. True-color image of Tangjiashan landslide dam and dammed lake captured by NASA's Earth Observing-1 (EO-1) (a) on 3rd June 2008 prior to overtopping and (b) on 8th June after overtopping but before the breaching of dam

northern part of the fault zone, and impounded a lake on the Jiangjian River (Fig. 1). This lake behind the 124 m high landslide dam had a maximum storage capacity of 320 million m³ (Liu at el., 2010). The dam posed a great threat of flooding to the 1.2 million people living along the lower reach of the river, therefore required immediate mitigation measures.

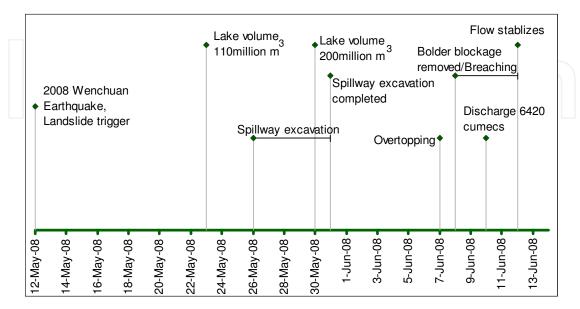
Fig. 2. Timeline of Tangjiashan landslide dam emergency response

total volume of the lake had reached 110 million m³ and then 200 million m³ till the end of May, 2008. The figure 2 presents the timeline of the Tangjiashan landslide dam emergency response. The lake hypsometric curve showed that if the lake level was kept at 740.3 m, the storage capacity of the lake would be reduced to 238 million m³ instead of 320 million m³ corresponding to the natural potential overtopping level of 755.0 m (Liu at el., 2010). Accordingly the civil works were carried out to excavate a spillway to minimize the potential dam breach damage. It took 7 days work from May 26 to 31, to excavate a 13 m deep and 8 m wide channel covering 475 m in length. The primary intension for the excavation of the spillway was to reduce the total volume of the lake and meanwhile to create a controlled flood to drain the lake. About 275,000 people evacuated from the downstream areas for the expected flood.

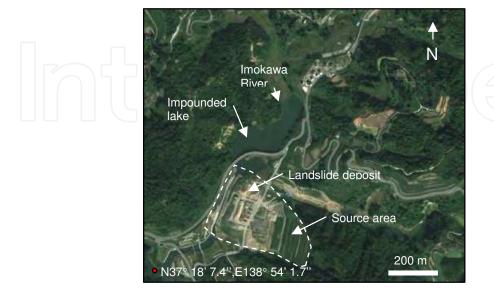
Fig. 3. Higashi Takezawa landslide dam and the dammed lake (Satellite imagery from Google Map)

landslide dam (N37° 18' 16.41", E138° 54' 16.13"), the largest landslide dam triggered by the earthquake (Fig. 3). The landslide originated from the left bank of the Imokawa River at Higashi Takezawa district. The landslide mass was about 350 m long and had volume up to 1 million m³ (Sassa, 2005). The blockage started to impound a lake and soon the water started to inundate the Kogomo village. Due to the possible danger of overtopping and successive breaching of the dam emergency measure were taken to prevent the failure.

Due to the danger of possible failure of the dammed lake, it was necessary to reduce the total capacity of the lake. Two possible mitigation measures were considered to cope with the flood hazard that the landslide dam posed. One of the possible measures was to remove the blockage to the original river level to drain the lake completely. This option would favor people living both upstream and downstream reaches of Imogawa River. However, there was a concern that removing only the toe part of the landslide mass would reactivate the movement of the remaining landslide mass. Removing the entire landslide mass would not be considered as a cost-effective solution. Therefore, the landslide mass was planned to be consolidated with the combination of diversion pipes and spillway. This meant that in exchange for abandonment of the upstream Kogomo village, the relevant authorities have secured the lower reach of the dam. Inhabitants of Kogomo Village were offered alternate sites for their new dwellings.

The following steps have been taken for stabilizing the landslide mass: twelve pumps were installed first to lower and keep the lake water level 11.5 m below the overflow point. In addition, the outflow level was raised by 3 m with sand bags at the outlet. Keeping in view the pumping power for this temporary system, diversion pipes were installed in case water overtopped the landslide mass (Fig. 4). Finally, a 280m long concrete-faced spillway was constructed with its cross-section large enough for snow melts.

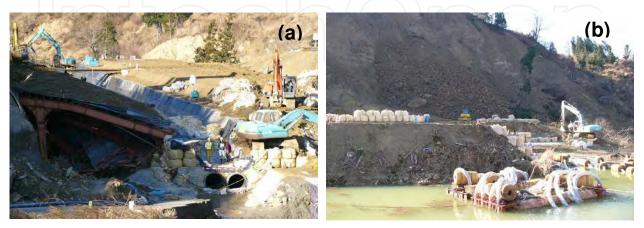
Fig. 4. Emergency works at Higashi Takezawa landsldide dam. Photo taken on 20.12.2004 by Takeji & Tadashi, 2005

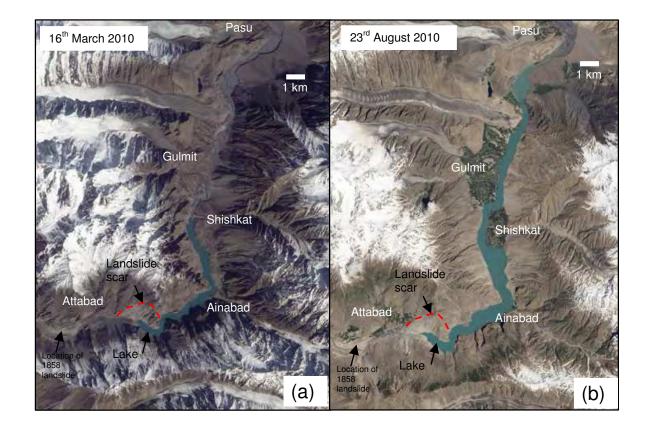
Fig. 5. The true-color image of the Attabad landslide dam (36° 18′ 50′′N, 74° 49′ 13′′E) and lake captured by Advanced Land Imager (ALI) on NASA's Earth Observing-1 (EO-1) satellite, on (a) 16th March 2010 and (b) 23rd March 2010

The Attabad landslide dam survived the much feared failure upon overtopping. The dam has emerged as a permanent geological feature that has caused a 23 km stretch of the Karakorum highway and about 232 houses to be inundated (NDMA) and isolated the communities at its upstream reaches. Moreover the longevity of the dam is coming under question. Erosion of the spillway occurred at the time of overtopping that continued for several days which later on was followed by a slow down-cutting of the channel. The channel erosion was stopped by the presence of large boulders embedded in the channel bed, which prevented the catastrophic failure, while slowed the drainage of the lake. The dam survived the high discharge of glacier melting of 2010. Blasting option was considered

A lake immediately started to develop at upstream of the debris mass. The impoundment created huge problems for the 25,000 people living at upstream of the landslide dam. Mitigation studies were conducted (Petley, 2010) and as an emergency repose a 30 m deep spillway was planned to be excavated to reduce the maximum possible volume of the lake. Seepage points emerged progressively at six different locations till April 2010. Meanwhile, closed circuit television, (CCTV) system was installed to issue a warning in case of much feared seepage failure. The excavation of the spillway started on 30th January 2010. The surface silty-clay deposit created problems during the excavation works as the construction machinery were bogged down with the muddy conditions at the site, and the work was stopped when the excavation had reached 15 m deep across the crest till 16th May 2010. The water started overflowing on 29th May 2010. At the time of overtopping the lake reached a length of 21 km and had an estimated volume of 450 x 10⁶ m³. Fig 5a and 4b shows the truecolor image of the Attabad landslide dam and lake captured by Advanced Land Imager (ALI) on NASA's Earth Observing-1 (EO-1) satellite, on 16th March 2010 and 23rd August 2010 respectively. About 25,000 people were cut off from the downstream population and are still suffering at the moment of writing.

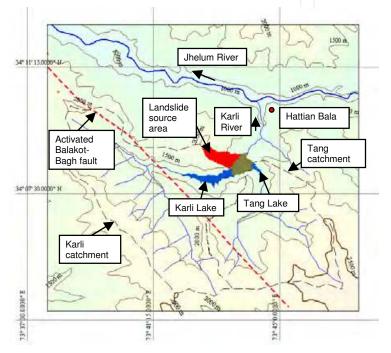
Fig. 6. Contour map of Hattian landside, dammed lakes with their catchments and downstream areas.

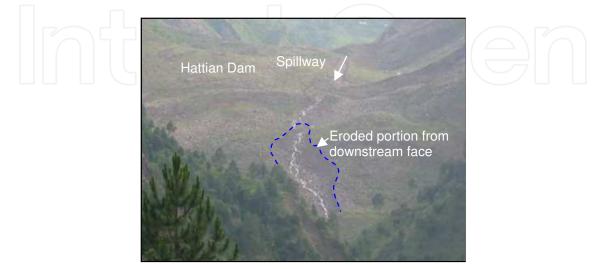
Fig. 7. Front view of the Hattian landslide mass, showing the downstream face erosion.

Gradual toe erosion was initially observed, which was then followed by a rapid head cutting erosion of the downstream face of the dam (Fig. 7). On 9th February 2010, the water of Karli Lake breached the debris dam after five days of incessant rain, and the breaching drained about 36 million m³ of water from the lake. According to the back analysis conducted by Konagai, at el., (2011) the peak outflow was about 5500 m³/s. A moderate 32 mm/day rainfall was estimated on the day prior to the day of breaching. About 7.78 million m³ of soil was estimated to have been eroded during the breaching event. The flushed debris mass was deposited along the Karli River. Fig. 9 shows the satellite image and profile of the Karli River before and after the breaching. A major portion of the eroded material is deposited over the approximately 2km downstream stretch from the dam along Karli River and less significantly beyond the stretch. The flow along the Karli River reached the depth up to 20 m. The debris deposit was about 40 m thick near the toe of the dam.

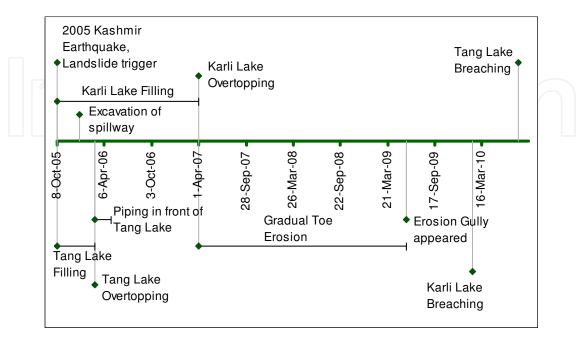
Fig. 8. Timeline of post formation features and major events at Hattian Bala landslide dam

million m³. The Tang Lake filled up in February 2006 and started overflowing. A timeline of various events occurring at Hattian Bala landslide dam after its formation are presented in figure 8.

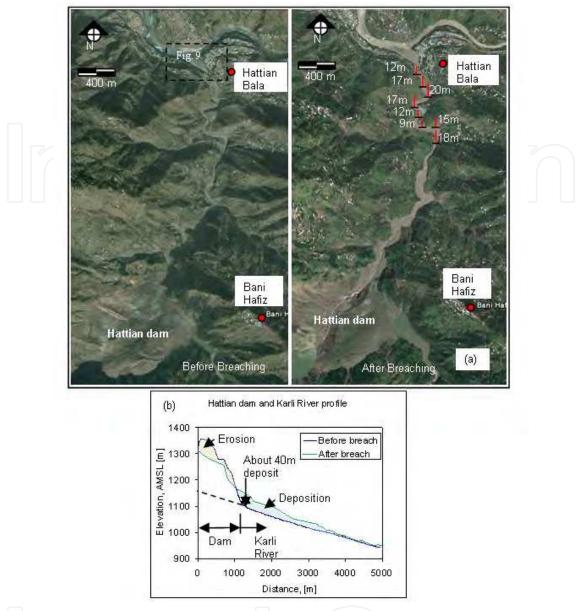
Fig. 9. (a) Satellite imageries of Karli River before and after breaching of Hattian dam (Google Earth), along with the maximum flow depths measured along the Karli River after failure of the dam (b) Profile of Hattian dam and Karli River before and after breaching of the Hattian dam

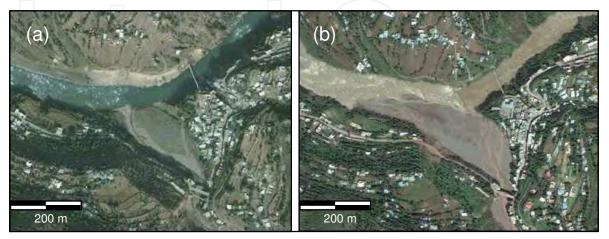
Fig. 10. (a) Satellite image of the junction of the Karli River with the Jhelum River before and after the breaching of Hattian dam (Google earth)

The dam break flood and debris destroyed one bridge near the junction of the Karli River with the Jhelum River and damaged about 24 houses as shown in Fig. 10. However major damage from the dam breach occurred as a landslide on the right bank of the Karli lake that was triggered by emptying of lake water. The figure 11 shows the satellite image of the right bank landslide after the breaching event, along with the contour map of the landslide and longitudinal profile of the landslide. This landslide destroyed 174 houses forcing about 1000 residents to evacuate.

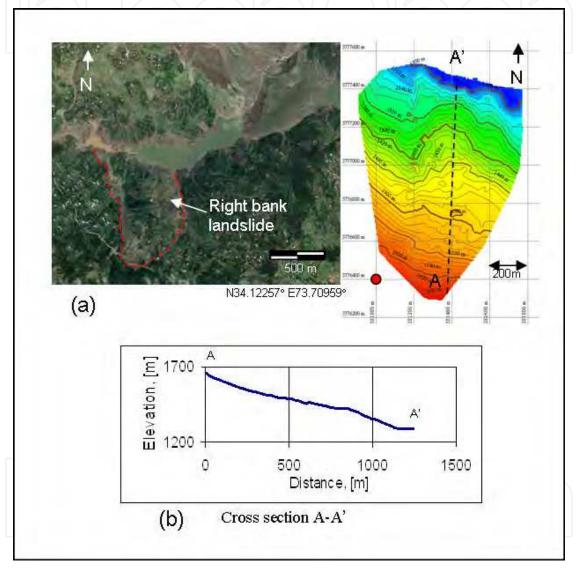
Fig. 11. (a) Satellite image of the Hattian landslide dam, Karli lake and the right bank landslide after the breaching event, along with the contour map of the landslide, (b) the longitudinal profile of the right bank slide. Modified from Konagai at el., 2011

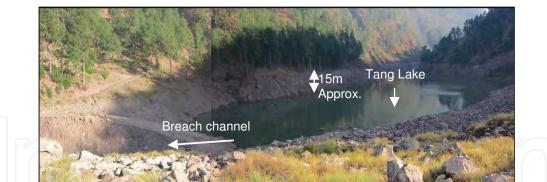
The Tang Lake breached during the monsoon rains (July-August) of 2010. In the breaching process, the water from Tang Lake eroded the north-eastern end of the landslide lobe, which had been covered with boulders segregated up at the time of deposit, and approximately 15 m depth of the lake water was drained leaving 1.9 million m³ water in the lake (Fig. 12).

Fig. 12. Tang Lake after breaching (Photo taken on 6th Dec-2010). From Konagai at el., 2011
