# Abrasive Effects Observed in Concrete Hydraulic Surfaces of Dams and Application of Repair Materials

José Carlos Alves Galvão,  
Kleber Franke Portella and Aline Christiane Morales Kormann  
*Federal Technological University of Paraná, Institute of Technology for Development,  
Federal University of Paraná  
Brazil*

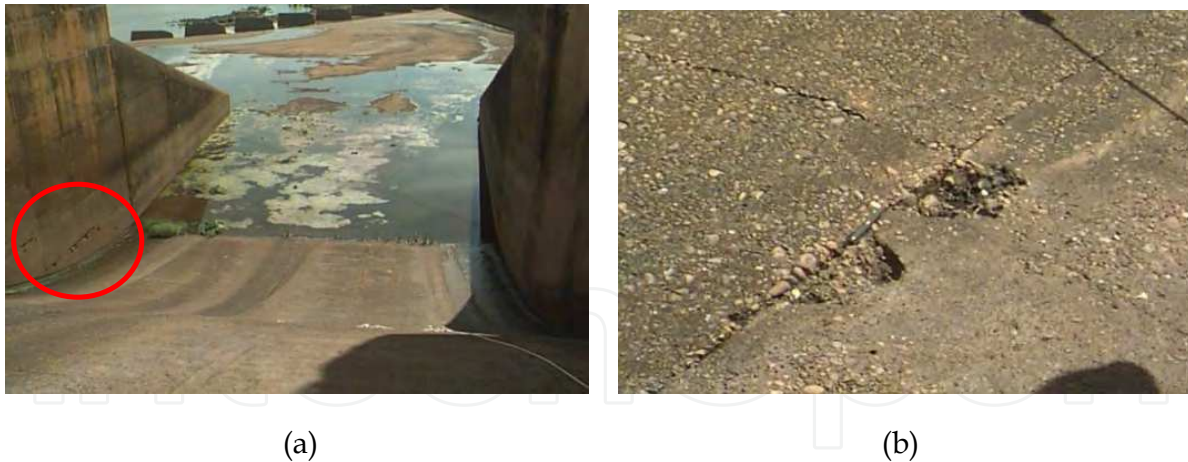
When performed visual inspection of the dam in southeastern Brazil were analyzed various structures such as the surface of the spillway surface of the slab, side walls, pillars of the gates and blocks of dissipation. These structures were found several points of deterioration and abrasive processes.

Is shown in Fig. 2a, overview of the spillway. It is observed that the wall of the gate shows signs of erosion (highlighted). Is shown in Fig 2b, defect in a slab of the spillway caused by abrasion.

Fig. 2. (a) Spillway dam presented deterioration by abrasion. (b) Defects in the concrete structure caused by abrasive process

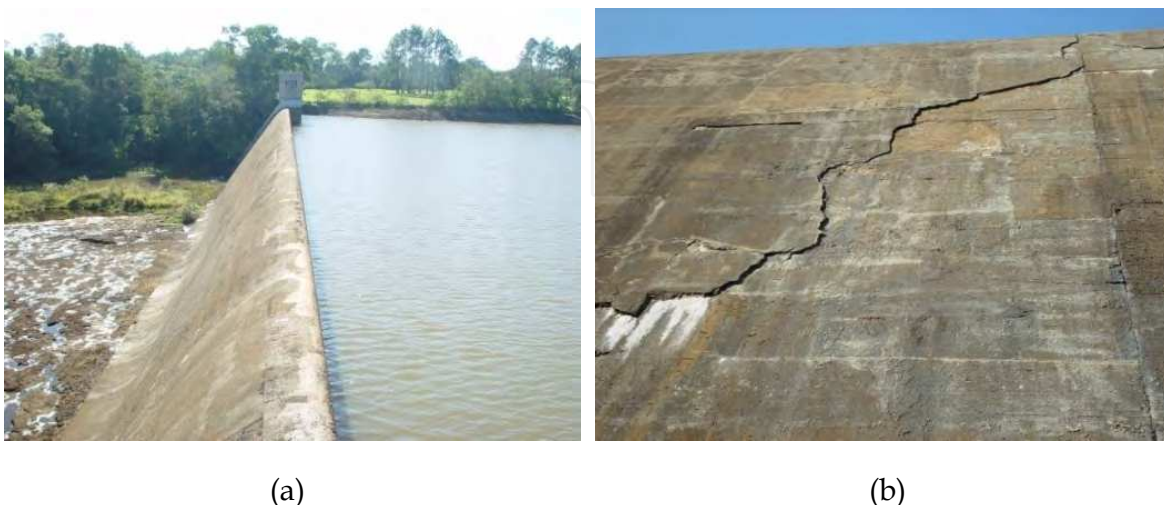
As a case study 2 assessed the repair of the spillway chute Hydroelectric Plant located in southern Brazil, with the use of concrete repair materials with the addition of polymeric materials. Seeking a proposed sustainable polymeric materials were analyzed from the recycling industry. The materials agglutinated low-density polyethylene (LDPE), crushed polyethylene terephthalate (PET) and rubber from useless tires were added to the concrete for the construction of the repair material degrades the surface hydraulic and abrasive processes.

In Fig. 8a presents the overview of the spillway of the dam and in Fig. 8b, a detail of the displacement of the surface caused by hydraulic abrasive processes.

Fig. 8. (a) Overview of the spillway of the dam. (b) Detail of the displacement of the surface caused by hydraulic abrasive processes.

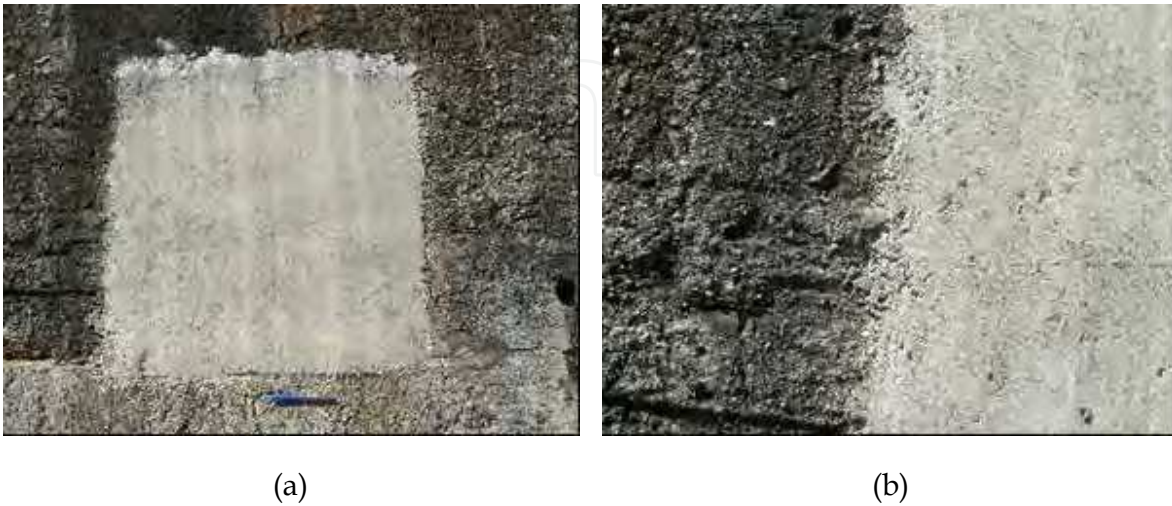
It can be seen in Fig. 11a the repair material applied to the surface of the hydraulic concrete structure is well adhered to the substrate. In the detail of Fig. 11b the interface between old concrete and the RM applied not showed flaws or defects, even after the period of water flow in the spillway of the dam and the middle attacks.

Fig. 11. Application point of repair material. (a) Reference concrete without additions. (b) Detail of the border between the RM and the substrate.

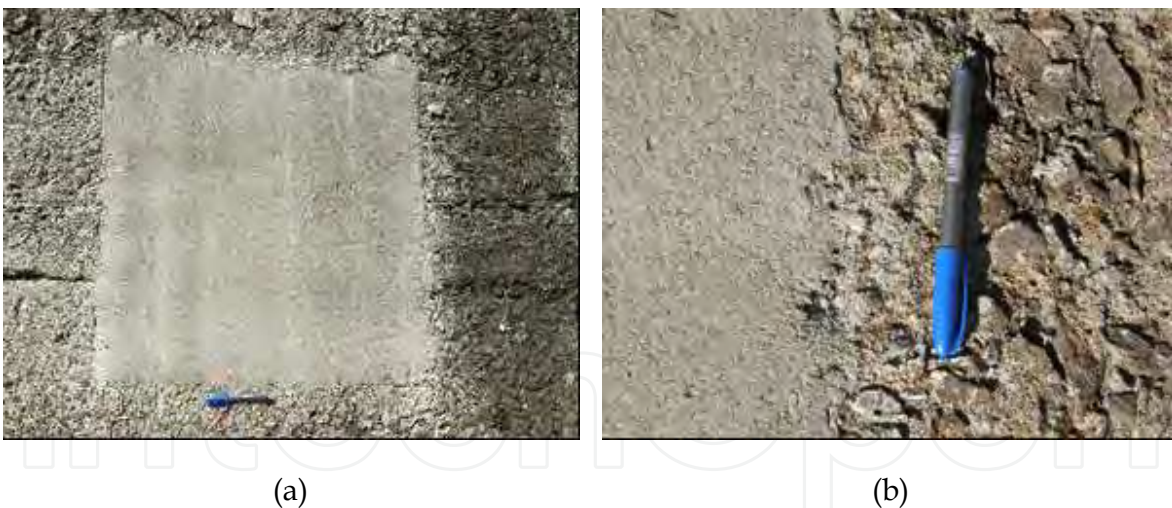
Fig. 12. Application point of repair material. (a) Concrete with addition of recycled LDPE in the content of 2.5%. (b) Detail of the border between the RM and the substrate.

It appears that the point of application above a superior performance compared with other repair materials. At this point the surface has good finish, smooth and free of imperfections, even after the occurrence of water flow in the spillway and aggression in the middle. At no point were visually observed cracks or fissures.

The defects in the substrate were completely contained at this point of application of RM made of concrete with added content in 2.5% recycled LDPE material.
