Fracture Analysis of Generator Fan Blades

Mahmood Sameezadeh and Hassan Farhangi

This chapter reports the failure investigation of a rotating axial flow fan of the Iran Montazer-Ghaem-VI 123 MW capacity generator unit. The unit was equipped with two rotating fans, one at each end namely at the turbine side and the exciter side of the generator. The failed fan consisting of 11 blades was mounted on the generator-rotor at the

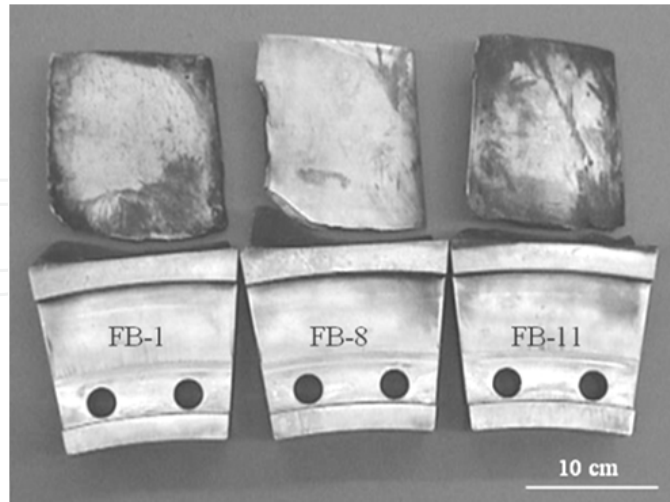
Visual inspections indicated that the accident has led to three different categories for the fan blades of the turbine side (Table 1). Dye penetrant testing revealed the cracked blades which did not completely fracture during the accident. A photograph of the fractured blades, labelled in according with their location on the fan is shown in Fig. 2.

Figure 2. Fractured fan blades

The fracture location of the broken blades can be identified from Fig. 2. It can be seen that the fracture had occurred close to the transition radius between the blade airfoil and the blade root. All the fracture surfaces exhibited very similar macroscopic features. A

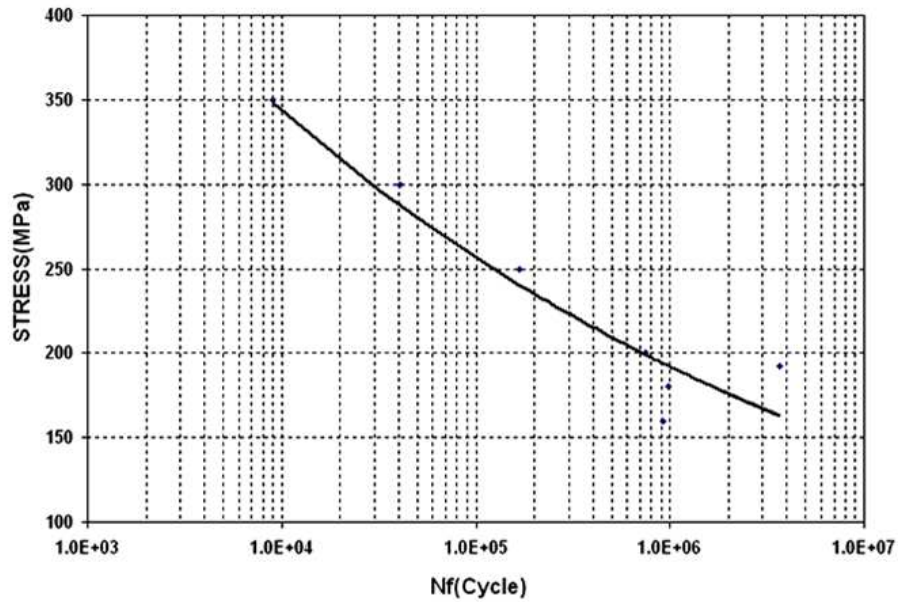
The measured lifetime versus applied stress from the rotary bending fatigue test is presented in Fig. 3. A SEM micrograph taken from the fracture surface of a tested specimen

Figure 3. Fatigue test S-N curve

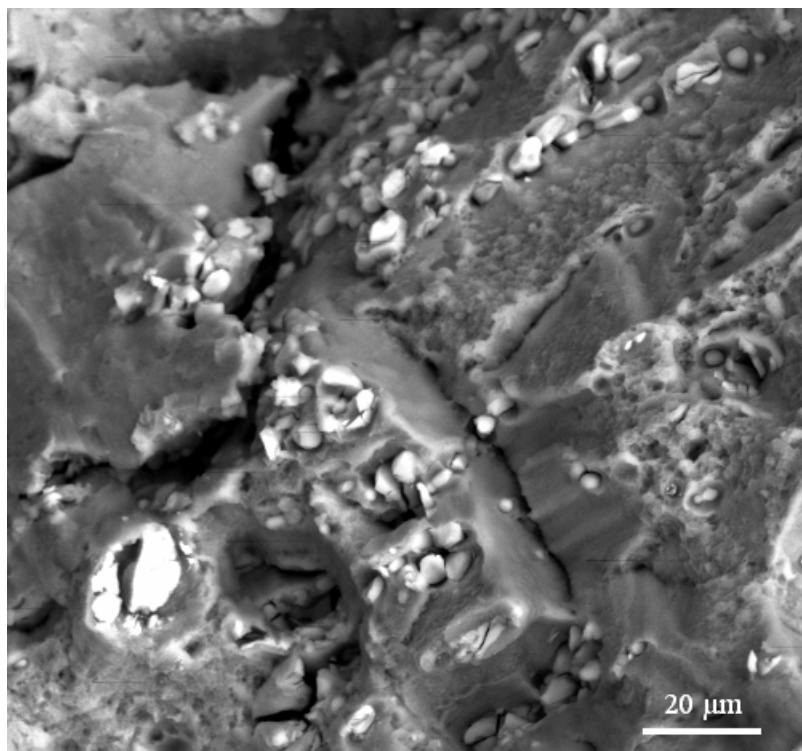
is shown in Fig. 4. Presence of several second phase particles on the surface is obvious. This kind of large particles can accelerate the fatigue crack initiation and affect the fatigue behaviour of the blade material.

Figure 4. Fracture surface of a fatigue test specimen

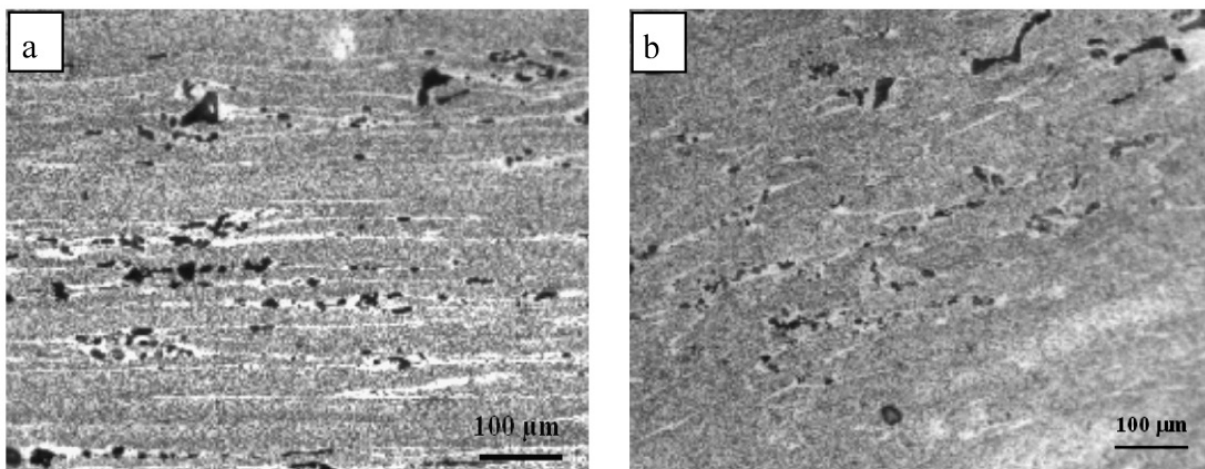
Typical microstructures of the blade material in the longitudinal and transverse sections of a cracked airfoil are shown in Fig. 5. The microstructure consists of elongated grains and second phase particles in the longitudinal direction. Various types of second phase particles can be identified in the SEM micrograph, shown in Fig. 6. The large and elongated particle on the micrograph was subjected to EDS analysis. The composition of the particle contained iron, copper and aluminum which is consistent with the β -phase (Al_7Cu_2Fe) particles common to aluminum alloys (Merati, 2005).

Figure 5. Microstructures of longitudinal (a) and transverse (b) sections of a cracked blade

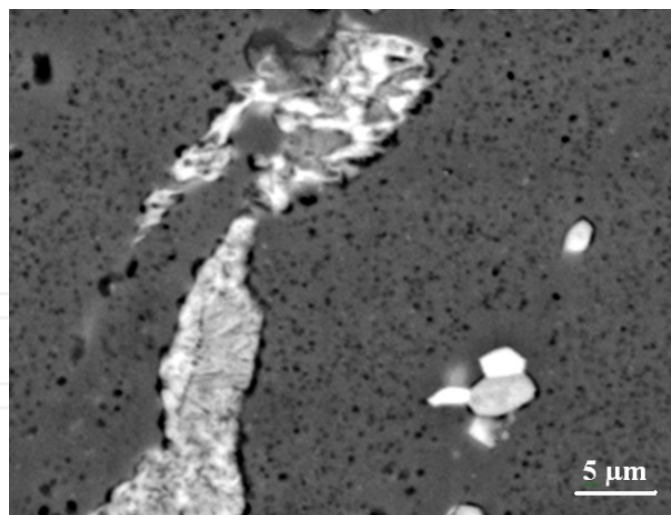
Figure 6. SEM micrograph showing large second phase particles

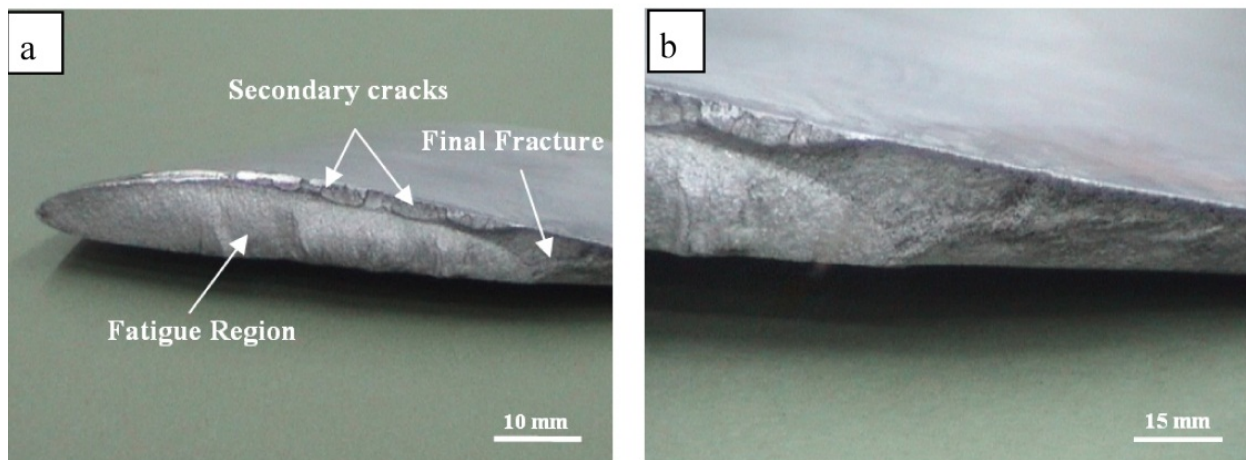
representative fractograph of the fracture surface of blade No. 8 is shown in Fig. 7a. It is observed to consist of two distinct regions at low magnification, a semi-elliptical and smooth region which is oriented normal to the blade axis and exhibits a macroscopically brittle appearance, and an outer region with a rougher and more ductile appearance. The transition from semi-elliptical region to the outer region can be clearly identified in Fig. 7b. In this region the remaining cross section of the blade failed by tensile overload.

Figure 7. (a) Fracture surface of blade No. 8, (b) transition from fatigue to tensile overload fracture

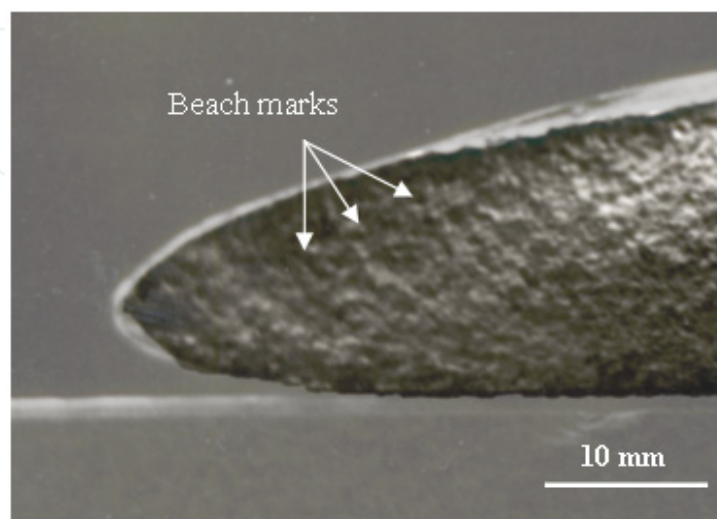
Faint beach marks indicative of the progressive nature of crack growth in the semi-elliptical region can be seen in Fig. 8. Parallel microscopic fracture surface markings can also be observed in this region at higher magnifications in SEM micrograph as shown in Fig. 9. A schematic drawing of the fan with the location of damaged blades is presented in Fig. 10. Visual inspections and fractographic assessments revealed that the sequence of fracture for the broken blades has been blade No. 1, blade No. 8 and blade No. 11 respectively (Sameezadeh, 2005).

Figure 8. Beach marks on the fracture surface near the leading edge of the blade

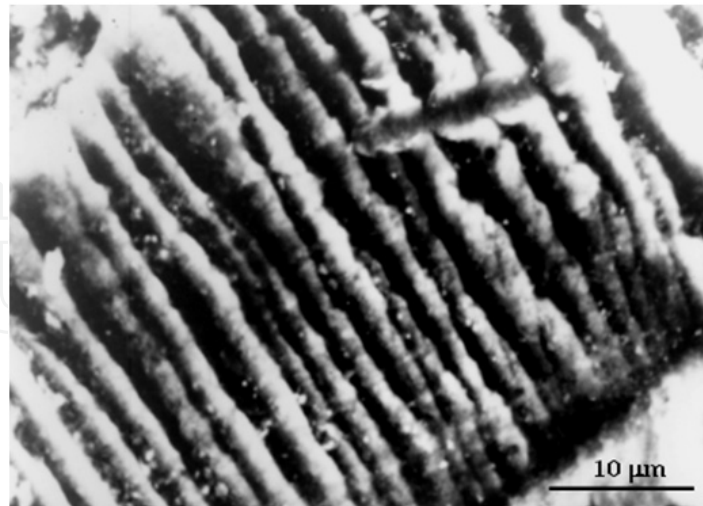
Figure 9. SEM fractograph showing parallel fracture surface markings

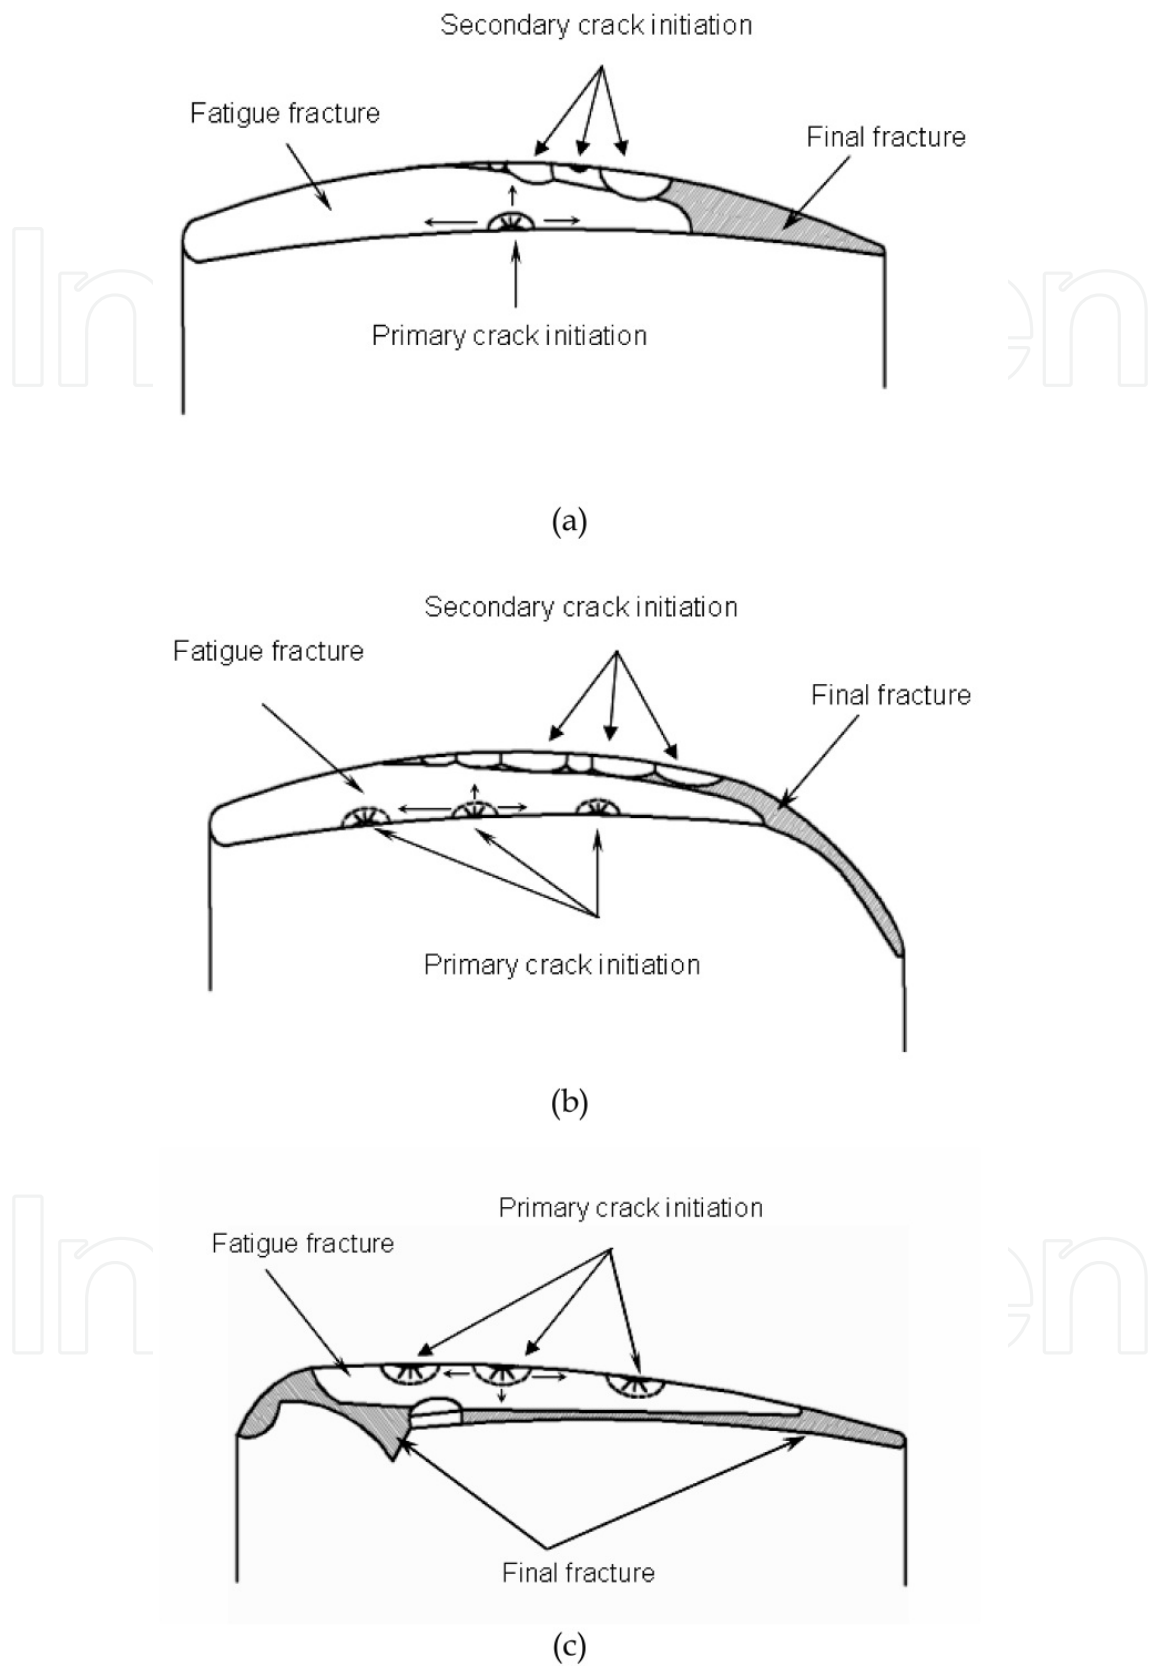
Table 3 shows the crack lengths which are measured on the surface of cracked blades. Schematic drawings of the fracture surfaces of three broken fan blades which show multiple crack initiation sites as well as the macroscopic crack growth paths are presented in Fig. 11. Also, For the first and the second fractured blades (blades No. 1 & No. 8), primary crack initiation sites are located on the concave side of the airfoils near the centre where the cross-sectional area is high. Primary cracks have coalesced during fatigue crack growth to form shallow semi-elliptical crack geometry and have propagated to reach the final cracks. In

According to Fig. 11 the presence of shallow semi-elliptical cracks on both concave and convex sides of the airfoils is indicative of the influences of considerable bending stresses during crack propagation.

Figure 11. Schematic drawings of the fracture surfaces: (a) blade No. 1, (b) blade No. 8 and (c) blade No. 11

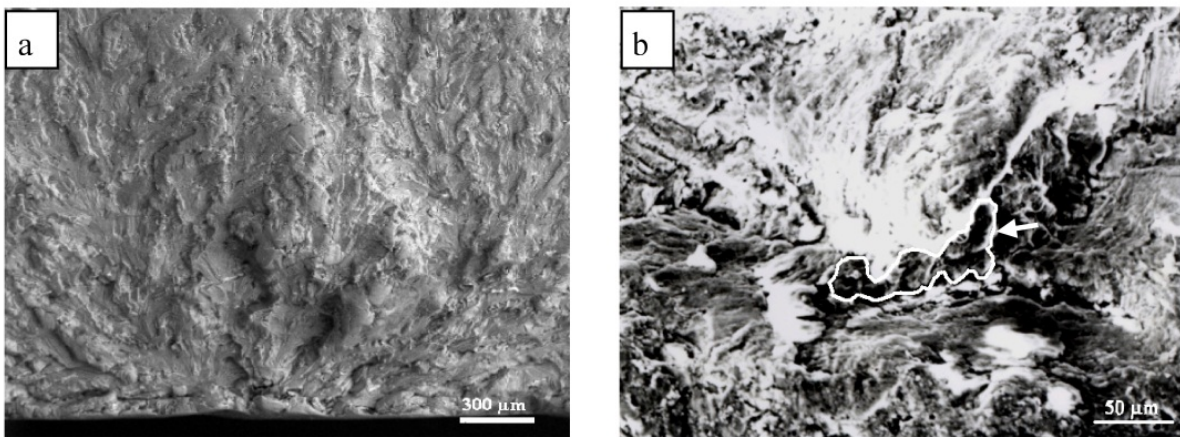
An SEM micrograph showing one of the typical primary crack initiation sites is presented in Fig. 12a. A secondary electron mode micrograph of this region revealed a large second phase particle with a length of about 100 μm at the crack origin as shown in Fig. 12b. The EDS spectrum of this particle identified that its composition is very similar to the intermetallic particle. Presence of the large particles at the origin of the crack have been shown to act as preferred fatigue crack nucleation sites in such alloys, despite the fact that they represent a small fraction of the particle population (Kung, 1979; Merati, 2005).

Figure 12. (a) Typical micrograph showing a primary crack initiation site and (b) a crack nucleating particle at the origin of the crack

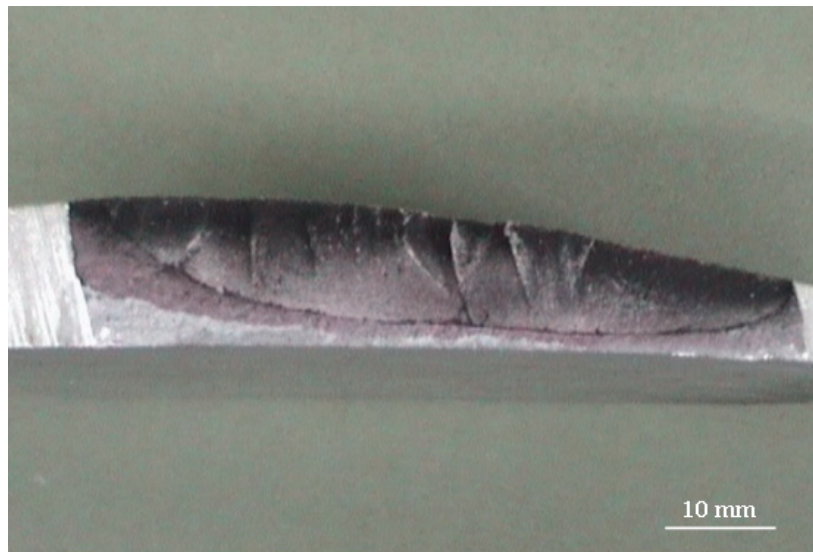
Dye penetrant non-destructive testing that was carried out on the blades after the accident identified that some of the non-fractured blades have been cracked. The crack surface of one of these blades (blade No. 7) was disclosed as shown in Fig. 13 by cutting the remaining cross-section of the airfoil and opening carefully. In this figure the semi-elliptical fatigue region is obvious. The crack surface is covered by the penetrant material and a higher magnification view identifies the transition of the penetrant material out of the fatigue region that has different microscopic features, so it can be recognized as the final fracture zone. Therefore, the final fracture stage could not be completed because of the generator stoppage after the fracture of the three blades.

Figure 13. Opened crack surface of blade No. 7

Crack initiation and growth from the convex side and also decrease in the fatigue region in comparison with the fractured blades, prove that the fluctuation of the stresses and the maximum stress had been highly increased during the accident probably due to excessive vibrations.

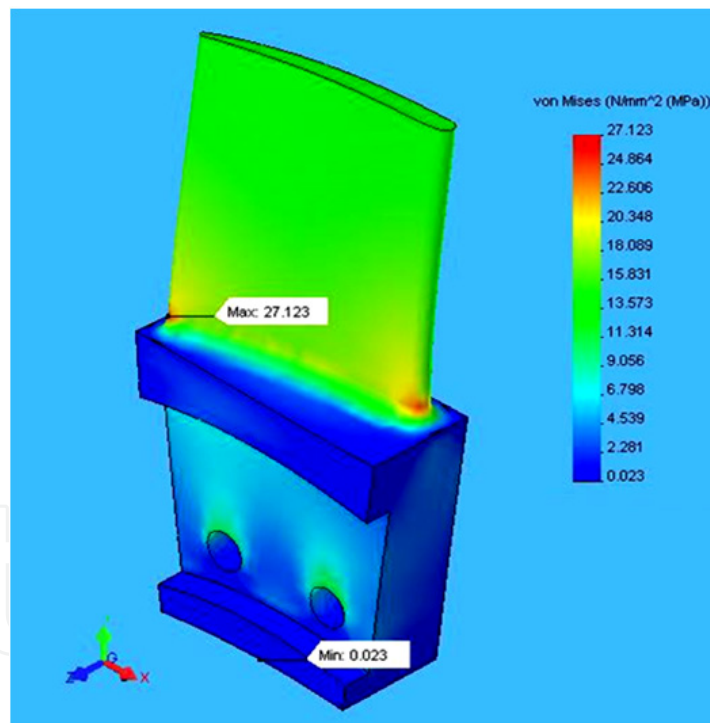
A 3D finite element model was used to simulate the normal operation of the fan blades. The results revealed that the maximum total stress acting on the blade under normal condition was about 27 MPa which occurred close to the transition radius between the airfoil and the root where the cracks initiated in fractured blades (Fig. 14) (Ataei, 2006). The bending stress introduced by the action of the air flow pressure are less important (Cohen, 1987) and was estimated as about 7 MPa. According to the results, the steady state stresses are very low in comparison with the strength of the blade material therefore, it can be concluded that the fracture accident was happened during an abnormal condition.

Figure 14. Finite element simulation of the fan blade, which shows the stress distribution under normal operating condition (Ataei, 2006)

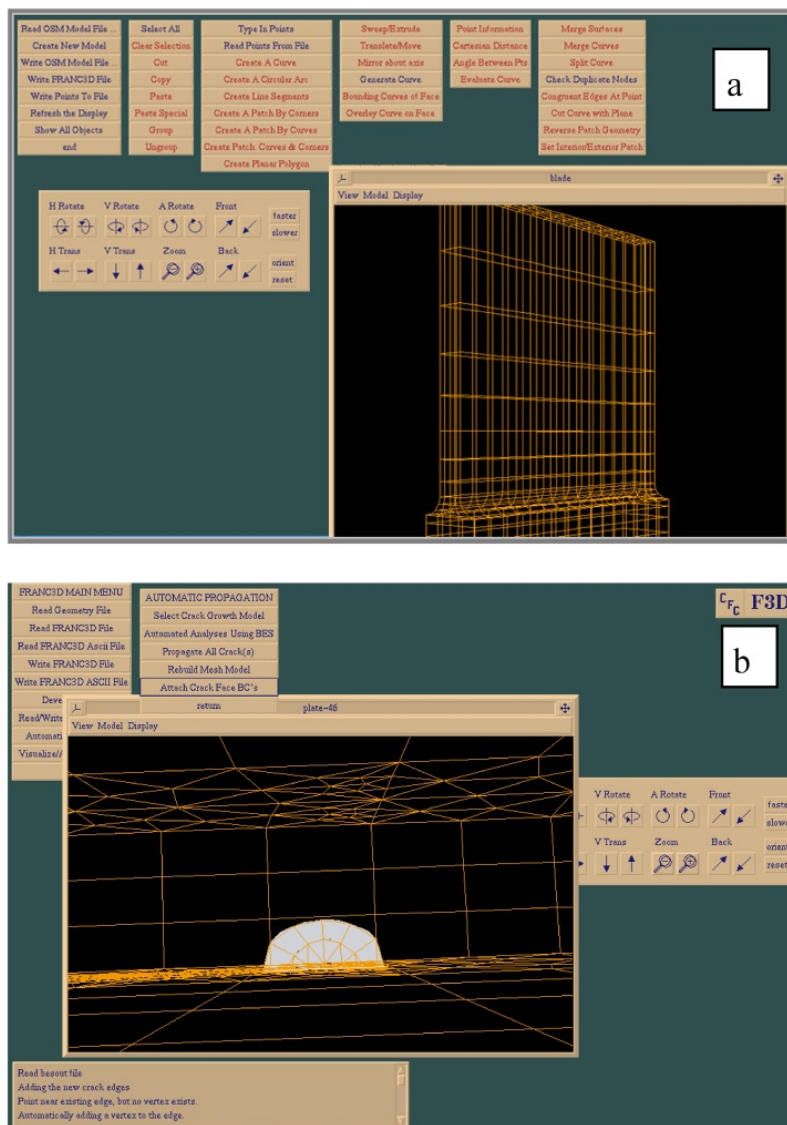
Based on the stresses applied by the model boundary conditions, the initial crack was grown in a series of crack propagation steps. Fig. 15a is a simplified 3D model of the airfoil that was meshed 2D (Boundary elements) in FRANC3D for simulating fatigue crack growth in fractured blades. Fig. 15b shows simulated fatigue crack in blade No. 8 after three steps of propagation.

Figure 15. (a) A 3D model of the airfoil with 2D mesh for simulating fatigue crack growth in FRANC3D software and (b) simulated fatigue crack in blade No. 8 after three steps of propagation

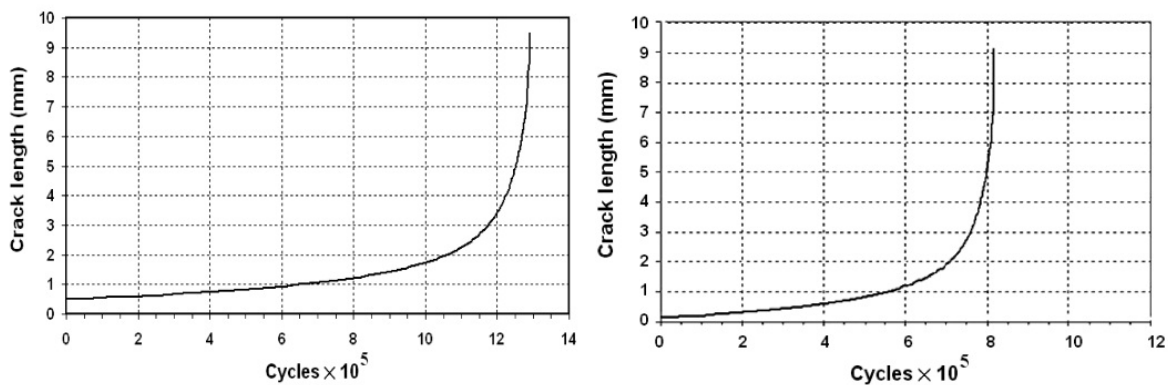
The empirical constants C and n were computed by fitting the near threshold crack growth data for AA 2124 aluminum alloy (Department of Defense, 1998) as $C = 9.5 \times 10^{-13} \text{ m} \cdot (\text{MPa}\sqrt{\text{m}})^{-n}$ and $n = 4.9$ for da/dN expressed in $\text{m}\cdot\text{cycle}^{-1}$ at a load ratio of $R = -0.1$ assumed in this case. The results of crack growth simulations in the first and the second fractured blades, where initial cracks are grown in small steps to their final dimensions are plotted in Fig. 16. These curves show the crack size as a function of the number of applied stress cycles. It can be seen that the number of cycles required to propagate initial cracks to their final dimensions for the first and the second fractured blades are just about 1.3×10^6 and 8×10^5 cycles respectively.

Figure 16. Crack length as a function of number of cycles in: (a) the first fractured blade (blade No. 1) and (b) the second fractured blade (blade No. 8)

Thus the total fatigue crack growth time is about one hour. This lifetime is within the 11 hours of actual operating period following the last overhaul, which ended with the failure of fan blades.
