Case-Based Reasoning of Man-Made Geohazards Induced by Rainfall on Transportation Systems

Kuan-Tsung Chang, Edward Wang, Chih-Ping Kuo,
Min-Cheng Teng and James Jin-King Liu

<http://dx.doi.org/10.5772/64412>

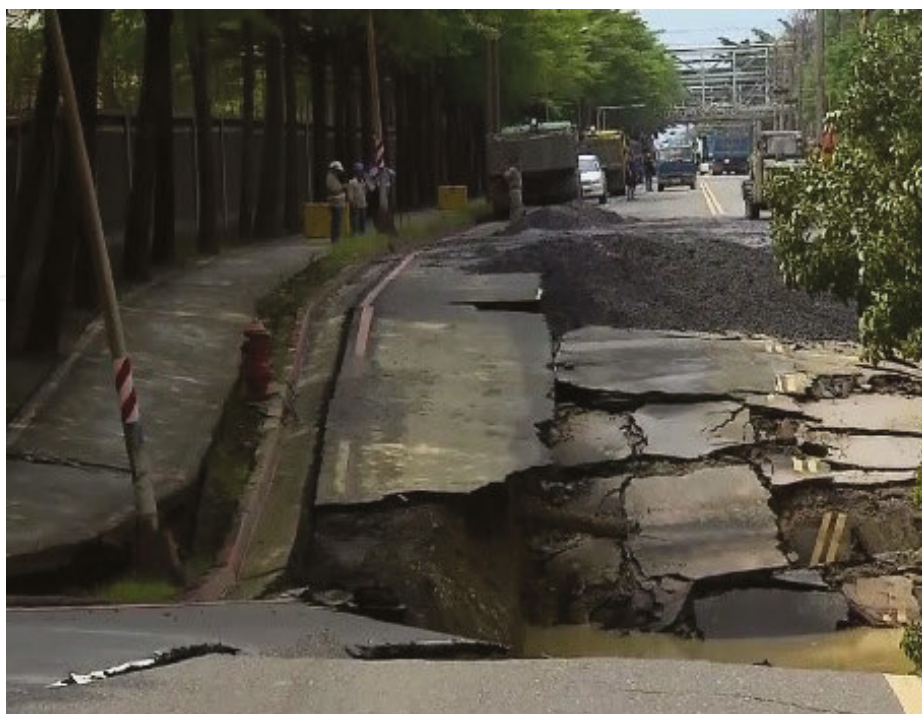
Figure 2. Destruction of roadway.

The accident occurred during the underground cable tunneling project of Taiwan Power Company. Due to the failure of the shield tunneling engineering machinery occurring 30 m underground, groundwater flooded into the excavation and caused the road pavement to collapse. In addition to the underground drinking water pipe failures, trees, and utility poles around the road tilted as well. Although the accident occurred at about 2 a.m. on the 18th of September, the construction personnel did not formally close the road and notify the impacted pipeline and business units until past 6 a.m. In addition, since the underground pipelines were already damaged, secondary damage occurred during the emergency repair, including oil and water leakage with the resulting environmental pollution. The collapse area continued to expand after the initial accident.

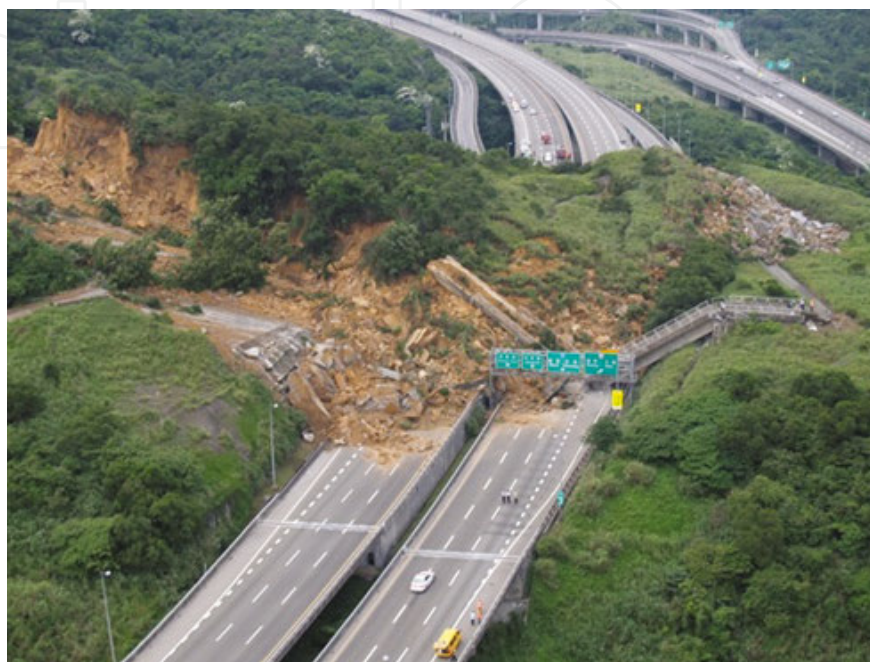
The landslide accident occurred in Madong Village, Qidu District, Keelung City. During the slide, the Dabu Bridge crossing Freeway No. 3 also collapsed onto the freeway mainline, thus blocking traffic (**Figure 3**).

Figure 3. Photograph of the landslide at Freeway No.3 (Source: http://www.nasc.gov.tw/files/duty_news_files/_4251883.JPG).

1. The disaster was caused by dip-slope sliding.
2. The dip slope at the location is formed through mutual stacking of sandstone and shale, and a slide is likely to occur at the interface of rock layers.
3. The sandstone in the upper layer is seriously weathered, rich in vertical joints, and permeable. The shale in the lower layer has poor water permeability; therefore, a higher water content and water pressure was caused in the interface between the two rock layers, reducing the friction between the rock layers and resulting in a slide.
4. The sliding rock is huge, and it is likely to exceed the original rock anchor capacity, causing the breakage of the sliding rock's connection to the base material.

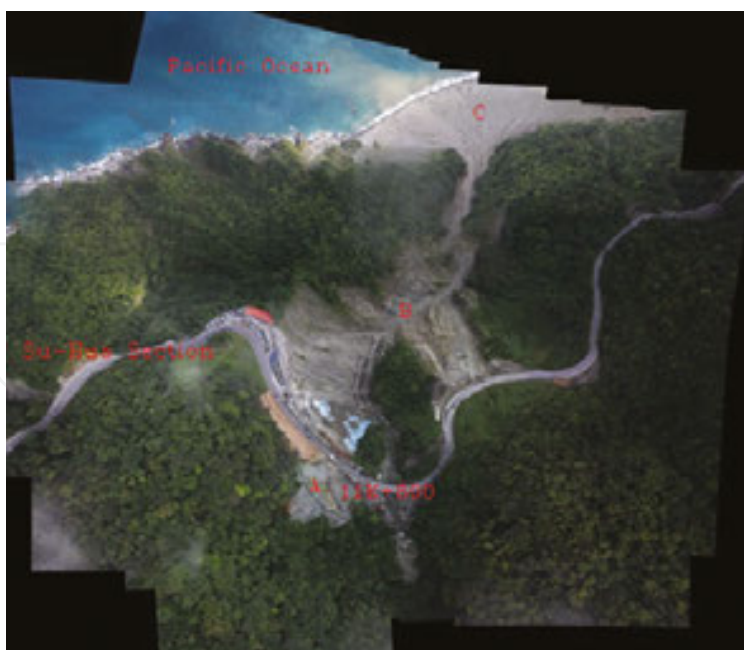
Due to the combined effects of Northeast seasonal winds and Typhoon Nalgae, heavy rainfall induced in the I-Lan area resulted in serious landslides. The Suao Landslide at the coastal Su-Hua Section of Highway Route 9 was located at the 11.8K-km mark. At this site, the entrainment effect of debris flow and toe erosion on the downslope induced a regressive sliding failure at the adjacent road causing the downslope collapse and roadside barrier failure. The rockfall barriers at the upper stream of the nearby Daken bridge were destroyed as well. The incident took place at 05:00 on 9th October 2011. The heavy rainfall lasted 12 h, with an average rainfall at the nearby rain station of 30.5 mm/h with a total rainfall of 418.9 mm. The affected landslide area along the road was 150 m². **Figures 4** and **5** show the photographs captured by the UAV camera. **Figure 4** shows the orthorectified image of the landslide. **Figure 5** shows some selected views of the landslide.

Figure 4. The ortho-rectified UAV image of the Suao Landslides (Source: GangYu Corporation).

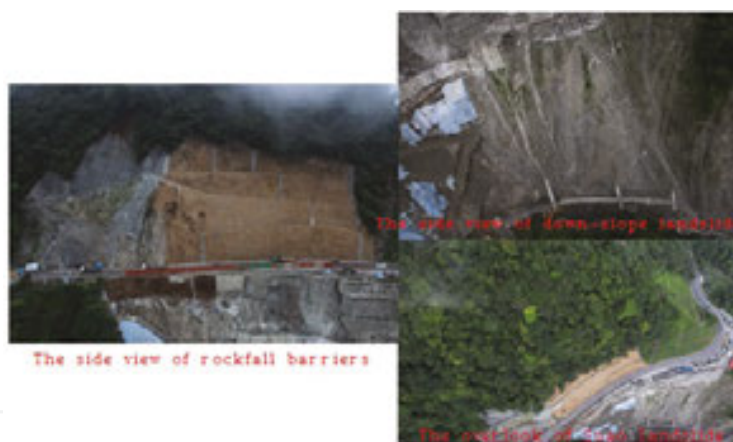
Figure 5. Some selected views of UAV images of the Suao Landslides (Source: GangYu Corporation).

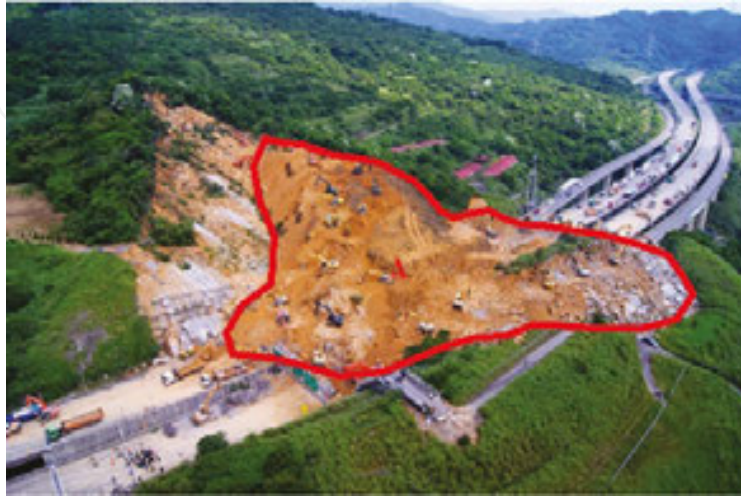
Figure 6. UAV side-view of the landslide taken by a rotary wing UAV owned by Flying Tiger Helicopter and Skyline Dynamics Co., Ltd.

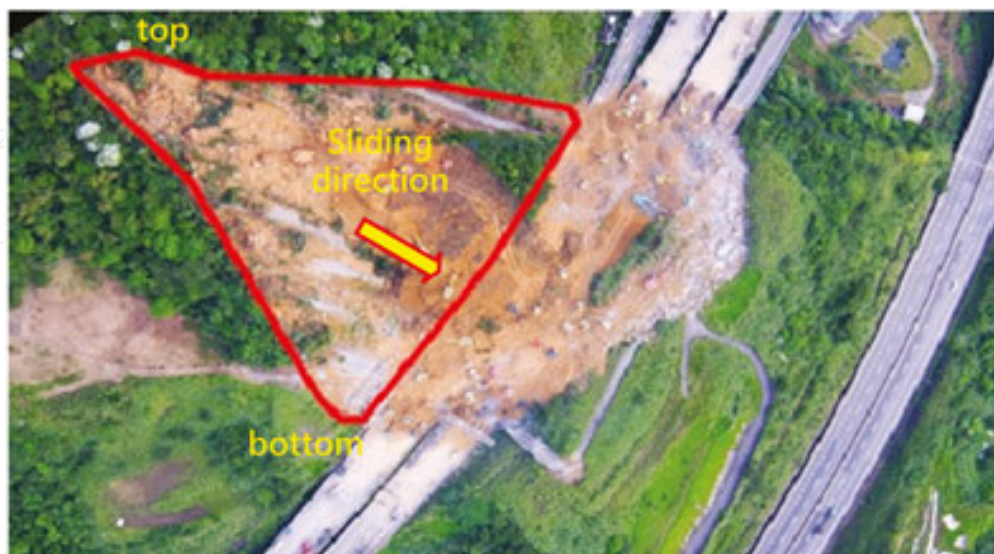
After the establishment of stereo-pairs, digital elevation models and orthophotomosaics were created. **Figure 9** shows the side boundary of the landslide and the limit of the freeway where the landslide overtopped it. The landslide area is estimated as 11,475 m² and the volume 137,571 m³, with an estimated material weight of 300,000 tons. These estimates were useful for managing the trucks used for debris disposal.

Figure 9. Side boundaries of the landslide and the freeway limits [23].

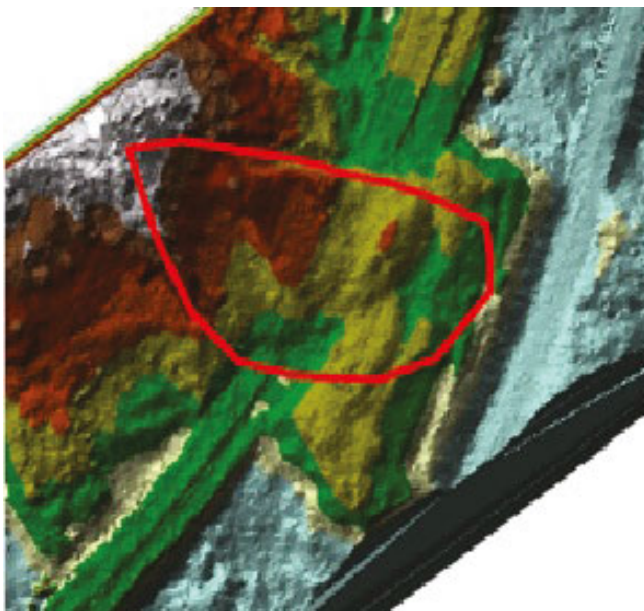
Figure 11. 3-D models following the event [23].

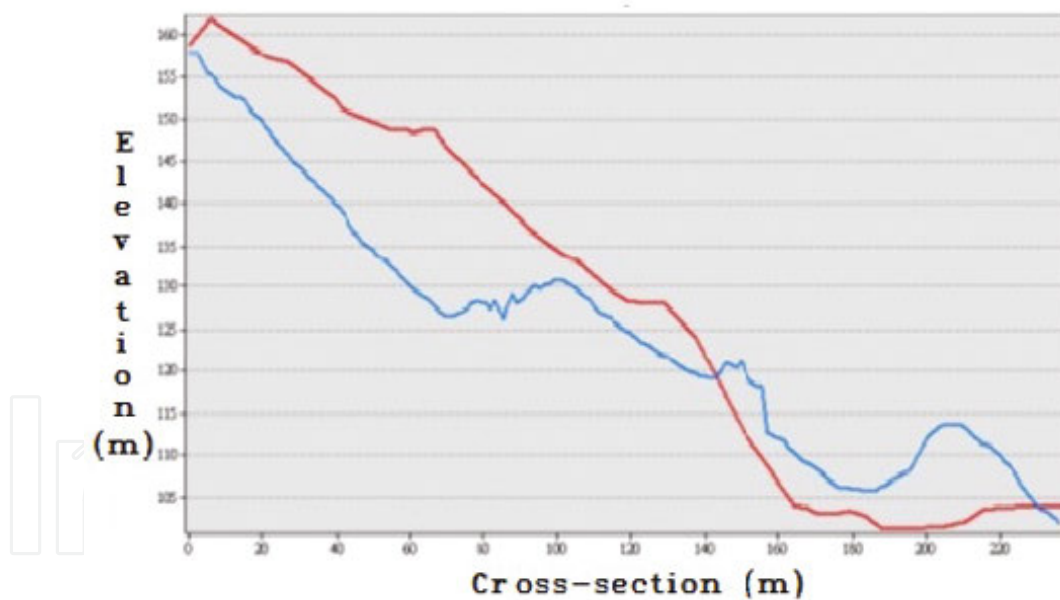
Figure 13. Cross sections for both prior to and following the event.
