Two-Dimensional Hydraulic Modeling and Geotechnical Analysis of Earthen Regulation Dams Located at Arroyo Las Viboras Watershed in a Major Transboundary Mexico-USA Metroplex: How an Ordinary Rain Event Caused Major Damage Related to Extraordinary Flooding?

Oscar Sotero Dena Ornelas, Diane Irene Doser,
Oscar Fidencio Ibañez Hernández,
Griselda Janeth Obeso Cortez and
Miguel Angel Galdean Vega

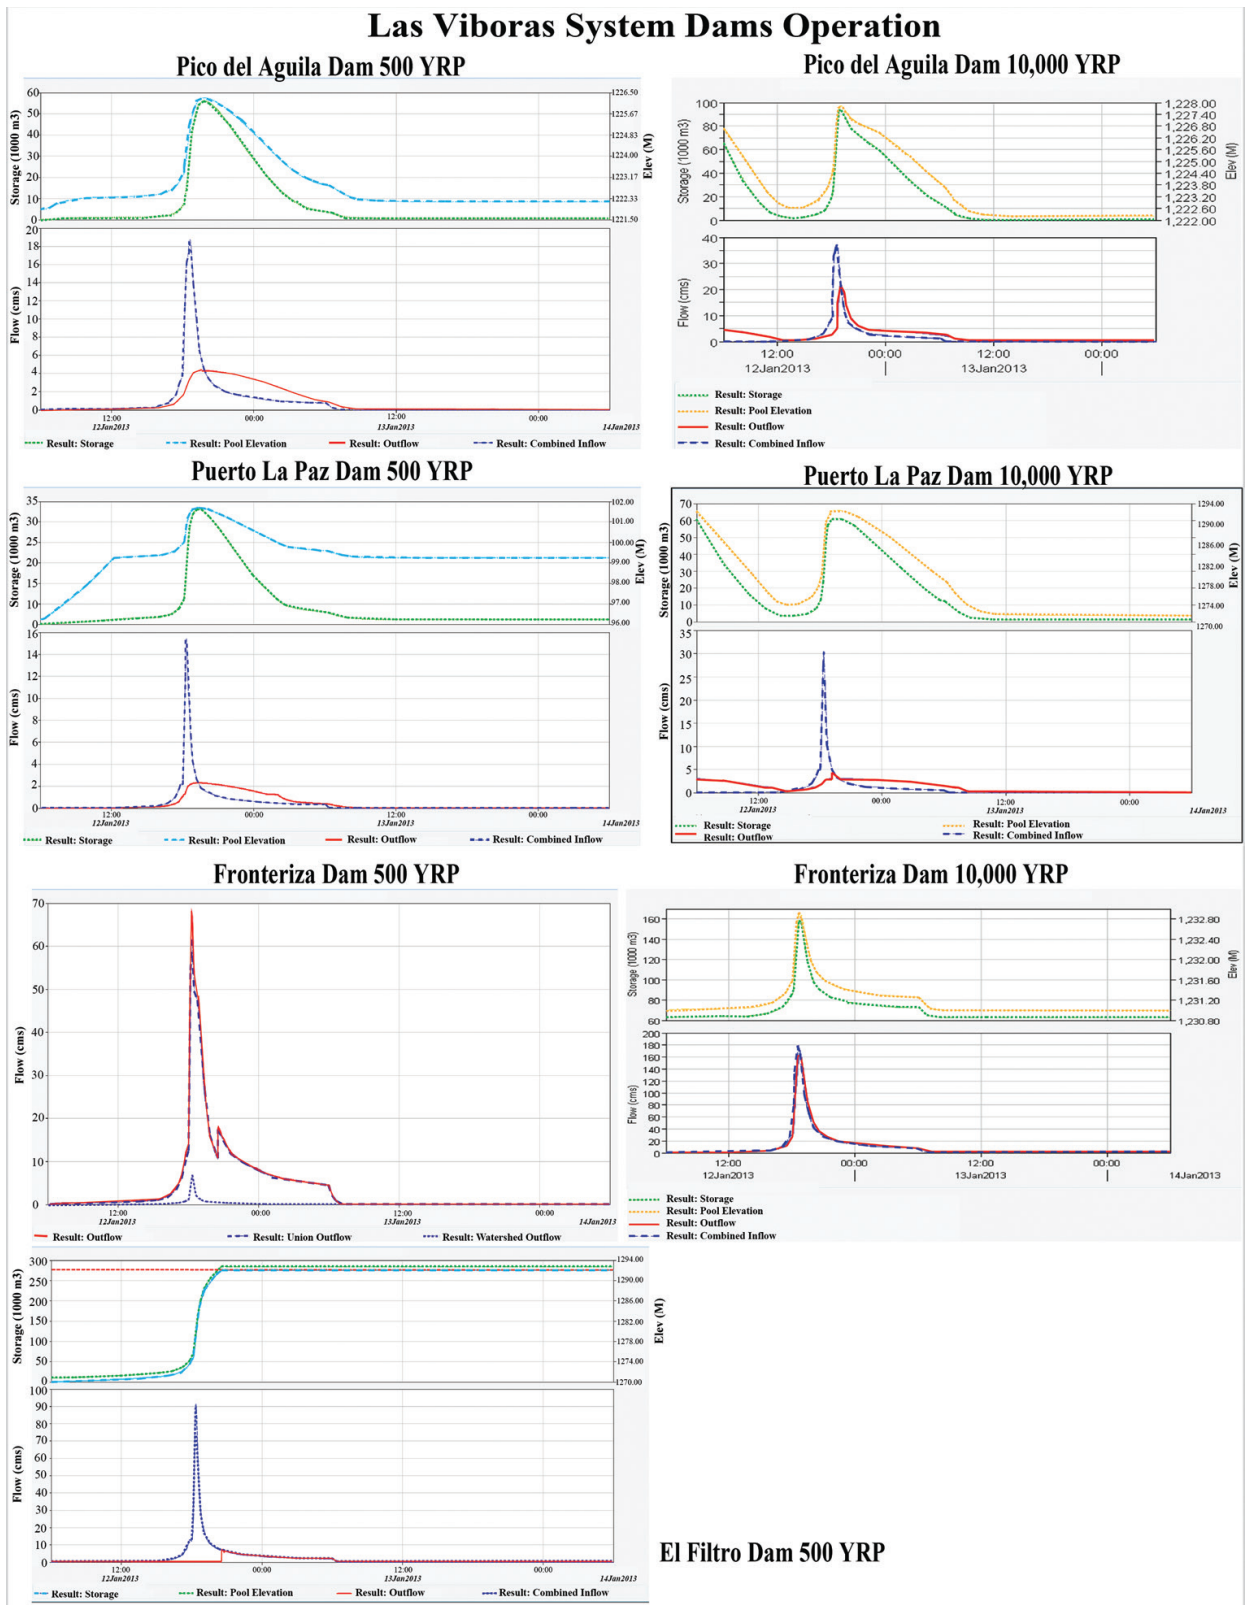
One of the main results of the hydrologic analysis of Las Viboras watershed shows how the paving process, linked to the urban development, has negatively affected the hydraulic condition of this watershed, since almost all the rain volume is conveyed downstream as runoff as consequence of the increase in impervious surfaces. According to the hydrologic modeling parameters, this watershed has a catchment area of 22 km². It is intended to be hydrologically protected by four regulation structures: The Pico del Aguila dam, regulating the north branch runoff flowing down from the SDJ, the Puerto La Paz dam, regulating volumes from the central branch of Las Viboras drainage system, La Fronteriza dam, regulating flow from the south-central and southern branches of Las Viboras and El Filtro, regulating upstream flow on the southern branch of Las Viboras. As consequence of the 10 YRP event of 2006, La Fronteriza dam failed by overtopping. It is now breached to avoid water accumulation since the dam is structurally compromised. The El Filtro dam, located upstream, was then emplaced to temporarily regulate the southern branch runoff, thus decreasing the hydrologic pressure downstream. We modeled each hydraulic structure, including Earth Regulation Dams and culverts, to determine their hydraulic operation, including storage, pool elevation, inflow and outflow. The dams were analyzed for ordinary rains (2 YRP) up to extreme events (10,000 YRP), whereas culverts were analyzed for 500 YRP rain events. The hydraulic operation for each dam for 500 YRP and 10,000 YRP rains is shown in **Figure 2**.

Figure 2. Models of hydraulic operation of dams for 500–10,000 YRP. The results were obtained by 1D hydrologic modeling.

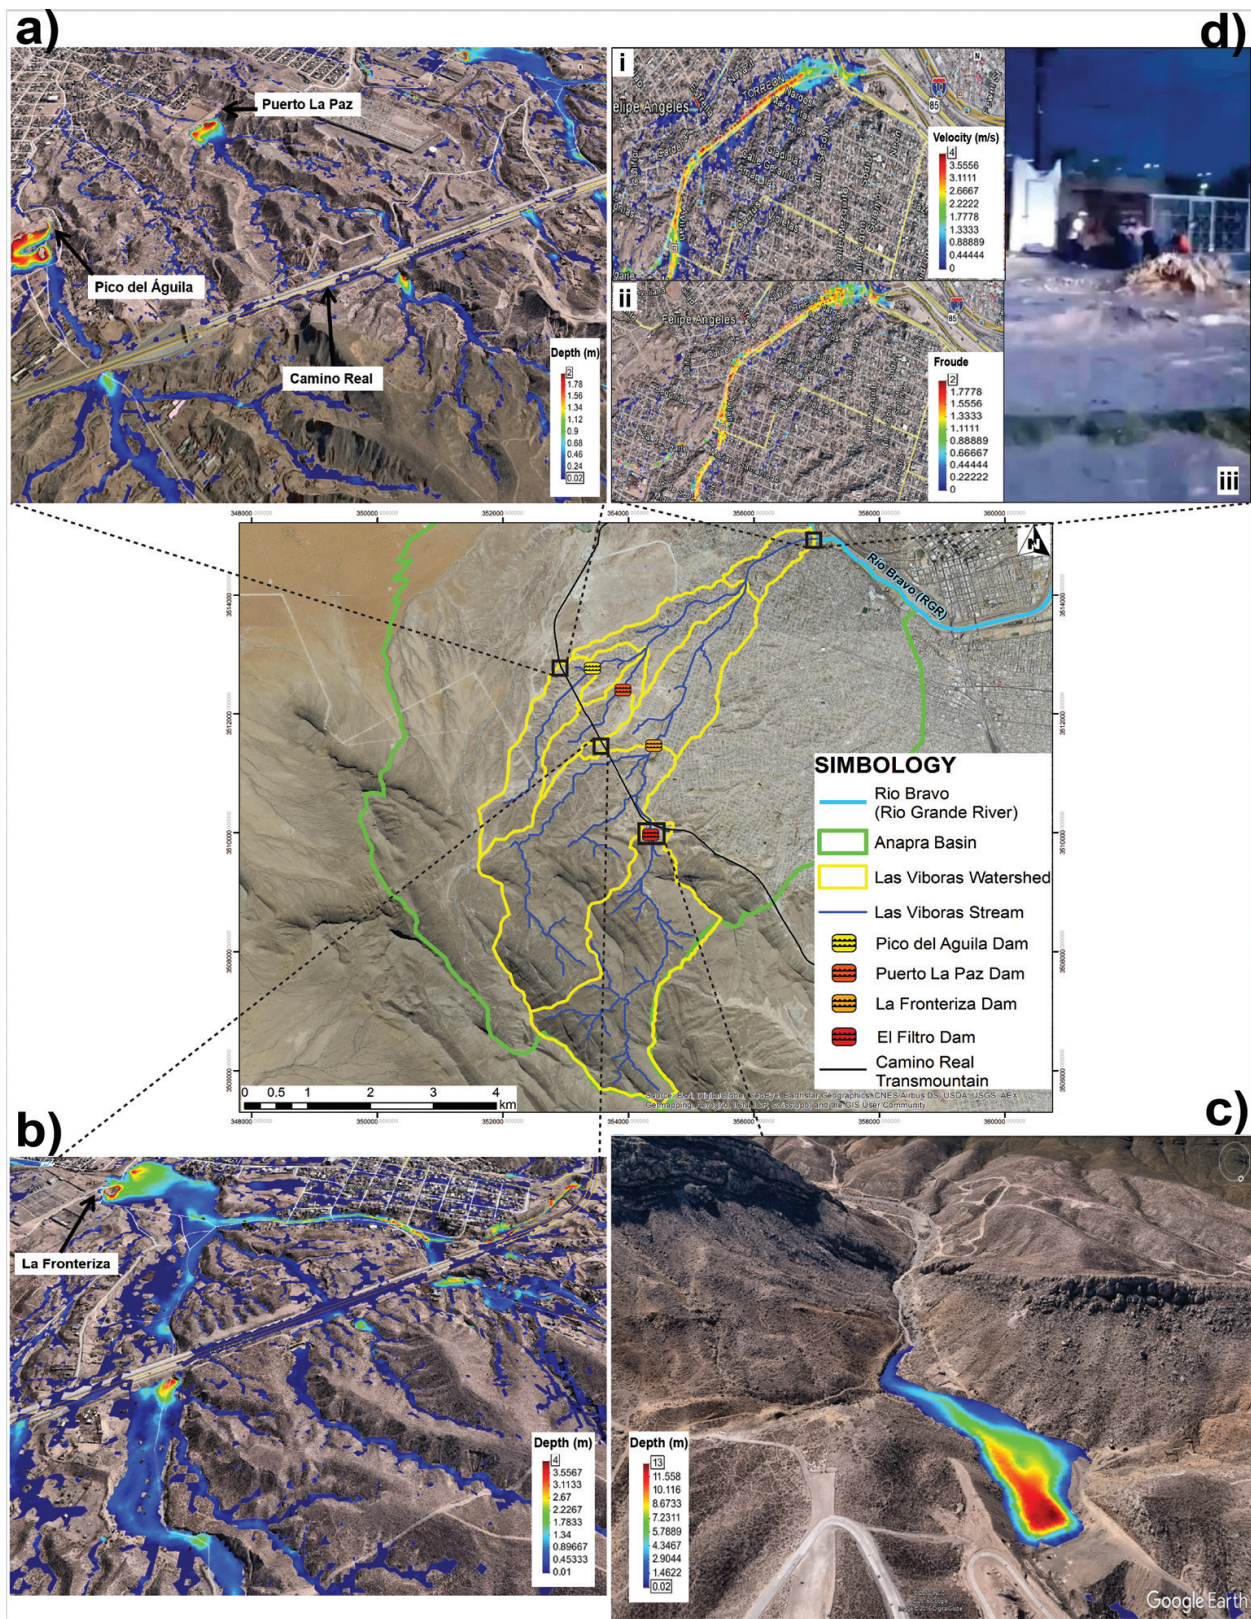
The main result for the 2 YRP modeling showed the lack of water regulation at La Fronteriza dam is a relative concept since the width of the reservoir prevents all water from flowing freely downstream through the channel at 70 m³/s, recording reservoir depths up to 2 m even for ordinary rains (**Figure 3(a)**). Nevertheless, this regulation is not sufficient since this drainage network branch is still the major contributing factor to the nearly 1 m water depths reached downstream of this location. In the same way, the bi-dimensional model at Pico del Aguila dam shows that this structure is properly regulating, reaching water depths of up to 1.60 m behind the dam. This is also the case for the Puerto La Paz dam, where runoff volume is properly regulated reaching depths of 1.80 m (**Figure 3**) behind the dam. Although this combined runoff flow regulation effectively diminishes the rate of water flowing downstream along this tributary stream, water depths of 0.40 m are still reached before the intersection of Las Viboras drainage with the RGR (**Figure 3**). This analysis also indicates that El Camino Real's culverts are retaining water, even for a 50% PE rain; a result not anticipated by the HMS modeling (**Figure 3**). Then, El Filtro dam is retaining, rather than regulating, a water volume flowing from the southern tributary watershed with a catchment area of nearly 6 km². For heavier rains it is anticipated that this poorly constructed wall, lacking riser spillway and emergency spillway or outlets may fail, perhaps just increasing the hydrologic risk rather than reducing it as forecasted by the HMS modeling results.

Figure 3. The results of 2D hydraulic modeling. (a) Water levels at Pico del Aguila and Puerto La Paz dams. (b) Water levels at culverts along El Camino and at La Fronteriza Dam. (c) Water levels at El Filtro Dam. (d) Velocity (i) and celerity (ii) results, (iii) turbulent flow at Las Viboras delivery point into Rio Grande River, photo taken by Azteca Noticias news.

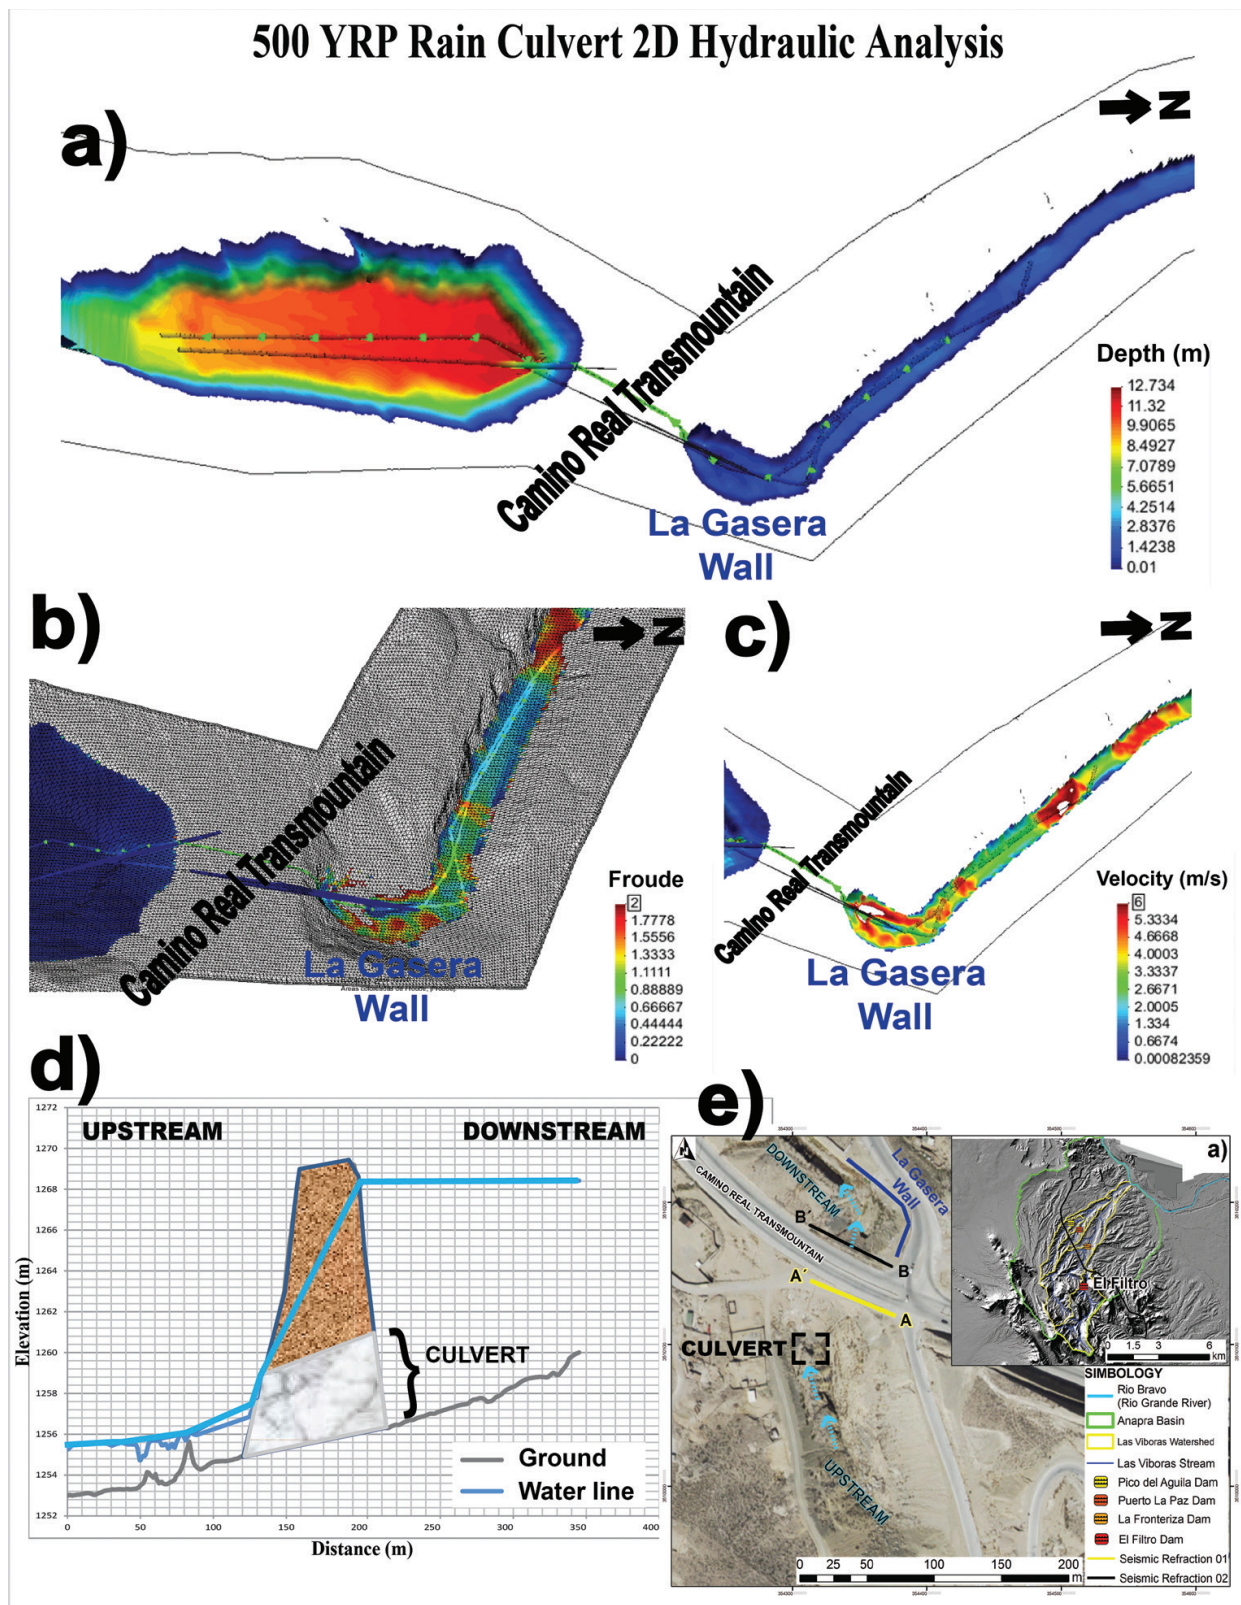
The second hydraulic scenario corresponds to El Filtro dam breaching for a 500 YRP event. The results are consistent with the hydrology, resulting in a runoff volume of 260 m³/s flowing through the simulated breach. This volume shows that the 4.5 × 4.5 m culvert located downstream is not able to efficiently conduct the flow (**Figure 4**), yet the 1D calculations showed it as capable of transporting 360 m³/s. The hydraulic jump generated at the upstream culvert opening reaches depths of 12 m, so that El Camino Real's embankments act as a regulation dam, albeit they are not designed to do so. The detailed bi-dimensional modeling of the breached El Filtro dam-culvert system, also shows that the closed turn of the channel at the downstream culvert outlet produces turbulent and erosive velocities which are scouring the diversion wall of "La Gasera" located only 35 m to the north (**Figure 4**). As consequence of these results, the system was modeled again for a 2 YRP, but with the hypothetical scenario of removing El Filtro dam. The results show dramatic downstream effects; the downstream culvert is completely overtopped with water depths of 4 m both sides of the culvert, whereas water depths increase up to 2 m for the last branch of the drainage network. To conclude the hydraulic analysis, field work was conducted to identify erosional features such as gullies at the slope toe of "La Gasera" wall. The result was even more complex than predicted by the model; the wall scouring process related to several ordinary rain events show that the culvert is partially occluded with debris scoured from the wall. The hydraulic jump caused by the occlusion at the culvert outlet is recorded by water depths of nearly 3 m, as shown by a water line traced upstream across the culvert passage (**Figure 4**).

Figure 4. Hydraulic modeling results for the breaching of El Filtro dam. Inset (a) Water depth. Inset (b) Froude number. Inset (c) Velocity. Inset (d) Cross section showing how El Camino Real acts as retaining wall.

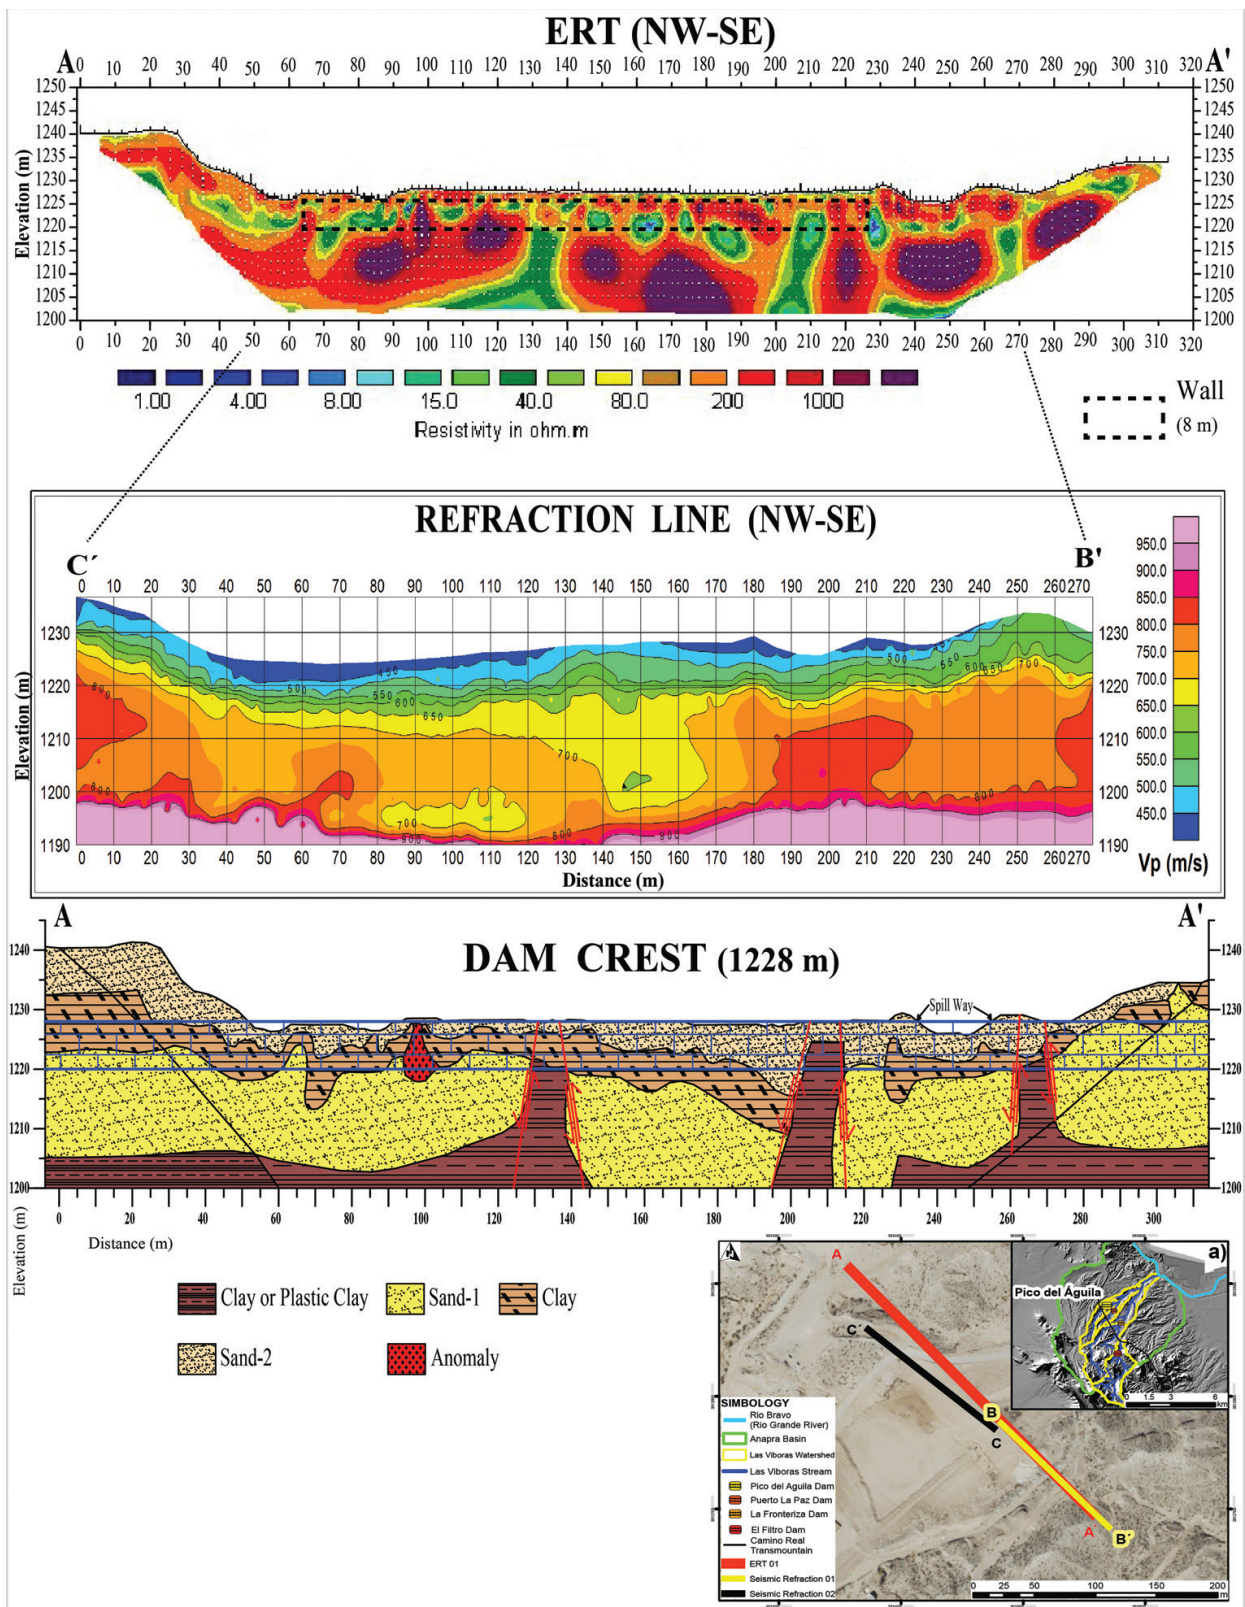
of interlayered beds of sand, gravel, silts and clays [17]. Also, a visual inspection of the wall showed the presence of a displaced block in the vicinity of the spillway. This block is readily identifiable, even in recent satellite imagery. No fractures and/or cracks were observed elsewhere. The geoelectrical analysis (**Figure 5**) of the wall and foundations revealed that, in general, inside the wall body, an interbedded sequence of high, low and high resistivity values are observed. At depths greater than 10 m beneath the wall the structure seems to be resting on a foundation with high electrical resistivity. The electrical resistivity layers do not show a quasi-horizontal and homogeneous pattern. Layers are actually updipping between model coordinates (MC) 70 and 120 m. At 130 m along the profile, a low-resistivity vertical anomaly is identified at the base of the wall. From 140 to 200 m MC the layers are down dipping. Beyond 200 m MC another vertical low-resistivity anomaly is observed. Besides showing a lower range in resistivity values, this anomaly is vertically propagated across the whole wall at MC 230 m. This resistivity anomaly matches the location of the vertical down dropped block observed at the surface, atop of the wall crest. Finally, by the end of the section, the layers beneath the emergency spillway are quasi-horizontal, until a new vertical low-resistivity anomaly is found again at MC 265 m.

Figure 5. Geotechnical and geophysical assessment results at Pico de Aguila EDR. Top image: geoelectric profile. Middle image: V_p Refraction profile. Bottom image: interpreted results. Inset map at bottom shows location of geophysical surveys relative to extent of dam.

specific lithologies found by direct exploration at the Puerto La Paz (PLP) dam. The interpreted lithological section (**Figure 5**, bottom image) shows that the body of the wall would be then composed of an interlayered sequence of silty sands associated with resistivities greater than 200 ohm-m. The interbedded stratum with resistivity values between 15 and 60 ohm-m is associated with a sandy clay unit. A nearly vertical high resistivity anomaly, located at M.C. 90 m, is perhaps associated with the presence of an abandoned concrete sewer line emplaced across the dam's body. Foundation of the dam is resting on a very high electrical resistive package (>1000 ohm-m) associated with clean sands and or gravel. Seismically, the interbedded sequence is not observed, but this might be a limitation of the method, unable to model velocity inversions [21]. But in contrast, a positive velocity gradient, starting at 350 m/s at the surface and increasing to over 700 m/s at the wall bottom, is observed in the velocity field. The V_p values at the foundation horizon are then defined by the 700 m/s isovelocity contour, interpreted as associated with Tertiary sediments composed by sand and gravel, which makes it a competent strata. Although the foundation layer is competent, the presence of the highly warped region of 600–700 m/s V_p velocities in the middle of the seismic section, reveals that the material forming the body of the wall was severely perturbed by deformation and movement. These materials appear to have been re-emplaced and compacted "a-posteriori." This process definitely does not lead to proper linkage or anchoring of the original layering to the recently emplaced material. This feature must be considered a serious flaw, which seriously compromises the structural integrity of the wall. Furthermore, the quasi-vertical low resistivity anomalies indicate clay bodies are intruding the structure in a similar fashion to that observed within the Puerto La Paz dam wall. Although no direct probing of the material is available, these inferred clay structures compromise the structural integrity of the wall, as evidenced by cracks and openings propagated along the wall slope at the same location as the clay bodies that are revealed by the geoelectrical data.

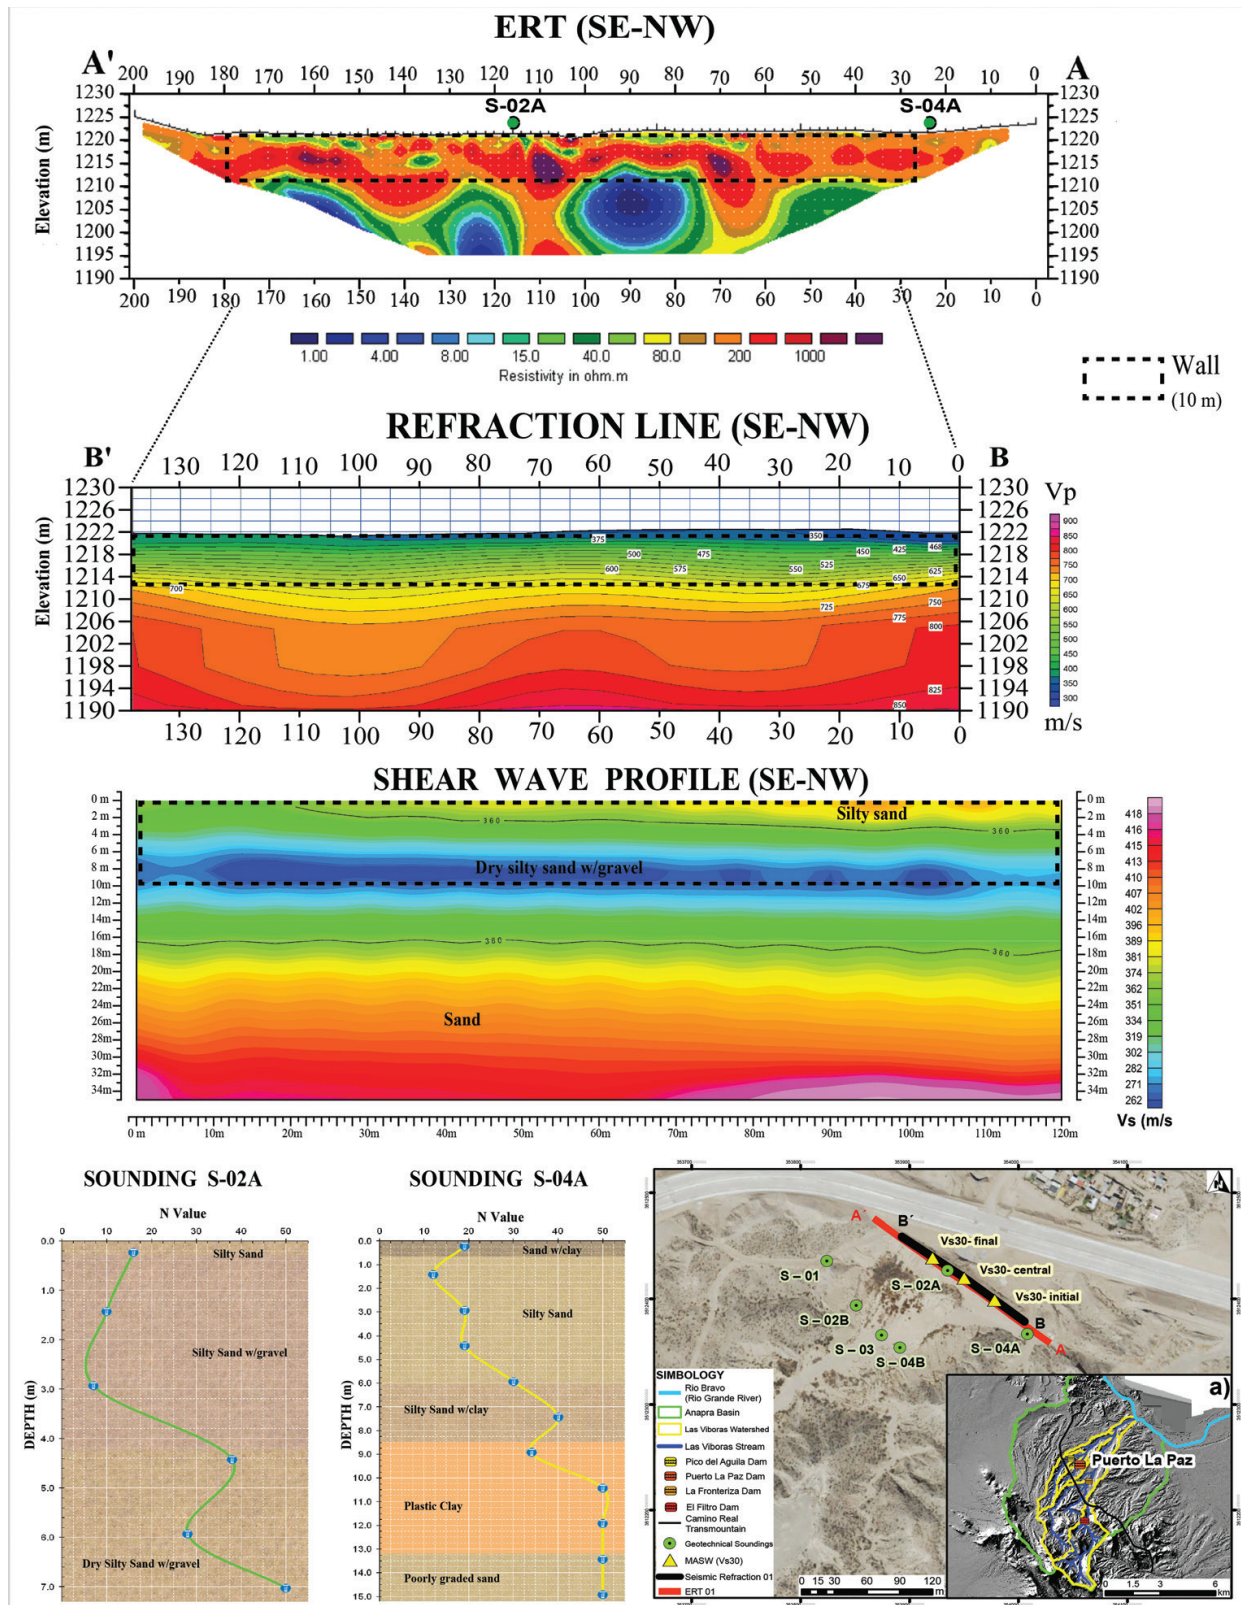
Figure 6. Geotechnical and geophysical assessment results for the Puerto de Paz dam. Top image: geoelectric profile. Position of soundings relative to dam are indicated. Middle Images top: V_p Refraction profile. Bottom image: V_s profile. Bottom left shows direct probing soundings. Bottom right shows geophysical and geotechnical survey locations with respect to the dam.

feature matches the depth and location of the low resistivity (<8 ohm-m) body observed in the ERT profile. The V_s section (**Figure 6**) does not show the same behavior observed in the V_p field, i.e., a positive velocity gradient as function of depth. The S-wave velocity (V_s) field shows a 270 m/s low shear velocity zone (LVsZ) located between depths of 6 and 10 m. The velocities above the LVsZ range from 360 to 380 m/s. The velocity field increases from 360 m/s at a depth of 10 m to 420 m/s at 20 m in depth. The V_p/V_s and Poisson's ratios are respectively: 1.66 and 0.22 at depths of 4 m, 2.2 and 0.37 at the LVsZ and 2.34 and 0.39 at 10 m in depth.
