# Failure Analysis of High Pressure High Temperature Super-Heater Outlet Header Tube in Heat Recovery Steam Generator

Ainul Akmar Mokhtar and  
Muhammad Kamil Kamarul Bahrin

Heat Recovery Steam Generator (HRSG) tube failure is one of the most frequent causes of power plant forced outage. In one of the local power plants, one of the boilers has experienced several defects and failures after running approximately 85,000 hours. 17 tube failures were found at the High Pressure High Temperature Superheater (HPHTSH) outlet header. The aim of this study is to find the root cause of the tube failures and to suggest the remedial action to prevent repetitive failure event. Several analysis methods were conducted to ascertain the potential cause(s) of failure. The results showed that the tubes failed due to long-term creep and thermal fatigue based on the cracking behaviour. Furthermore, the power plant has been operating as a peaking plant which concluded that the tubes have undergone the thermal stress due to frequent temperature change in the tubes. Flow correcting device (FCD) was also found damaged, causing flow imbalance in the tubes. Flow imbalance accelerated the creep degradation o

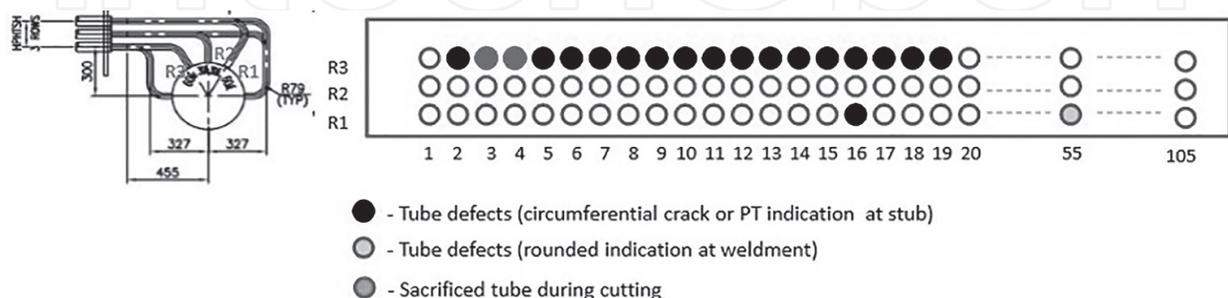
**Figure 1.** Tube mapping of recent failure of HPHTSH outlet header tubes.

start-up/shutdown. The frequency of tube failures has increased when the plant was having more cyclic operation as compared to 5 years after commissioning. The connecting tubes of the outlet header of HRSG High Pressure High Temperature Superheater (HPHTSH) have suffered leakage, and all the failed tubes were located next to each other in a row (i.e. Row 3) as shown in **Figure 1**.

The outcomes from the inspection showed that no defects were found on HTRH and HPLTSH inlet and outlet header; however, circumferential cracks were found at 17 tubes on HPHTSH outlet header. The flow correcting devices (FCD) also were found detached and misaligned from its original position. Maintenance team has appointed internal inspection team to investigate the possible failure mechanism and the root cause of HPHTSH outlet header tube failures. Also, they requested external laboratory to conduct a remaining creep life prediction [1].

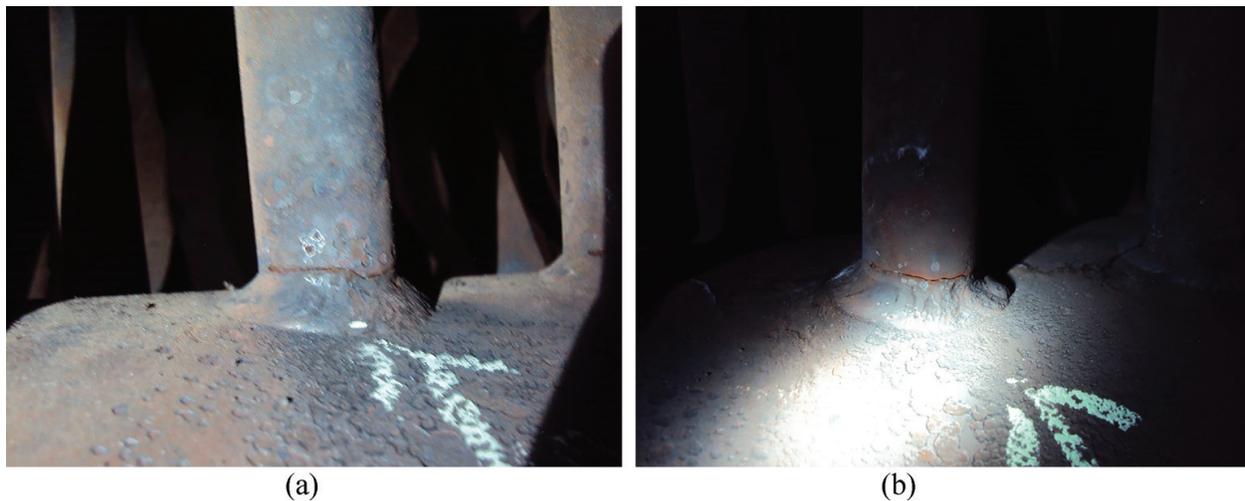
**Figure 2.** Appearance of Row 3 tube failures, (a) Tube 8 and (b) Tube 9.

The investigation covered the failure of Tube 8, Tube 9, Tube 10 and Tube 18 of the HPHTSH section. **Figure 2** shows the samples of tube failures. Several analysis methods were carried out to ascertain the potential cause(s) of failure such as visual examination, dimensional

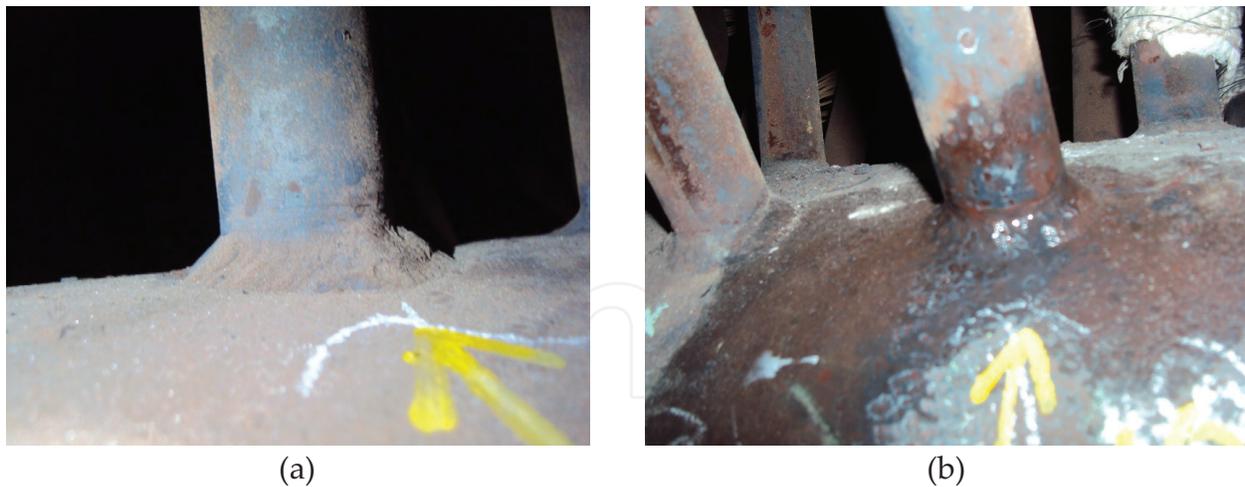
**Figure 4.** Appearance of tube failure at Row 3: (a) Tube 8 and (b) Tube 18.

The connecting tubes are welded directly on the header without the presence of stubs. Cracks have developed at the heat-affected zone (HAZ) of the welds on the tube side. All cracks were circumferential in nature with no branching characteristics. The cracks propagated at the outer radius plane of the connecting tubes with an average length of approximately 25 mm as shown in **Figure 4**.

The tube sections have not undergone visible bulging and deformation over the entire length. The external surfaces of all sections appeared to be normal, with no signs of significant corrosion/erosion damage. The magnetite layer on the inner, steam-touched surfaces appeared thick, homogenous, adhesive and continuous, with no signs of serious/apparent exfoliation. The circumferential cracks have penetrated the tube wall.

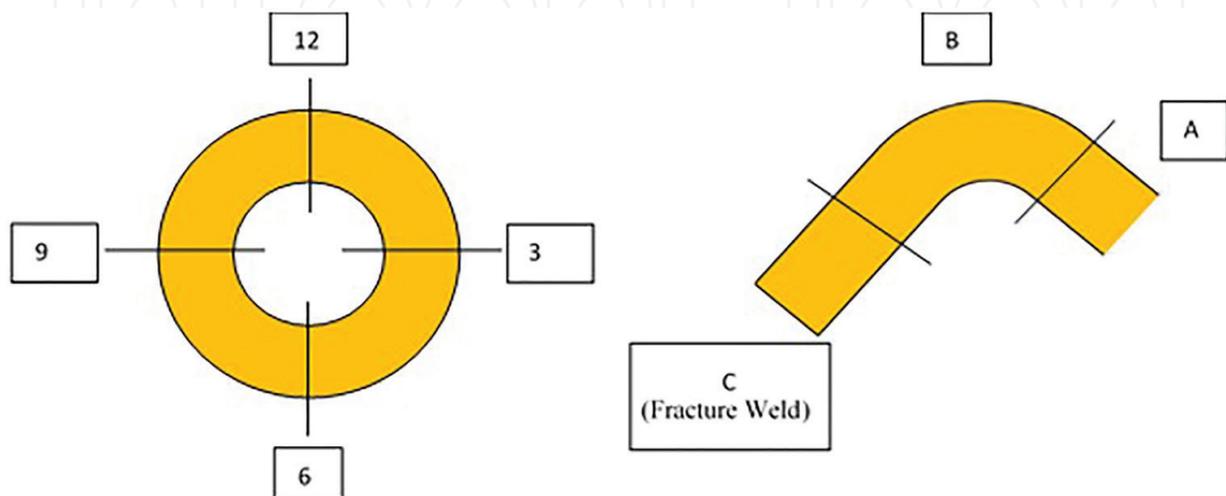
**Figure 5.** Dimensional references of thickness measurement on a tube.

Tube 8 and Tube 18 out of five tubes were chosen for dimensional measurement since the Tube 8 may be a representative of Tube 9 and Tube 10. The tube was cut into six pieces in order to do OD and inner diameter (ID) measurement. The thickness of Tube 8 and Tube 18 was measured by ultrasonic thickness at three locations for each tube, designated as A, B and C. Four spots with respect to clock position 12, 3, 6 and 9 were measured at each location as shown in **Figure 5**. The results are recorded in **Tables 2** and **3**.

The minimum measured thickness readings were compared with the minimum required thickness from the RBI report and Doosan (HRSG OEM) report. Several locations of Tube 8 and Tube 18 showed that the wall thickness was lower than the minimum required thickness, which was considered unsafe and unacceptable. It implied that the risk of stress rupture

was high. The significant wall thinning could be due to the excessive steam oxidation, which caused a high consumption rate of metal.

2. The thickness profile of all the affected superheater tubes shall be measured in extensive manner during outage opportunities. Tube sections with remaining wall lower than minimum required thickness shall be cut and replaced.

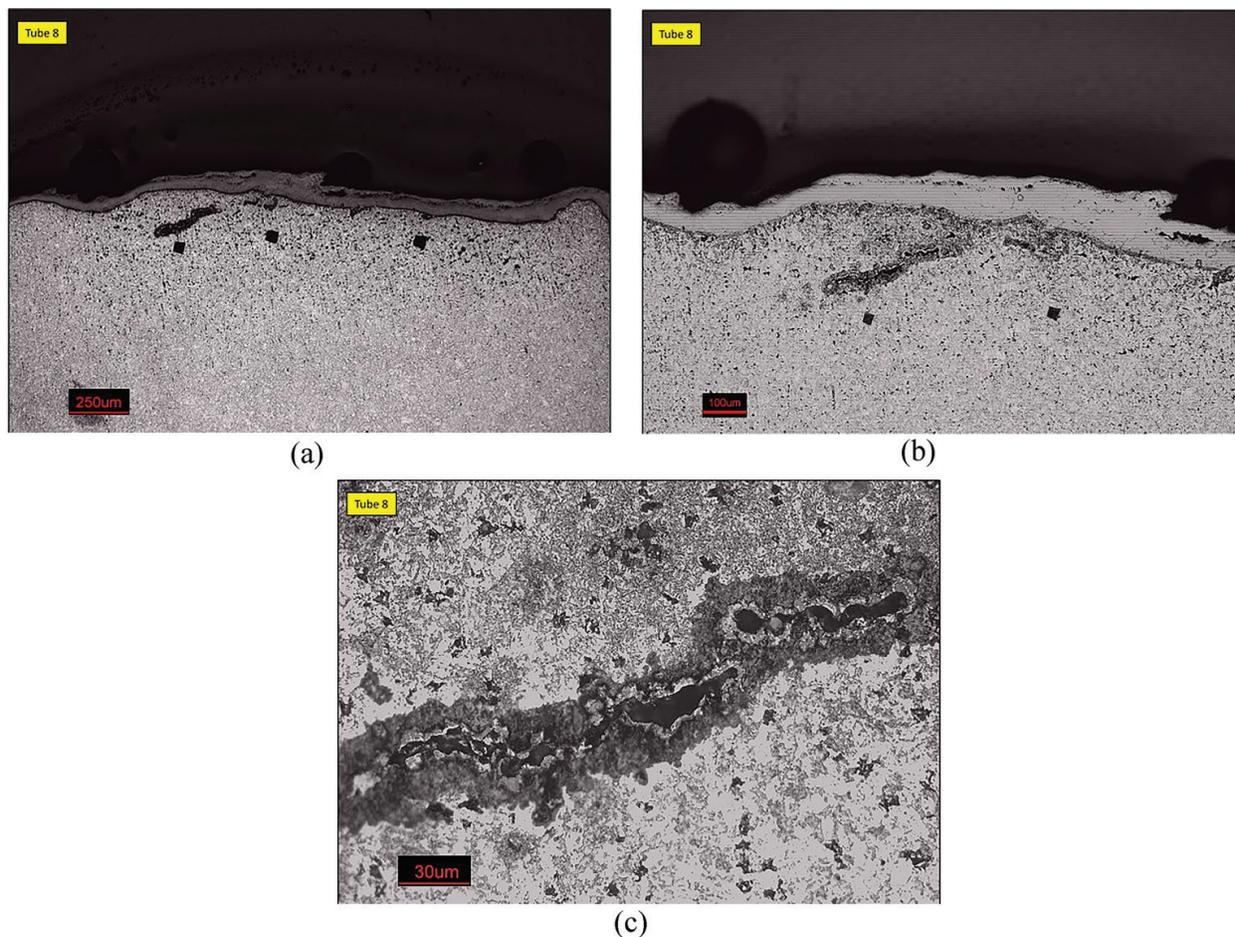
**Figure 8.** The microstructure of Tube 8 shows a crack at different magnification: (a) 250 μm, (b) 100 μm and (c) 30 μm.

- a. The cracks were fairly straight and had a transgranular appearance, thick oxide filled, without branching characteristics. The cracks propagated in the HAZ.
- b. Isolated, aligned cavities and microcracks were presented in the vicinity of the cracks. The cavities were predominantly aligned in parallel to the cracks, and some were perpendicular to the cracks.

- c. Under high magnifications, the grade 91 microstructure of base metal still appeared normal (martensitic) with no signs of thermal degradation such as phase transformation, grain growth and precipitate coarsening. A small amount of isolated cavities were found in the remote base metal of Tube 8.
- d. The fracture surfaces had oxidized heavily. The oxide layers at the steam touch surfaces (inner surface) were considered thick, in excess of 300 μm.

Figure 8 shows the microstructure of Tube 8 at the fracture area at different magnification. Isolated cavities, aligned cavities, microcrack and thick oxidation layer were observed at that particular location.

The above observation suggested that the tubes had likely suffered a combination of two damage mechanisms, which were fatigue and short-term creep. The numerous and extensive creep cavities in the HAZ suggested that the tubes at the weld region had undergone advanced and progressive creep damage. For Tube 8, microcracks had formed and the creep damage was classified as 4 according to rating guideline provided in the NORDTEST NT TR 170 (1992) code. For Tube 18, the creep cavities were preferentially oriented and aligned, suitably to be classified as 3.3 according to the NORDTEST rating. The heavy thermal degradation was supported by the low hardness readings at the HAZ (minimum 142 HV was reported, as compared to acceptable range 200 HV–260 HV). It was obvious that the two tubes had undergone time-dependent, high-temperature creep process.

1. As the connecting tubes had begun to show signs of advanced creep damage at HAZ, there is likelihood that the header, especially at the weld and HAZ had also undergone similar creep damage. It is recommended to conduct extensive replication and hardness testing at all the connecting tubes and header shell during outage opportunities. The area of interest is weld and HAZ.

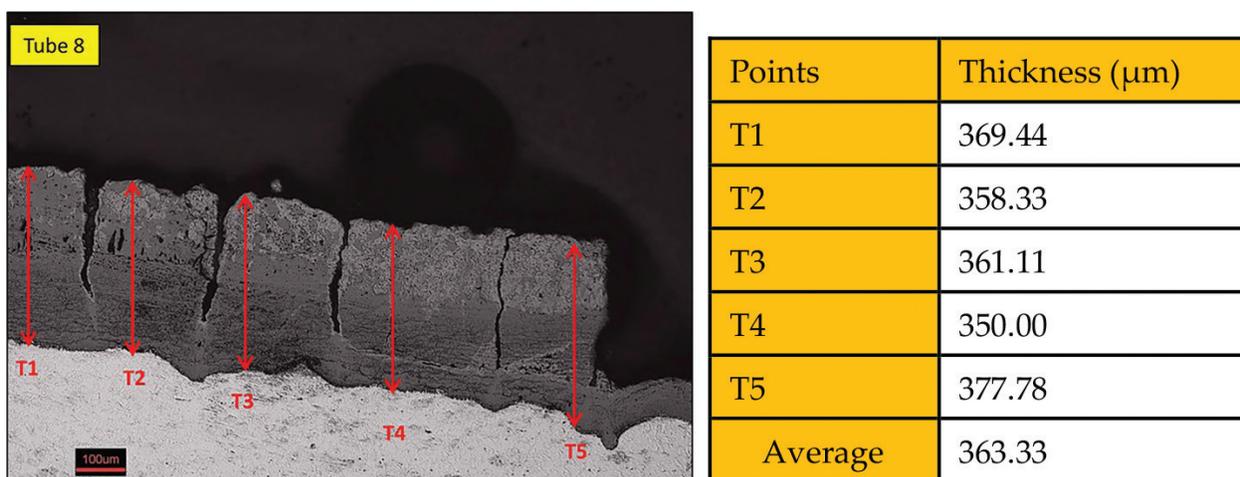
Figure 10. Internal oxide thickness at Tube 8 (fracture area).

The steam-side oxide scale of micro specimens of Tube 8 and Tube 18 was measured under optical microscope. Both Tube 8 and Tube 18 were found to have undergone excessive steam oxidation. The oxide layer had cracked. The oxide thickness was measured and tabulated in **Figures 10** and **11**. The maximum thickness of the steam side oxide scale was 363  $\mu\text{m}$  for Tube 8 and 390  $\mu\text{m}$  for Tube 18.

Based from steam oxidation calculation [4], the thick oxide scale suggested that both Tube 8 and Tube 18 had been exposed to temperature in excess of 615°C as compared to material specification of SA 213T91 (design temperature, 602°C). The two tubes had experienced long-term overheating during operation.

Both the tubes (i.e. Tube 8 and Tube 18) have been exposed to temperatures of more than 600°C as compared to material specification of SA 213T91, where the design temperature is only 602°C. With this exposure, it had further promoted degradation of tubes material and formation of creep cavities. For fracture surface at Tube 8, with oxide thickness of 118 µm, the crack had been initiated for 8982 h. For fracture surface at Tube 18, with oxide thickness of 107 µm, the crack had been initiated for 7722 h.
