3D Digital Simulation for Material Damage Mechanism Identification in a Railway Carriage Pressure Vessel

Alessandra Caggiano and Roberto Teti

<http://dx.doi.org/10.5772/intechopen.73233>

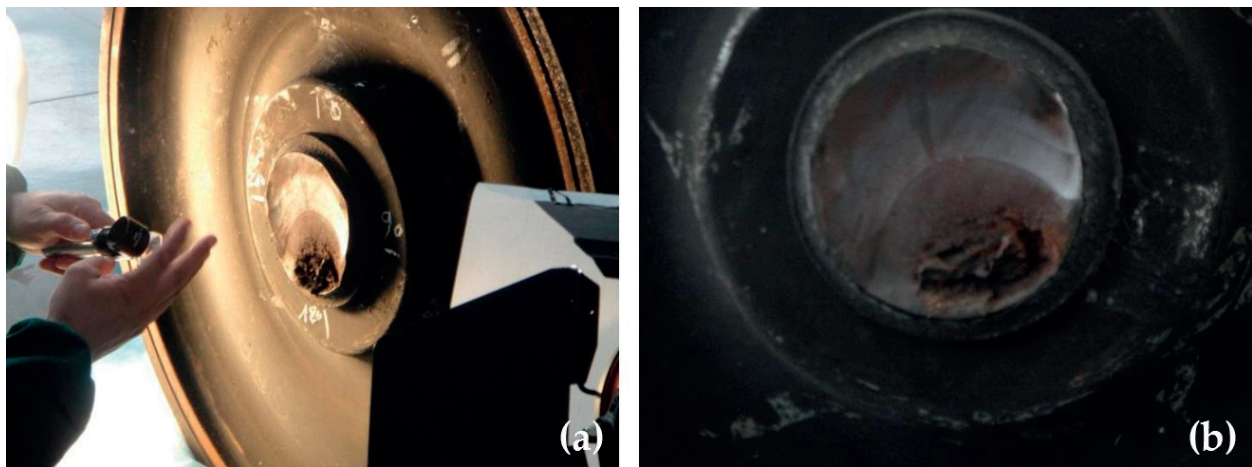
The train derailment was caused by the sudden failure of the second axle of the front bogie of carriage number 1 [5, 6]. The axle breakage was caused by rotating flexural fatigue, determining a fatigue crack extension up to more than 65% of the axle resisting section. **Figure 1** [6] shows that the axle was fractured externally with respect to the left wheel (**Figure 1a**), and this failure was the original cause of the train derailment. **Figure 1b** illustrates the characteristic fatigue failure of the fracture surface of the axle on the wheel side: presence of a smooth area related to the slow propagation of the fatigue crack (upper zone in the image) and of a rough area of rapid failure of the residual axle section (lower zone in the image). The same characteristic fatigue failure is observable on the matching axle fracture surface on the axle box side.

Figure 1. (a) Fatigue failure of the fracture surface of the axle on the wheel side. (b) Presence of a smooth area related to the slow propagation of the fatigue crack and of a rougher area of rapid failure of the residual axle section.

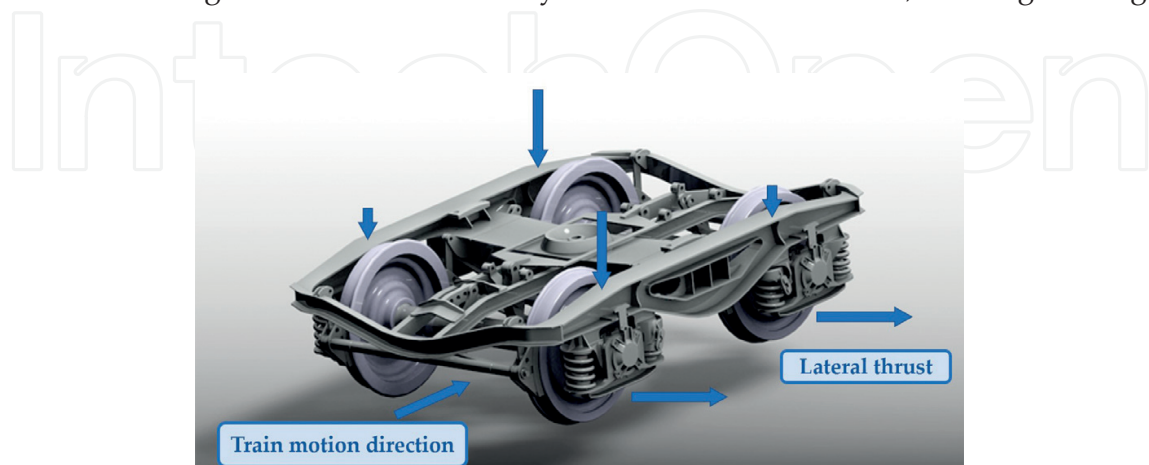
Figure 2 shows the bogie model Y25 mounted on the pressure vessel carriages composing train no. 50325, with indication of some of its components, including the axle boxes. Due to a fatigue crack in its final development phase transversally with respect to the wheelset axle, the vertical rigidity of the axle box supported by the axel spindle was notably reduced up to reaching a nonequilibrium condition of the vertical forces pressing the wheels on the rails. The surmounting of the rail occurred due to a notable reduction of the vertical force acting on the right front wheel, diagonally opposed to the force acting on the weakened axle spindle (left rear wheel).

Figure 2. Forces acting on the first bogie of carriage no. 1 after breakage of the second axle (rear wheelset) due to fatigue failure externally with respect to the left wheel.

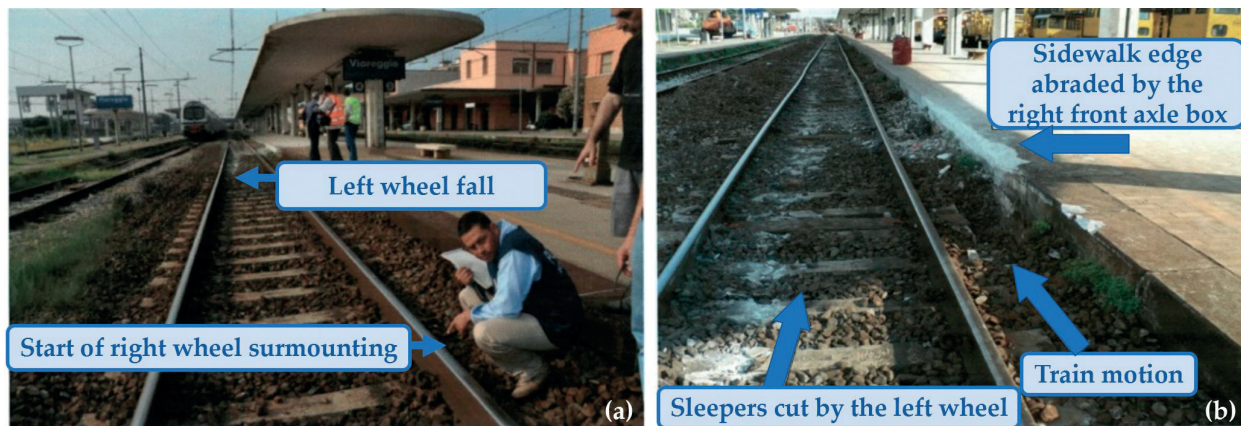
Figure 3 shows the traces of the initial phase of the derailment and in particular: (a) the start of the surmounting of the rail by the right front wheel of the first bogie of carriage no. 1. (b) The sleepers cut by the left wheel and the sidewalk curb abraded by the right front axle box of the first bogie of carriage no. 1.

Figure 3. Traces of the initial phase of the derailment. (a) Start of the surmounting of the rail by the right front wheel of the first bogie of carriage no. 1. (b) Sleepers cut by the left wheel and sidewalk edge abraded by the right front axle box of the first bogie of carriage no. 1.

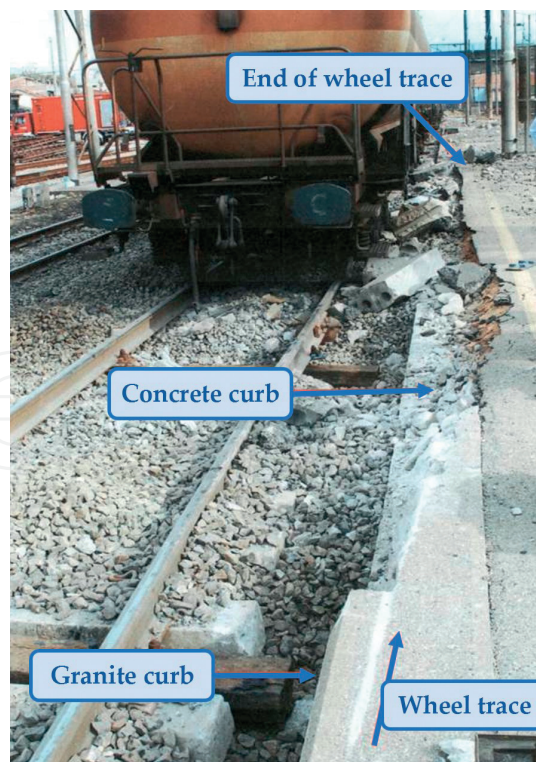
Figure 6. Concrete sidewalk damaged by the right wheel of the front wheelset of the first bogie of carriage no. 1 and starting point of the carriage overturning.

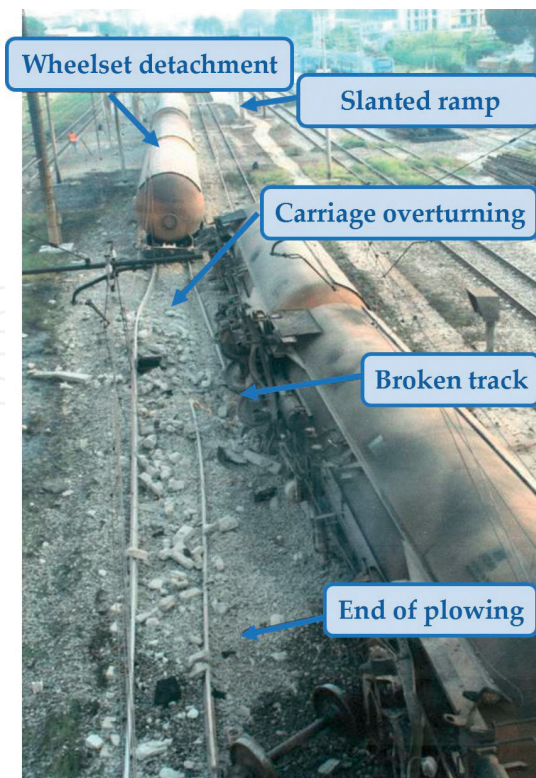
Figure 7. Superstructure zone wrecked due to the “plowing” mechanism of the track by the front wheelset of the first bogie.

beginning of the superstructure zone wrecked by the “plowing” mechanism of the track, as shown in **Figure 7**.

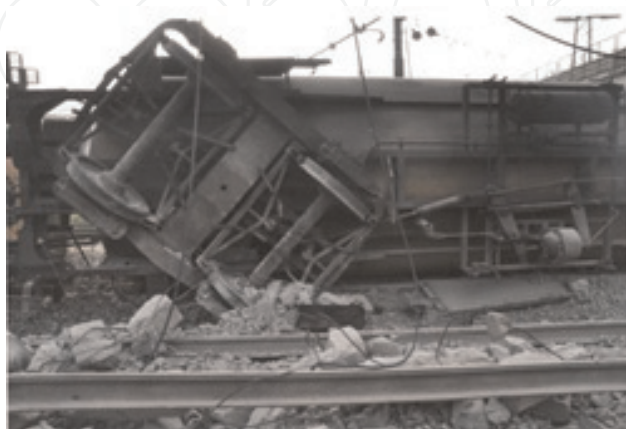
Figure 8. Plowing mechanism of the track by the bogie of the overturned carriage.

When, at the end of the overturning phase, carriage no. 1 crashed onto the infrastructure, it presented the remaining wheelset still mounted on its first bogie with its axis slightly slanted forward and the wheel, originally on the left side in the train motion direction, stuck under the sleepers; as the carriage proceeded its course under these conditions, the track was plowed according to the mechanism illustrated in **Figure 8**.

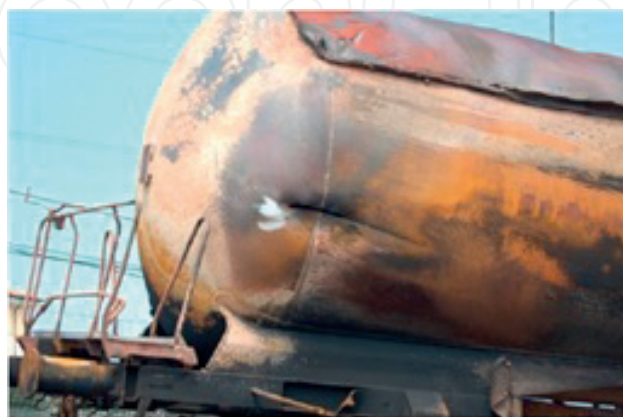
Figure 9. Carriage no. 1 with a cut opening on the tank shell.

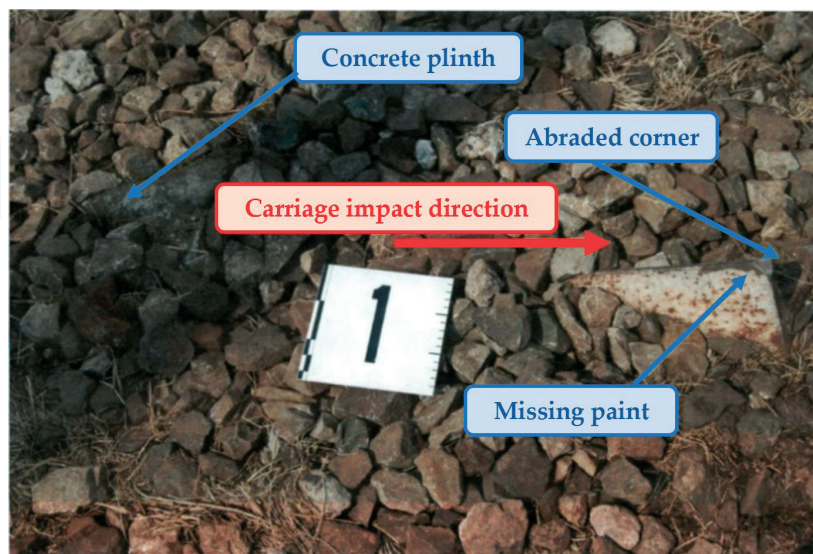
In **Figure 15**, a detail of track reference stake no. 24, found under the tank of carriage no. 1 almost completely buried in the track ballast, is shown. The sharp corner of the lower surface of the rail chunk, making up the track reference stake, appears highly abraded with its abraded metal surface still not subjected to oxidization. This confirms that the abrasion process, due to sliding against the carriage, was very recent during the examinations carried out in the accident scenario.

Figure 15. Track reference stake no. 24, photographed during the investigations on the accident site conditions, almost completely buried in the track ballast following its impact against the pressure vessel of carriage no. 1.

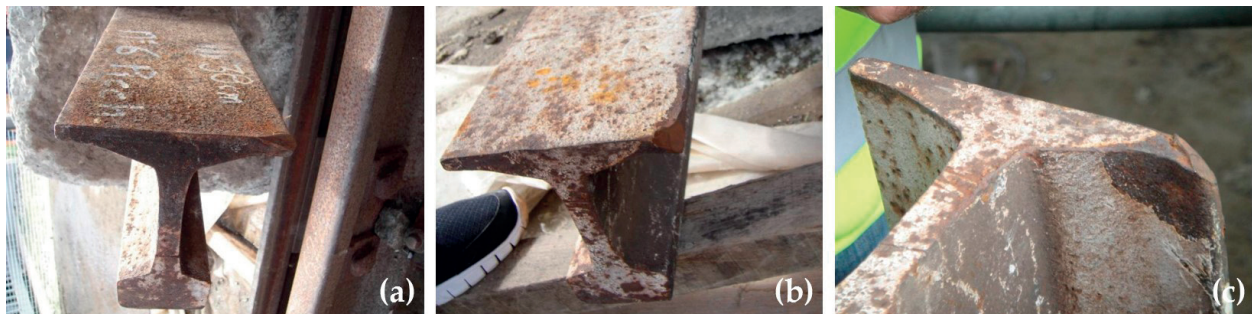
Figure 16. Track reference stake no. 24 photographed after its extraction from the track ballast. (a) In the foreground: flange of the track reference stake with damaged edge; in the background: view of the concrete plinth; and (b) and (c) details of the damaged edge.

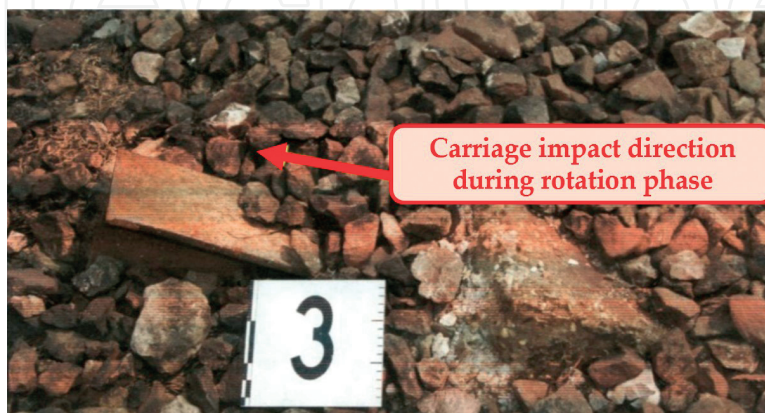
In **Figure 17**, a detail of track reference stake no. 23 knocked down by the pressure vessel of carriage no. 1 about 10 m after track reference stake no. 24 had been hit is shown. The track reference stake no. 23 was found under the tank, and its sharp corners did not show significant traces of abrasion. At the moment of impact against track reference stake no. 23, the carriage was by then almost steady and therefore endowed with a much lower kinetic energy with respect to the moment of impact against track reference stake no. 24.

Figure 17. Track reference stake no. 23, photographed during the investigations on the accident site conditions, partially buried in the track ballast following its impact against the pressure vessel of carriage no. 1.

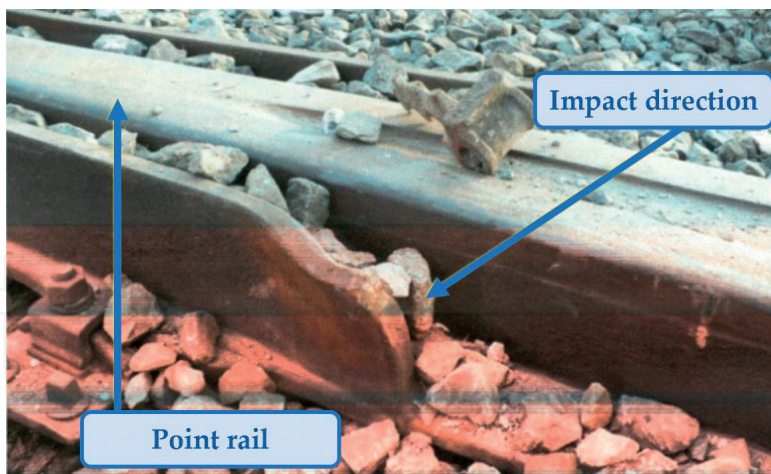
Figure 18 shows a detail of the deformation of the wing rail. The impact on the wing rail has a component in the transverse direction, oriented toward the left side in the train motion direction, and there are no traces of abrasion due to sliding on the deformed zone of the wing rail.

Figure 18. Wing rail photographed during the investigations at the accident site conditions.

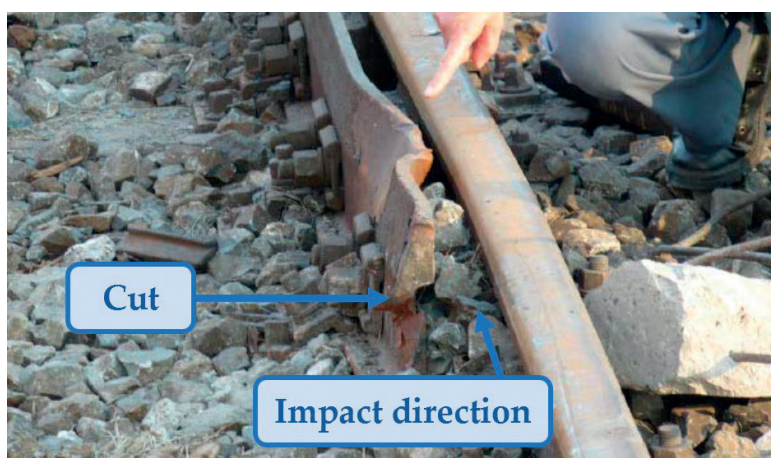
Figure 19. Check rail opposite to the wing rail photographed during the investigations on the accident site conditions.

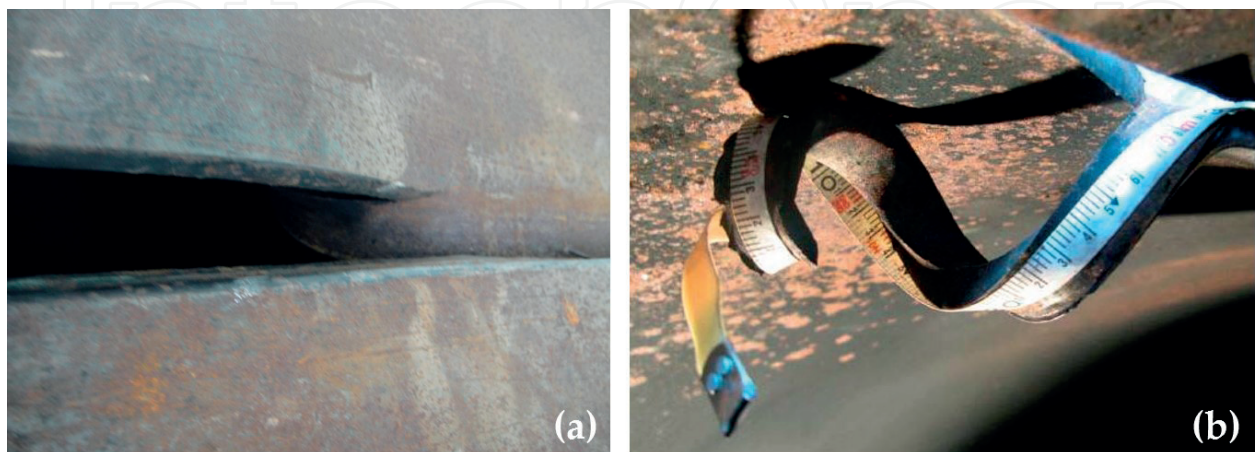
Figure 20. (a) Enlarged external view of the end side of the cut with the attached corresponding chip bent internally inside the tank shell and (b) enlarged internal view of the chip portion still attached to the tank shell.

The final part of the chip remained attached to the tank shell (**Figure 20**), while the initial chip portion was detached from the shell and was found inside the tank. This segmented chip shows the typical morphology of a chip formed during a machining operation that generates a notable chip segmentation (**Figure 21**).

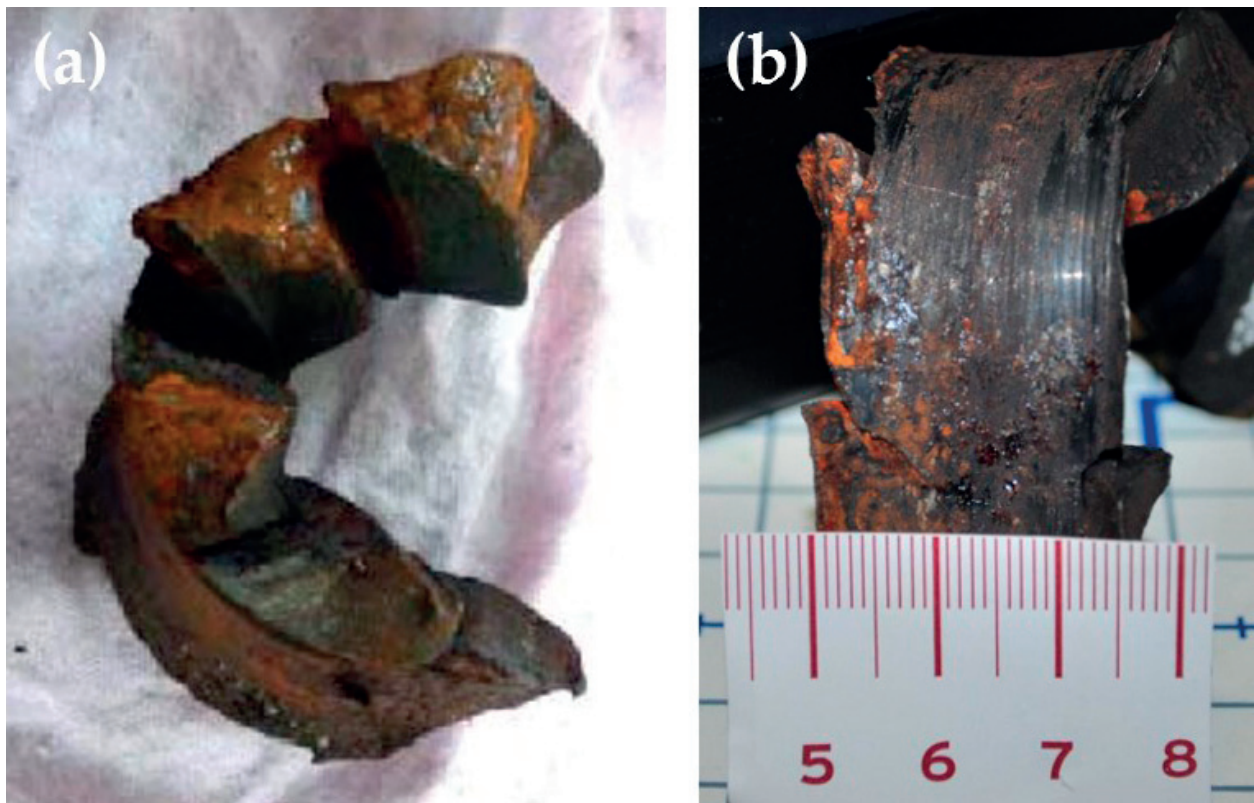
Figure 21. Chip portion detached from the tank shell showing the segmented morphology typical of a chip generated during a machining operation.

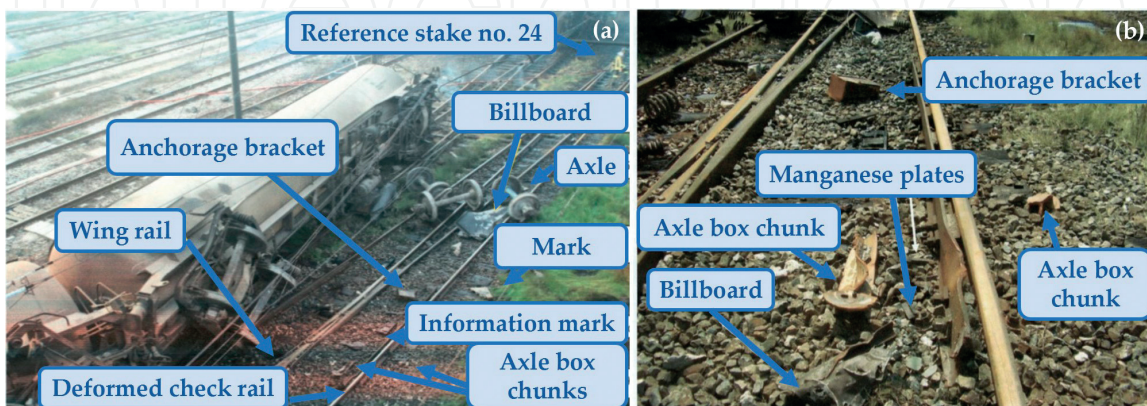
Figure 24 shows a series of details of the core zone of railway switch 13B. The scene refers to the zone around the wing rail and the check rail as it appeared after the accident, where the following elements were found:

- The anchorage bracket of carriage no. 1, sitting at about 3.5 m beyond the position of the wing rail.
- A chunk of the right-side axle box, in the train motion direction, of the first (front) wheel set no. 85890 of the front bogie, i.e., the axle box which remained mounted on carriage no. 1 after the second (back) wheel set no. 98331 of the front bogie was detached.
- Part of the sheet metal billboard welded on the side of carriage no. 1 for the application of transport documentation.

Figure 24. Zone of the heart of railway switch 13B around the wing rail and the check rail immediately after the accident.

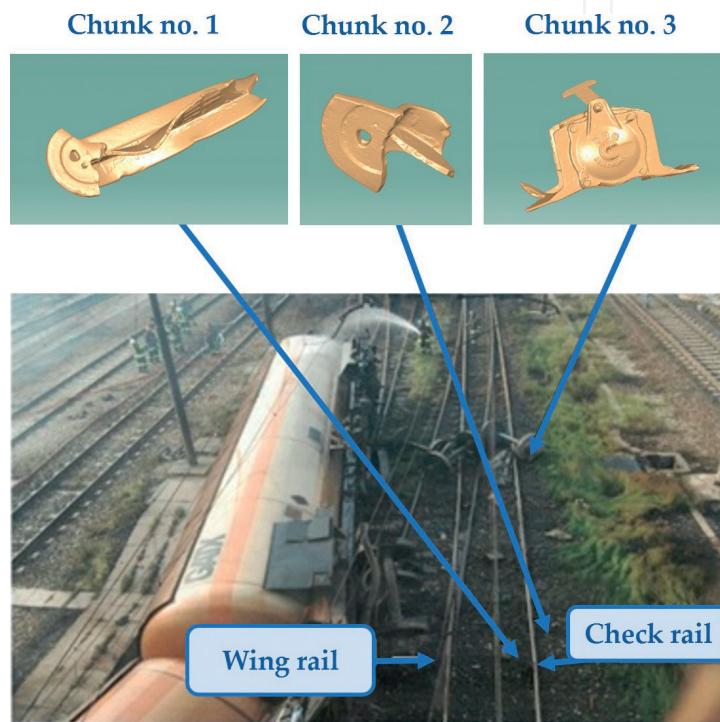
Figure 25. Position, in the accident scene, of the chunks of the right axle box of the front wheelset of the front boogie of carriage no. 1; the axle box was greatly abraded and broken into three fragments.

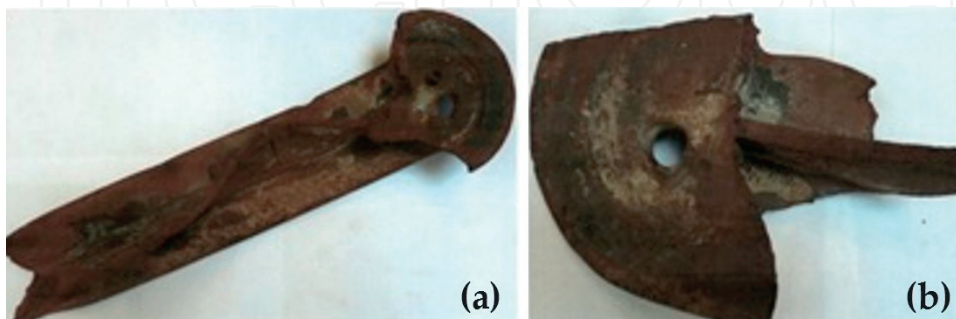
Figure 26 shows two of the three chunks of the right axle box of the first wheelset of the front bogie of carriage no. 1, whereas **Figure 27** shows the digital model of the fragment of **Figure 26b** obtained by reverse engineering reconstruction based on geometry acquisition with a structured light optical sensor.

Figure 26. Two of the three chunks of the right axle box of the front wheel set of the front bogie of carriage no. 1: (a) chunk of the axle box found between the rails near the deformed check rail and (b) chunk of the axle box greatly abraded by the granite sidewalk curb exerting a grinding action on the right axle box, found externally to the track near the right-side rail in the train motion direction.

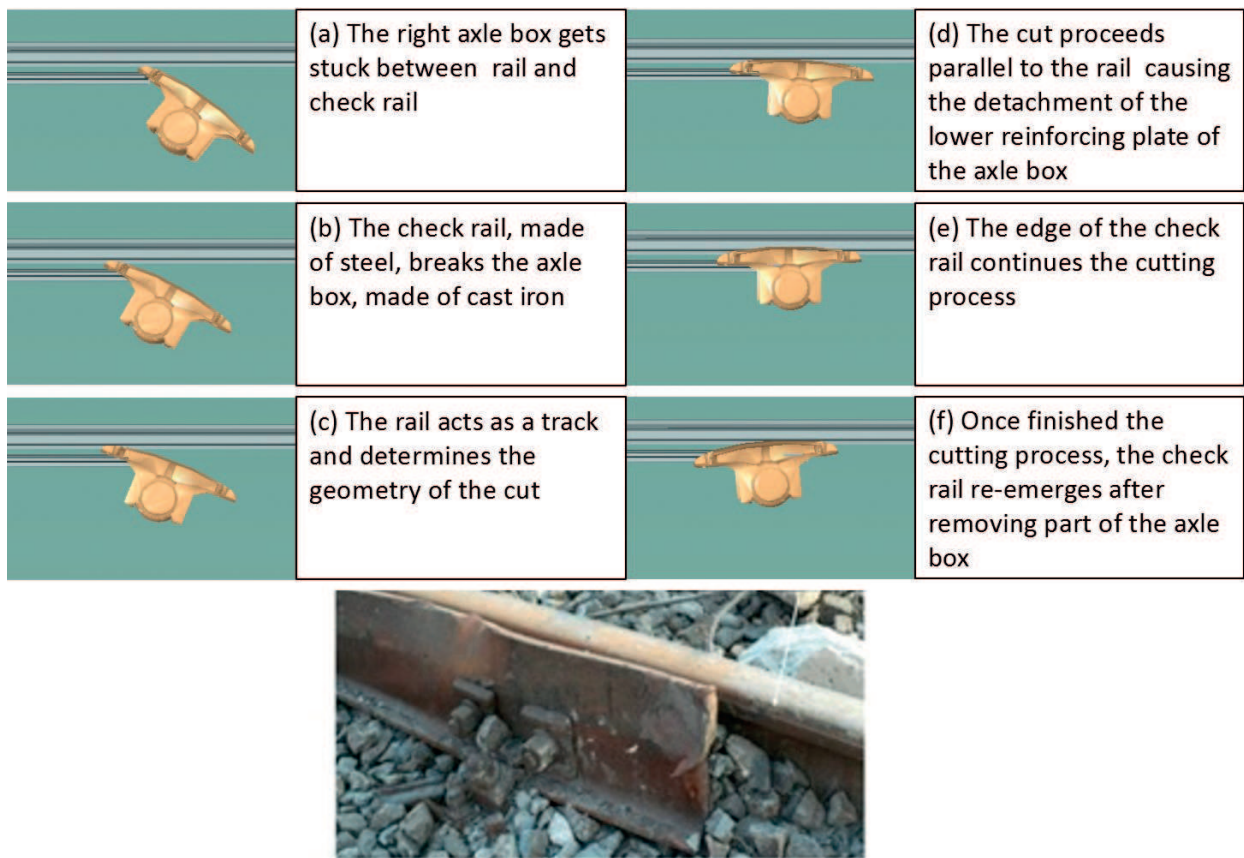
The realization of the digital twins of the check rail and the right axle box of the first wheel set of the front bogie of carriage no. 1, obtained by reverse engineering reconstruction based on geometry acquisition with a structured light optical sensor, allowed to reconstruct under simulation the kinematics of the impact between axle box and check rail, as illustrated in **Figure 28a**. **Figure 28b** shows the traces of damage on the check rail, which confirm the kinematics illustrated in **Figure 28a**.

It is, therefore, evident that the damage on the check rail cannot be related to the opening of the cut on the tank shell of carriage no. 1.

Figure 28. (a) Simulation reconstruction of the kinematics of the impact between check rail and right axel box of the first wheel set of the front bogey of carriage no. 1 and (b) traces of damage on the check rail confirming the kinematics described in Figure 28a.

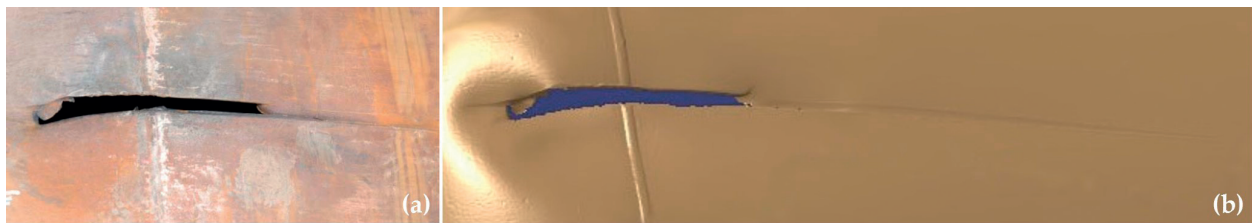
By examining the digital models of **Figures 29 and 30b**, it can be noted that the cut starts with an incidence angle of 5.1° and ends with an incidence angle of 9.8° . Accordingly, the rotation of the tank around a vertical axis, as illustrated in **Figure 12**, was about 5° .

Figure 30. (a) Photograph of the cut present on the tank shell of carriage no. 1 and (b) digital model of the cut obtained by reverse engineering reconstruction based on geometry acquisition with a time-of-flight laser sensor.

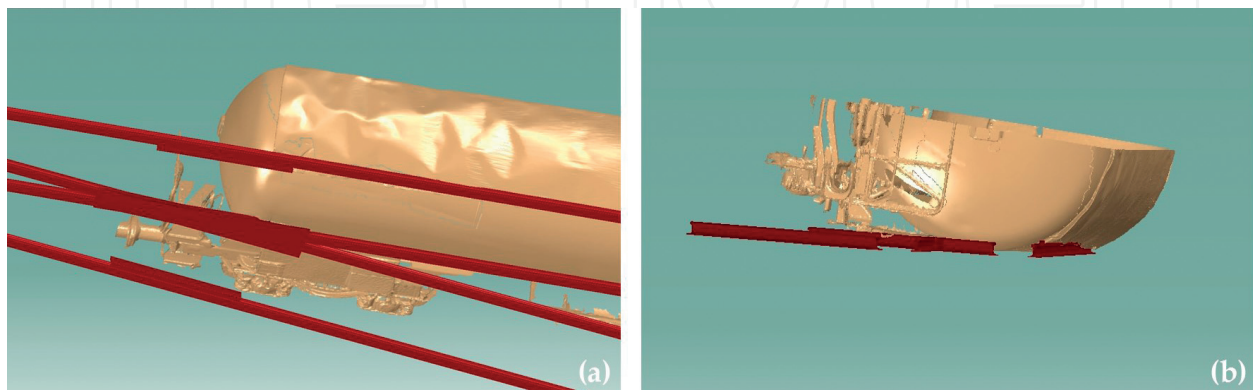
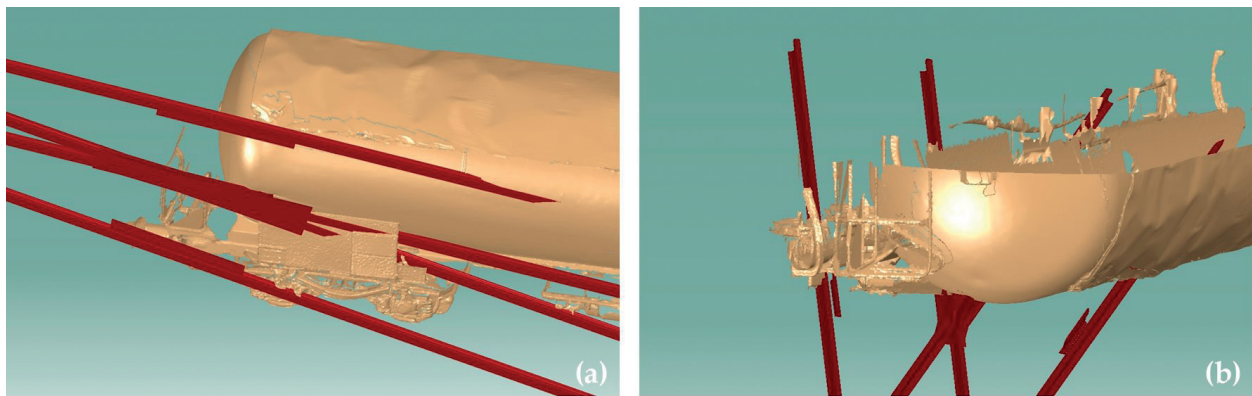
It can thus be stated that the wing rail cannot have been the cause of the cut opening on the tank shell side.

Figure 39. Views of the positions assumed by tank carriage no. 1 in the framework of the railway infrastructure under the hypothesis of tank shell cutting by the wing rail during the phase corresponding to **Figure 32c** and **33a**.

Figure 40. Views of the positions assumed by tank carriage no. 1 in the framework of the railway infrastructure under the hypothesis of tank shell cutting by the wing rail during the phase corresponding to **Figure 32d** and **33b**.

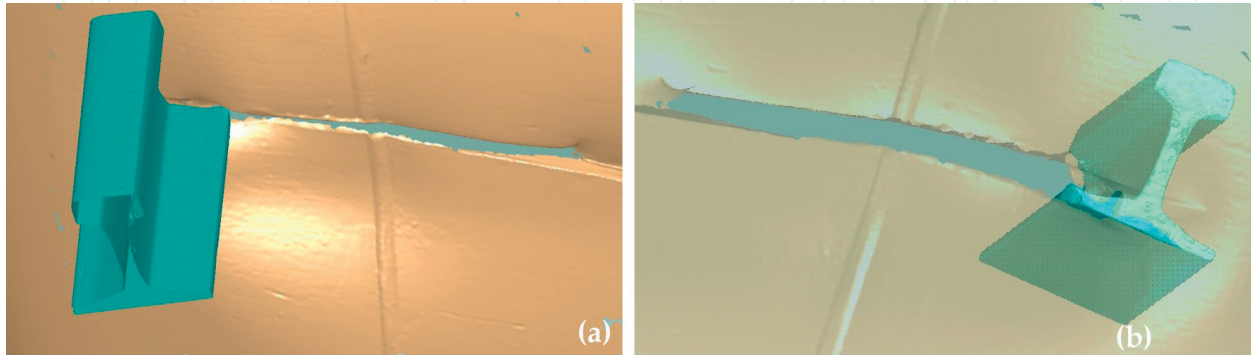
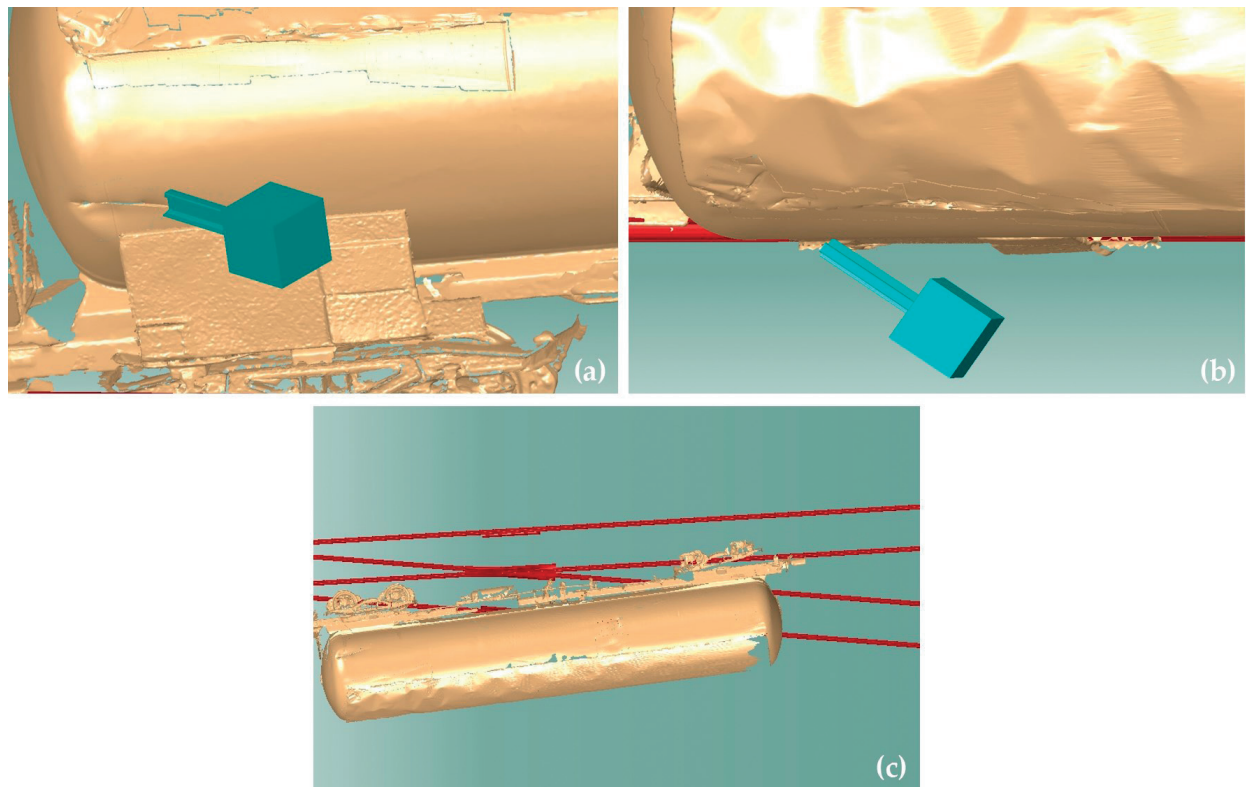
Figure 45. Details of the position of track reference stake no. 24 during the penetration phase into the tank shell: (a) view from the outside of the tank and (b) view from the inside of the tank.

Figure 46. Position of track reference stake no. 24 during the sliding phase against the tank shell.

It can thus be stated that the track reference stake has been the actual cause of the cut opening on the tank shell side.

The introduction of alternative track positioning and control systems, capable to provide more advanced solutions for safer conditions in the railway infrastructure and operations, is highly desirable to avoid future disastrous accidents of the kind reported in this work. One such alternative system is represented by the railway surveying system already introduced by the national railways in Germany and Norway [12]. Its operation requires the setting, along the track of interest, of topographic reference points, the position of which is previously determined through a precision polygon. Through traditional topographic methods, these points are subsequently referred to by the points materialized through fastening devices, incorporated in the concrete basis of the poles or portals of the electric power line, for the positioning
