# **Degradation Monitoring of Photovoltaic Plants: Advanced GIS Applications**

Miguel de Simón-Martín, Ana-María Díez-Suárez,  
Laura-Álvarez de Prado, Alberto González-Martínez,  
Álvaro de la Puente-Gil and Jorge Blanes-Peiró

<http://dx.doi.org/10.5772/intechopen.75650>

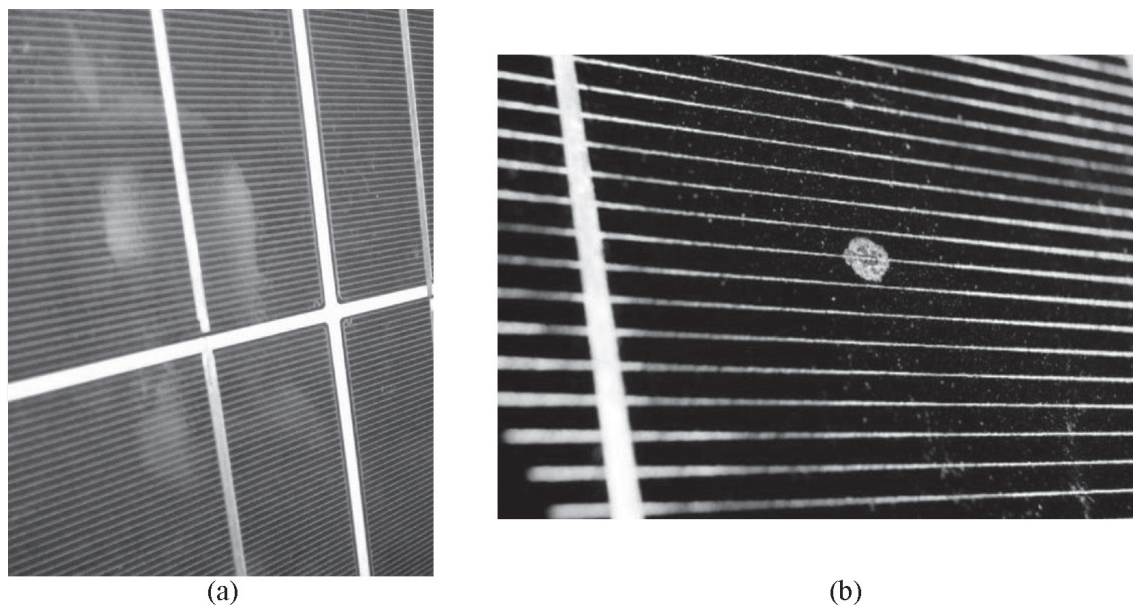
Degradation of the encapsulation material (normally ethylene vinyl acetate or EVA) is an esthetic issue that does not usually affect the performance of a module. It can, however, lead to an average current loss of 0.5%/year or 0.8%/year for Si PV modules [10].

Rising temperatures, the photo-degradation of EVA by UV radiation, and the existence of molecular oxygen lead to the production of acetic acid and volatile gases, that are trapped within the module, and can produce delamination or the formation of bubbles [11].

On the other hand, inappropriate temperatures or an excessively long lamination procedure [14] during the manufacturing of the photovoltaic module can cause bubbles of gas to be formed either as a direct or as an indirect consequence of melting and solidification processes (**Figure 1**). In **Figure 1(a)** an EVA discoloration can be appreciated while in **Figure 1(b)** we can observe an example of a bubble formed over a metal contact.

**Figure 1.** Examples of (a) EVA discoloration and (b) bubble formation.

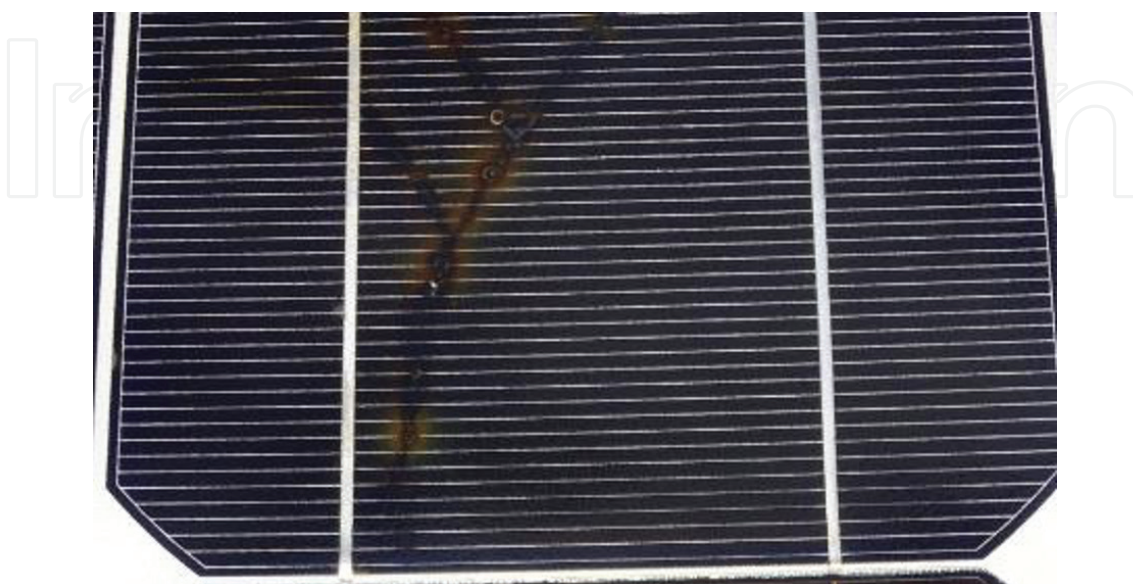
**Figure 2** shows a clear example. Cell cracks may occur during or after production. Major sources of cell cracks are during packaging and transport or during the reloading of PV modules and installation in the field.

Small cell cracks show a great tendency to develop into larger, wider cracks during operation of the solar module due to mechanical stress [15] from wind or snow load and thermo-mechanical stress [16] from temperature variations due to changes in weather and intermittent cloud cover.

An inactive cell area of 8% or more is unacceptable. Apart from the risk of power loss there is also the chance of hot spots being formed. This can happen when a cracked cell has a localized

**Figure 2.** Example of cracks in a PV cell.

reverse current path in the still active cell part. The cell may reverse bias and the full current will be able to flow along the localized path as a consequence of the missing cell area. This can cause hot spots and subsequently burn marks [17].

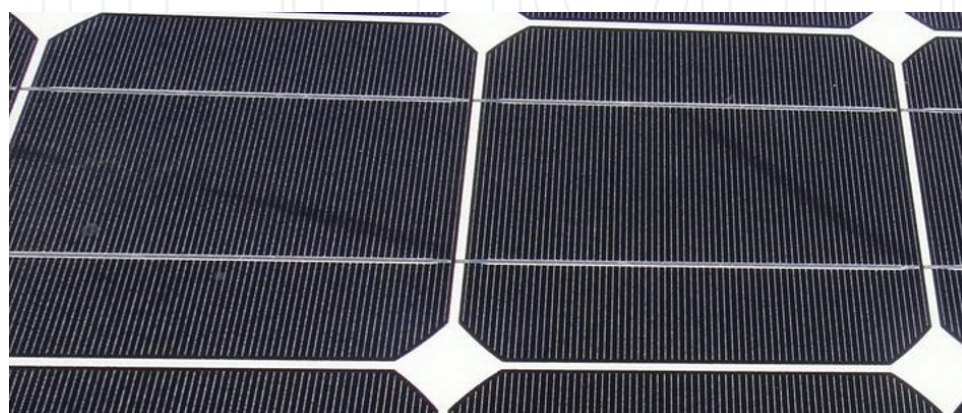
Snail tracks are discolorations of the silver fingers on solar cells. A significant example can be seen in **Figure 3**. The effect looks like a snail has passed across the front glass of the PV module. The discoloration takes place on cell cracks that are not visible at the edge of the solar cell. This typically happens between 3 months and 1 year after installation of the PV modules [18]. Discoloration speed is initially dependent on seasonal and environmental conditions, such that snail tracks seem to spread faster during summer months and in hot climates [5]. PV modules affected by snail tracks have been compared with reference modules under laboratory conditions [19] and results showed a 40% reduction in maximum power under standard conditions with a 25% lower yield than expected when measured over a 30-day period.

**Figure 3.** Example of a snail track over a PV cell.

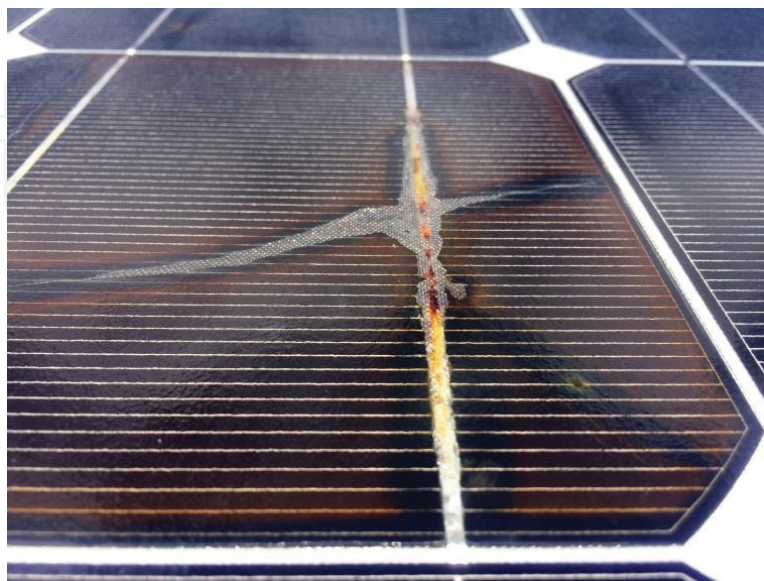
A typical and very common failure in silicon PV modules is burn marks. This failure occurs due to part of the module becoming very hot and can be because of ribbon breakage, solder bond failure, or localized heating from reverse current flow or other hot spots [5]. Burn marks can produce power losses and serious safety problems. They are usually located on or closed to the metal contacts of the PV solar cells, such as it can be seen in **Figure 4**.

Hot spots are areas in a photovoltaic module that have very high operating temperatures when compared to surrounding areas. This may be due to interconnection failures, defects in the cell, dispersion of characteristics between modules of a generator and between cells of the same module connected in series, potential-induced polarization in modules manufactured with novel techniques, or when a cell generates less current than other cells connected in series as a consequence of intermittent cloud cover or partial shading [20]. As a consequence, the cell becomes polarized (the voltage between the terminals becomes negative) and starts to dissipate the power generated by the other serial cells in the form of heat.

**Figure 4.** Example of a burn mark on a PV cell.

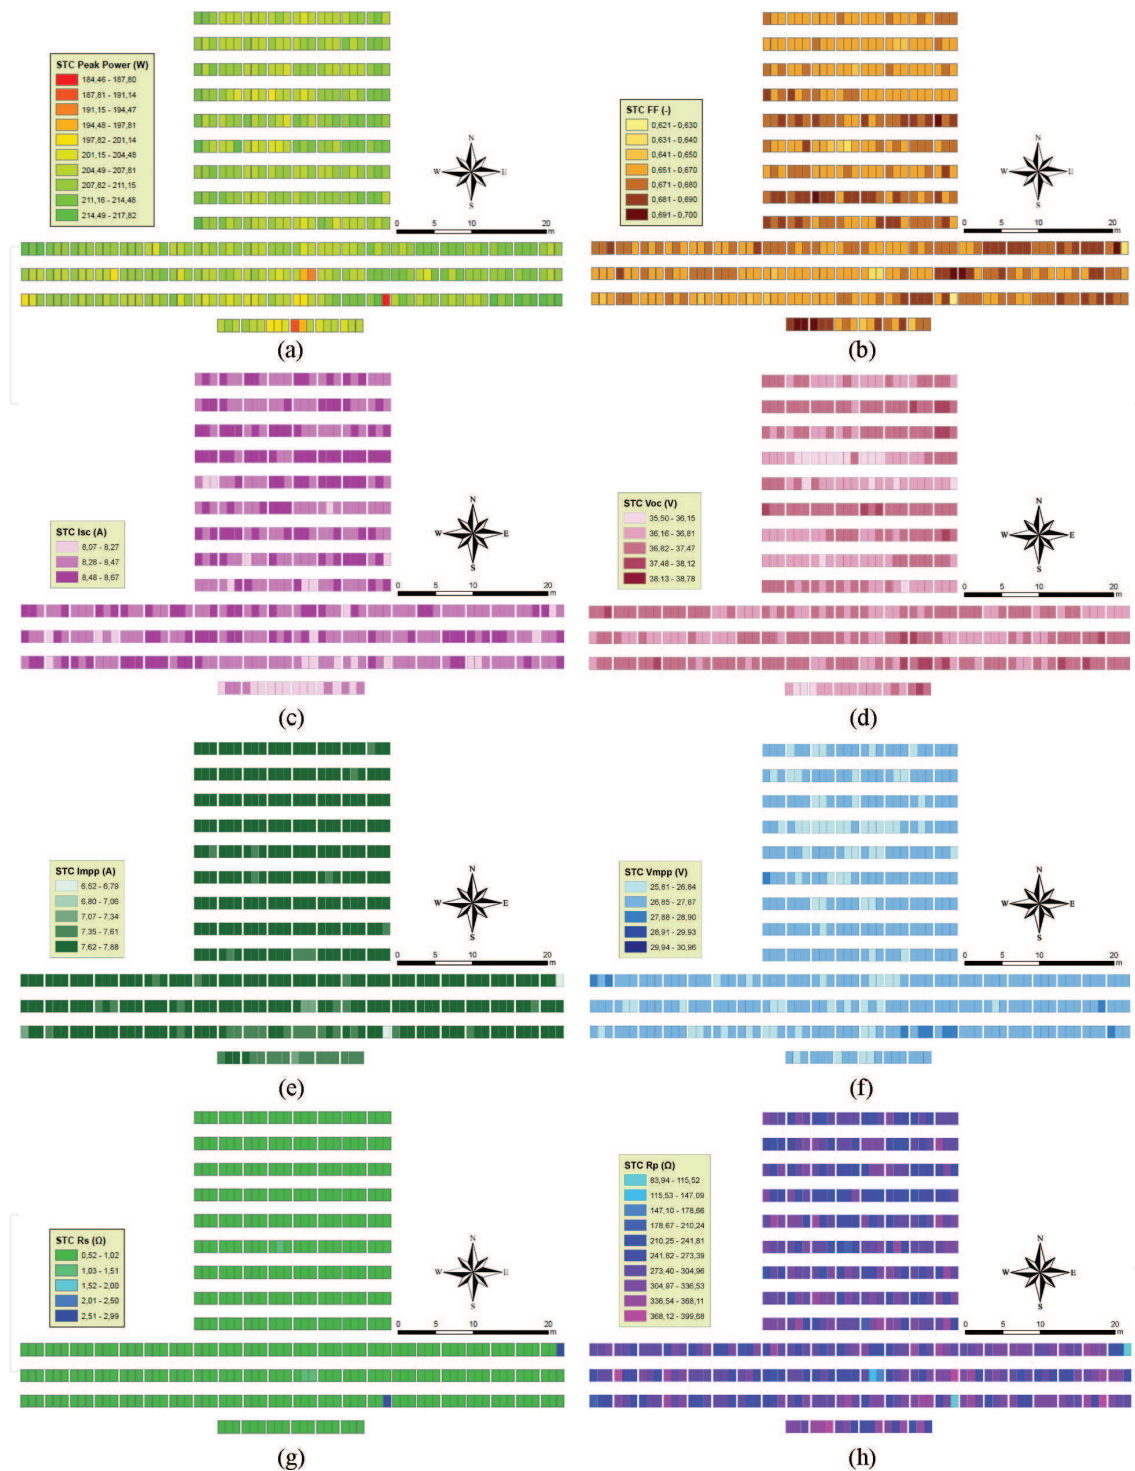
The effective application of the GIS tool allows the observation of all electrical parameters in a holistic way. As shown in **Figure 8(a)**, critical peak power performances can be easily detected among more than 400 PV modules. Other electrical parameters, such as fill factor, open circuit voltage, or short circuit current dispersion, can also be observed in the context of the facilities.

**Figure 8.** Electrical parameter distributions: (a) STC peak power, (b) STC fill factor (c) max. power voltage, (d) max. power current, (e) open circuit voltage, (f) short circuit current, (g) serial resistance, (h) parallel resistance (108 kWp PV plant).

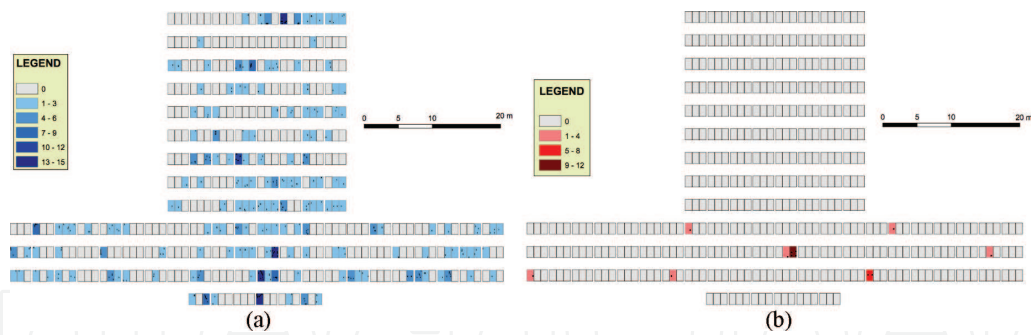
Figure 9. PV faults and defects in the 108 kWp PV plant: (a) snail tracks (b) hot spots and burn marks.

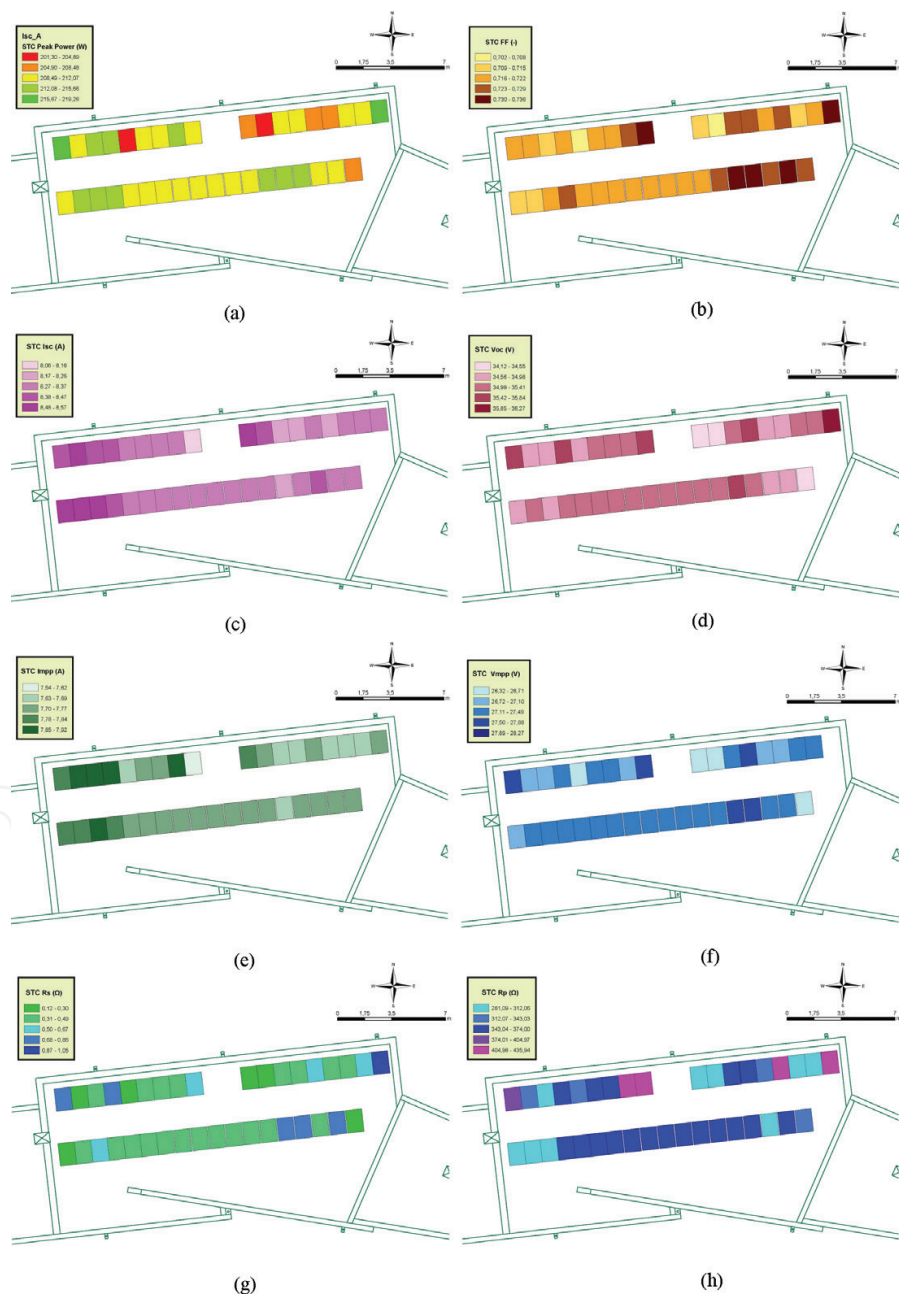
Once again, it is considerably easier for staff to supervise and monitor the PV plant state. However, distribution of electrical parameters may be less significant as only 36 PV panels are included in this installation.

Figure 10. Electrical parameter distributions: (a) STC peak power, (b) STC fill factor (c) max. power voltage, (d) max. power current, (e) open circuit voltage, (f) short circuit current, (g) serial resistance, (h) parallel resistance (9 kWp PV plant).

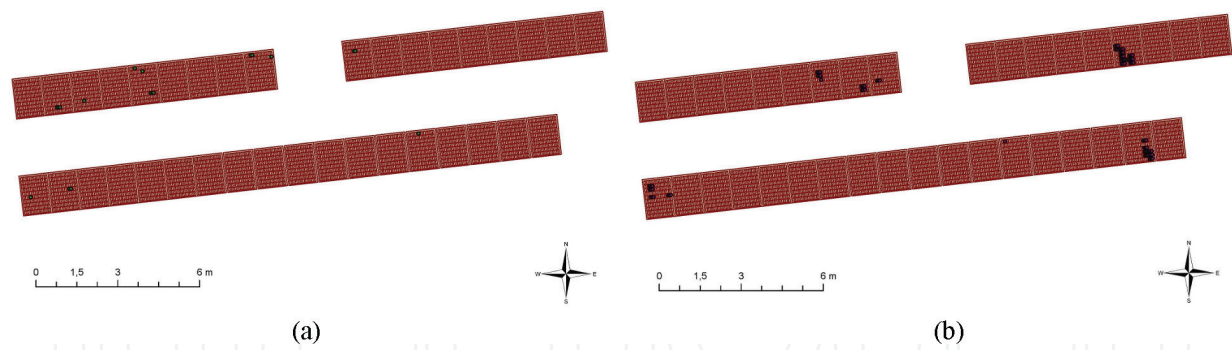
**Figure 11.** PV faults and defects in the 9 kWp PV plant: (a) snail tracks (b) cell discolorations.

almost no degradation has yet been observed. However, **Figure 11(a)** and **(b)** show some snail tracks and cell discoloration that might lead to the modules needing future maintenance. The distribution of these defects does not appear homogeneous and seems to be concentrated at string series extremes.
