Introductory Chapter: Environmental Characteristics of a Dobrudja Famous Archeological Monument

Daniela Turcanu-Carutiu and Rodica-Mariana Ion

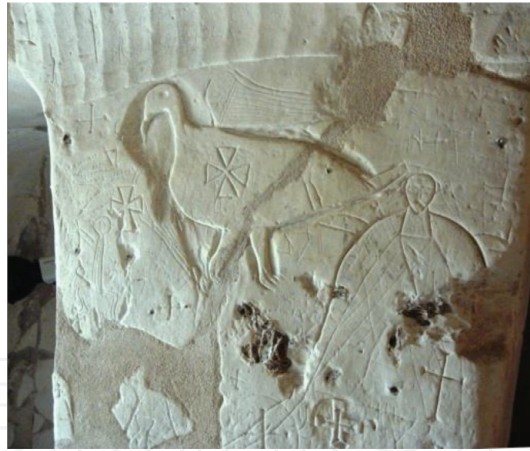
Assembly, dated IX–XI centuries is located in a hill of chalk cliff into a Roman career style, with churches, galleries branched vaults, housing the tombs [1]. Facings are inscribed with symbolic designs and different scenes and a large number of inscriptions. Some of these are palaeoslavonic and Cyrillic and some are written in Glagolitic or in Greek, but mostly in an enigmatic writing that could not be decoded so far [2, 3] (**Figure 1**).

Figure 1.
The interior of the churches and crosses, figures incised in the chalk wall.

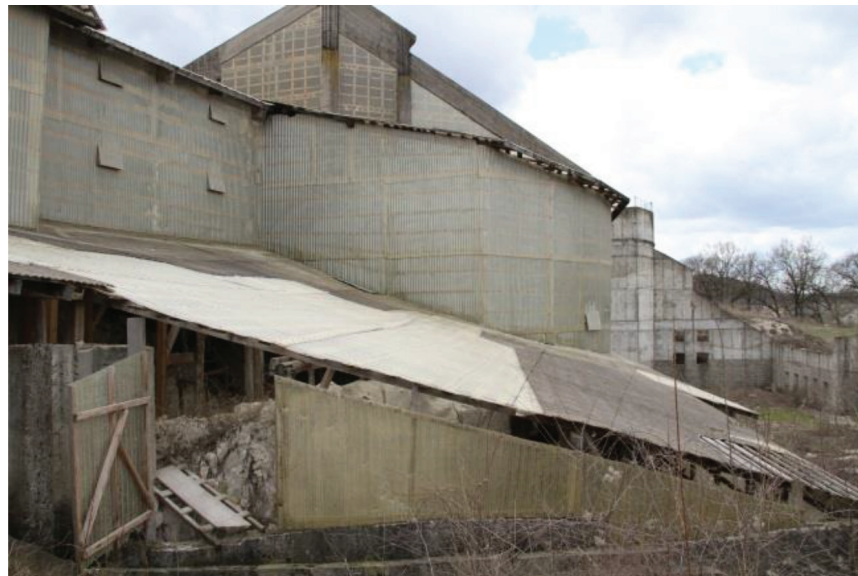
Currently, the wooden structure of the building was repaired under provisional protection, and cardboard asphalt was replaced with polycarbonate enclosures in summer 2006 (**Figure 2**).

Figure 2.
Provisional protection structure.

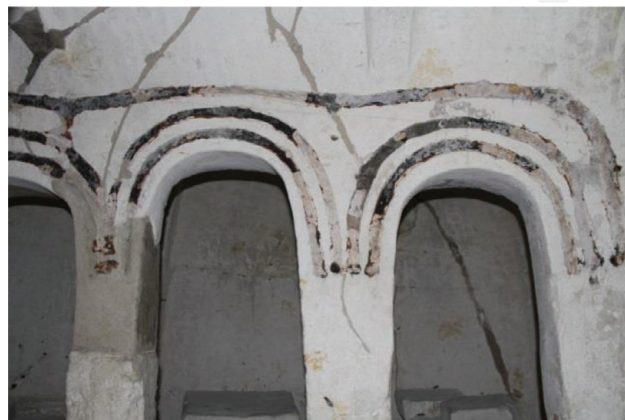
Figure 4.
The photo of naos.

The proposed investigations refer the groundwater conditions' hydro-geological site near the monument, water accumulation in career and possible leakage of leachate to landfill career. For all these, it has been achieved six boreholes to depths of 15–20m, located outside the site with research role (**Figure 4**). Except these, the chemical analysis of pre-elevated water from drilling and the analysis of physical properties of the materials present in drilling have been achieved.
