The Position and Function of Macroscopic Analysis in the Failure Analysis of Railway Fasteners

Guodong Cui, Shuaijiang Yan, Chengsong Zhang, Dazhi Chen and Chuan Yang

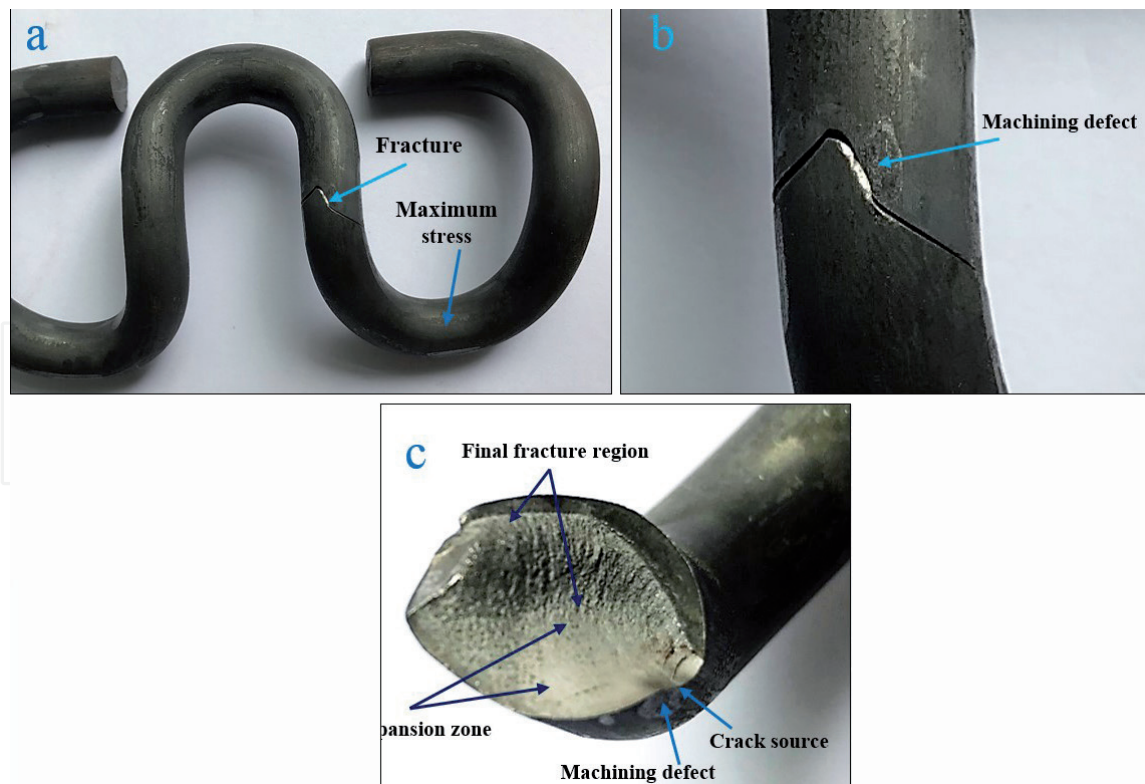
Figure 1 shows the fracture condition of a rail fastening clip after the fatigue test of 4×10^5 cycles. However, according to the TB/T2329-2002 Chinese standard for the fatigue tests of rail fasteners, the samples should not fracture after 5×10^6 cycles. In order to find out the reasons of the premature failure, macroscopic analysis was conducted on the failed sample. As shown in **Figure 1a**, the fracture surface is not located in the position bearing the maximum stress during fatigue tests. The detailed observation reveals that a processing defect exists near the crack initiation region, as is shown in **Figure 1b**. This defect is mainly caused by the excessive extrusion of the hot plastic mold during induction heating, resulting in a local stress concentration at the defect. Subsequent quenching further increased the local stress at defects. During the fatigue tests, crack initiated from the stress concentrated position at the defects leading to the premature failure of the tested sample. As shown in **Figure 1c**, the characteristics of the fracture surface were revealed by the macroscopic analysis. The fracture surface shows the feature of a typical fatigue failure mode. The crack initiation region, crack expansion zone, and the final fracture region can be clearly observed on the fracture surface as marked in **Figure 1c**. Since the crack expansion zone occupies a large area, it indicates that,

Figure 1.
Macroscopic analysis of the premature fatigue fractured rail fastening clip caused by surface processing defects: (a) the overall morphology of the fractured clip, (b) the processing defects near the crack initiation region, and (c) the morphology of the fractured surface.

after the cracks initiated at the surface defect, the sample undergoes a crack expansion period under the cyclic load before the final fracture. According to the theoretical equation reported in the literature [17, 18], the fracture strength of the tested rail fastening clip can be calculated based on the area of the instantaneous fracture zone and the maximum load applied.

In Section 2.1, if the macroscopic analysis is not carried out, the processing defects near the crack source cannot be found, and the causes of the premature fracture of the fasteners will not be accurately determined, which will have a serious impact on the production and sales of the products. If the unqualified products with surface defects flow into the market, it will cause serious danger to the safety of the train operation. Moreover, as discussed in Section 2.2, combined with the macroscopic factors of the changes of production conditions (medium-frequency induction heating to high-frequency induction heating), it is preliminarily believed that the premature fatigue failure of the railway fastener is caused by the uneven heating. Then, under the guidance of the macroanalysis, the microscopic analysis is carried out, and the cause of the premature fatigue failure is finally determined. Based the failure analysis results, the manufacturers were told to make improvements in time to avoid major economic losses and safety hazards. Similarly, in the example of Section 2.3, the causes of the fastener premature fracture were determined by combining the macroscopic damage on the appearance of the failed fastener with the complex force during service, through the investigation of the on-site service environment. It provides an important basis for the further improvement of the performance of railway fasteners.

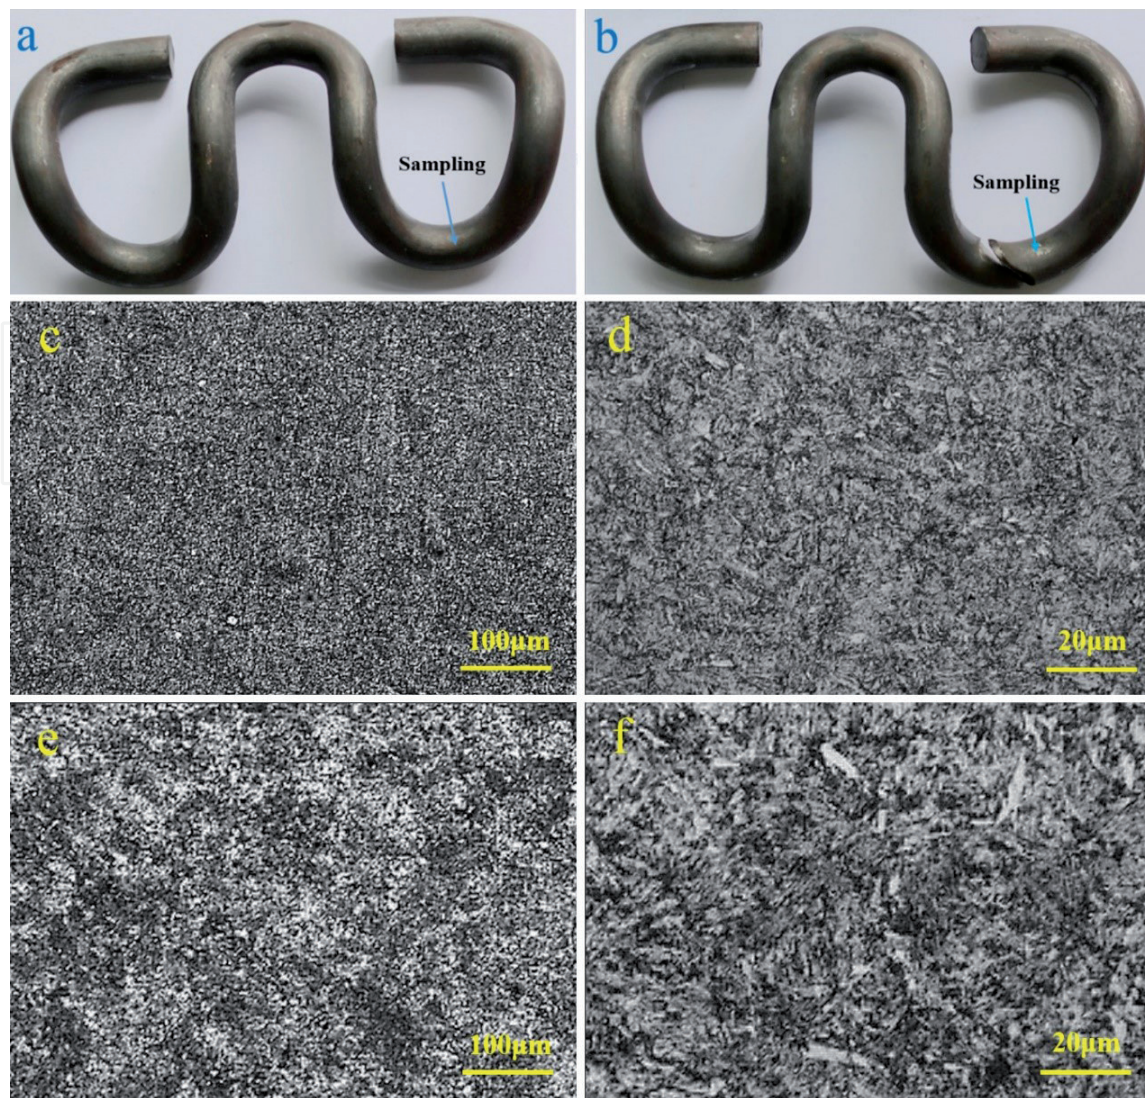
As shown in **Figure 3a** and **b**, the samples for microstructure observation of the normal and prematurely failed fasteners were cut from the same position near the fracture surface. The samples were ground by SiC paper and polished. The Nital solution (4% alcohol solution of nitric acid) was used as the etching solution. An optical microscope was used to complete the microstructure observation of the samples, and the results are shown in **Figure 3c–f**. **Figure 3c** and **d** shows the microstructure of the normal railway fastener after quenching and tempering in the medium temperature range; the typical tempered troostite and a small amount of ferrite can be clearly observed. The troostite and ferrite grains are fine, and they distributed evenly in the microstructure. **Figure 3e** and **f** shows the microstructure of the prematurely fractured samples. The obvious microstructure segregation

Figure 3.
The sample extraction position of normal (a) and prematurely failed railway (b) fasteners. (b, c) and (e, f) are the corresponding metallographic microstructure of the normal and prematurely failed fasteners, respectively.

can be observed from **Figure 3e**, which is caused by the large amount of dissolved cementite due to the fast heating rate of the high-frequency-inducing heating. The cementite came from the pearlite before heat treatment. As can be seen from **Figure 3f**, the grains are coarser, and in addition to the undissolved cementite, large block-shaped ferrite can also be observed. This is mainly due to the high heating rate and high temperature caused by the high-frequency-inducing heating. The rapid heating speed leads to the existence of a large amount of undissolved cementite. The heating temperature is too high, resulting in the formation of coarse microstructures [22]. This microstructural inhomogeneity can seriously affect the fatigue performance of the samples. Cracks are more prone to initiate at the microstructure with poor mechanical properties under the applied cyclic load, resulting in the premature fatigue fracture. This example shows that in the process of failure analysis, in addition to the analysis of the macroscopic characteristics of the sample, the macroscopic factors such as the production environment and the service environment of the sample parts are also important and sometimes are important causes of sample failure. It is sometimes difficult to directly and accurately determine the cause of failure from macroanalysis. This requires a combination of macroanalysis and microanalysis to achieve the accurate failure analysis results.

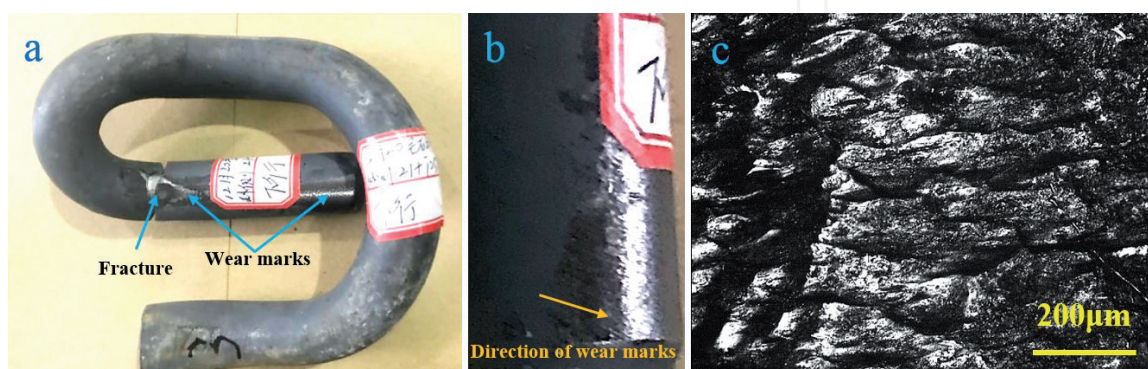
Figure 4.

As can be seen from **Figure 4a**, the breaking position located at the root of the straight section of the fastener, and this straight section is installed in the fixed slot. The fracture happened at the boundary between the straight section and the residual curved part, in which the maximum stress is loaded in the broken position in the actual working condition. A detailed observation of the sample surface reveals obvious wear marks. Moreover, the wear marks are in the same direction along the transverse arc of the fastener sample (see **Figure 4b**). As can be observed from the magnified view shown in **Figure 4c**, the wear marks have a certain depth, and their propagation direction is consistent. Based on the direction and depth of the wear scar, it can be preliminarily concluded that the wear scars on the surface of the straight section of the railway fastener were caused by the relative rotation with the spring clip slot it contacted with. However, in the normal circumstances, this type of rotation is not allowed, because the rotation will reduce the pressure between the fastener and the railway track, affecting the train safety. Combined with the relatively deep wear marks, the broken fastener is subjected to a large external force before failure. The reason causing this large external force can only be determined by the on-site investigation with the understanding of the service situation.

According to the investigation of the service scene, the subway operates along a circle line, and the fasteners with premature fatigue failure occurred mostly at or near the curve region of the railway track. This indicates that in addition to the force of caused by the vibration of the track when a train passed, the spring bar is also subjected to the centrifugal force when the train is adjusting directions. Under the combined force of the vibration and the centrifugal force, the fastener rotated relatively in the slot, resulting in a surface with a consistent direction of wear scar. After multiple friction, the wear marks at the position where the fastener is in contact with the edge of the slot became deeper and deeper, and thus fatigue cracks were

The macroscopic morphology and surface wear scars of the fractured metro fastener: (a) the macroscopic morphology of the failed fastener showing the position of the fracture surface and the wear marks, (b) the obvious wear scar that can be observed on the surface of the straight section of the fastener clip, and (c) the enlarged view of wear scar.

The early failure of the railway fasteners caused by the external service environment indicates that in addition to considering the material selection and processing technology and performance of the product, the actual working environments should also be taken into consideration. In order to ensure the operation safety of the equipment, the design and manufacture of the product can be improved based on the actual working condition of the components. Only then can the safety factor in the actual service process be increased.

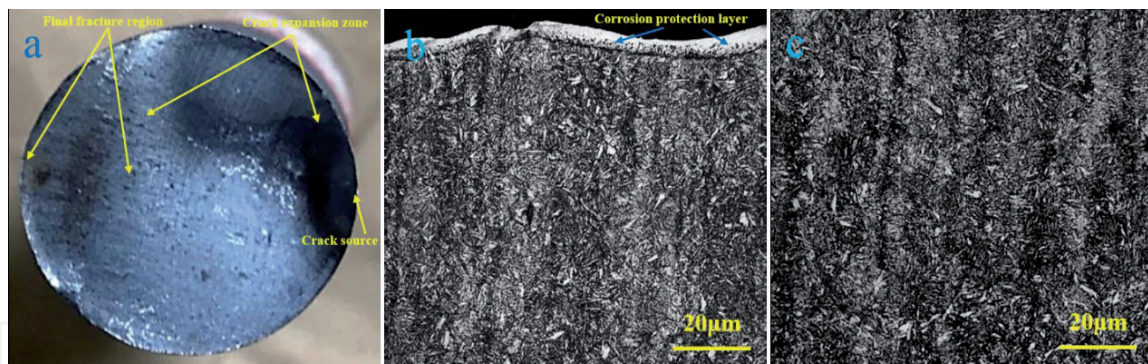
Figure 5.
The macroscopic morphology of the fracture surface and the microstructure of the samples near the fracture surface: (a) the fracture surface morphology, (b) the cross-sectional microstructure of the sample near the fracture surface, and (c) the microstructure of core region of the sample near the fracture surface.

generated. Due to the large external force, the crack spreads rapidly, resulting in the final premature fracture failure of the fastener. In order to more accurately determine the cause of the failure of the elastic strip, combined with the macroscopic analysis of the fracture surface, the metallographic microstructures near the fracture surface were further observed and analyzed. The results are presented in **Figure 5**.

From the macroscopic analysis of the fracture surface as shown in **Figure 5a**, the crack initiation region has a certain area, and the color is dark blue and slightly black, which is mainly due to the inconsistent deformation of the elastic strips on both sides of the crack, and the oxidation of the fracture surface resulted from the temperature rising caused by the relative extrusion and friction. This again proves that the elastic strips underwent severe torsional deformation during actual service. From the morphology of the crack extension area in **Figure 5a**, the extended area has obvious macroscopic fan-shaped stripes, and the spacing between the stripes is large. The spacing between the fan-shaped stripes is large, which indicates that under the load of the torsion force, the severe wear scars were first produced on the surface where the stress reaches the maximum value. Then, micro-cracks were formed in the most severely worn areas. Under the combined load caused by the vibration of the rail tracks and the centrifugal force, the cracks expanded rapidly, resulting in the final premature fracture. At the same time, samples near the fracture surface were extracted for the preparation of the metallographic sample. The surface and center microstructure of the surface of the prepared samples is shown in **Figure 5b** and **c**. It can be observed that the tempered troostite (or tempered torsite) and a small amount of ferrite are the main microstructure of the elastic stripe after quenching with medium temperature tempering, which is the normal microstructure. A layer of anticorrosion treatment can be observed on the surface, which is a conventional treatment for railway fasteners.
