Windstorm Resilient Rural Housing: Lessons learned in Temerloh, Malaysia

Foong Sin Lam¹, Jer Vui Lee², Yeok Meng Ngeow³

In 2019 alone, Temerloh district located in central Peninsular Malaysia has been hit by unpredictable wind storms in localised areas which damaged more than 185 rural homes. This research set out to assess the structural vulnerabilities of damaged rural houses to severe winds in Temerloh and lessons learned from windstorm damage through field surveys of damaged homes between March 2019-August 2019 and supplemented by district-level post-windstorm reconnaissance reports prepared by Malaysia Civil Defense Force (APM) and other information gathered from local government. Results indicate poor performance of structural and non-structural building components in resisting high wind loads due to inadequate design, under-strength of failed building materials and defective construction details. The results of this study could have important implications for government agencies, NGOs, builders, and engineers in assisting rural communities in reconstructing windproof resistant homes and planning for future windstorm risk management efforts specially catered to homeowners i

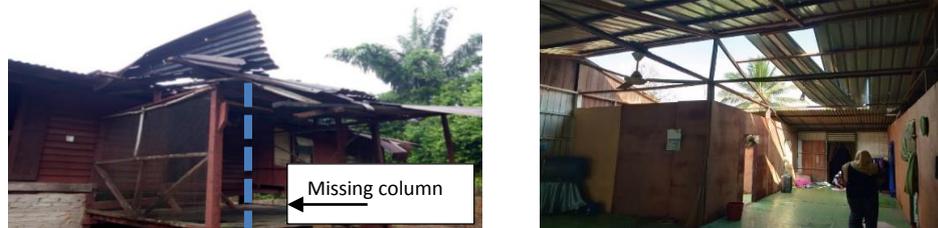
Based on the rapid evaluations, we identified and defined major typical failure modes of all the damaged houses evaluated based on photographic evidence, as shown in Figure 3-4. For each of the typical structural failure modes, we included a sample representative photograph, and a summary of posting (Safe, Restricted Use or Unsafe) and we presented a description of possible causes of failure under each figure.

Fig. 3. (a) Loss of vertical column support and overhang roof damage; Post Restricted Use with barricade the front portion (b) Purlin and rafter section sizes were inadequate and purlin-rafter connection failure and roof blown away) Damaged interior contents due to broken fallen roof sheathings; rain water intrusion; Post Unsafe with falling hazard

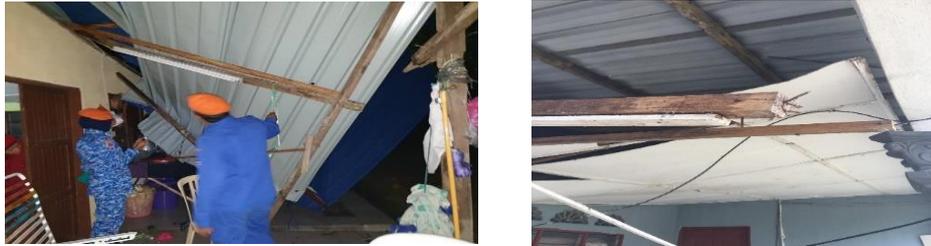
Typically damaged roof sheathings were 0.18mm thick corrugated zinc roof sheets attached by roof nails to timber trusses. Interviews with homeowners showed that thicker sheathings did not replace these thin corrugated during repair and replacement after the windstorm. Wind uplift caused roof sheathings to displace a distance away, but most of the walls remained intact. Based on observations of roo debris, roof nails and sheathings were rusty. Rust decreased nail strength that caused roof sheathings to pull out from the rusted connections.

Fig. 4. (a) Roof sheathing damage due to overturning failure mode at roof edges and absence of cross bracing; Post Restricted Use and barricade the side of the house (b) Weak and rusted nail connections

Based on field surveys and findings from this study, we recommend some structural strengthening that can be adopted to rebuild better windstorm resilient rural housing. Thin roof sheathings need to be replaced by locally manufactured thicker roof sheathings. At least 0.38 mm or more in thickness painted with durable zinc coating to replace the 0.18mm thick corrugated zinc sheets used in older houses (IFCR-SRU, 2017). More substantial and closer roofing screws are the preferred fasteners (diameter = 20 mm) to prevent roof uplift subject to strong winds (IFCR-SRU, 2017). From findings, builders used small, smooth-shank roofing nails. Laboratory work done by Wan Chik (2013) confirmed the findings. For a maximum wind speed of 53.7 km/h in selected study areas in rural Malaysia, screw fasteners resisted much higher pull force than nail fasteners at a spacing of 850mm between purlin and roof sheathings. Cross bracings in rafters and trusses prevent overturning and provide load path for lateral wind loads to the foundation. Hipped roofs have a better aerodynamic performance of wind results in lower suction pressure compared to gable and mono-pitched roofs (IFCR-SRU, 2017). More massive overhangs have more substantial wind pressures as seen in some of the damaged roofs.

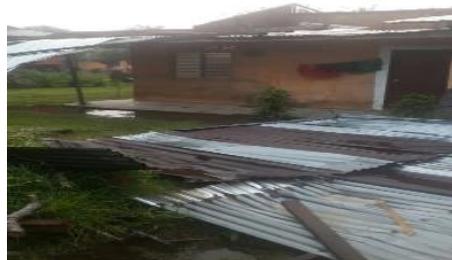
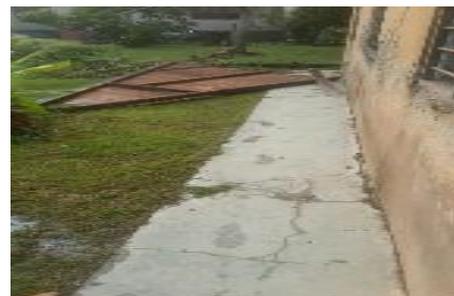
Fig. 7. (a) Roofing damage and transported a distance away due to failure of poor connection and use of lightweight zinc materials creating higher net uplift forces (b) Loss of wall frame due to poor connections between wood and brick wall (Source: Field survey reports by APM)

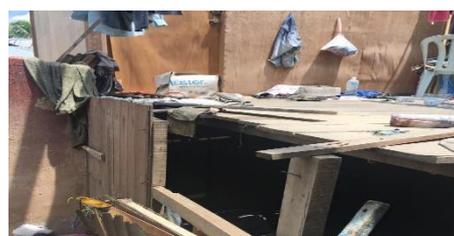
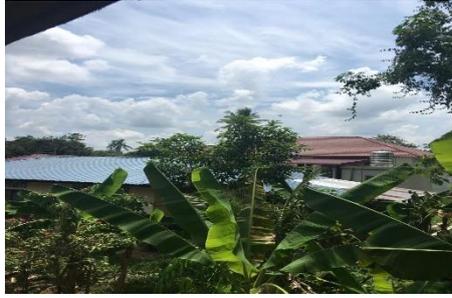
One of the main observation from the field survey was that older building experienced more severe damage compared with newer homes. Figure 8(a) shows an older and newer located in the vicinity of the area, with the older home experienced severe damage. In contrast, the newer building with a newly built roof system did not experience any damage. The older home experienced damage to external facade. The poor conditions of the zinc roof and poor connections could not withstand the higher than average wind speed. Some properties have a second story provide shelter during a strong windstorm and protection from flying debris and fallen trees and branches. The time to start repair work was slow due to lack of workforce.

Fig. 8. (a) Adjacent rural homes with newly built roof with thicker roof sheathings did not experience any damage (b) Wind damage to interior walls and possibilities of damage to vertical support structural system when the roof was breached

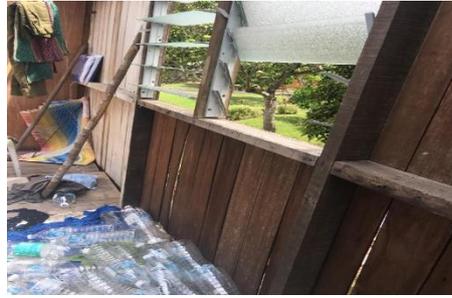
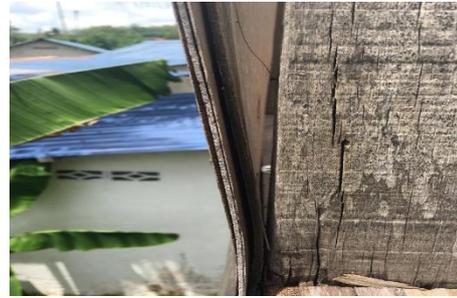
Fig. 9. (a) Damage to windows & (b) Plywood separation from structure

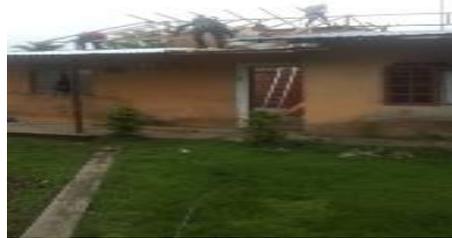
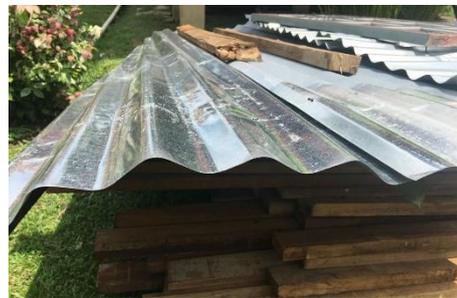
Fig. 10. (a) Repair work undertaken by Malaysian Armed Forces (b) There's no change in material used in house reconstruction
(Source for Fig. 9-12: Field survey photo taken during authors' visit on 30th August 2019)
