## **Development Of A Procedure For The Detection Of Subsurface Defects In Bridge Deck Joint Armor Using Ground Penetrating Radar And Seismic Properties Analysis**

Larry Lance Rickard, Jr.

A thesis submitted to the graduate faculty in  
partial fulfillment of the requirements for the degree of  
MASTER OF SCIENCE

North Carolina A&T State University  
Greensboro, North Carolina  
2011

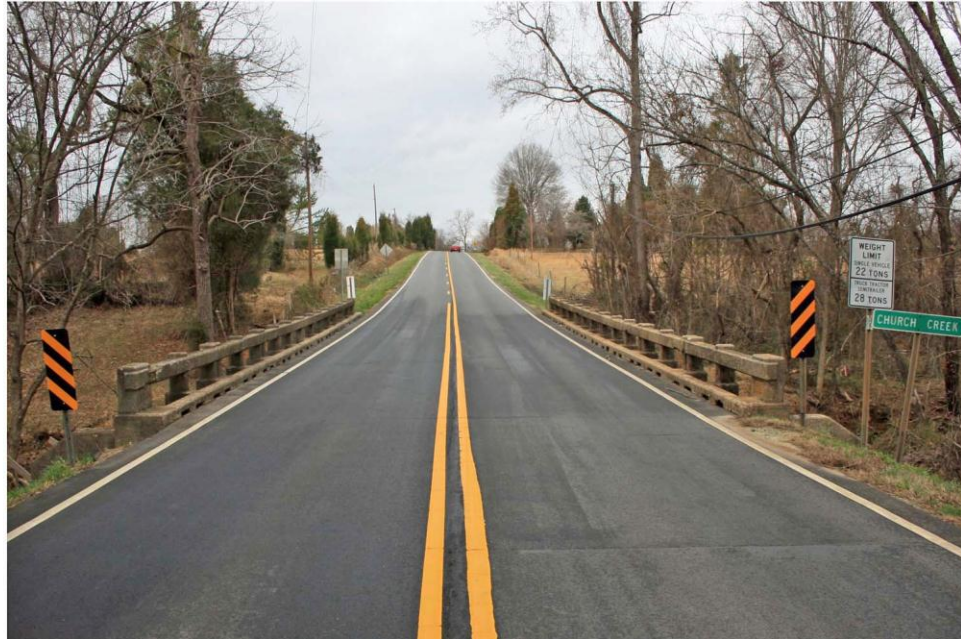
This is an example of a structure that was both functionally obsolete and structurally deficient. The last field inspection for this bridge was performed on September 24, 2010 and the resulting report listed its condition as “poor”, with a sufficiency rating (SR) of 27.8. The posted single vehicle load limit (SV) was 22 tons (20 metric tons) and the tractor-trailer/semi-trailer load limit (TTST) was 28 tons (25.4 metric tons) [6]. Its FO status was determined by several factors, including deck width and deck elevation [7].

With regards to deck width, Figure 1.2 shows that the deck was only wide enough to accommodate the actual travel lanes. The problem wasn’t the 12 ft. (3.7 m) width of the individual lanes - standard for most modern bridges - but the lack of additional clearance toward the barrier rails. This left little room for oversized vehicles and didn’t allow space for water to drain during periods of heavy rainfall. The scuppers at the base of the rail were also prone to clogging with road debris, which also hindered drainage.

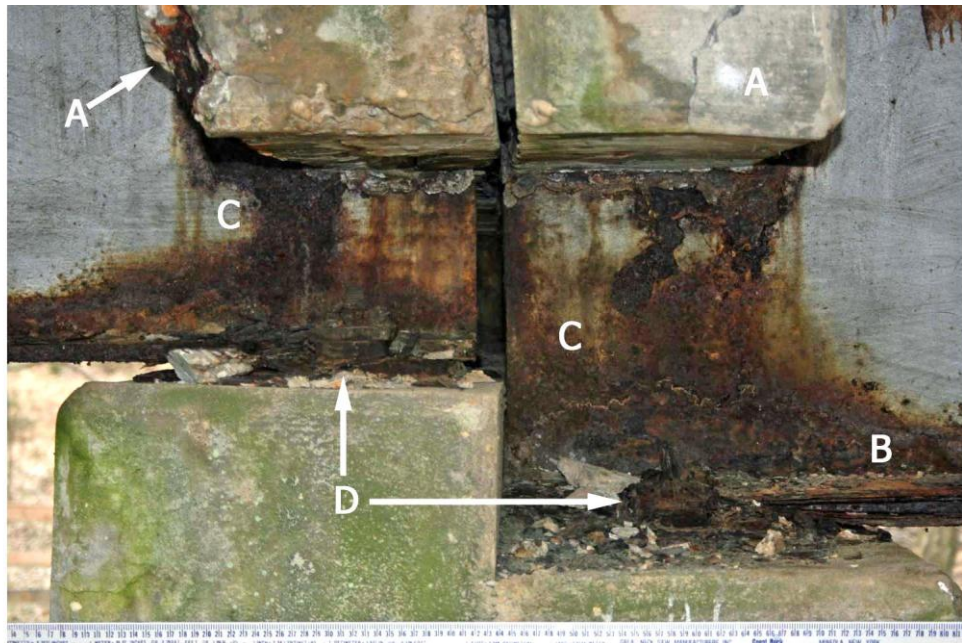
**Figure 1.4. Damage to the northern end of Bent 2.**

Figure 1.4 illustrates the damage to the northeastern side of Bent 2 (see Figure 1.3 for the exact location). Apparent chloride intrusion had caused corrosion of the rebar, resulting in spalling of the exterior concrete (A). Years of direct exposure to water and de-icing agents had caused extensive corrosion of the girder ends, with a resulting loss of section on both. This loss was much more severe on the lower flanges of each girder, where water tended to accumulate. Delamination of the steel in the lower flange was evident at (B); this would likely exacerbate any reduction in shear capacity caused by section loss in the web, shown at (C). Corrosion of the bearing bolts (D) was so severe that only vestiges of them remained. There was little or no sound steel left to fix the girders in place.

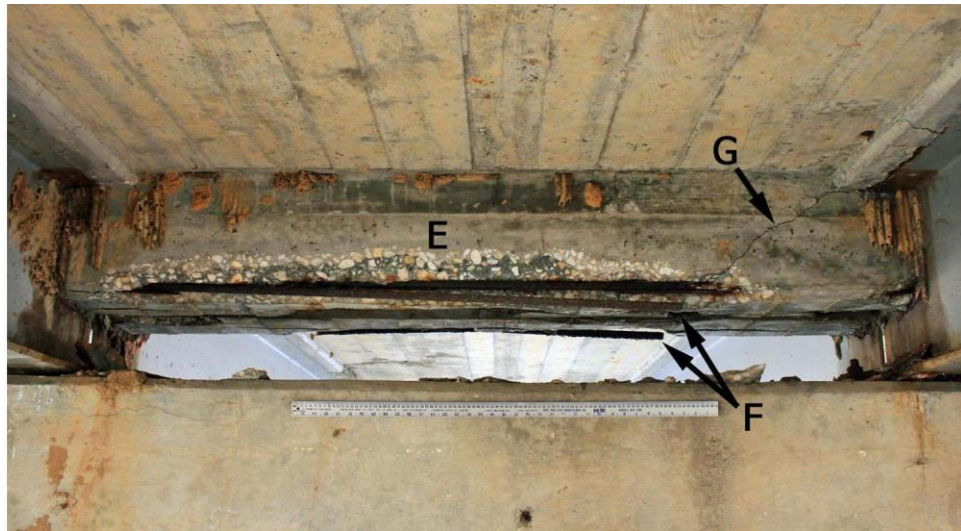
**Figure 1.5. Damage to diaphragm.**

Water infiltration from the unsealed deck joint above had also caused chloride intrusion of the concrete in the deck and the diaphragms (Figure 1.5). This resulted in rebar corrosion and spalling (E) just as severe as that found on the exterior girders. The

spalling along the diaphragm shown was extensive enough to have caused an almost complete loss of development length in the rebar (F), compromising this member's ability to carry tensile loads along its bottom half. This ultimately caused the shear cracking at (G).

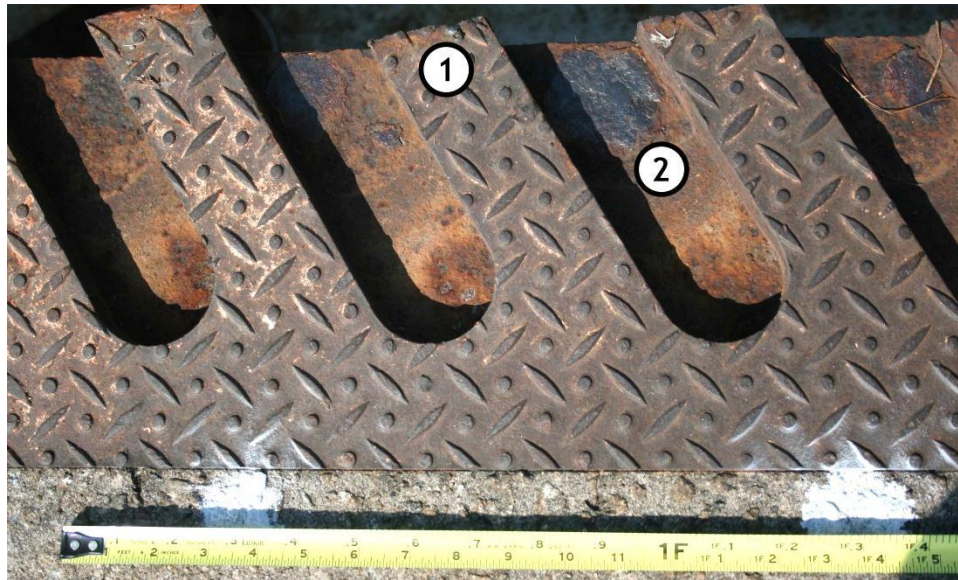
**Figure 4.6. Finger joint detail.** Note the rough cutoffs at the ends of the fingers (1) and the wear on the anchor plate troughs caused by the opposing fingers (2).

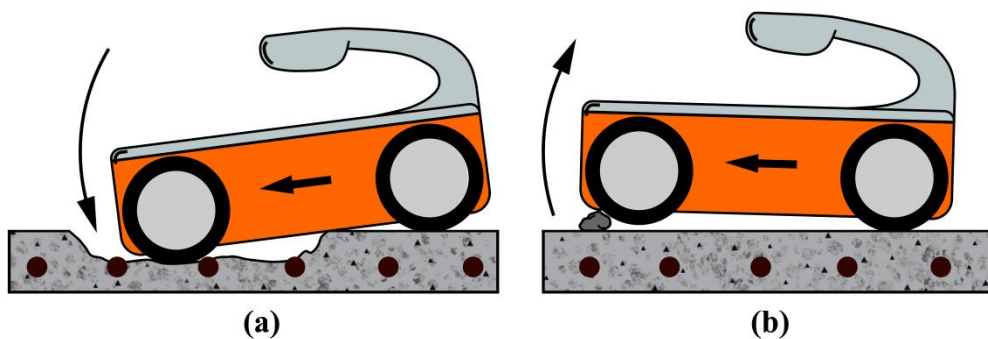
Surface uniformity was another consideration. Although not expressly stipulated in the SSM instructions, it could be inferred that any surface under test needed to be reasonably smooth. The unit's low clearance – approximately  $\frac{1}{8}$  in. (3 mm) - combined with the relative non-uniformity of the test surface made it imperative that the scanned area be clean and free of major spalling, small stones, pieces of concrete and other debris. Any object between  $\frac{1}{8}$  in. (3 mm) and  $\frac{1}{4}$  in. (6 mm) diameter was a matter for concern. Aside from causing cosmetic damage to the unit, these objects could lodge beneath it and act as a fifth “wheel”. This would cause erroneous readings by increasing the unit's clearance above the test surface or by causing it to veer off the designated scan path (Figure 5.1).

**Figure 5.1. Effects of surface damage and debris on the SSM.**

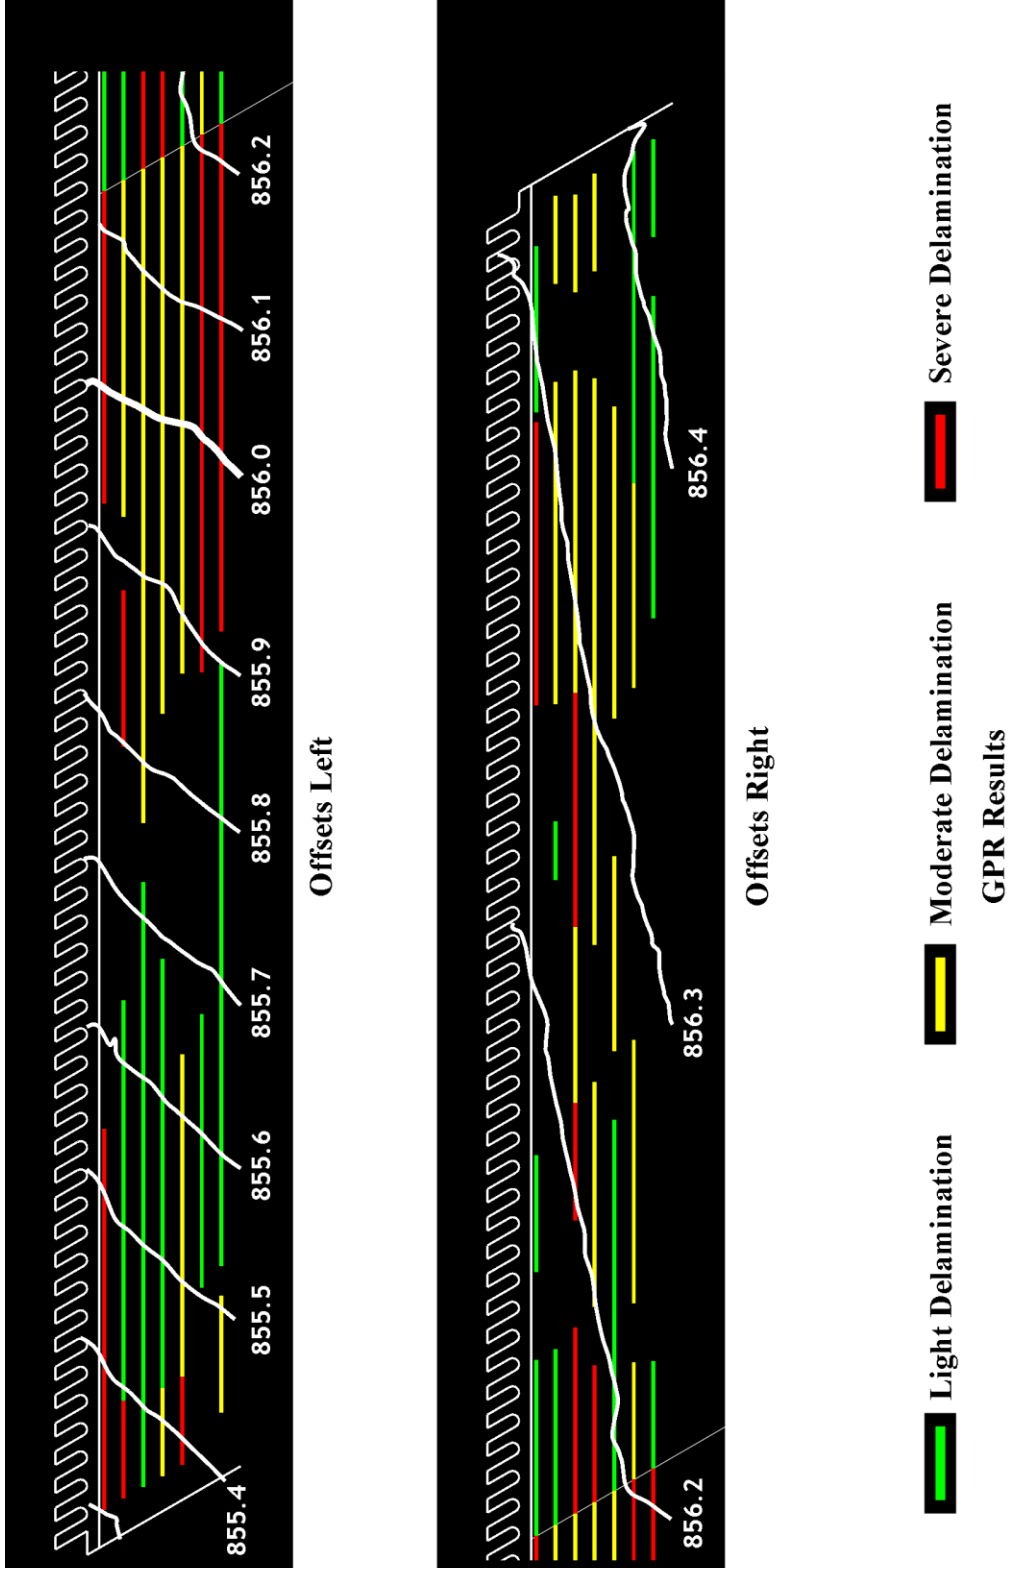
Figure 6.4. Deterioration map: HDS and GPR data.

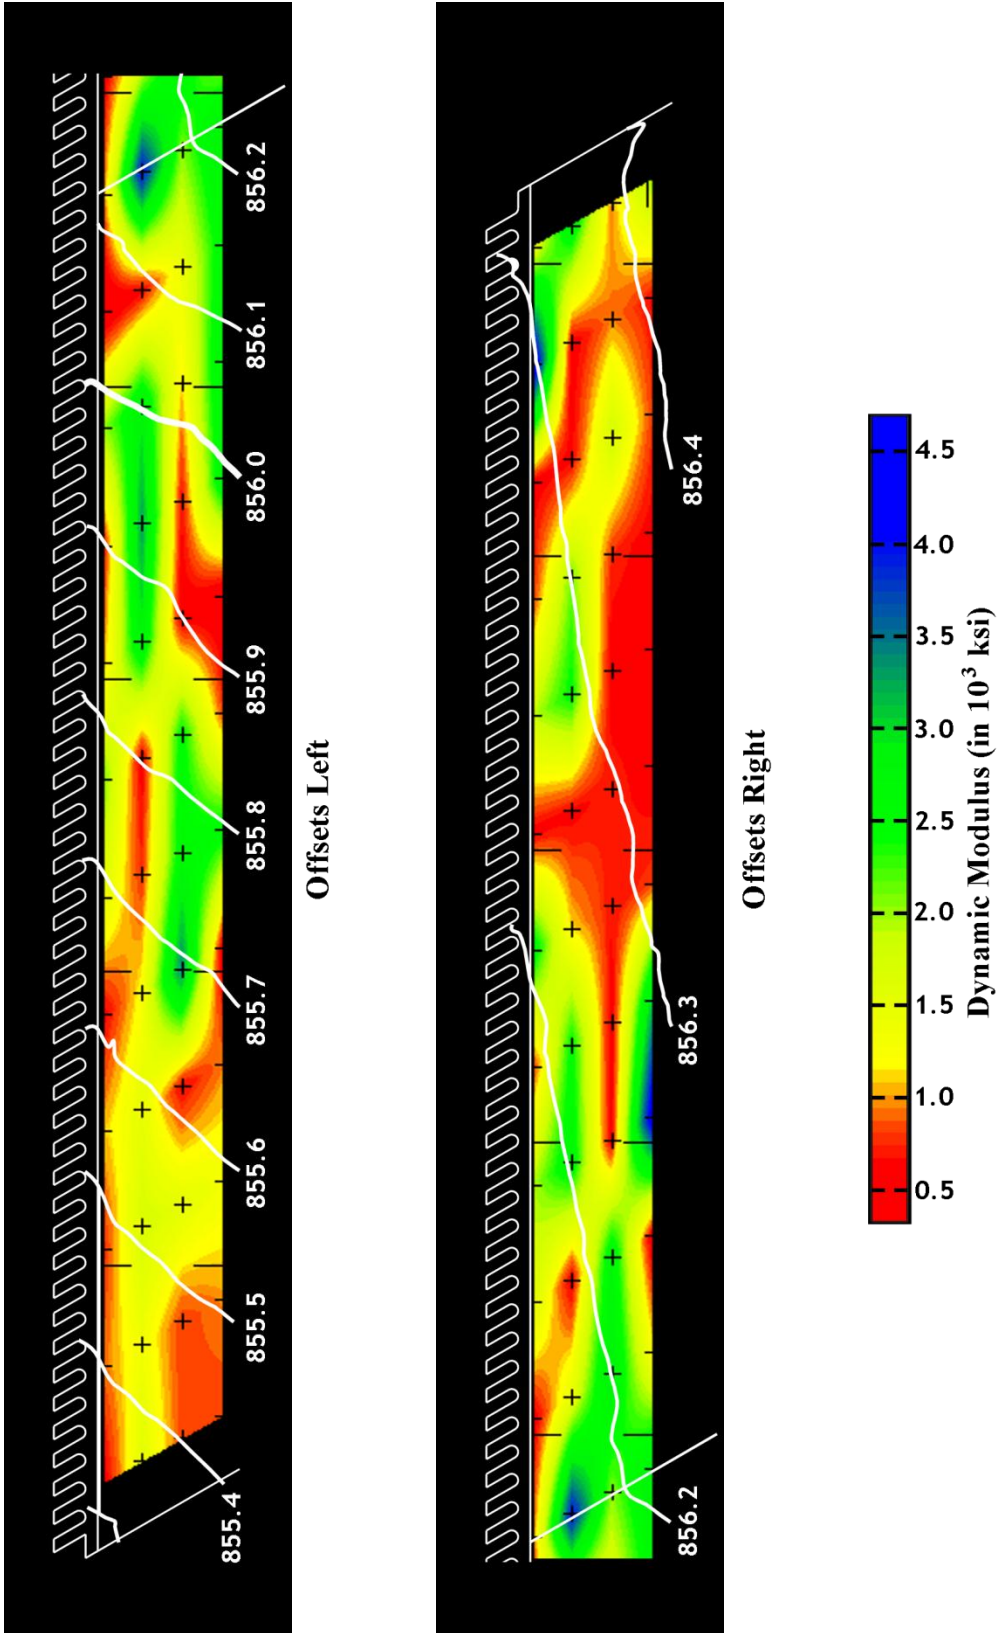
Figure 6.6. Deterioration map: HDS and SPA data.

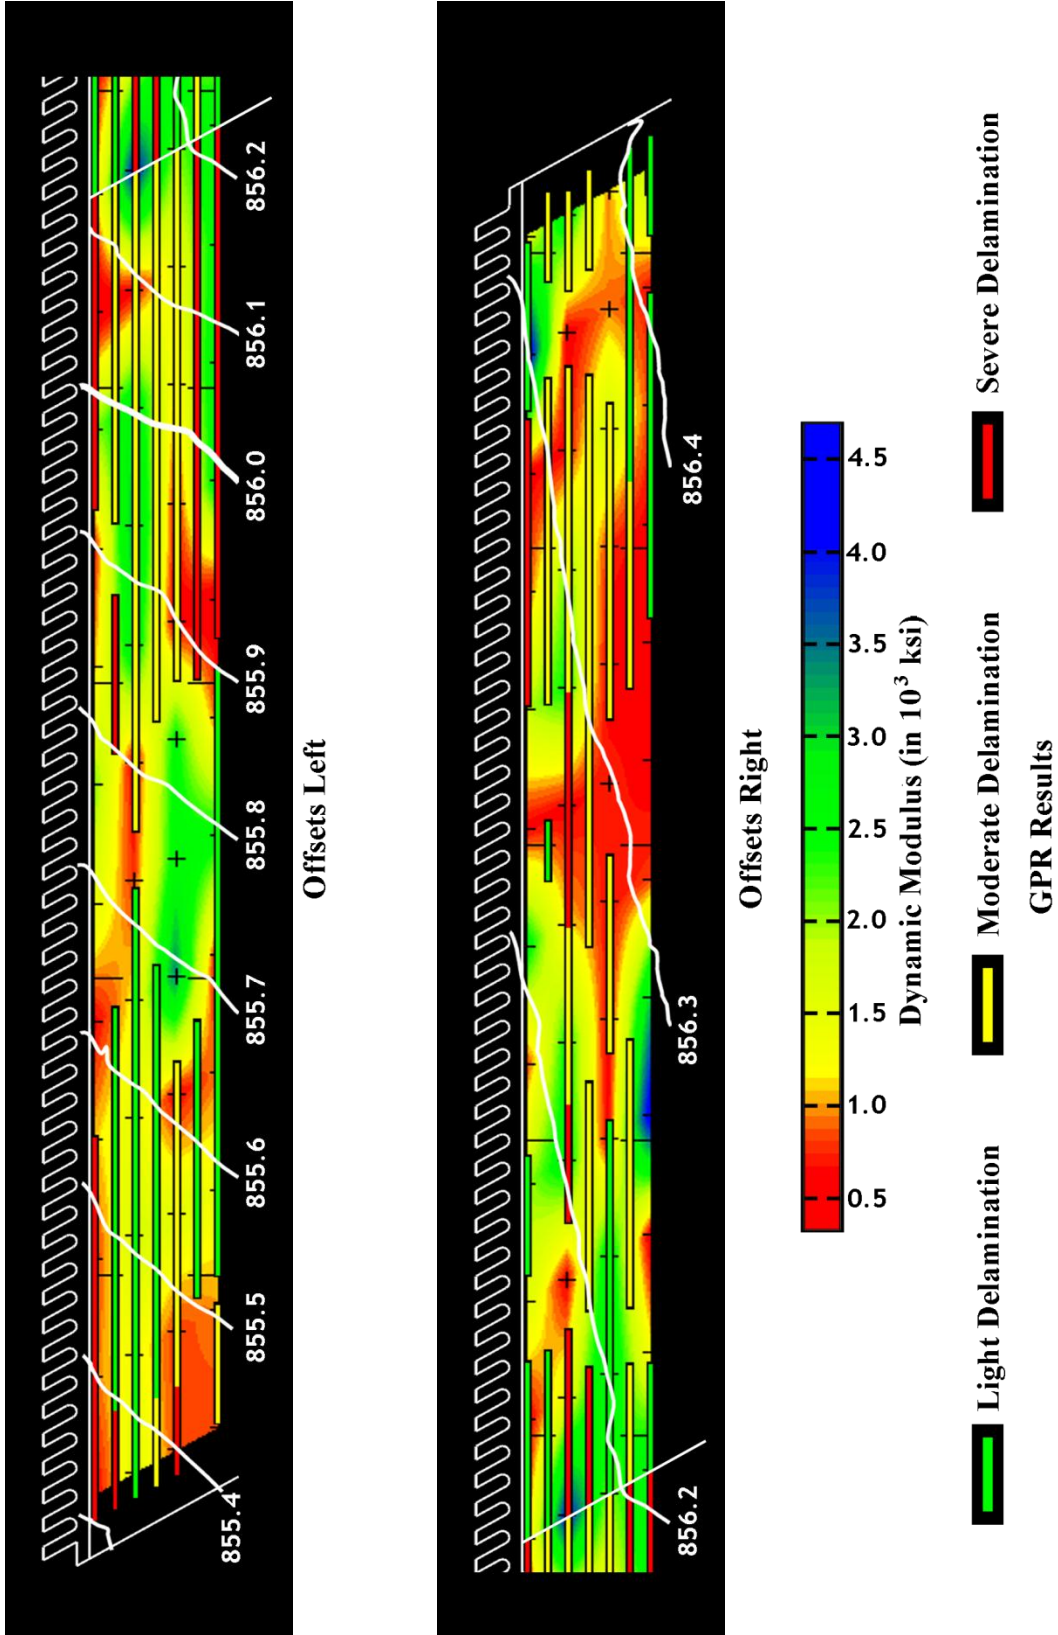
Figure 6.7. Deterioration map: HDS, GPR and SPA Data.
