Case Studies in Engineering Failure Analysis

Case study

Failure analysis of Co–Cr hip resurfacing prosthesis during solidification

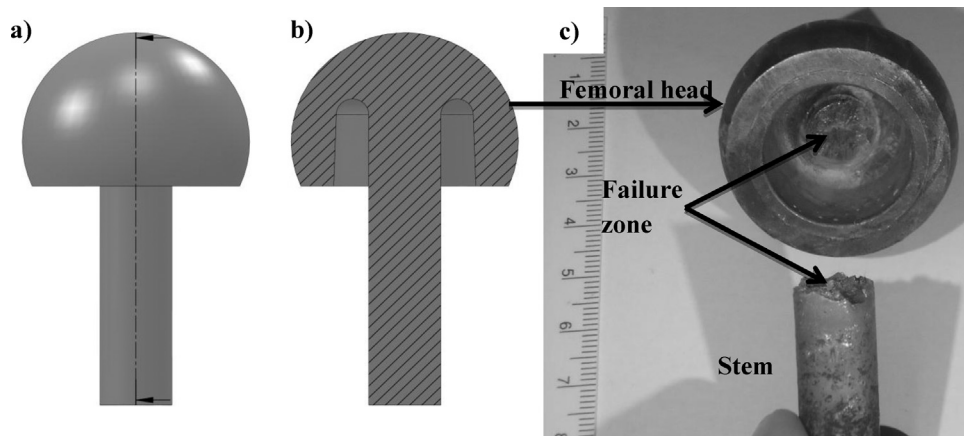
Fig. 1. Femoral prosthesis: (a) schematic prosthetic component, (b) schematic half section, and (c) view of the hip prosthesis showing the failure zone.

The femoral component stem showed an extended failure located between the femoral head and the beginning of the stem at the change geometry direction as shown in Fig. 1c. It is possible to observe half section of the femoral component

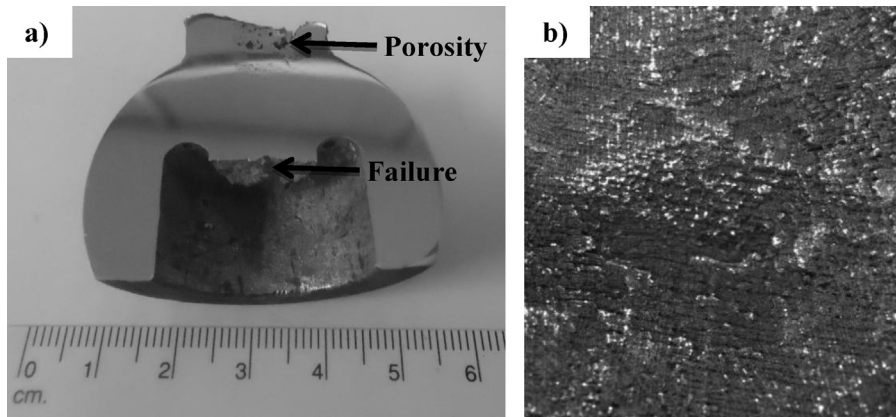
Fig. 2. Femoral component showing: (a) the failure and porosity defects and (b) failure component zone.

showing the failure zone (see Fig. 2a). In addition, shrinkage porosity defects are visible into the femoral head. In Fig. 2b is shown the crack surface with presence of oxides.

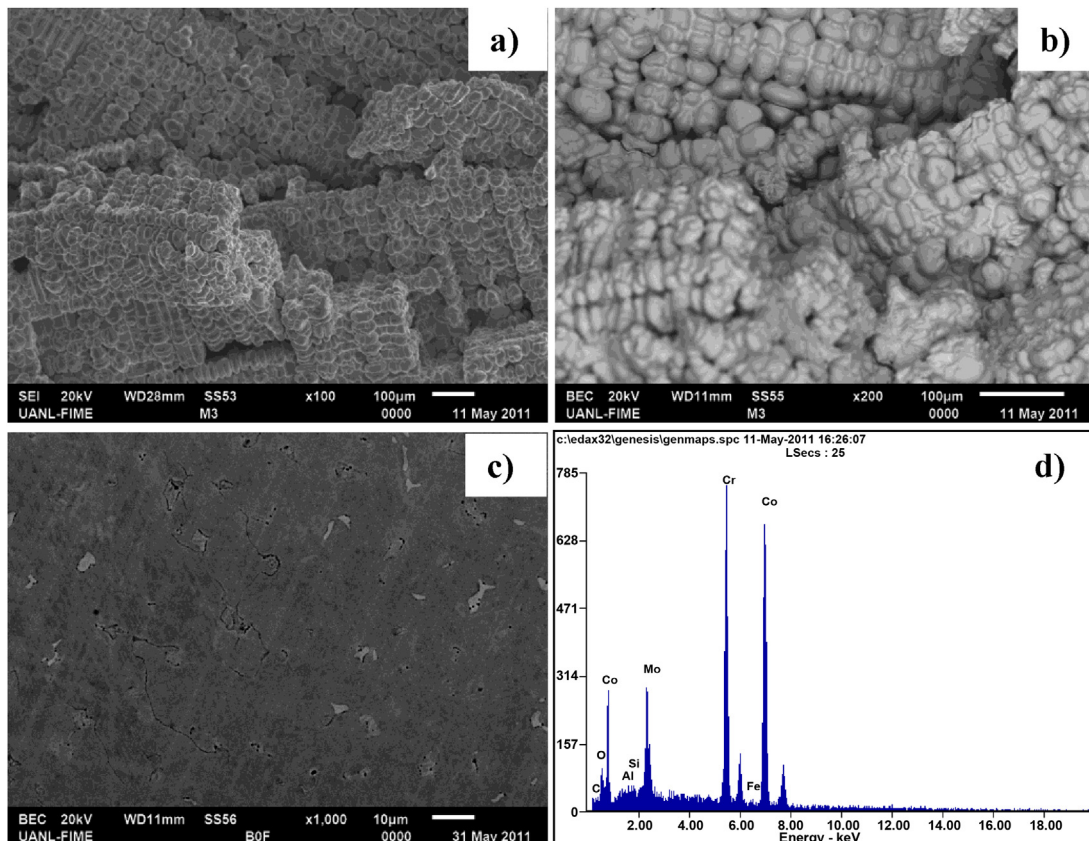
In Fig. 3a and b are shown the SEM images at high magnification of the hot tearing failure zone with dendritic surface morphology. It is possible to observe the last solidified dendrites layer and the interdendritic crack. This effect may be explained due to the interdendritic tear occurred during the last stage of solidification. In Fig. 3c shows the typical secondary phases ($M_{23}C_6$ carbide) embedded in the cobalt-base alpha matrix (fcc) [10,11]. It is possible to observe the presence of

Fig. 3. The image shows: (a and b) SEM micrographs at 100× and 200× for hot tearing, (c) Co–Cr microstructure at 1000×, and (d) EDS analysis defects.

microporosity of the failure zone. The EDS spectrum in Fig. 3d shows the composition of characteristic ASTM F75-07 alloy with presence of oxygen which lead a layer oxide shown in Fig. 2b.

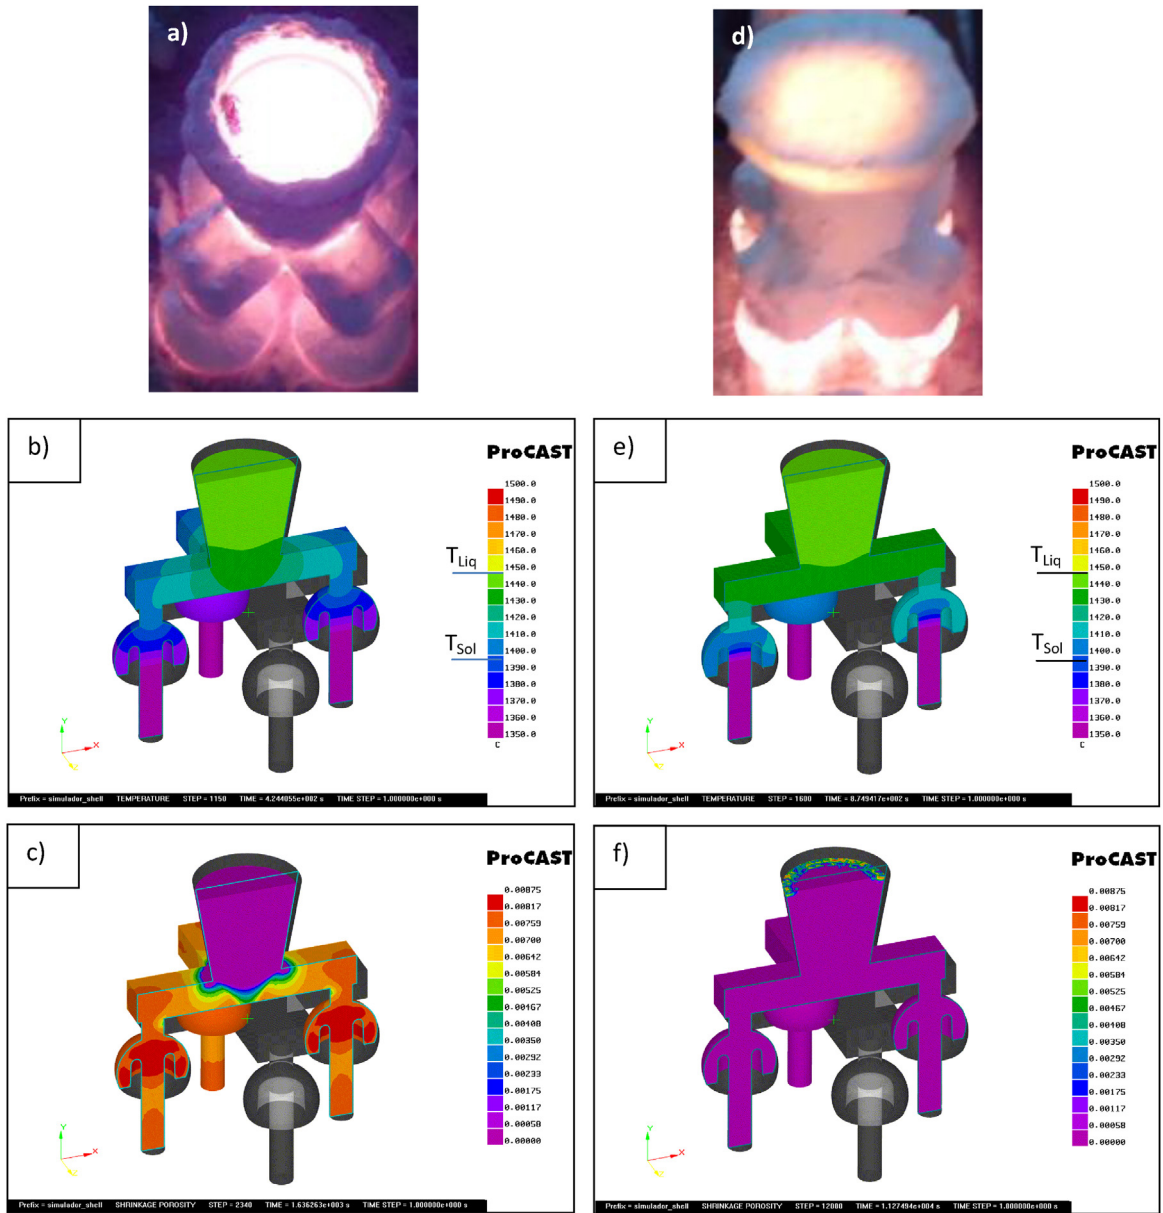
Fig. 4. Simulations of solidification process for both normal and insulated conditions. (a) Picture of casting solidification, (b) solidification temperature, (c) shrinkage porosity for normal casting heat transfer condition and (d) picture of insulated casting solidification, (e) solidification temperature, and (f) shrinkage porosity for insulated condition.

The hot tearing defect was confirmed by the ProCAST simulations. In Fig. 4a is shown the casting solidification process where is possible to observe how the heat irradiation is homogenous at all parts of the ceramic mold. In Fig. 4b is shown the solidification temperature where the liquid temperature T_{liq} is 1449 °C and the solidus temperature T_{sol} is 1397 °C. It is possible to observe how solidification occurred at 424 s this did not permit to feed enough the hot spot located on the stem change direction. It was confirmed when was analyzed the shrinkage porosity prediction in Fig. 4c where is possible to observe that in this location was accumulated heat resulting in thermal contraction and as a consequence hot tearing coinciding with the examination made in visual inspection, see Fig. 2a.

With the purpose to eliminate these defects, it was undertaken additional experimentation setting an adiabatic insulation on the feeder, runners and gates as is shown in Fig. 4d, where is possible to observe how the heat irradiation is higher on the HR prosthesis regarding to the insulated upper part of the ceramic mold. It suggests a directional solidification which was validated by ProCAST simulations. In Fig. 4e is possible to observe a better temperature distribution of the feeder system being more efficient, this was confirmed in shrinkage porosity prediction image presented in Fig. 4f where porosity defects were present only on the pouring cup. This simulation was validated analyzing the transversal section of the femoral component where none defects were seen, see Fig. 5.

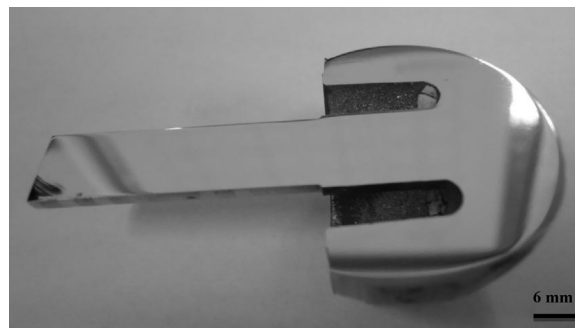
Fig. 5. Femoral prosthesis without defects.
