Falkland Islands Malvinas Exploitation Report 2015

Fenix- Insight Ltd.

Demining Programme Office in the Falkland Islands – Exploitation 2015

FALKLAND ISLANDS LANDMINE EXPLOITATION – MARCH 2015

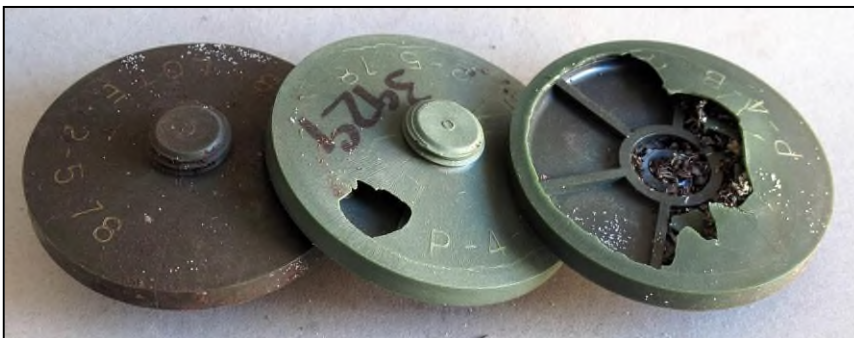
A significant proportion of the fuze casings had hardened and cracked, with many partially disintegrated. The proportion of degraded fuzes recovered so far during Phase 4A is substantially greater than on previous phases.

In examples where the top of the fuze casing had broken away, the striker spring and spacer were often missing altogether, leaving the mechanism incomplete. This means that the fuze could no longer function as designed.

A range of degradation was present among P4B fuze casings

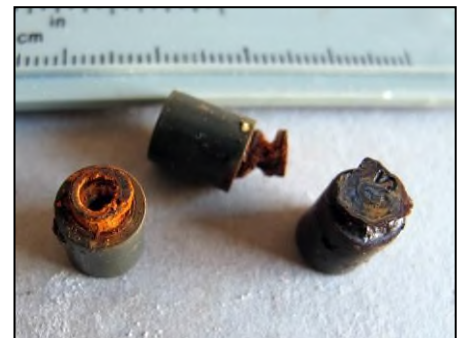
Any corrosion of the striker spring reduces its metallic mass and makes it even less detectable.

Many springs were corroded

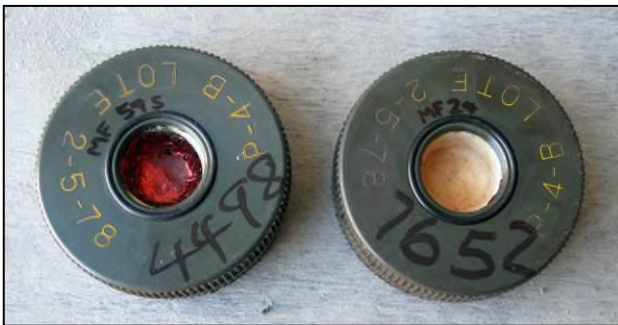
The foil is installed in the P4B body as a flat disc, but is broken when the fuze is fitted. In most cases, the foil ruptures in several places, creating 'fingers' that protrude into the fuze well. In some examples the foil remains virtually intact, while in others a portion is absent, but every P4B mine examined (including previous phases) has had some foil present.

Variations in the foil covering the main charge

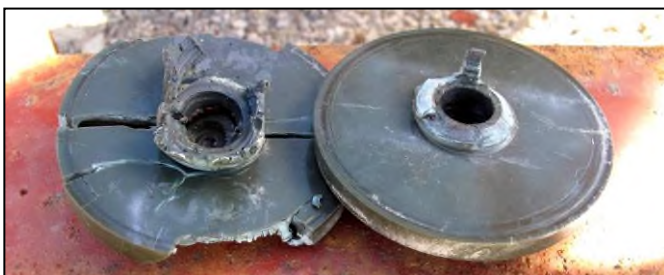
Of the 50 fuzes tested, only 16 (approximately one third) produced any explosive effect. The majority of these were recovered from a mine dump, where the packaging provided some measure of protection against the environment. Test results are shown in the table below:

Out of those that exploded, the majority produced a weak effect that would probably fail to propagate to the main charge. In other words, actuation of mines in this category would be unlikely to cause injury.

Results from P4B detonator testing. The fuze on the left was one of the few that detonated fully; the one on the right barely had the energy to break the housing and would not have detonated the main charge

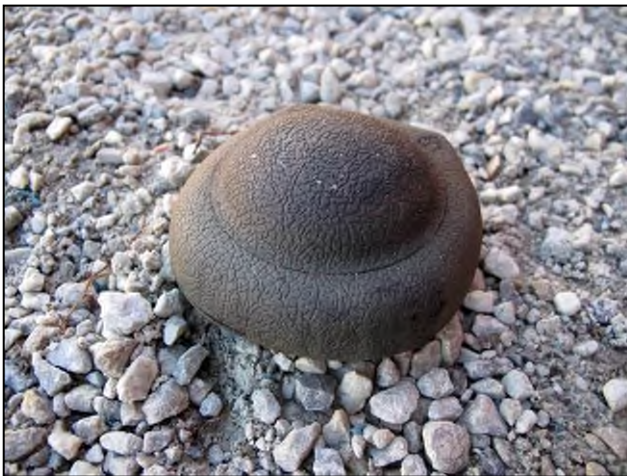
As noted in previous phases, the rubber covers of the SB-33 mines were generally domed where prolonged exposure to water had caused the material to swell. Despite the rubber remaining intact, it appears that water eventually permeated, since most mines were moist inside.

The rubber domes on the SB-33 mines have swelled and allowed some moisture to enter

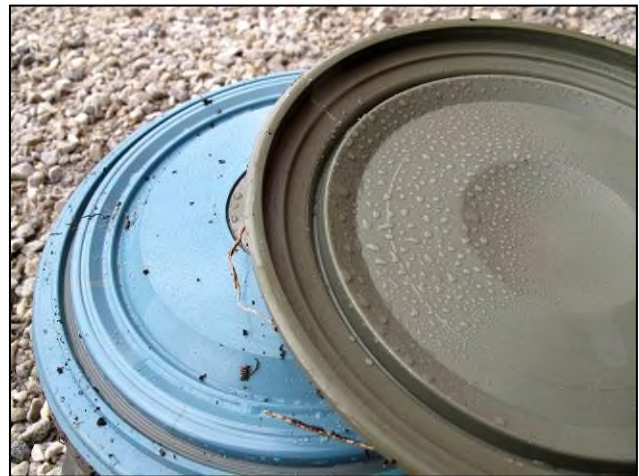
Moisture was also present in most of the SB-81 mines, despite the integrity of the rubber pressure plate. The SB-81 fuze is actuated pneumatically, so the seal and flexibility of this plate are critical to its function; both aspects appeared to be unaffected in the mines examined³

The pressure plates (right) of the SB-81 mines were in good condition; most were wet on the inside

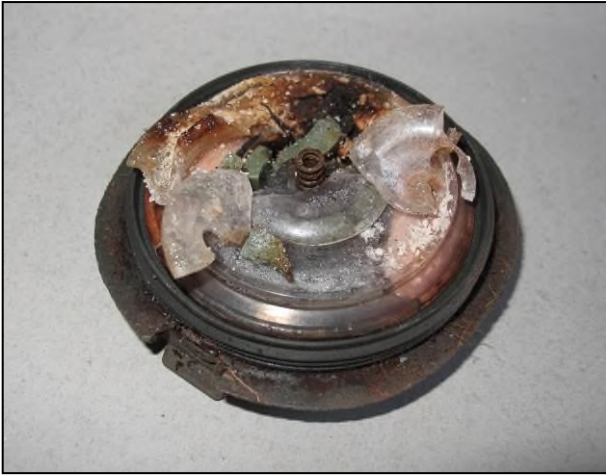
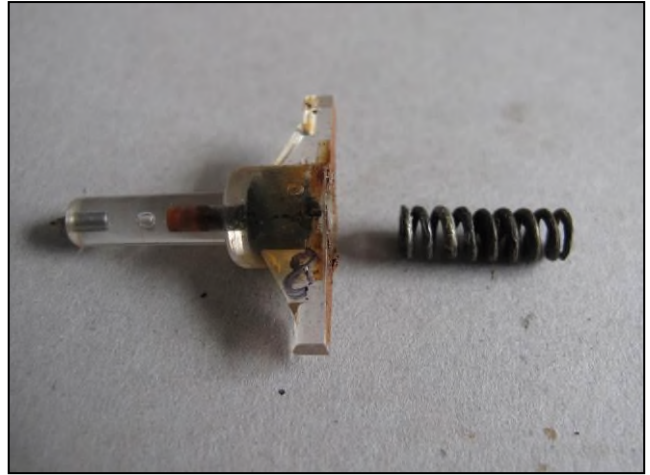
Even where water had entered the mines, rusting of the striker springs was generally light and superficial. This means that the metal content of both mine types still remains well above the detection threshold.

Even when rusted, the steel springs had lost little of their original mass (SB-33 left, SB-81 right)

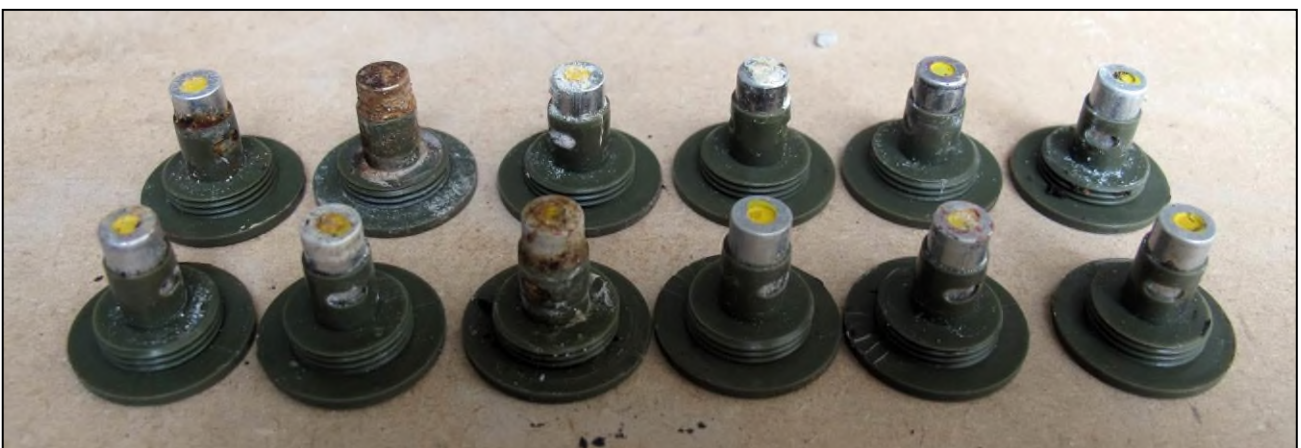
Most detonators appeared to be in good condition; however, some had white crusting (probably aluminium oxide from the detonator capsule) while others had a brown gelatinous exudation from the stab receptor.

Detonators from the SB-81 mines, some of which show signs of deterioration

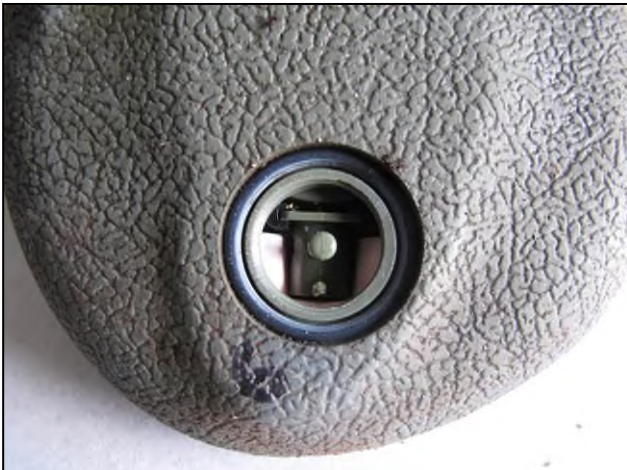
The gradual decline of detonators within SB-33 mines was also apparent from mines that had failed to fully function when actuated. Of the 16 mines examined, 6 had the firing pin embedded in the detonator, which did not initiate.

The presence of the firing pin in the stab receptor of the detonator is a major and unexpected hazard, since further movement could cause initiation. During disarming, the detonator is withdrawn from the mine body at right angles to the firing pin, meaning that the two components scrape together. If the detonator is still active, this could initiate the mine in the hands of the deminer.

An SB-33 detonator plug removed to reveal the detonator still in position, impaled on the firing pin

- Trials are arranged to assess the feasibility of using GPR for the detection of the P4B.
- No attempt should be made to defuze SB-33 mines in the field.
- SB-33 mines should be recovered, fully fuzed, and demolished within the minefield. A special demolition procedure should be developed to ensure complete destruction.
- Scientific analysis should be conducted to investigate the changes occurring within the mine detonators, including the causes.
- The effects of ageing on recovered mines and other significant ordnance⁴ continue to be monitored in future phases.
- Further data are needed on the location and circumstances of recovered mines in order to understand the factors affecting their condition. All contractors and authorities involved in demining operations should consider ways to collect such data without impeding clearance work.

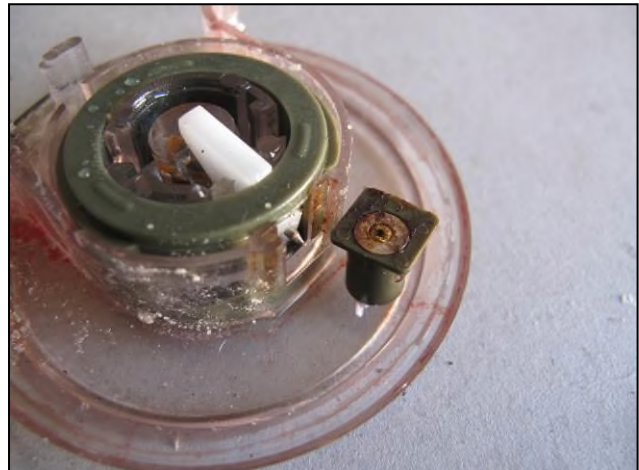
An SB-33 disassembled, showing the pin in the fired position and a hole visible in the detonator

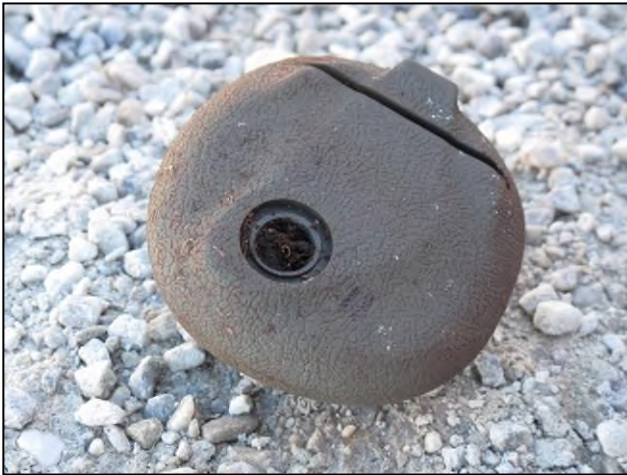
A further 4 mines were recovered with no detonator plugs present. It was initially assumed that these mines had been laid unarmed, without plugs, but examination showed that all had been actuated.

Several SB-33 mines had detonator plugs missing and were initially assumed to be unarmed

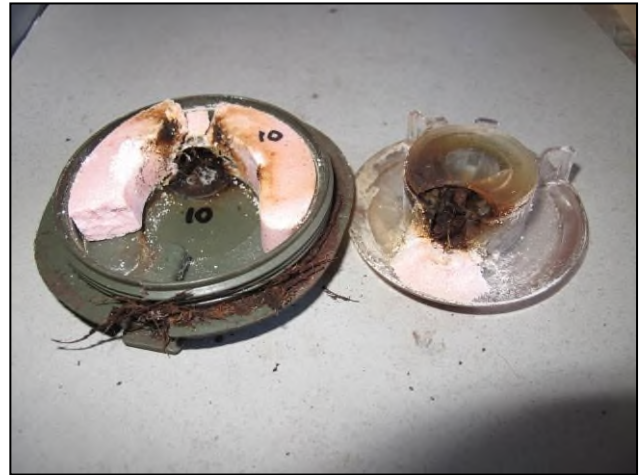
In each case, the detonator had exploded (ejecting the plug) but with insufficient force to initiate the main charge. The most likely explanation for this is deterioration of the detonators.

Examination revealed that the detonators had exploded, but failed to initiate the main charges
