Building Performance Assessment Protocol for Timber Dwellings – Conducting Thermography Tests on Live Construction sites

3.2 Building Performance Assessment (BPA) protocol – in-Construction Testing: Thermography iCT_Th

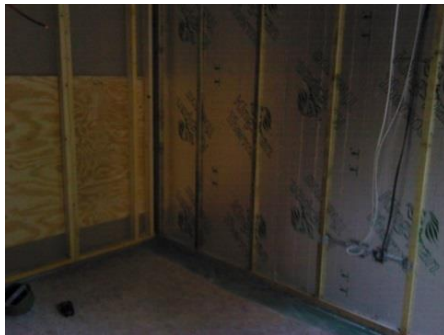
1st floor apartment – Internal view of external wall, North Façade (Bedroom)

Digital Image 1 illustrates the corner of one of the external walls which is North facing.

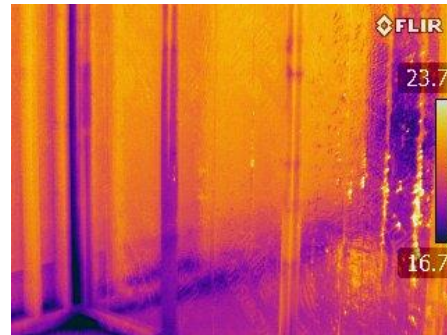
Thermogram 1 illustrates the overshadowing effect of the high reflective coating of the insulation

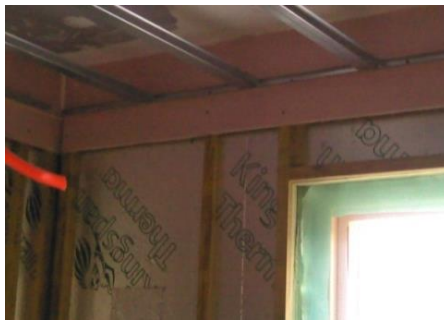
1st floor apartment – Internal view of external wall, West Façade. Ceiling to wall junction and window detail. (Bedroom)

Digital Image 2 Junction detail

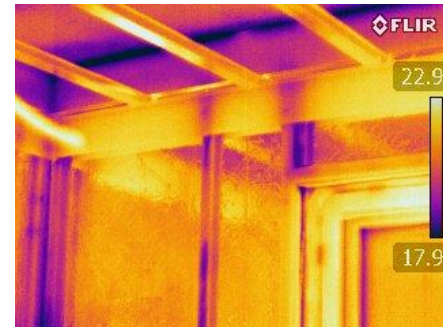
Thermogram 2 Junction detail
