Citation: Nezhad, H. Y. ORCID: 0000-0003-0832-3579, Egan, B., Merwick, F. and McCarthy, C. T. (2017). Bearing damage characteristics of fibre-reinforced countersunk composite bolted joints subjected to quasi-static shear loading. *Composite Structures*, 166, pp. 184-192. doi: 10.1016/j.compstruct.2017.01.029

Bearing Damage Characteristics of Fibre-reinforced Countersunk Composite Bolted Joints Subjected to Quasi-static Shear Loading

Hamed Yazdani Nezhad, Brian Egan, Fiachra Merwick, Conor T. McCarthy

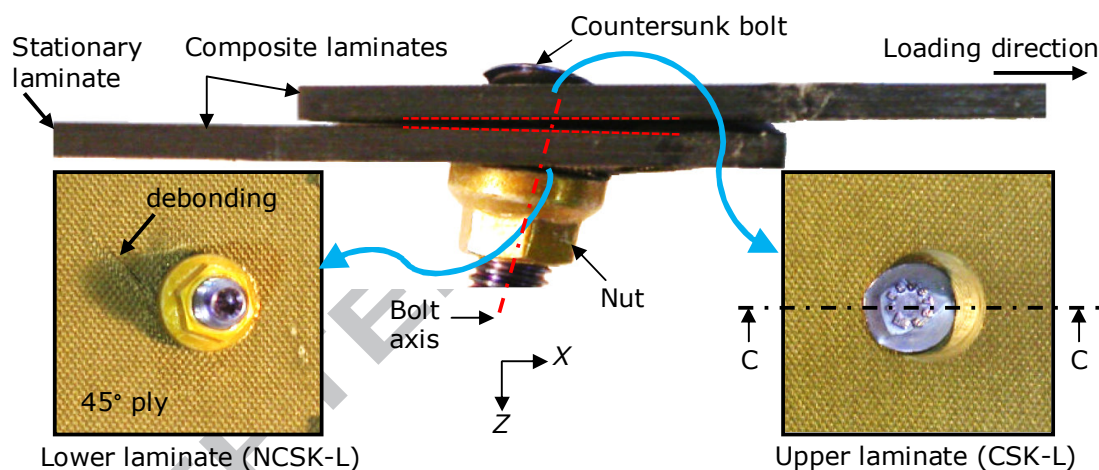
In the quasi-static tests of the CBJ specimens, fastener pull-through, fastener failure and bearing damage were observed as final failure modes. Figure 2 shows the single-bolt CBJ failed by a combination of the bearing failure and fastener pull-through. Extensive bearing damage was observed in all tests until very late in the loading history prior to fastener failure. Some fibre-matrix cracking/debonding can be observed in NCSK-L close to the composite-nut interaction (see inset to Figure 2). However, the main source of damage in the joints was extensive bearing damage at the countersunk hole, which occurred prior to final catastrophic failure. This was to be expected as the joints were designed to initially fail in bearing [15]. The dashed line C-C represents the section where cut through CSK for microscopic studies presented later.

Figure 2: Combination of bearing and bolt failure in single-bolt CBJ. Dashed line C-C represents cut-through section for microscopic studies

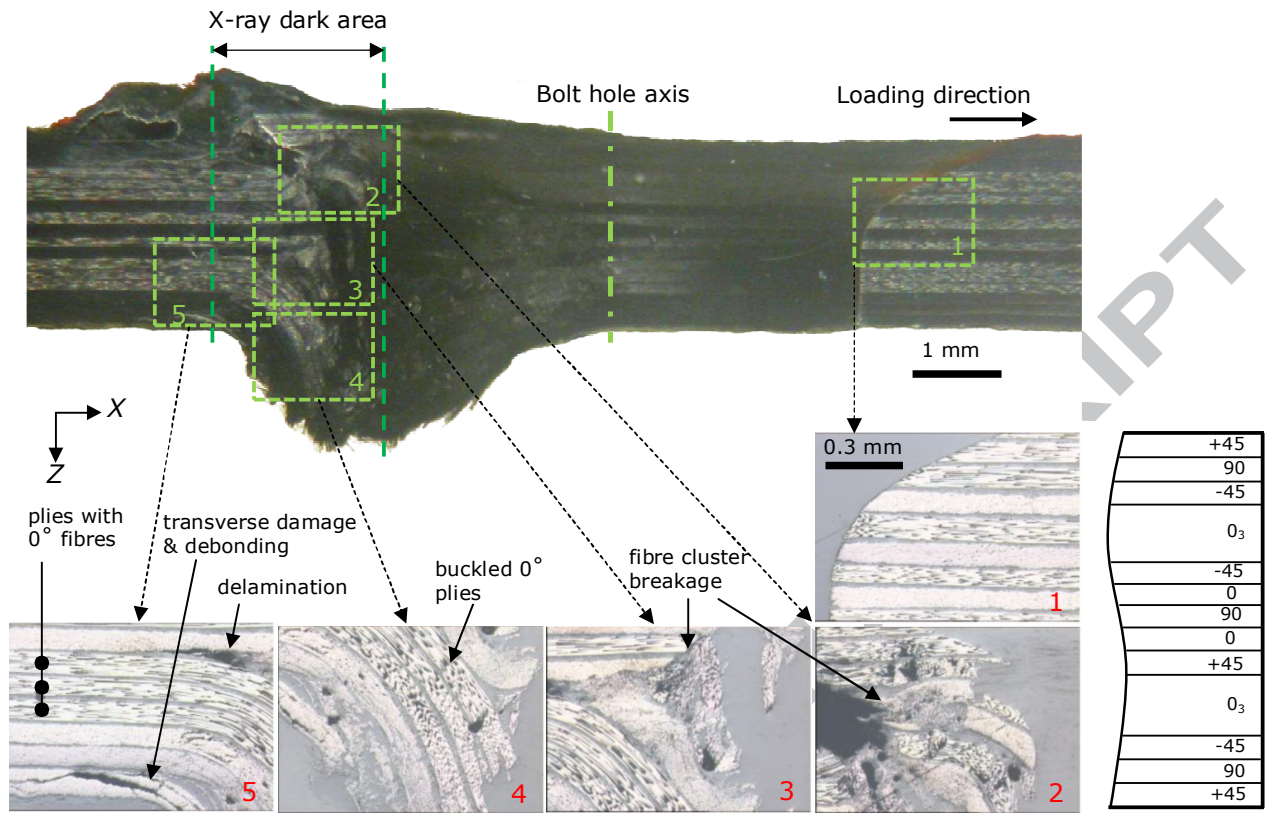
The bearing damage in the microscopic image of Figure 4 is seen to consist of combined inter/intra-laminar damage to include fibre breakage and buckling under compressive load from the bolt, matrix damage, fibre-matrix debonding and delamination. The locations of interest are magnified in regions (1) to (5). Region (1) shows the furthest right-hand side of CSK-L where no damage is observed, expected due to having no contact with the bolt. Fibre buckling and breakage is observed in regions (2), (3) and (4) where the compressive stress was introduced by the fastener. Region 5 is located further from these local regions, where inter-laminar delamination occurred between plies 6 and 7, from bottom, in this region between (0° and 45° fibre orientations). This delamination follows from the combined damage seen in region (3). In region (5) an extensive fibre-matrix debonding occurs in the bottom (45°) ply. Transverse matrix damage is also visible. No in-plane or delamination damage was observed in the regions extending beyond region 5.

As seen in Figure 4 and Figure 5, X-ray has not captured damage *beyond* the countersunk edge which consists of debonding and delamination with no indication of fibre breakage. However, *within* the countersunk edge and also within the X-ray dark area, the combined damage occurred consisting of significant fibre buckling and breakage.

Figure 4: Damage in single-bolt CBJ's CSK

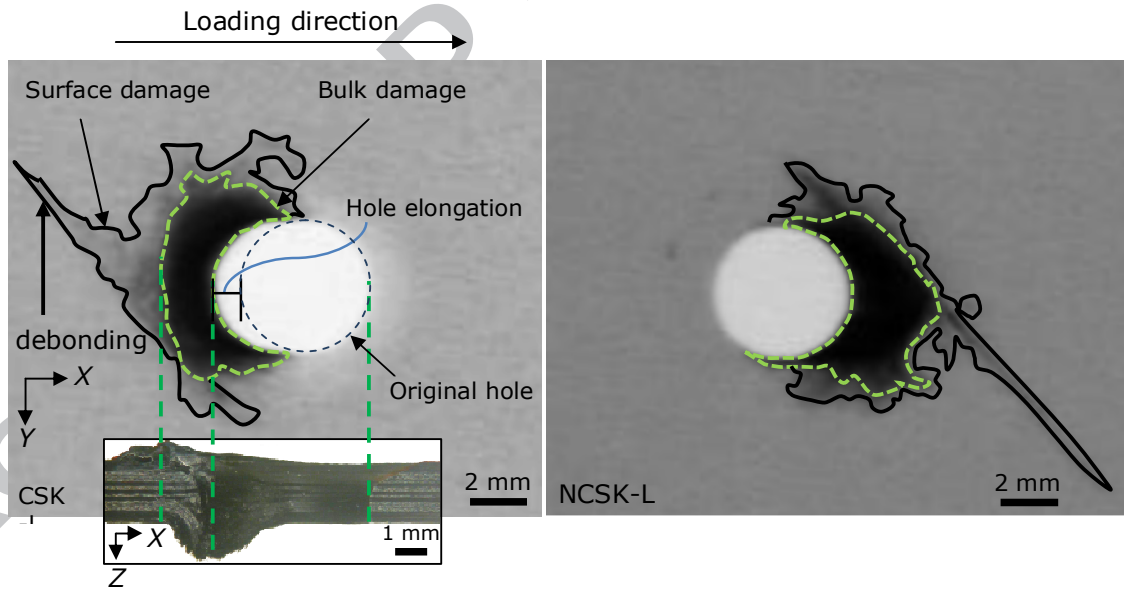
Figure 5, showing the image for CSK and NCSK parts at joint extension of approximately 2 mm, where ultimate failure occurred (the ultimate strength is 816.7MPa). Hole elongation is evident in CSK due to compressive bearing damage, but no apparent elongation was observed in NCSK-L. The evident elongation in CSK is attributed to further compressive deformation introduced by the countersunk head of the bolt to the CSK material and area that has already been reduced due to insertion of the countersunk (hole elongation in Figure 5 is 15% at the joint maximum load.). The joint is orientated with the 0° fibre direction coinciding with the loading direction. Two major damage regions are identified in the X-ray image: 'dark' and 'bright' representing regions, respectively, with extensive and mild damage. The region with the near-surface damage (surrounded by the solid line) is not sharply captured in the X-ray image as opposed to the *dark* region within the dashed line where damage occurs within the bulk of the laminate. Damage beyond the countersunk region is attributed to the surface damage, and occurred by the bolt head crushing into the laminates and friction between the CSK and NCSK parts. This is consistent with the optical observations in Figure 4 where beyond the edge of the dark region surface damage, and not the bulk damage, is dominant.

Figure 5: X-ray image of single-bolt CBJ (inset: optical image taken from Figure 4)

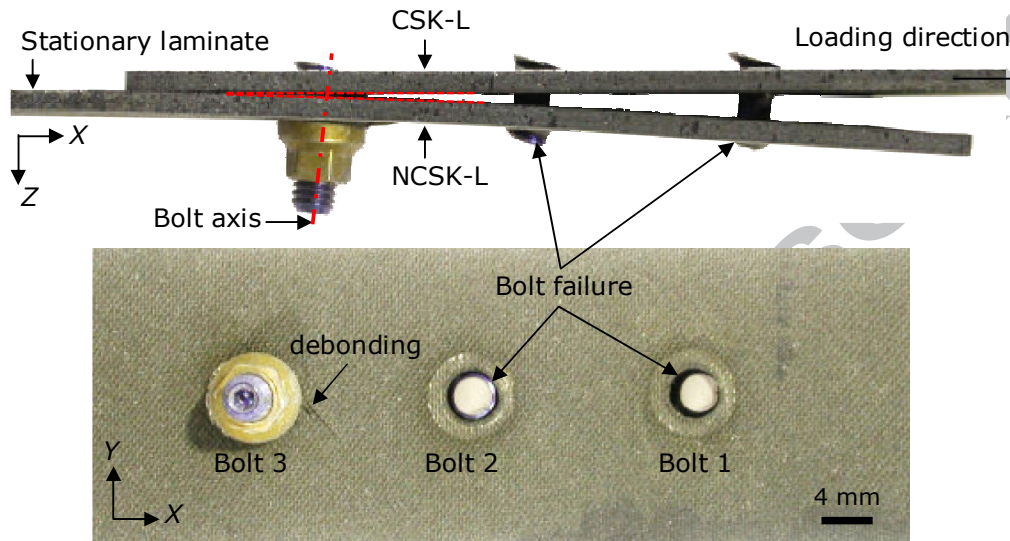
Figure 6 shows the three-bolt CBJ after failure in which bolt failure is the final dominant failure mechanism. Note that the third bolt in the figure also failed but was not fully separated from the joint. Two bolts closest to the loading edge end (bolts 1 and 2) failed after significant bearing damage development.

Figure 6: Combination of bearing and bolt failure in three-bolt CBJ

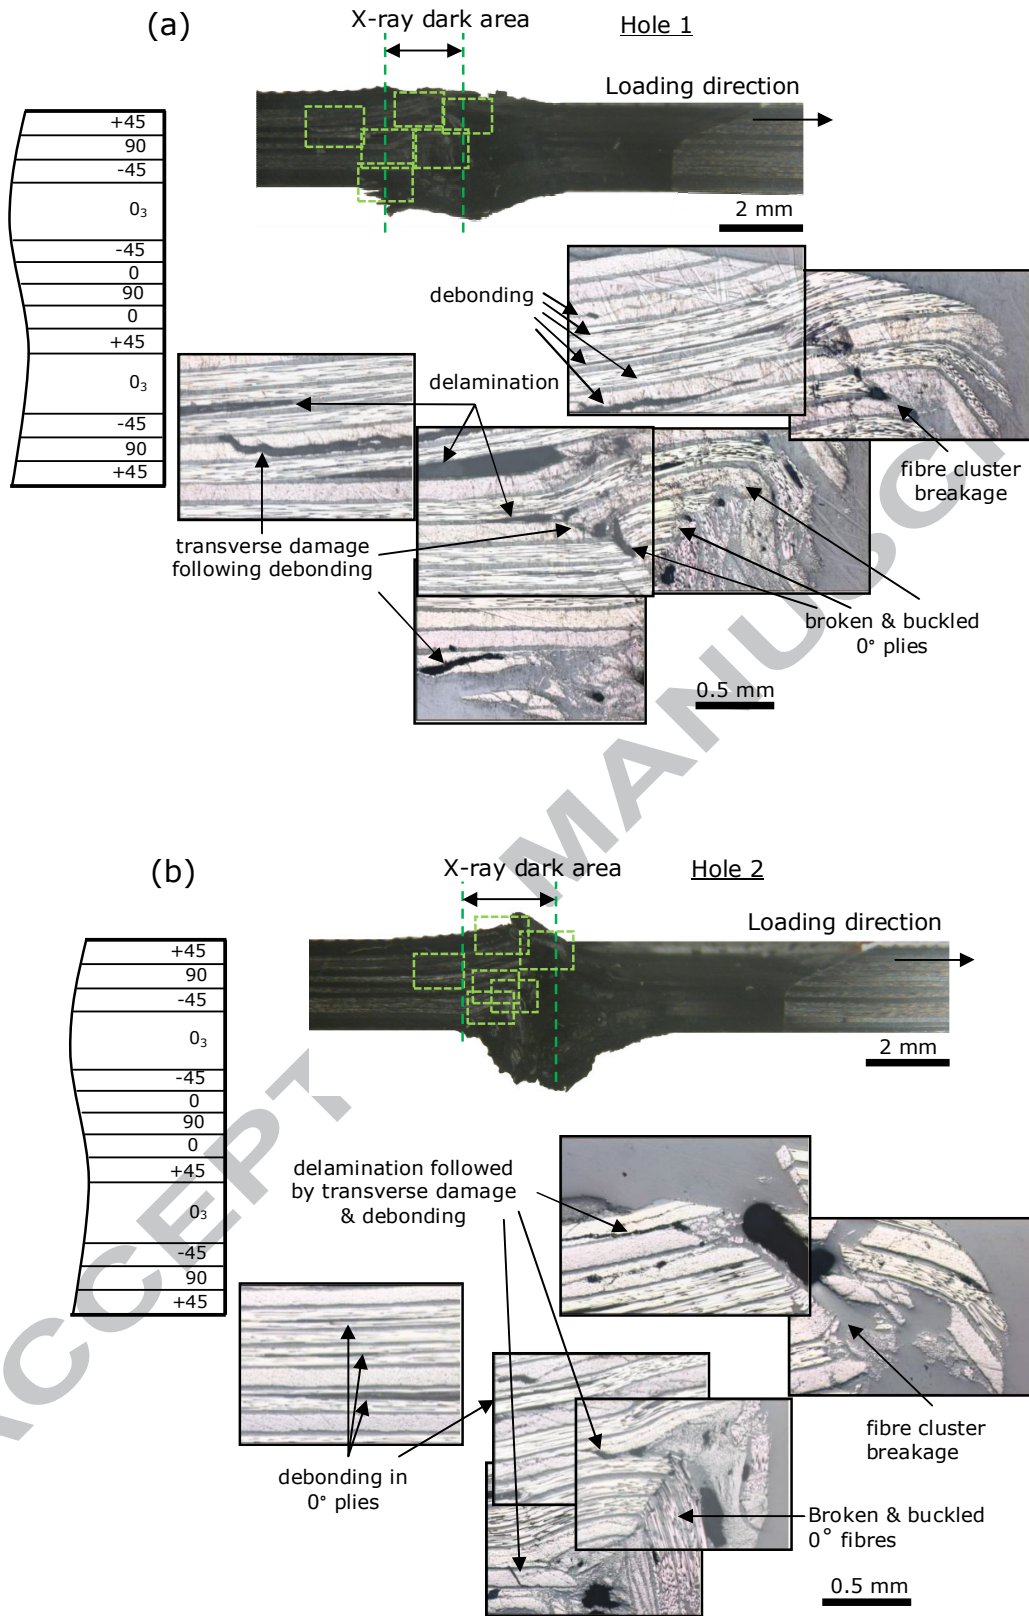
Severe buckling of 0° plies under compressive load is apparent in the three-bolt CBJ shown in Figure 8. For the single-bolt case (Figure 4), the 0° plies were also buckled in compression when the peak load was taken up to 8.3kN. Hence, assuming that in-plane damage is dominant, two simple statements can be derived for the CBJs examined here: 1- fibre buckling and breakage dominantly determine the load where ultimate failure occurs, and 2- 0° fibre buckling and breakage is present when the peak load ≥ 8.3 kN.

Figure 8 also shows delamination followed by slight transverse matrix damage between 0° and 45° plies (in mid to bottom plies) as was also observed in single-bolts (6th and 7th plies from bottom in Figure 4). Similar to the single-bolt CBJ, the region where delamination occurred was not captured inside the X-ray dark region and neither the fibre-matrix debonding occurred at the bottom plies.

Figure 8: Damage in three-bolt CBJ's CSK; (a) Hole 1, (b) Hole 2

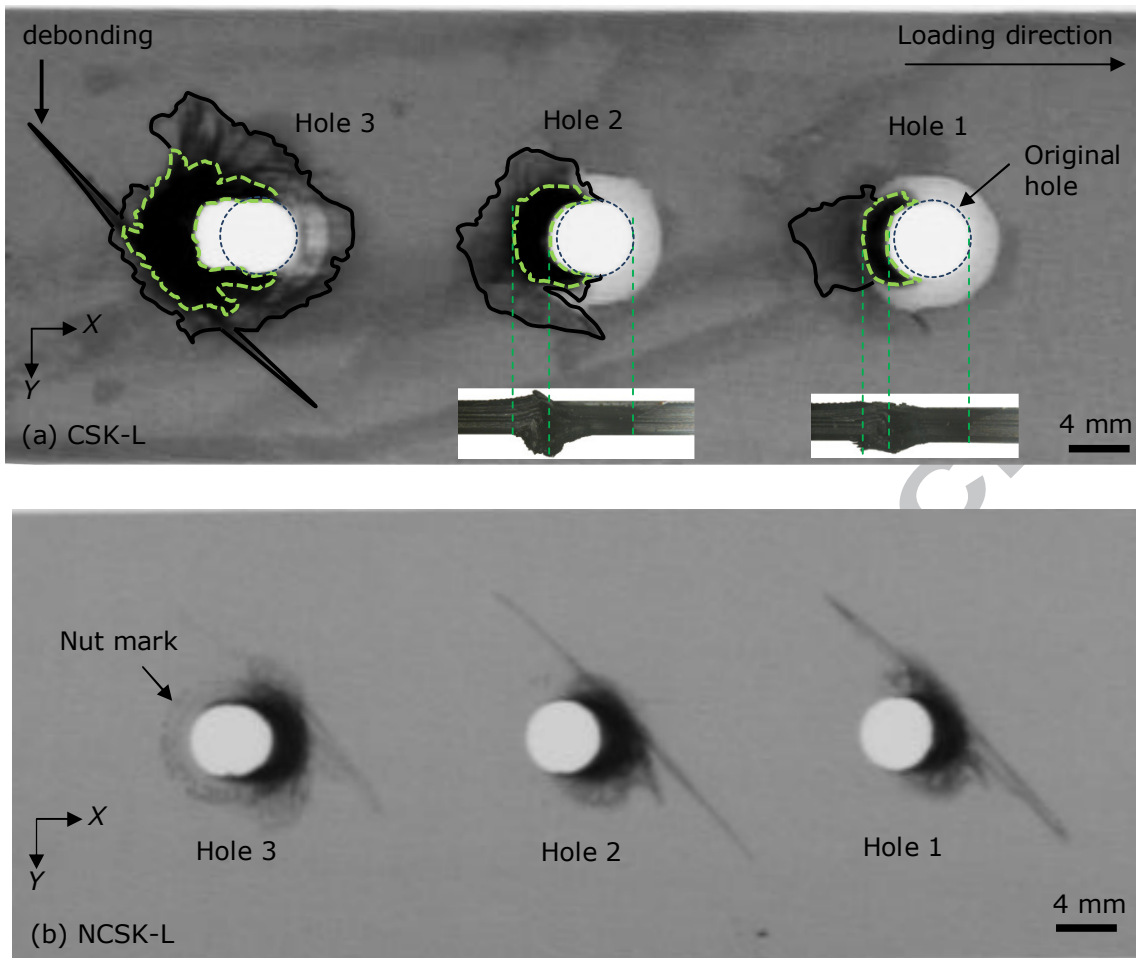
Figure 9: X-ray image of three-bolt CBJ using X-ray, (a) CSK-L, (b) NCSK-L

As seen in Figure 9(a), damage area in the CSK part is largest at Hole 3 and smallest at Hole 1, while damage at each bolt-hole in the NCSK laminate in Figure 9(b) is almost identical. This difference in damage area is attributed to the presence of countersunk head crushing into the top surface of the CSK laminate, as was clearly observed during testing. This observation is in stark contrast to what is observed in protruding head bolted joints, where damage is anti-symmetric, meaning that damage at Hole 1 in one joint member is normally equal to damage at Hole 3 in the opposite joint member [16, 17]. This loss of anti-symmetry means that countersunk bolted joints must be analysed fully at each bolt-hole, and that simplifying extrapolations derived from single-bolted joint tests must be used with caution. We thus now offer a new method to predict the damage growth in CSK joints based on the concept of damage areas.
