Geometrical and geotechnical characterization of the earth fissures appeared in the Guadalentín Valley (southeastern Spain) after the September 2012 flooding

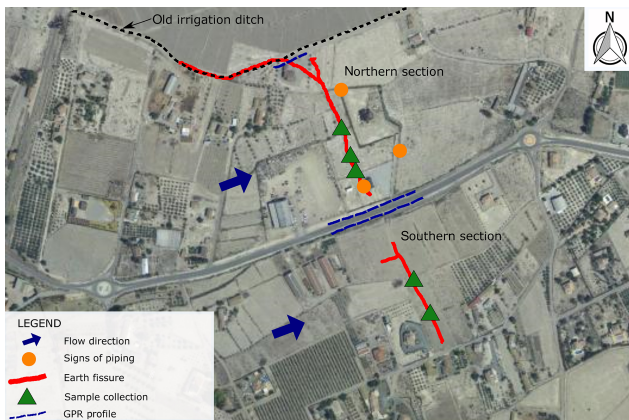
Figure 1. Location of the Puerto Lumbreras earth fissure and the locations of signs of piping and sample collection (modified from Mulas, 2013). Orthophoto from PNOA 2019 CC-BY scene.es.

The mapping of the Puerto Lumbreras earth fissure is shown in Fig. 1, modified from Mulas (2013). This figure shows the distribution of the fissure that appeared when waters receded on a very flat land. The main crack was about 400 m long and was perpendicular to the main flow of the flood, except for the northern section of the crack where it was nearly parallel to the flow. The crack presented a main NW–SE orientation (N150E) that changes to E–W in the northern section.

It is important to point out that the continuity of the earth fissure was disrupted by the road located at the center of the figure, which presents a lower elevation. The orange points in Fig. 1 indicate those locations in which signs of piping were recognized in the field (Fig. 2), and the green triangles indicate the locations from which soil samples were collected to be tested later in the laboratory.

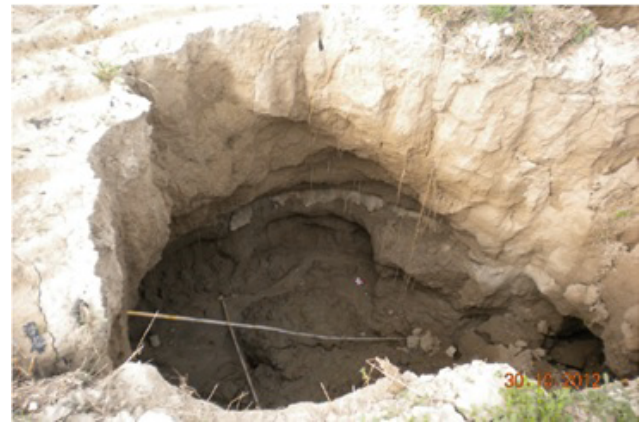
Figure 2. Signs of piping along the fissure. Soil erosion caused by water beneath the surface of the ground creating an underground tunnel.

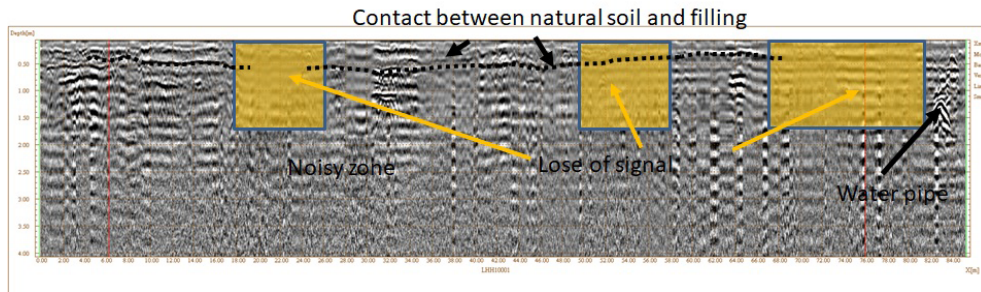
Figure 3. Ground-penetrating radar along the ditch beside the road.

During the field inspection, a damaged ditch was observed beside the aforementioned road after the flooding. This road was approximately parallel to the main flow of the flood and some erosion was clearly observed below the ditch.

A GPR was used along the ditch beside the road to analyze what was beneath the concrete (Fig. 3). The contact between the natural soil and the filling is observed in this figure. A water pipe was also detected, as well as some loss of signal that can be due to soil erosion. However, no good information was obtained below 1.5 to 2.0 m, probably due to the silty clay composition of the soil. Figure 4 shows an aerial view of the northern section of the crack and the runoff flow direction. Note how the fissure intersects and surrounds the building. Figure 5 shows the location in which the direction of the fissure changed from NE–SW to E–W. The aperture of the fissure can be seen in this figure. The fissure showed rough and vertical sides with a maximum depth of 3.7 m and a maximum aperture of 2.7 m.

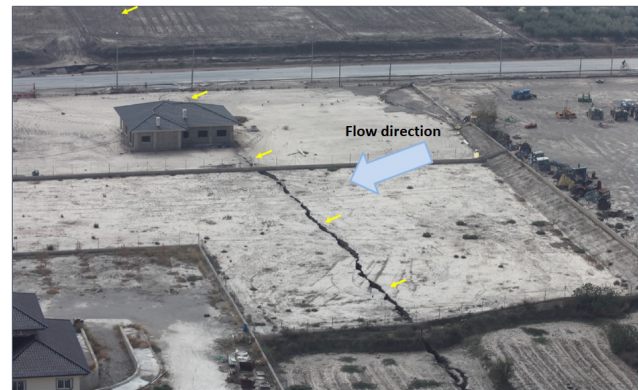
Figure 4. Aerial view of the northern section of the crack (courtesy of Puerto Lumbreras City Council). The yellow arrows indicate the location of the earth fissure (modified from Mulas, 2013).

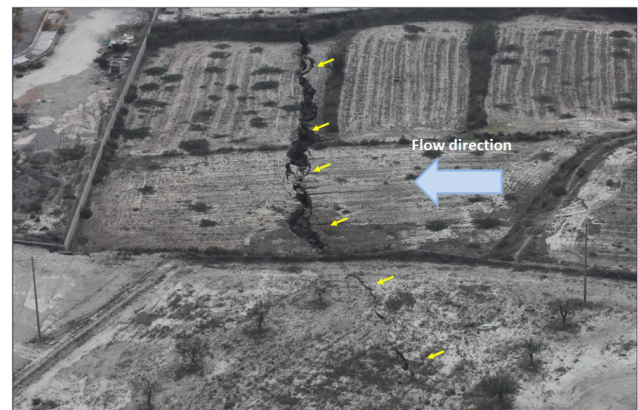
Figure 5. Aerial view of the third and second northern sections of the crack (courtesy of Puerto Lumbreras City Council). The yellow arrows indicate the location of the earth fissure (modified from Mulas, 2013).

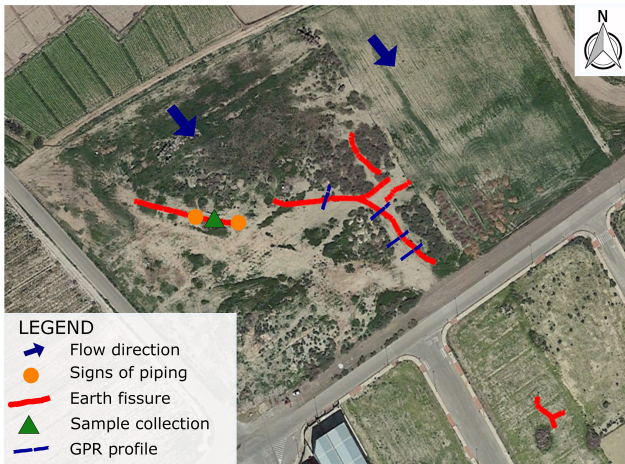
Figure 6. Location of the Totana earth fissure and the locations of signs of piping and sample collection. Orthophoto from PNOA 2019 CC-BY scene.es.

Regarding the Totana earth fissure, the location and distribution of the fissure observed when water receded can be seen in Fig. 6. Figure 7 shows a view of the fissured that appeared in Totana. The fissure appeared on a flat land and was discontinuous and ramified. Both soils, in Totana and Puerto Lumbreras, have a similar origin and a distal alluvial fan, although the age of the soils in Totana is older than in Puerto Lumbreras, Late or Upper Pleistocene (more than 10 000 years ago) in Totana and Holocene (less than 10 000 years ago) in Puerto Lumbreras. Some signs of piping were also observed in this fissure and one sample was collected at the site to test it later in the laboratory. The results of the tests show sand, silt and clay of 25 %, 53 % and 22 %, respectively. The liquid limit was 31.8 and the plasticity index 8.3. Therefore, the soil was classified as a low-plasticity silt (ML) according to the USCS. The results to assess the soil dispersion (crumb, double hydrometer and pinhole tests) showed a non-dispersive soil.

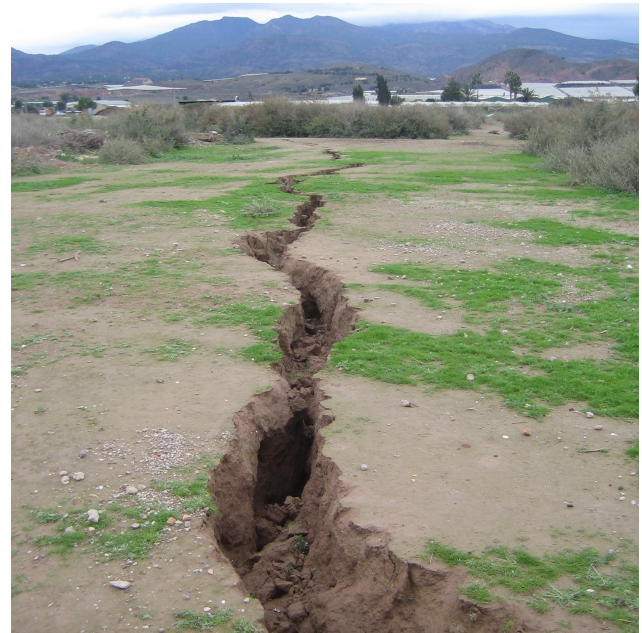
Figure 7. Image of the fissure that appeared in Totana.

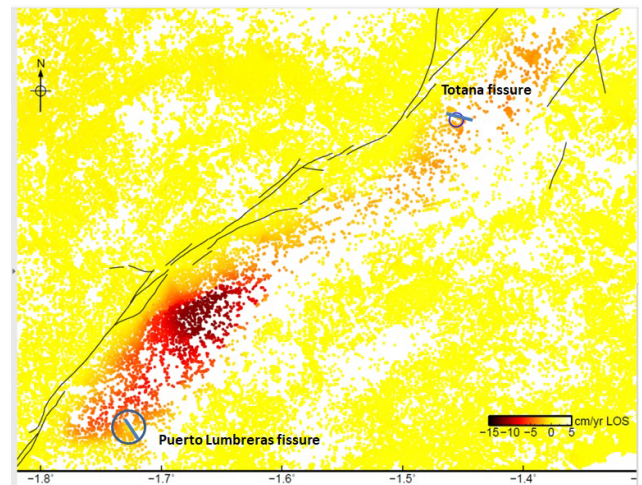
Figure 8. Locations of both fissures on the SAR interferometry deformation map of the Guadalentín Valley from Envisat 2003–2010. Continuous black lines represent surficial faults.

an Envisat dataset covering the period 2003–2010, where the location and main direction of the fissures have been drawn. As can be seen, both fissures are located near the edge of the subsidence bowl. It is worth pointing out that this valley presents the highest subsidence rate due to groundwater extraction in Europe, with accumulated settlements up to 2.5 m from 1992 to 2012 (Bonì et al., 2015).

The direction of one of the main geological structures of the Guadalentín Valley can be seen in Fig. 8. The other main direction is perpendicular to the first one (Cerón, 1997). Therefore, the directions of both fissures are approximately

parallel to one of the directions of these main geological structures or faults in this area.
