## 281. Catastrophic deformations of Weller endoprosthesis heads

Janusz CWANEK<sup>1</sup> and Andrzej Antoni CZAJKOWSKI<sup>2</sup>

**Keywords:** Weller endoprosthesis, catastrophic wear of metal endoprosthesis heads

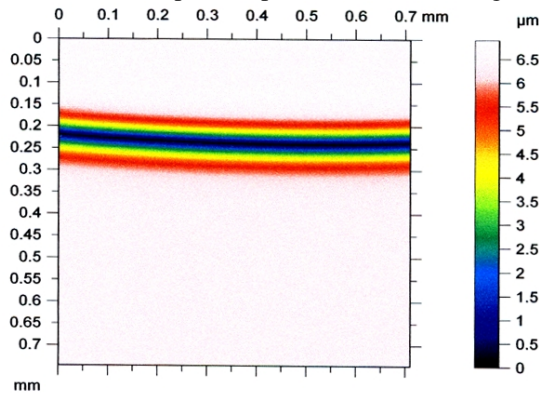
The characteristic picture of deep and continuous scratch on the surface of Weller endoprosthesis head exploited by 12 years is shown on the contour plot (Fig. 1).

Fig. 1. Contour plot of a deep and thin scratch on the surface of Weller endoprosthesis head

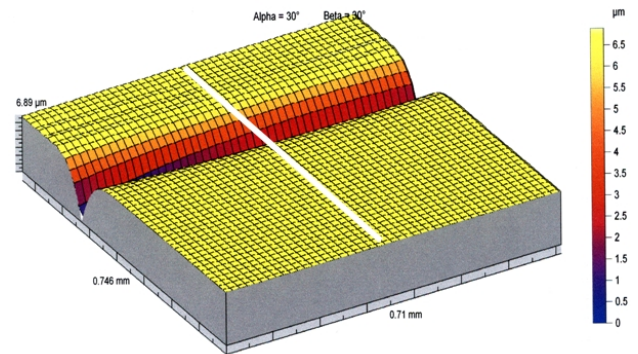
The picture of irregularities of metal head surface is presented on the figure 2.

The presented scratch is deep and has steep edge. The depth of the scratch has about 6  $\mu\text{m}$ . Intersection of the scratch, in the pointed place visible on the figure 2, is

Fig. 2. Structure of a deep and continuous scratch on the surface of Weller endoprosthesis head with pointed place of intersection

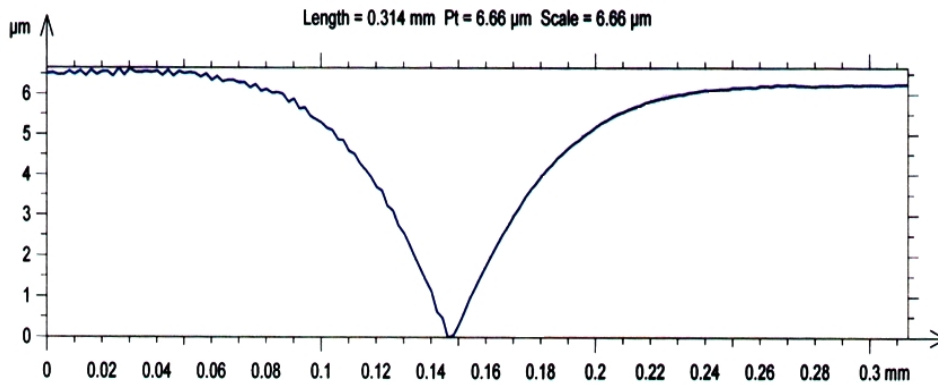
illustrated on the figure 3.

Fig. 3. Intersection of a deep and continuous scratch on the surface of Weller endoprosthesis head at the pointed place on figure 2

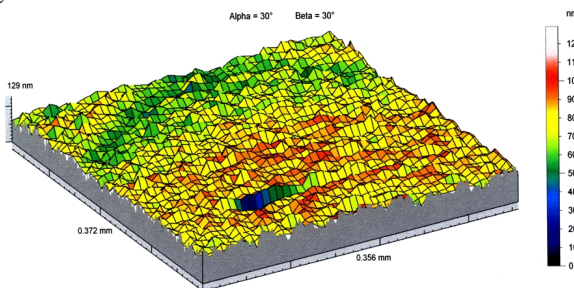
The geometry of surface of exploited Weller endoprosthesis head, outside scratch limits, presents a picture of ideal smoothing surface. The parameter St has value about 120 nm.

Fig. 4. Geometrical configuration of a surface of Weller endoprosthesis head outside scratch limits

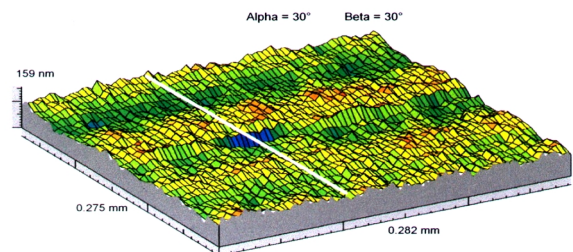
The characteristic picture of not very deep and discontinuous scratch on the surface of Weller endoprosthesis head exploited for 8 years is shown on the figure 5. Moreover intersection of the scratch is illustrated on the figure 6. The presented scratch was a few times deep in compare with the biggest high of surface irregularities of Weller endoprosthesis head, but it was considerable shallower from the scratch shown on the figures 1-3.

Fig. 5. Picture of not very deep and discontinuous scratch on a surface of Weller endoprosthesis head at the pointed place of intersection

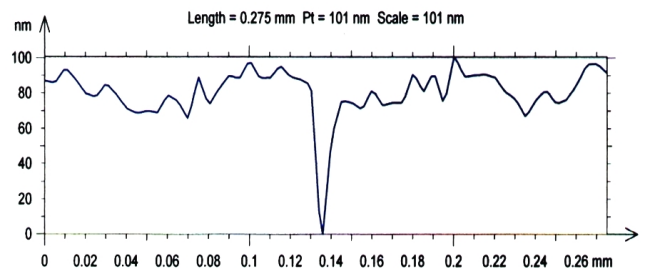
Fig. 6. Intersection of discontinuous and not very deep scratch on the surface of Weller endoprosthesis head at the pointed place on figure 5
