1046. Blades rubs and looseness detection in gas turbines – operational field experience and laboratory study

Leong M. S.¹, Lim Meng Hee²

¹Institute of Noise & Vibration, Universiti Teknologi Malaysia, Malaysia

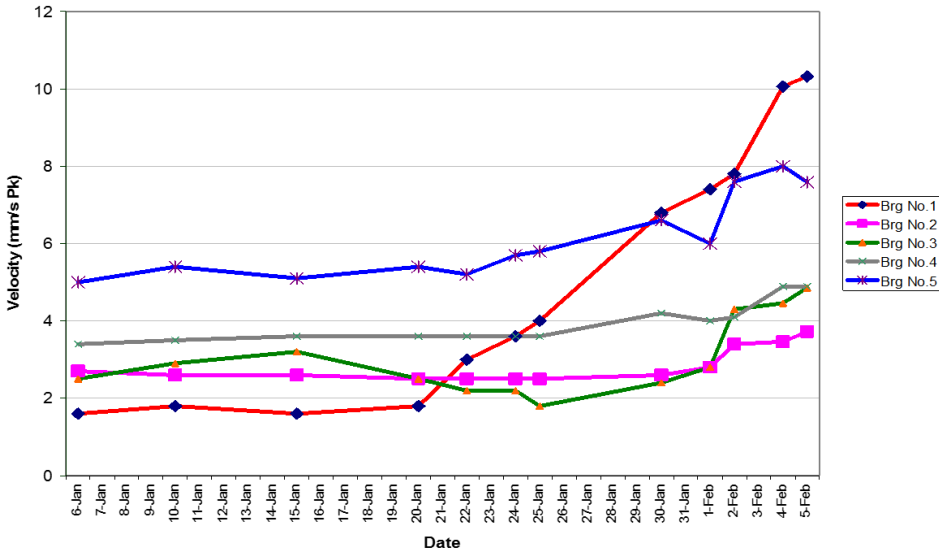
Fig. 2 shows trends of the x1 synchronous component for bearing casings in vertical direction over a month time span leading to the impending failure. Bearing (Brg.) No. 1 (compressor non-drive end), No. 3 (turbine drive end) showed marked increase over the latter two weeks period. Vibration levels in the four months period prior to this were less than 1 mm/s for bearings No. 1 and 3, and 3.3 mm/s for bearing No. 5 (generator non-drive end). The alarm limit was 12 mm/s and trip level at 25 mm/s (0-Pk). The synchronous amplitude and phase angle plots with speed

Fig. 2. Casing overall vibration levels as a cracked shaft was developing

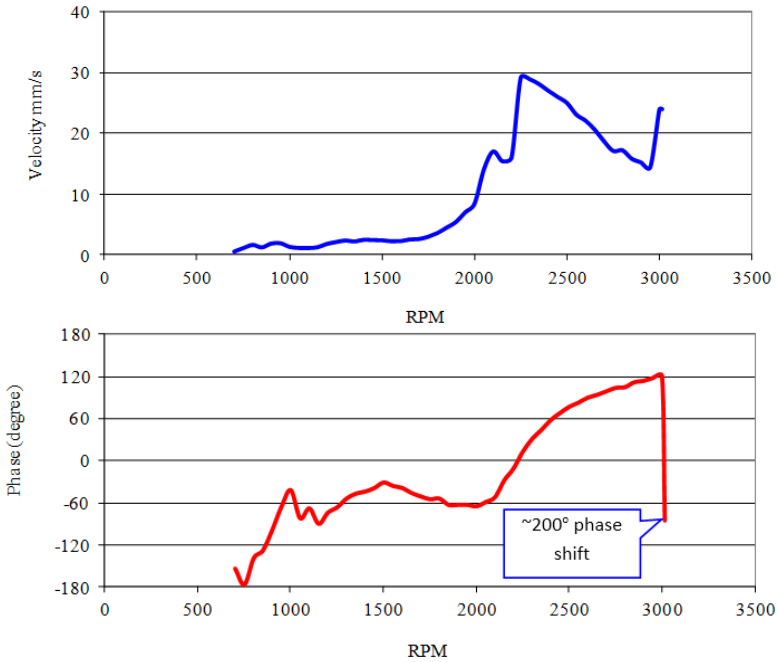
Fig. 3. Run up vibration amplitude (x1 RPM) and phase angles vs. RPM

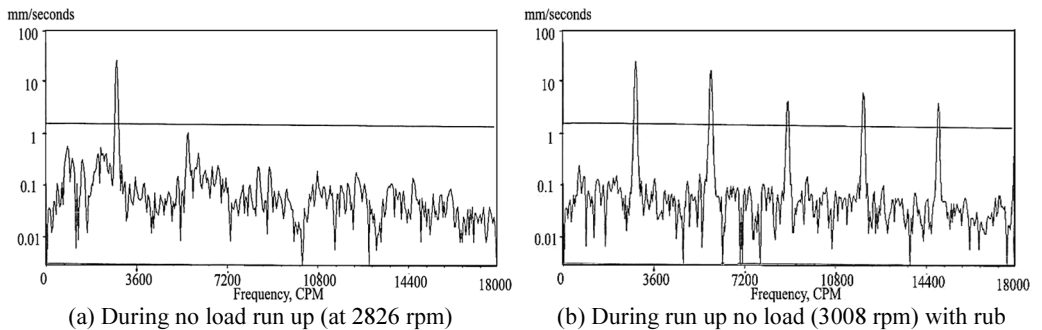
The vibration spectra during the run up past the first critical speed until the second critical speed were dominated by the synchronous x1 RPM component (see Fig. 4a). Vibration amplitudes however increased substantially as the second critical of 2280 rpm was approached. At this stage, high harmonics of x2, x3 and x4 rpm were noted (Fig. 4b). This suggested a rotor rub at the second critical had occurred due to excessive amplification at the second critical speed. After passing the second critical, vibration levels dropped with less prominent harmonic components. This

suggested the rub being relieved at this point in time. As the unit approached full speed no load (FSNL) conditions at ~3000 rpm vibration levels were below the trip limit.

Fig. 4. Vibration spectrum during run up (before and rub)

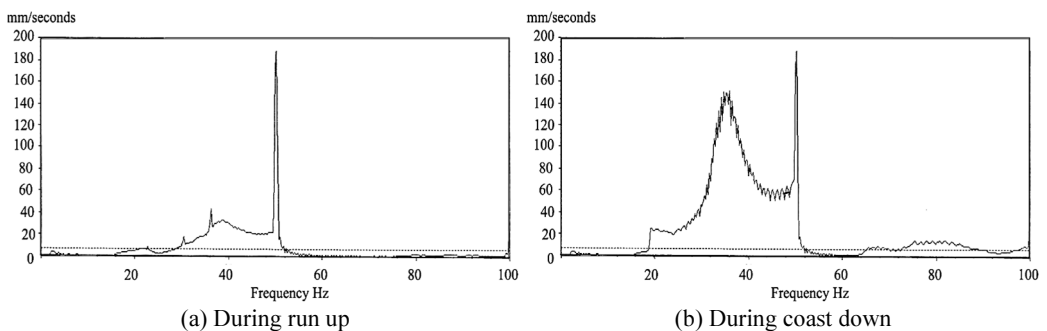
During the coast down, the dynamic amplification at the second critical was more severe as compared to the run up; Fig. 5a and b. The vibration response in the vertical directions was significantly higher than response in the horizontal direction particularly in the compressor NDE (Brg. 1) and turbine DE bearings (Brg. 3). A cracked shaft and/or thermally bent shaft were suspected to the root cause of the increasing vibrations particularly at the compressor bearing. A full rub was thought to have occurred as the unit passes through the second critical, with further development of a thermal bent shaft aggravating the problem which explained the severe excursion.

Fig. 5. Peak hold spectra during run up and coast down after a rub (bearing 1 vertical)

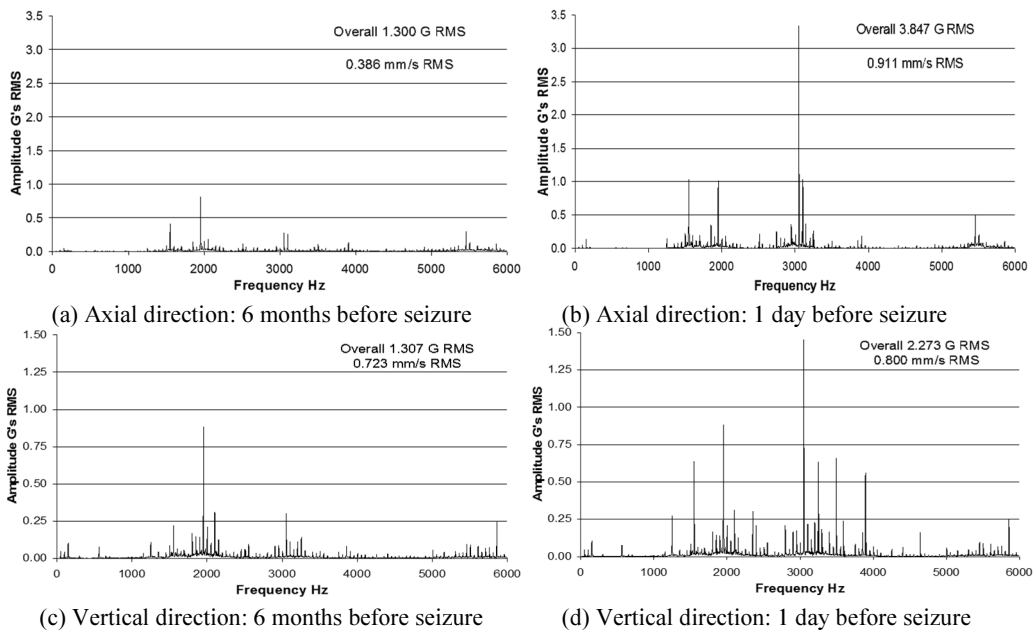
Fig. 6. Acceleration spectrum as measured on bearing 6 months and 1 day before shaft seizure

Typical vibration spectra on the generator drive end bearing casing undertaken six months earlier are given in Fig. 6a and c. Vibration spectra at the same location under suspected fault condition are given in Fig. 6b and d. Comparison of the spectrum showed distinct increase in specific blade passing frequencies (BPF), and with increased side bands of the BPF at intervals of the synchronous rpm. BPF at 3050 Hz, 3250 Hz, 3850 Hz and 3900 Hz were exceptionally high in vertical axis. Measurements in axial axis showed that the BPF of 3050 Hz was extraordinary high. Multiple harmonics of 3400 Hz, 3500 Hz, and 3600 Hz were also noticeable. The BPF of 3050 Hz (corresponding to compressor blades row 11, 12 and 14) in the vertical and axial directions showed increase with standard deviations as high as 13 times. For BPF of 3250 Hz (row 13), an equally high amplitude exceeding 28x standard deviations was noted. Other BPF of 3850 Hz (row 15-21) and 3900 Hz (stator blades row 15-20) also increased above 7x standard deviation. Trends of the BPFs are shown in Fig. 7.

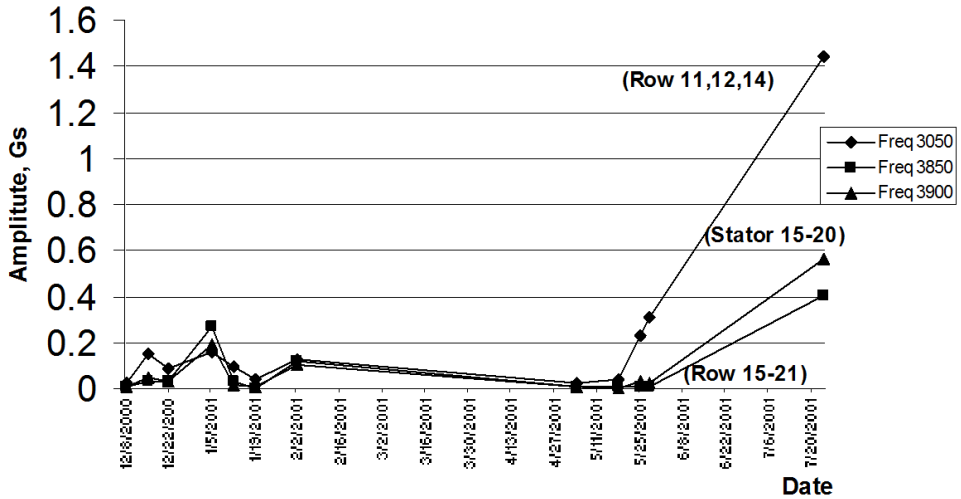
Fig. 7. Trending of selected blade pass frequencies

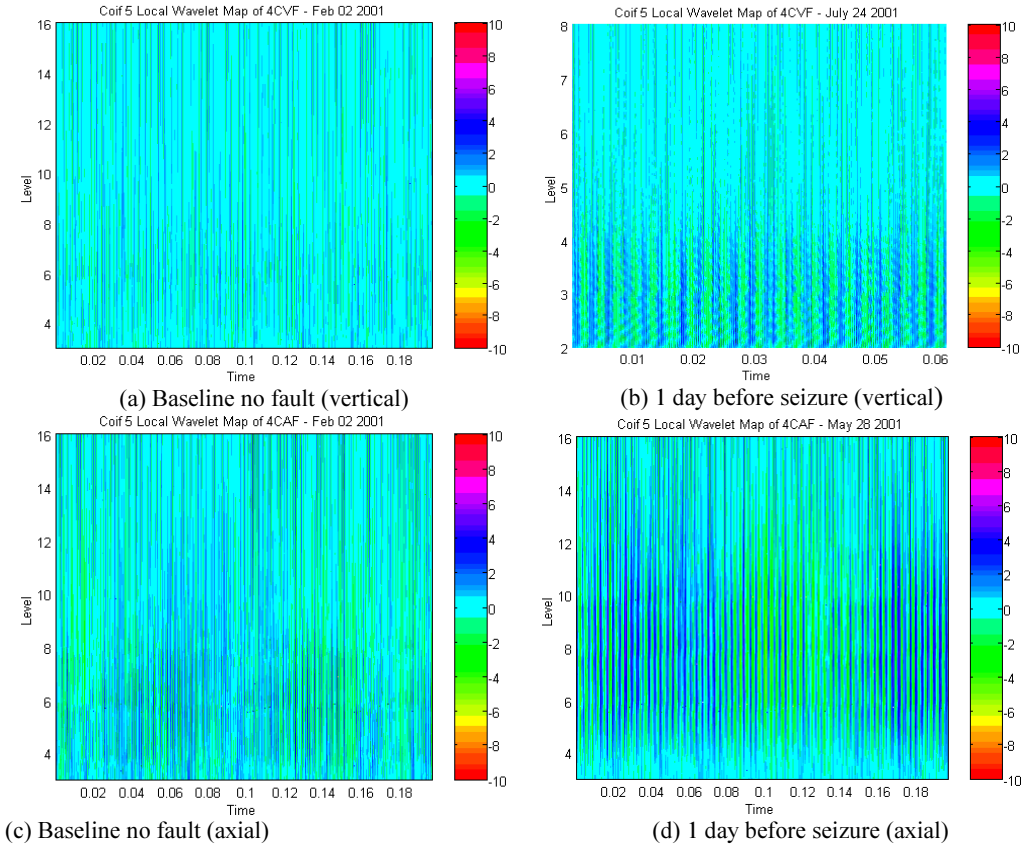
Extending the BPF analysis for the blade rubs, wavelet maps were also derived using time series data of the same measurements. The wavelet maps for the case prior (to fully developed fault) and during rub conditions are shown in Fig. 8 below. The wavelet maps under blade rub conditions did demonstrate noticeable changes.

Fig. 8. Local wavelet at time of increased BPFs leading up to shaft seizure

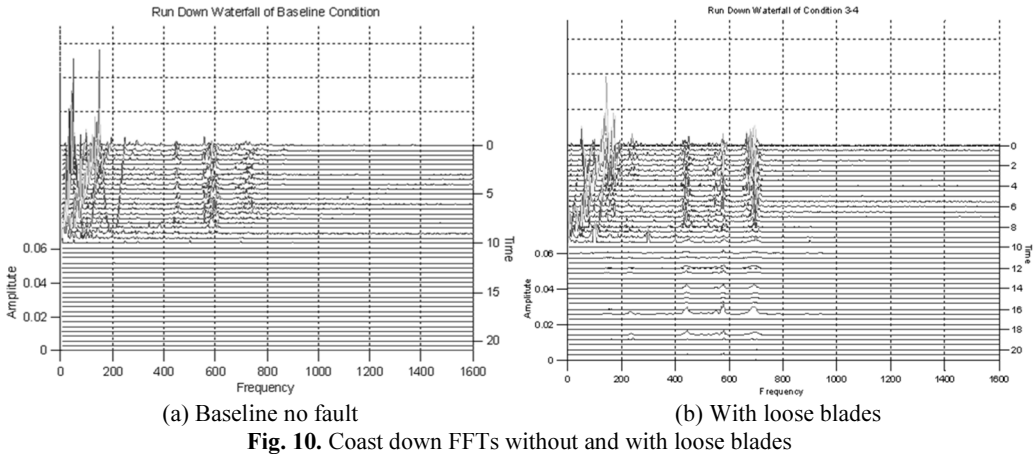
Fig. 10. Coast down FFTs without and with loose blades

Fig. 10 shows a cascade plot of FFTs spectra as the rotor coast down from operating speed to stationary conditions. The plots showed no discernable differences that suggested any abnormality in the vibration response between no fault conditions with the case having induced blade looseness. In the baseline condition (no fault), the coast down wavelet map was clean, Fig. 11a. Fault conditions with blade looseness showed distinct changes in the coast down wavelet, Fig. 11b. Looseness severity, the number of loose blades, as well as configuration of the loose blades governed the time duration of consecutive impacts and severity level of the wavelet maps. This finding was in good agreement with the finding of Aretakis et al [7] that the wavelet analysis allows local features and hidden details of a signal to be identified that may make it useful for condition monitoring when detection of small dynamic changes is important.

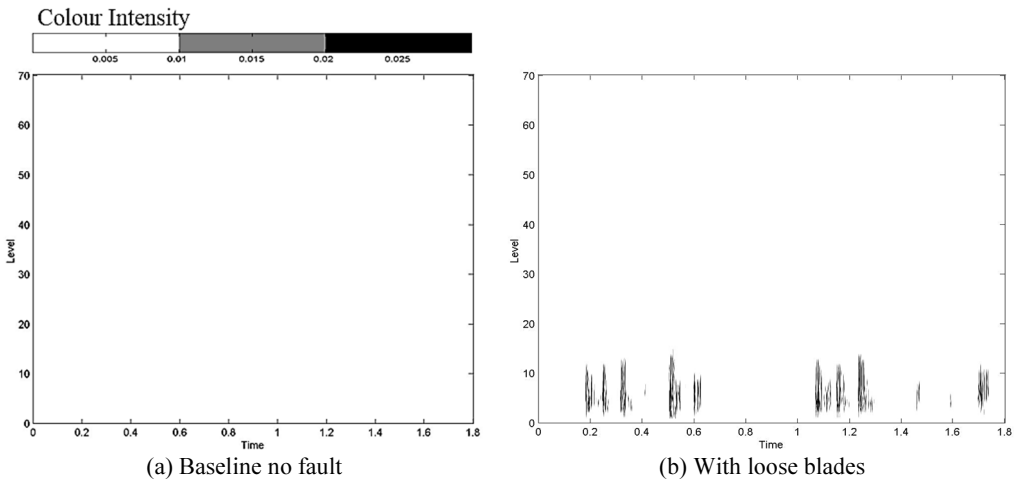
Fig. 11. Wavelet maps without and with loose blades
