Failure of two overhead crane shafts

Faculty of Electrical Engineering, Mechanical Engineering and Naval Architecture; University of Split; Split, Croatia

Abstract

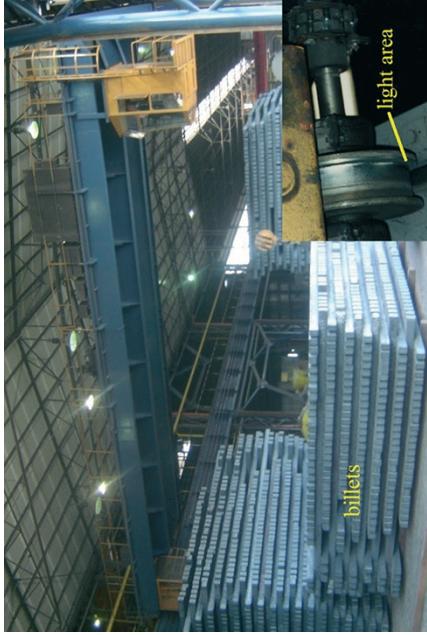
Fig. 1. Overhead crane for transport of billets

ture examination of the wheel and rail revealed smooth and light contact area on the sides of both parts due to mutual rubbing, detail in Figure 1, which was caused by additional torsional load. Post-failure verification of parallelism and straightness of the rails with optical instrument revealed misalignment in parallelism and straightness.

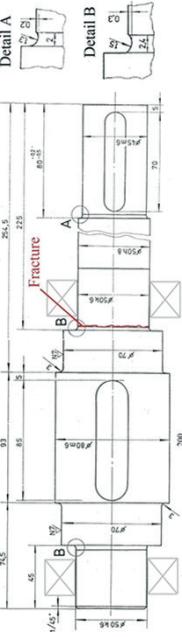
tigue. The primary cause of the fracture was the bending load during the rotation, although the total load was a combination of bending and torsional loads. The small radius of the fillet at a change in shaft diameter, detail B in Figure 3, resulted in high stress concentration, which initiated the crack.

Fig. 3. Stepped drive shaft

due to change between two different diameters of the shaft approximately 225 mm from the driven end and approximately 30 mm from one end of the keyway where the crane wheel was keyed to the axle, Figure 3.

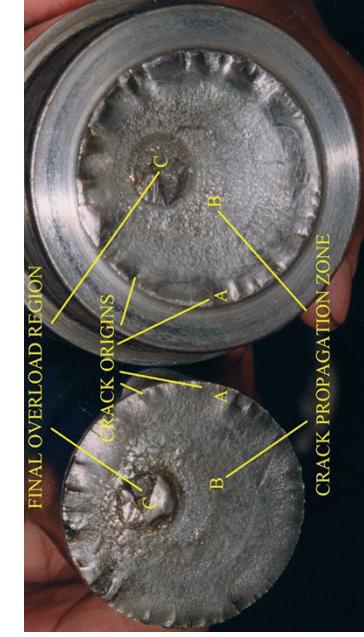
The contour of the fracture surface was convex with respect to the smaller-section side. There were three fracture regions, Figure 4: a region of multiple crack origins around the outer perimeter (at A); a region of the crack propagation zone (at B); and a region of the final, fast fracture (at C).

Fig. 4. Fracture surfaces

The presence of multiple crack origins separated by ratchet marks around the outer perimeter was an indication of rotational-bending fatigue with severe stress concentration.

The relatively small size of the final fracture region was an indication of low nominal stress. In rotational-bending, during each revolution, every point of the shaft circumference was subjected to tensile-compressive stress and therefore the crack could be initiated at any point on the shaft periphery.

The individual cracks propagated toward a single crack front, region B, Figure 4. The crack surfaces were pressed together during the compressive component of the stress cycle, and mutual rubbing occurred. The beach marks were not visible because they were obliterated by rubbing.

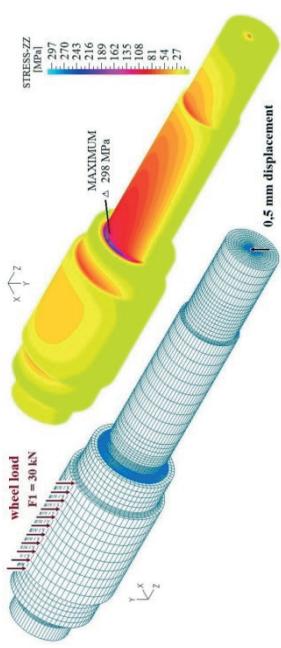
Fig. 5. Numerical analysis

A numerical analysis of local stresses was done by the finite element method using ADINA software. The linear elastic model with 3D solid elements with eight DOF per nodes was used, Figure 5. Each node had 3 degrees of freedom, translation in X, Y and Z direction. The model is fixed in the line on the positions of bearing centers and loaded with concentrated forces in the nodes. The numerical analysis of local stresses revealed that design force due to vertical load should not have led to shaft fracture. Force 30 kN caused local stresses of 79 MPa in the critical area.

Post-failure verification revealed parallel misalignment of 0.5 mm between two shaft axes. The numerical analysis of local stresses revealed that displacement of 0.5 mm caused an increase in local stresses in the critical area three times (298 MPa), Figure 5.

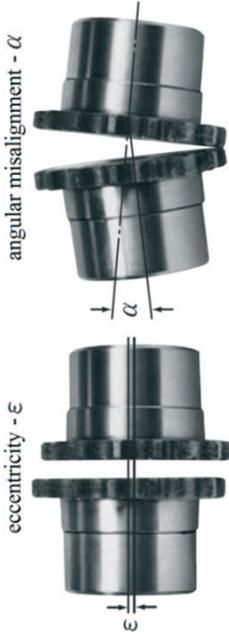
A roller chain coupling was used to transmit power between shafts. The torque was transmitted through a double roller chain. Due to clearances between the chain and the sprocket teeth on two couplings, the roller chain coupling permitted eccentricity ε (parallel misalignment) between shafts up to 2% of the roller chain pitch

Fig. 6. Roller chain coupling [3]

and angular misalignment – α between shafts up to 1° , [3], see Figure 6.

If eccentricity and angular misalignment between the wheel shaft axis and the drive axis is higher than the chain coupling can compensate, there is a vertical force on the end of the wheel shaft and also corresponding additional bending stresses in the critical place.

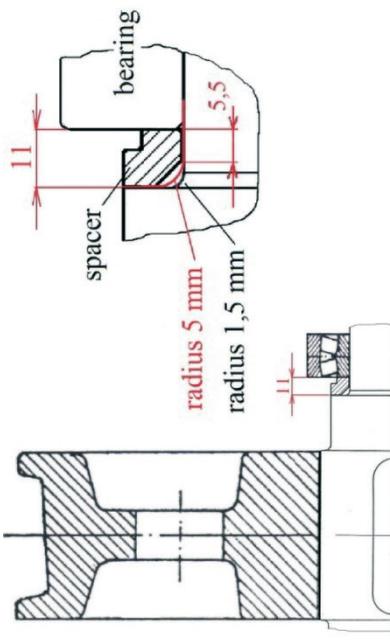
The distance between the large diameter of the shaft (wheel) and the bearing was 11 mm, Figure 7. The spacer was positioned between the wheel and bearing. Increasing the size of the fillet radius was limited by the design of the spacer.

Fig. 7. Design of the spacer

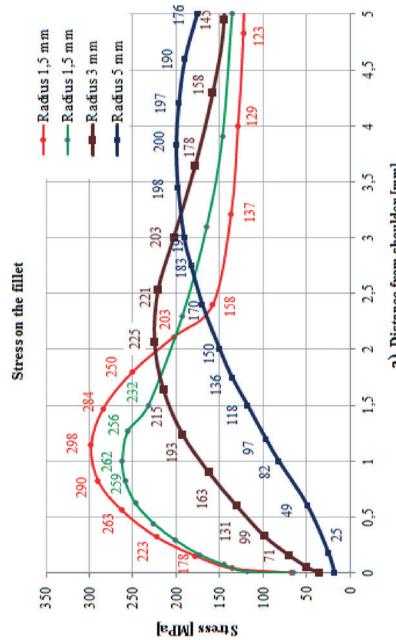
Fig. 8. Stress distribution

The curves in Figure 8 show the increasing size of the fillet radius from 1.5 mm to 5 mm, reducing maximum local stress by about 1.5 times (from 298 to 200 MPa).

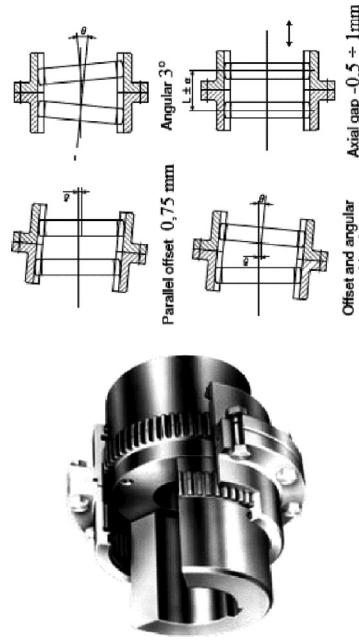
Fig. 9. Gear coupling, [7]

A gear coupling was considered to substitute the roller chain coupling, Figure 9. The gear coupling can accommodate more eccentricity and angular misalignment than the roller chain coupling. According to [7], the gear coupling permits parallel offset 0.75 mm, angular 3° and axial gap from -0.5 to 1 mm. Since post-failure verification revealed parallel misalignment of 0.5 mm between two shaft axes, the application of the gear coupling in this case can eliminate force on the shaft due to misalignment and can also reduce local stresses in the critical area.

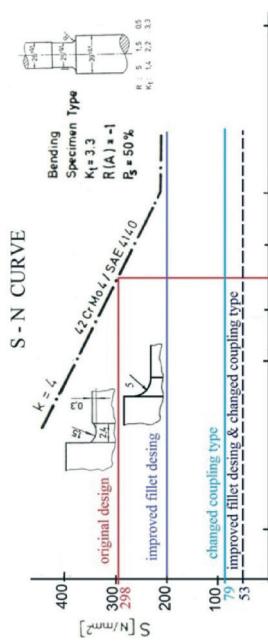
Fig. 10. Influence of corrective actions on fatigue life

Figure 10 shows the influence of considered corrective actions on fatigue life.

The actual service life was estimated from the working time of the crane, the number of liftings and the wheel diameter. The crane was in service for about 400 working days in the period of two years. The average number of transports per day was 100 with the travel of the trolley 10 m per each transport. For the wheel diameter of 250 mm and the corresponding shaft the actual service life was about $4.8 \cdot 10^5$ cycles. The estimated service life from the numerical model was about $3 \cdot 10^5$ cycles, Figure 10.

The redesign of the shaft fillet radius from 1.5 mm to 5 mm reduced maximum local stress below the fatigue endurance limit (about 90% of endurance limit). The application of a gear coupling to accommodate parallel misalignment reduced maximum local stress to about 35% of the endurance limit, what was more than two times in comparison to the redesign of the shaft fillet radius. A combination of the fillet radius redesign and the application of the gear coupling additionally reduced local stresses, Figure 10.

New shafts were made from quenched and tempered steel 42CrMo4 according to DIN [1] with a larger-size fillet, which minimized stress concentration in this region and prevented recurrence of the failure. The roller chain couplings were replaced by gear couplings to reduce the influence of parallel misalignment between the shaft axis and coupling axis on local stresses.

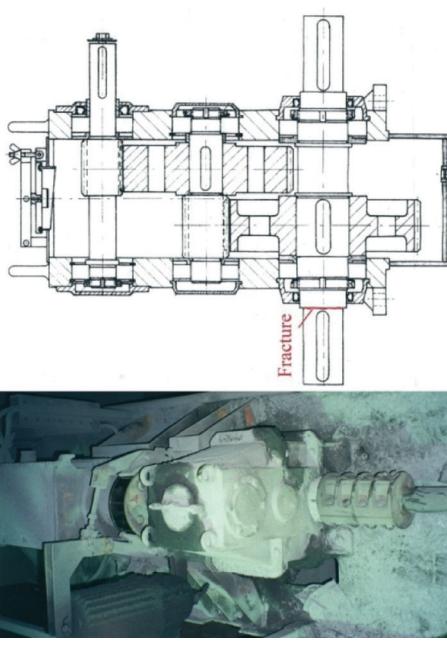
Fig. 12. Overhead crane trolley gearbox

A split muff coupling was used to transmit power between the shafts, Fig. 12.

The split muff coupling is a type of rigid coupling and should be used when the alignment of the two shafts can be maintained very accurately. A small misalignment between two shafts can cause high stresses. Post-failure verification revealed parallel misalignment of 0.8 mm between the gearbox shaft axis and the drive shaft axis of the wheel, Figure 16.

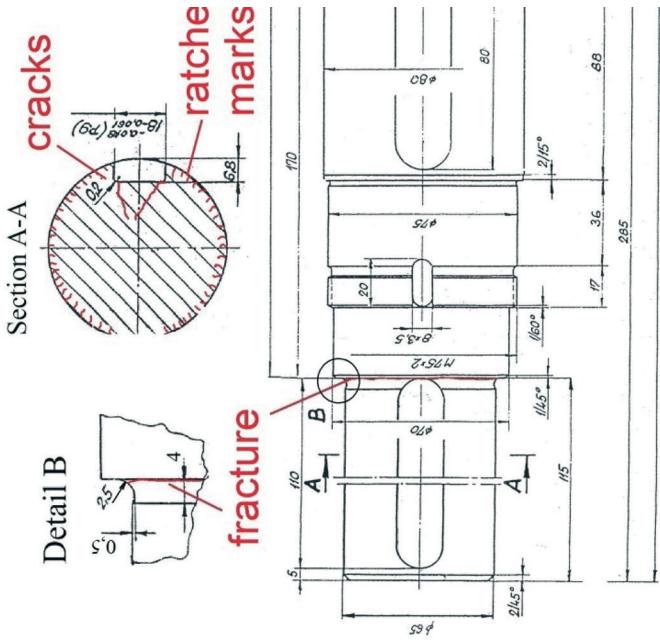
Fig. 13. Stepped drive shaft [8]

In this case there were two stress raisers in the same area: a sharp corner in the keyway and a change in the shaft diameter. Additionally, the end of the keyway was due to change in the shaft diameter, fracture section in Figure 13, causing high concentration of stresses.

in the intersection of two stress raisers, on the sharp corner in the keyway and on the radius of the fillet due to change in the shaft diameter, detail B in Figure 13.

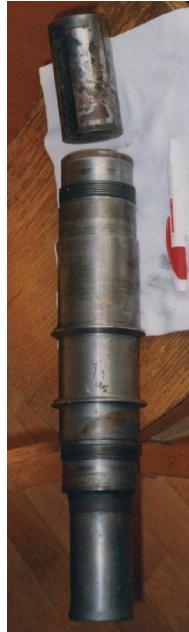
Fig. 14. Stepped drive broken shaft

The shaft was made of construction steel St 52-3 according to DIN [9]. The fracture occurred on a fillet due to change between two different diameters of the shaft approximately 110 mm from one end. The contour of the fracture surface was convex with respect to the smaller-section side.

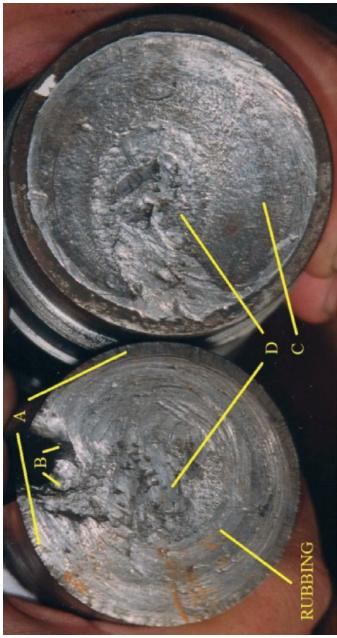
There were four fracture regions, Figure 15. Numerous ratchet marks (at A), on the outer edge of the surface and the dark band at this edge indicate fatigue cracks initiation, what is a characteristic of rotational-bending fatigue. Two cracks (at B) from the keyway corners suggested torsional stresses. The cracks propagated circumferentially around the shaft (at C). The final fracture was a mixed ductile and brittle fracture in the middle of the elliptical contour (at D). The beach marks were not visible because they were obliterated by rubbing.

The conclusion from the surface investigation was that the shaft fractured as a result of the rotational-bending fatigue due to high stress concentration. The cracks were initiated

Fig. 15. Fracture surfaces

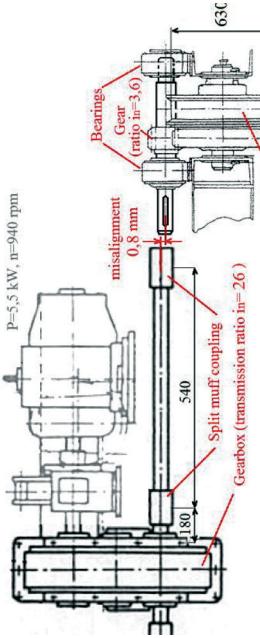
Fig. 16. Misalignment between the gearbox shaft axis and drive shaft axis of the wheel

The numerical analysis of local stresses was done by the finite element method using ADINA software. The applied force of $F=15000$ N was estimated from the parallel misalignment of $d=0.8$ mm according to expression (1), Figure 17, where $l = 720$ mm and $a = 180$ mm, Figure 16.

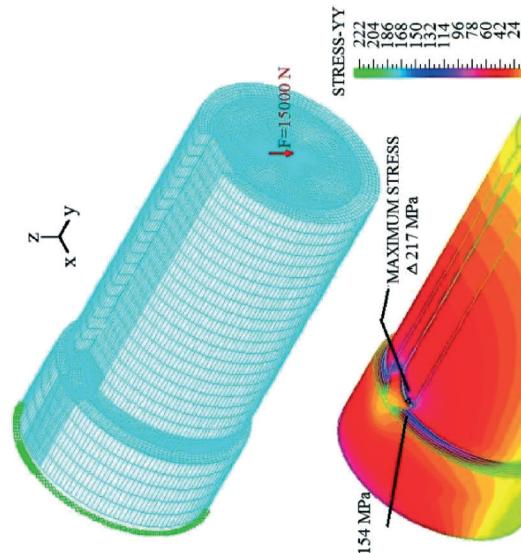
Fig. 18. Numerical analysis

The FEM analysis of local stresses revealed that the maximum stress 217 MPa was in the sharp corner of the keyway and the stress on the fillet due to change in the shaft diameter near the keyway was 154 MPa, Figure 18. Stress concentration factors in critical areas had a good agreement with literature [4] and [5].

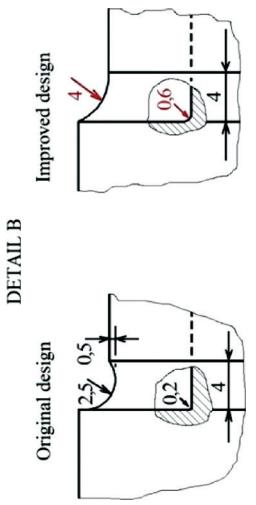
Fig. 19. Original and improved design of the fillet radius

- Increasing the fillet radius due to change in the shaft diameter from 2.5 mm to 4 mm, Fig. 19.

b) Increasing the radius in the keyway corner of the maximum size. The maximum radius size in the keyway corner for the shaft diameter 65 mm according to DIN [10] was 0.6 mm, Fig. 19.

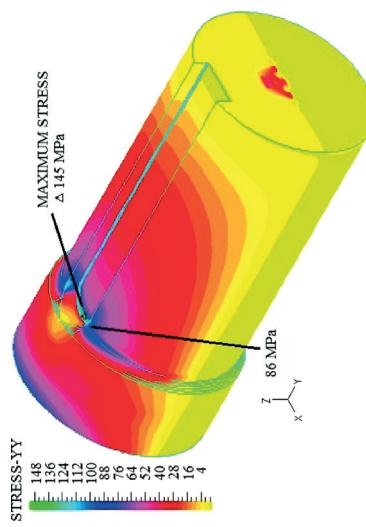
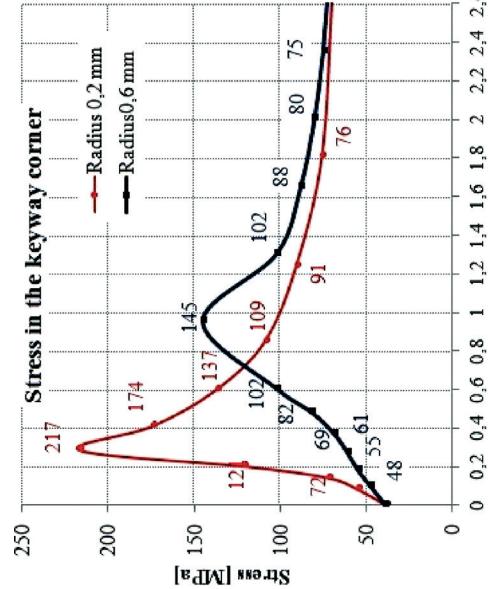
The FEM analysis of local stresses after the redesign revealed decreasing the maximum bending stress in the sharp corner of the keyway from 217 MPa to 145 MPa as well as decreasing stresses of the fillet radius due to change in the shaft diameter from 154 MPa to 86 MPa, Figure 20.

Fig. 20. Numerical analysis

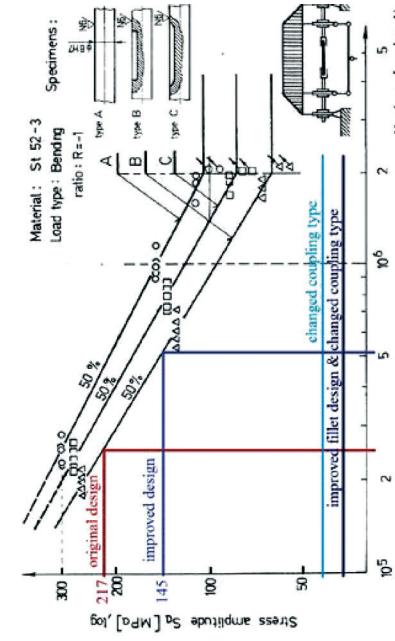
Fig. 21. Influence of corrective actions on the fatigue life

The redesign of the shaft fillet radius reduced the maximum local stress and the estimated fatigue life was about two times longer according to actual fatigue life, Figure 21. The application of a gear coupling to accommodate parallel misalignment eliminated force due to misalignment, and bending stresses became negligible. A combination of the fillet radius redesign and application of the gear coupling additionally improved fatigue life.

Based on this analysis, the actual service life of a shaft can be improved from finite ($3.5 \cdot 10^5$ cycles) to infinite lifetime.

New shafts were made with the radius size due to change in the shaft diameter 4 mm and the radius size in the keyway corner 0.6 mm, minimizing stress concentration in both critical areas and preventing recurrence of the failure.

Split muff couplings were replaced by gear couplings to reduce the influence of parallel misalignment between the shaft axis and the coupling axis on local stresses.
