**EVALUATION OF CONSERVATION PROBLEMS  
OF DEĞİRMENDAĞI DISTRICT  
IN İZMİR**

**A Thesis Submitted to  
the Graduate School of Engineering and Science of  
İzmir Institute of Technology  
in Partial Fullfilment of the Requirements for the Degree of**

**in Architectural Restoration**

**by  
Özge AKBULUT**

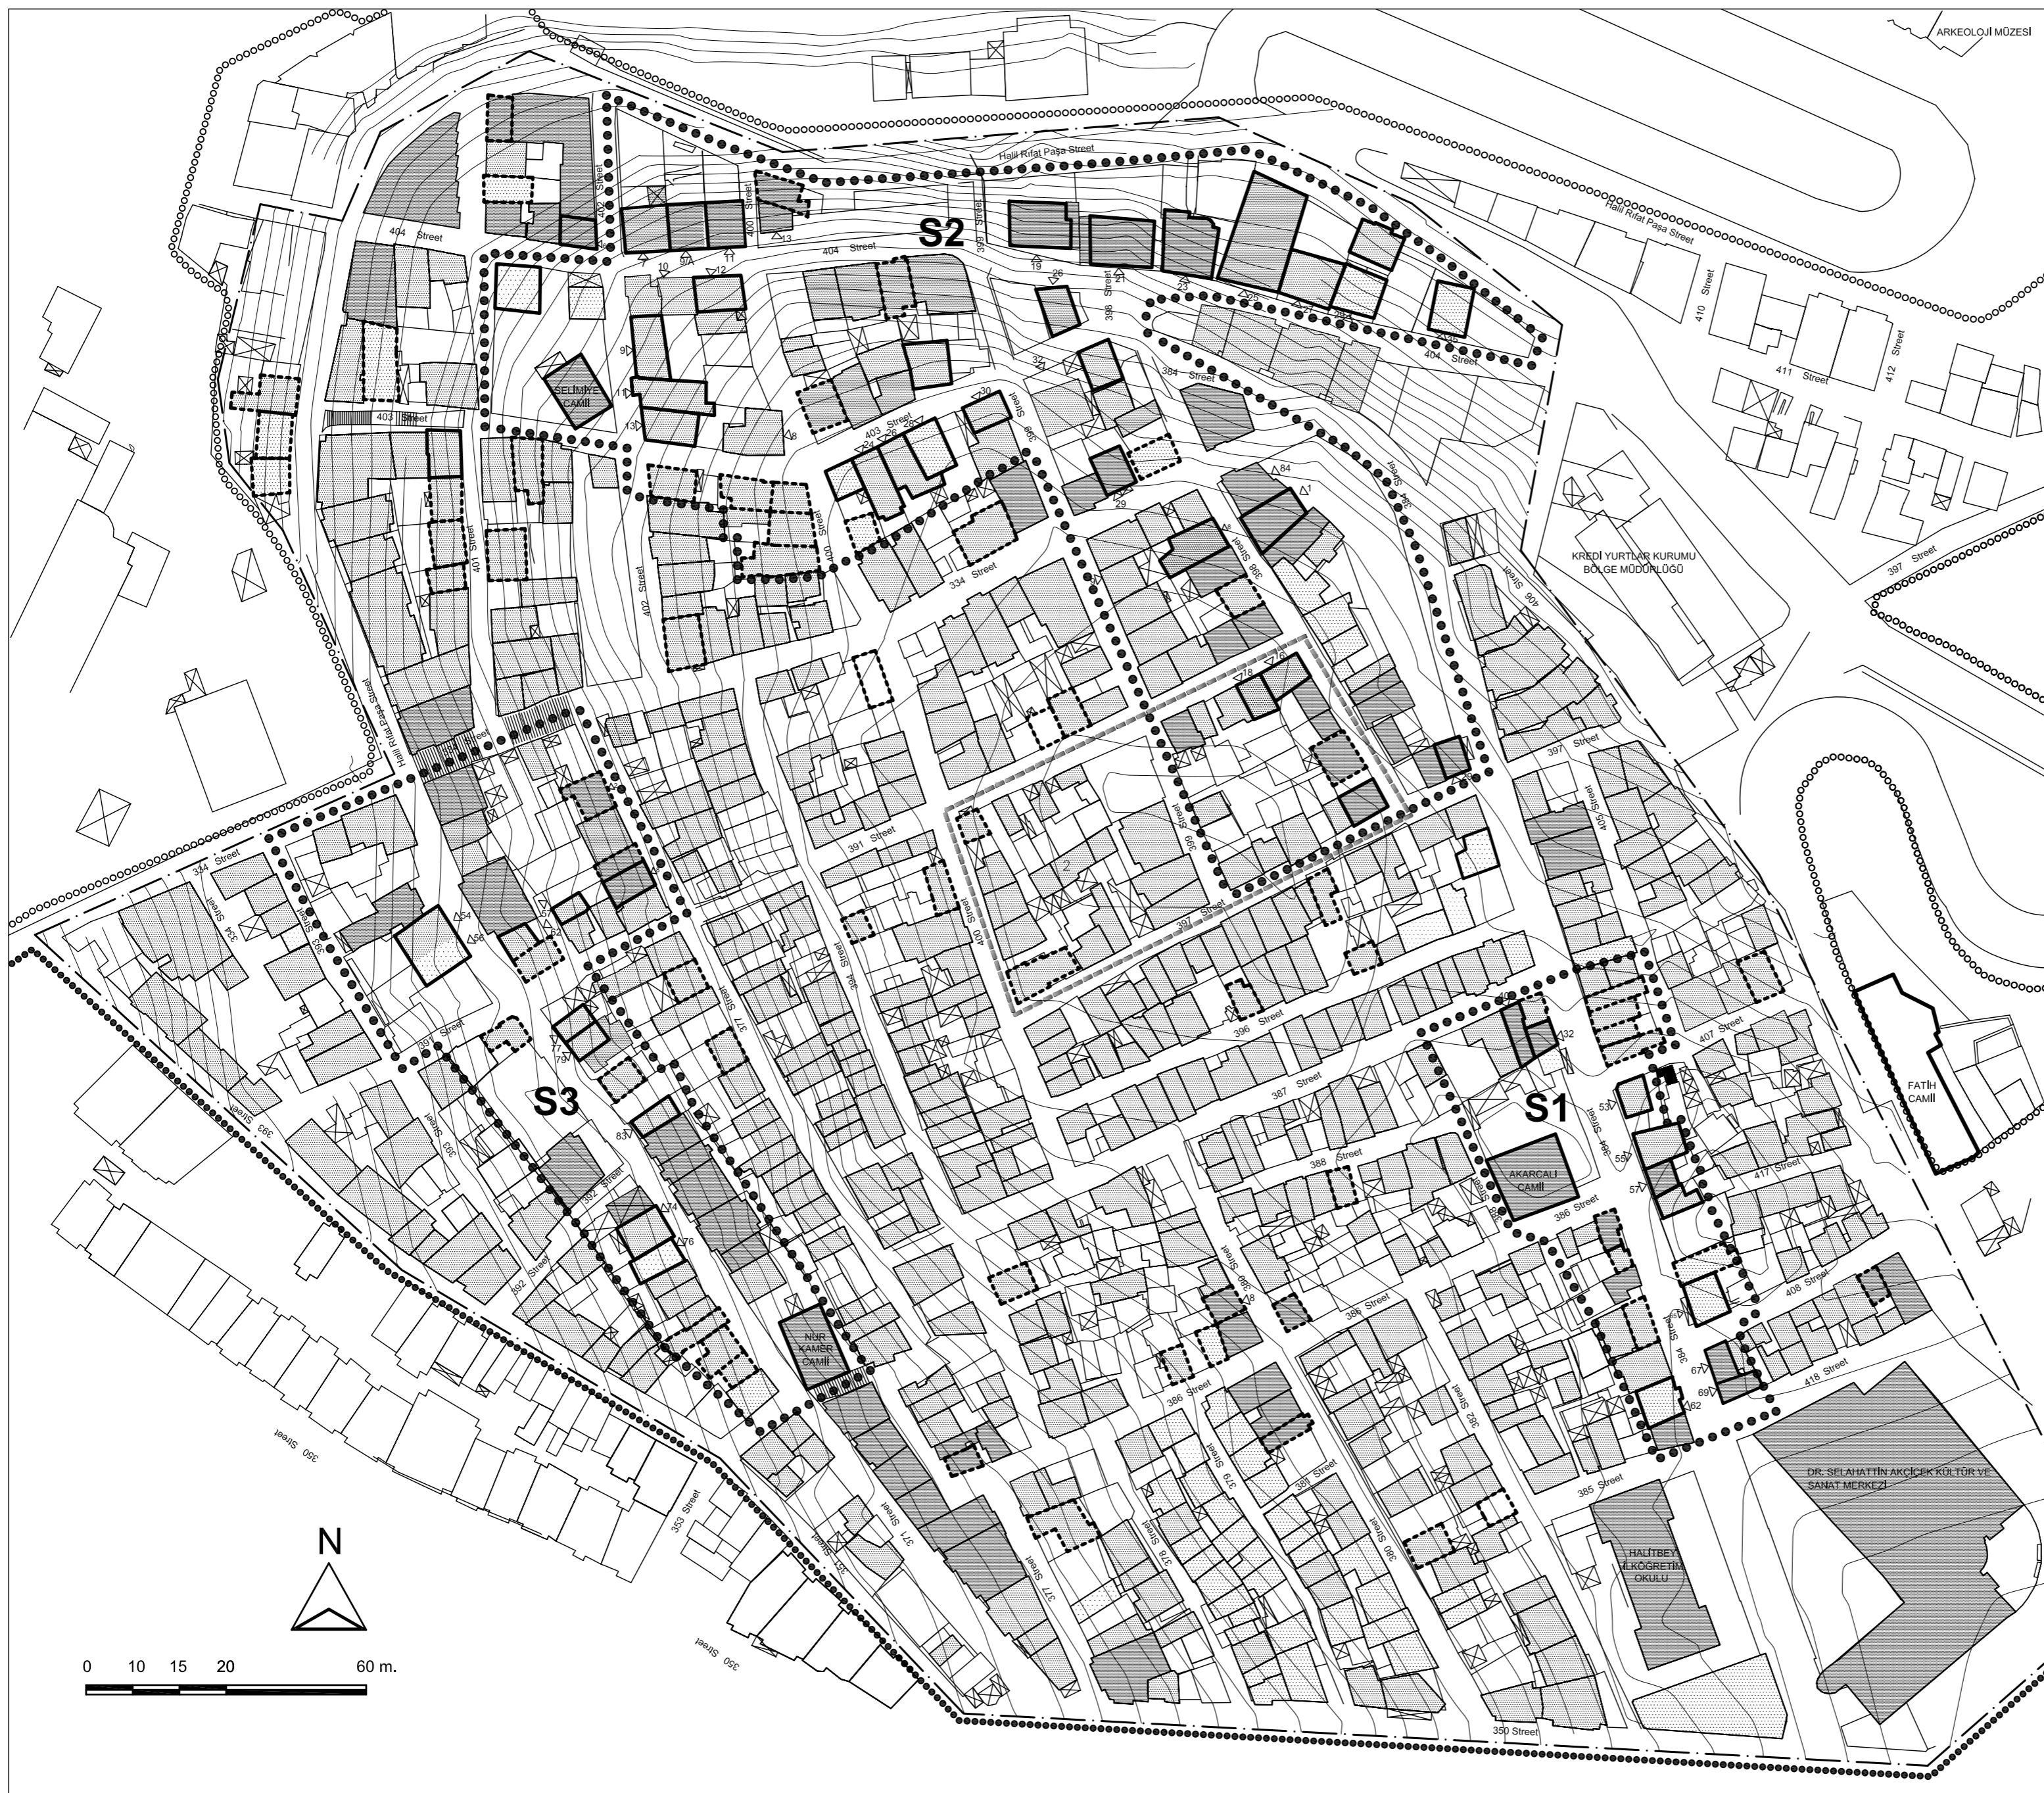
Figure 3.62. Structural Condition

When the buildings in the survey area were examined from the outside, their structural condition was seen to be generally mediocre.

1. Buildings in good condition: no problems were evident in the main structural elements and materials displayed no decay,
2. Buildings requiring minor repair: no problems were evident in the main structural elements, materials displayed some minor problems,
3. Buildings requiring major repair: evident and serious problems in the main structural elements and materials,
4. Dilapidated buildings: main structural system is totally dilapidated.

As shown in Table 3.7, there are 9 buildings in good condition, 18 buildings requiring minor repair, and 4 buildings requiring major repair out of 31 buildings in the S1 zone; there are 9 buildings in good condition, 18 buildings requiring minor repair, and 4 buildings requiring major repair out of 105 buildings in the S2 zone; there are 9 buildings in good condition, 18 buildings requiring minor repair, and 4 buildings requiring major repair out of 105 buildings in the S3 zone.

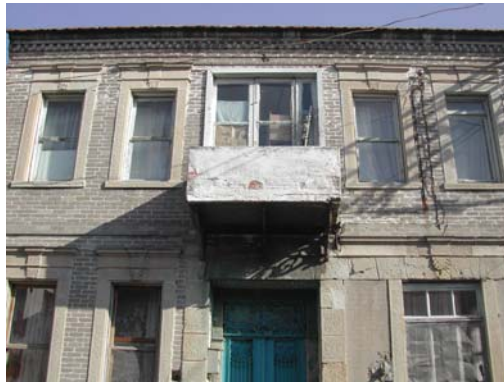
In the S1 zone, two cumbas are converted into balconies while another cumba is eliminated (Figure 3.64.). Horizontal division is observed in 6 buildings while a building with an eave addition is determined.

Figure 3.64. Cumba converted into balcony (384th Street No. 65)

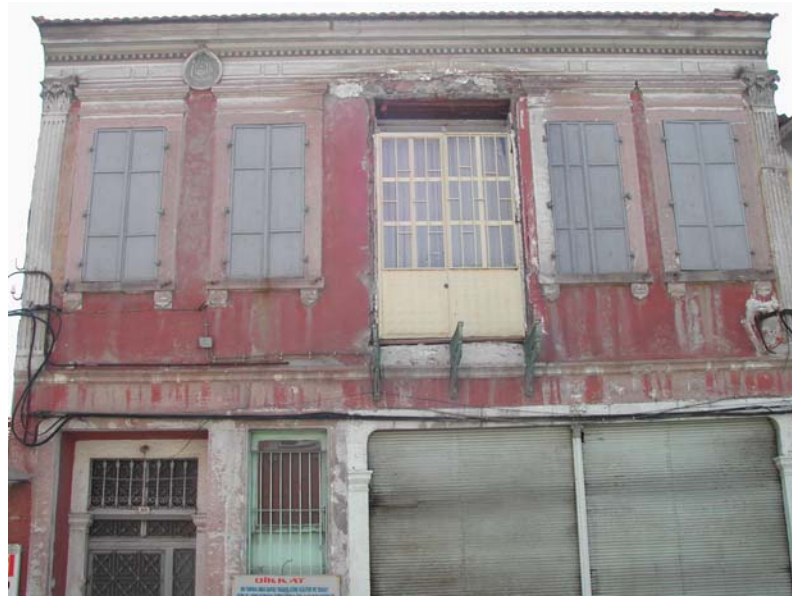
Since its structural condition is derelict and it is about to lose all its characteristics, the building located at 384th Street No. 62 should immediately be taken up (Figure 4.5). The buildings which do not require any handling depending on their good structural conditions and in that they preserve their characteristics are the building located at 384th Street No. 69 and Akarcalı Mosque. The building which needs major repair is the building located at 384th Street No. 65 because it is about to lose all its characteristics since the building was handled improperly. The other buildings in the S1 zone only require some minor repairs and basic façade arrangements (Figure 4.6).

Figure 4.5 Registered building 384th Street No. 62

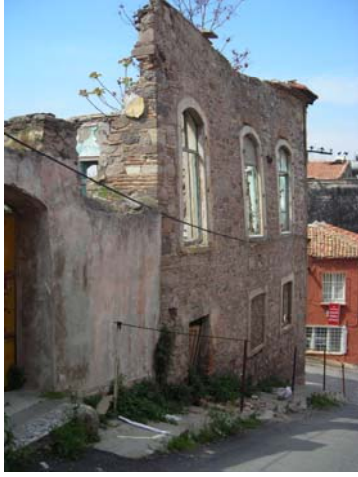
Figure 4.8 Ruined walls belonging to Selimiye Mosque on 404 Street

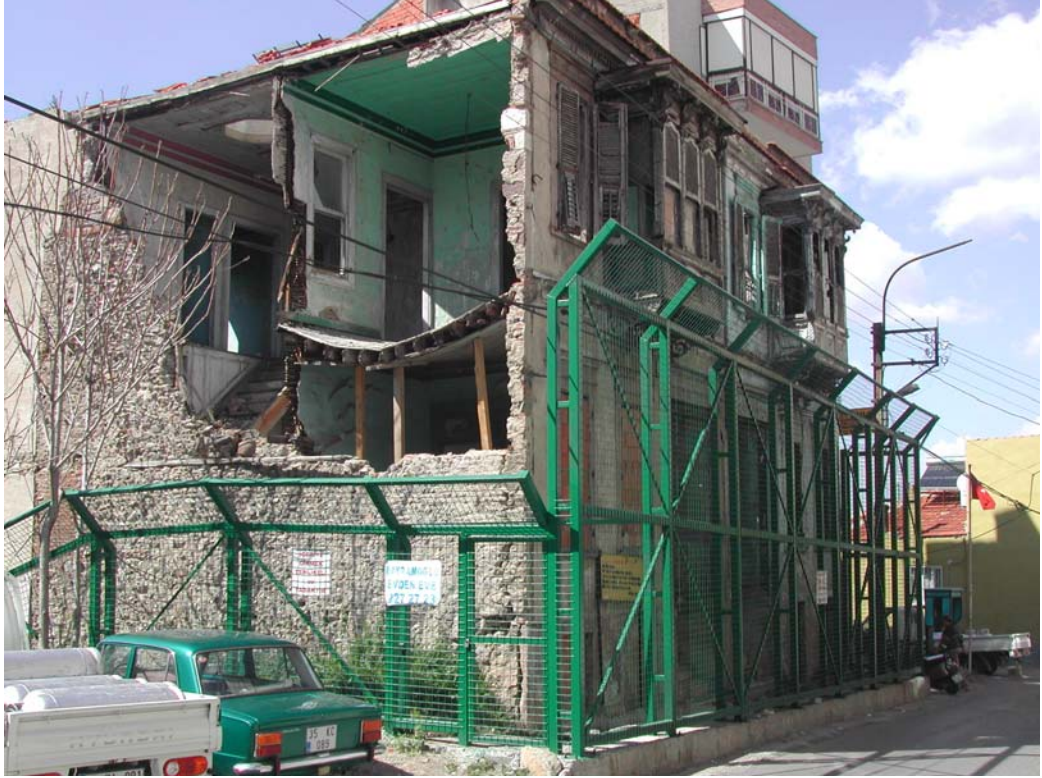
Since their structural conditions are derelict and they are about to lose all their characteristics, the building at Halil Rıfat Paşa Street No. 81 (Figure 4.10) and the twin buildings located at Halil Rıfat Paşa Street Nos. 54 and 56 should immediately be taken up as they are about to collapse (Figure 4.9). The buildings which do not require any handling depending on their good structural conditions and in that they preserve their characteristics; there is no building other than Nur Kamer Mosque which does not require any handling. There are two buildings at Halil Rıfat Paşa Street which are about to collapse. The registered building at Halil Rıfat Paşa Street No. 76 is dilapidated so it should be reconstructed in accordance with its previous pictures.

Figure 4.10 Twin registered buildings at Halil Rıfat Paşa Street No. 54-56
