Qualitative and Comparative Analysis of Stormwater management in the Tan Brook Watershed

Qualitative and Comparative Analysis of Stormwater Management in the Tan Brook Watershed

Natalia von Hausen

Landscape Architecture and Regional Planning Department

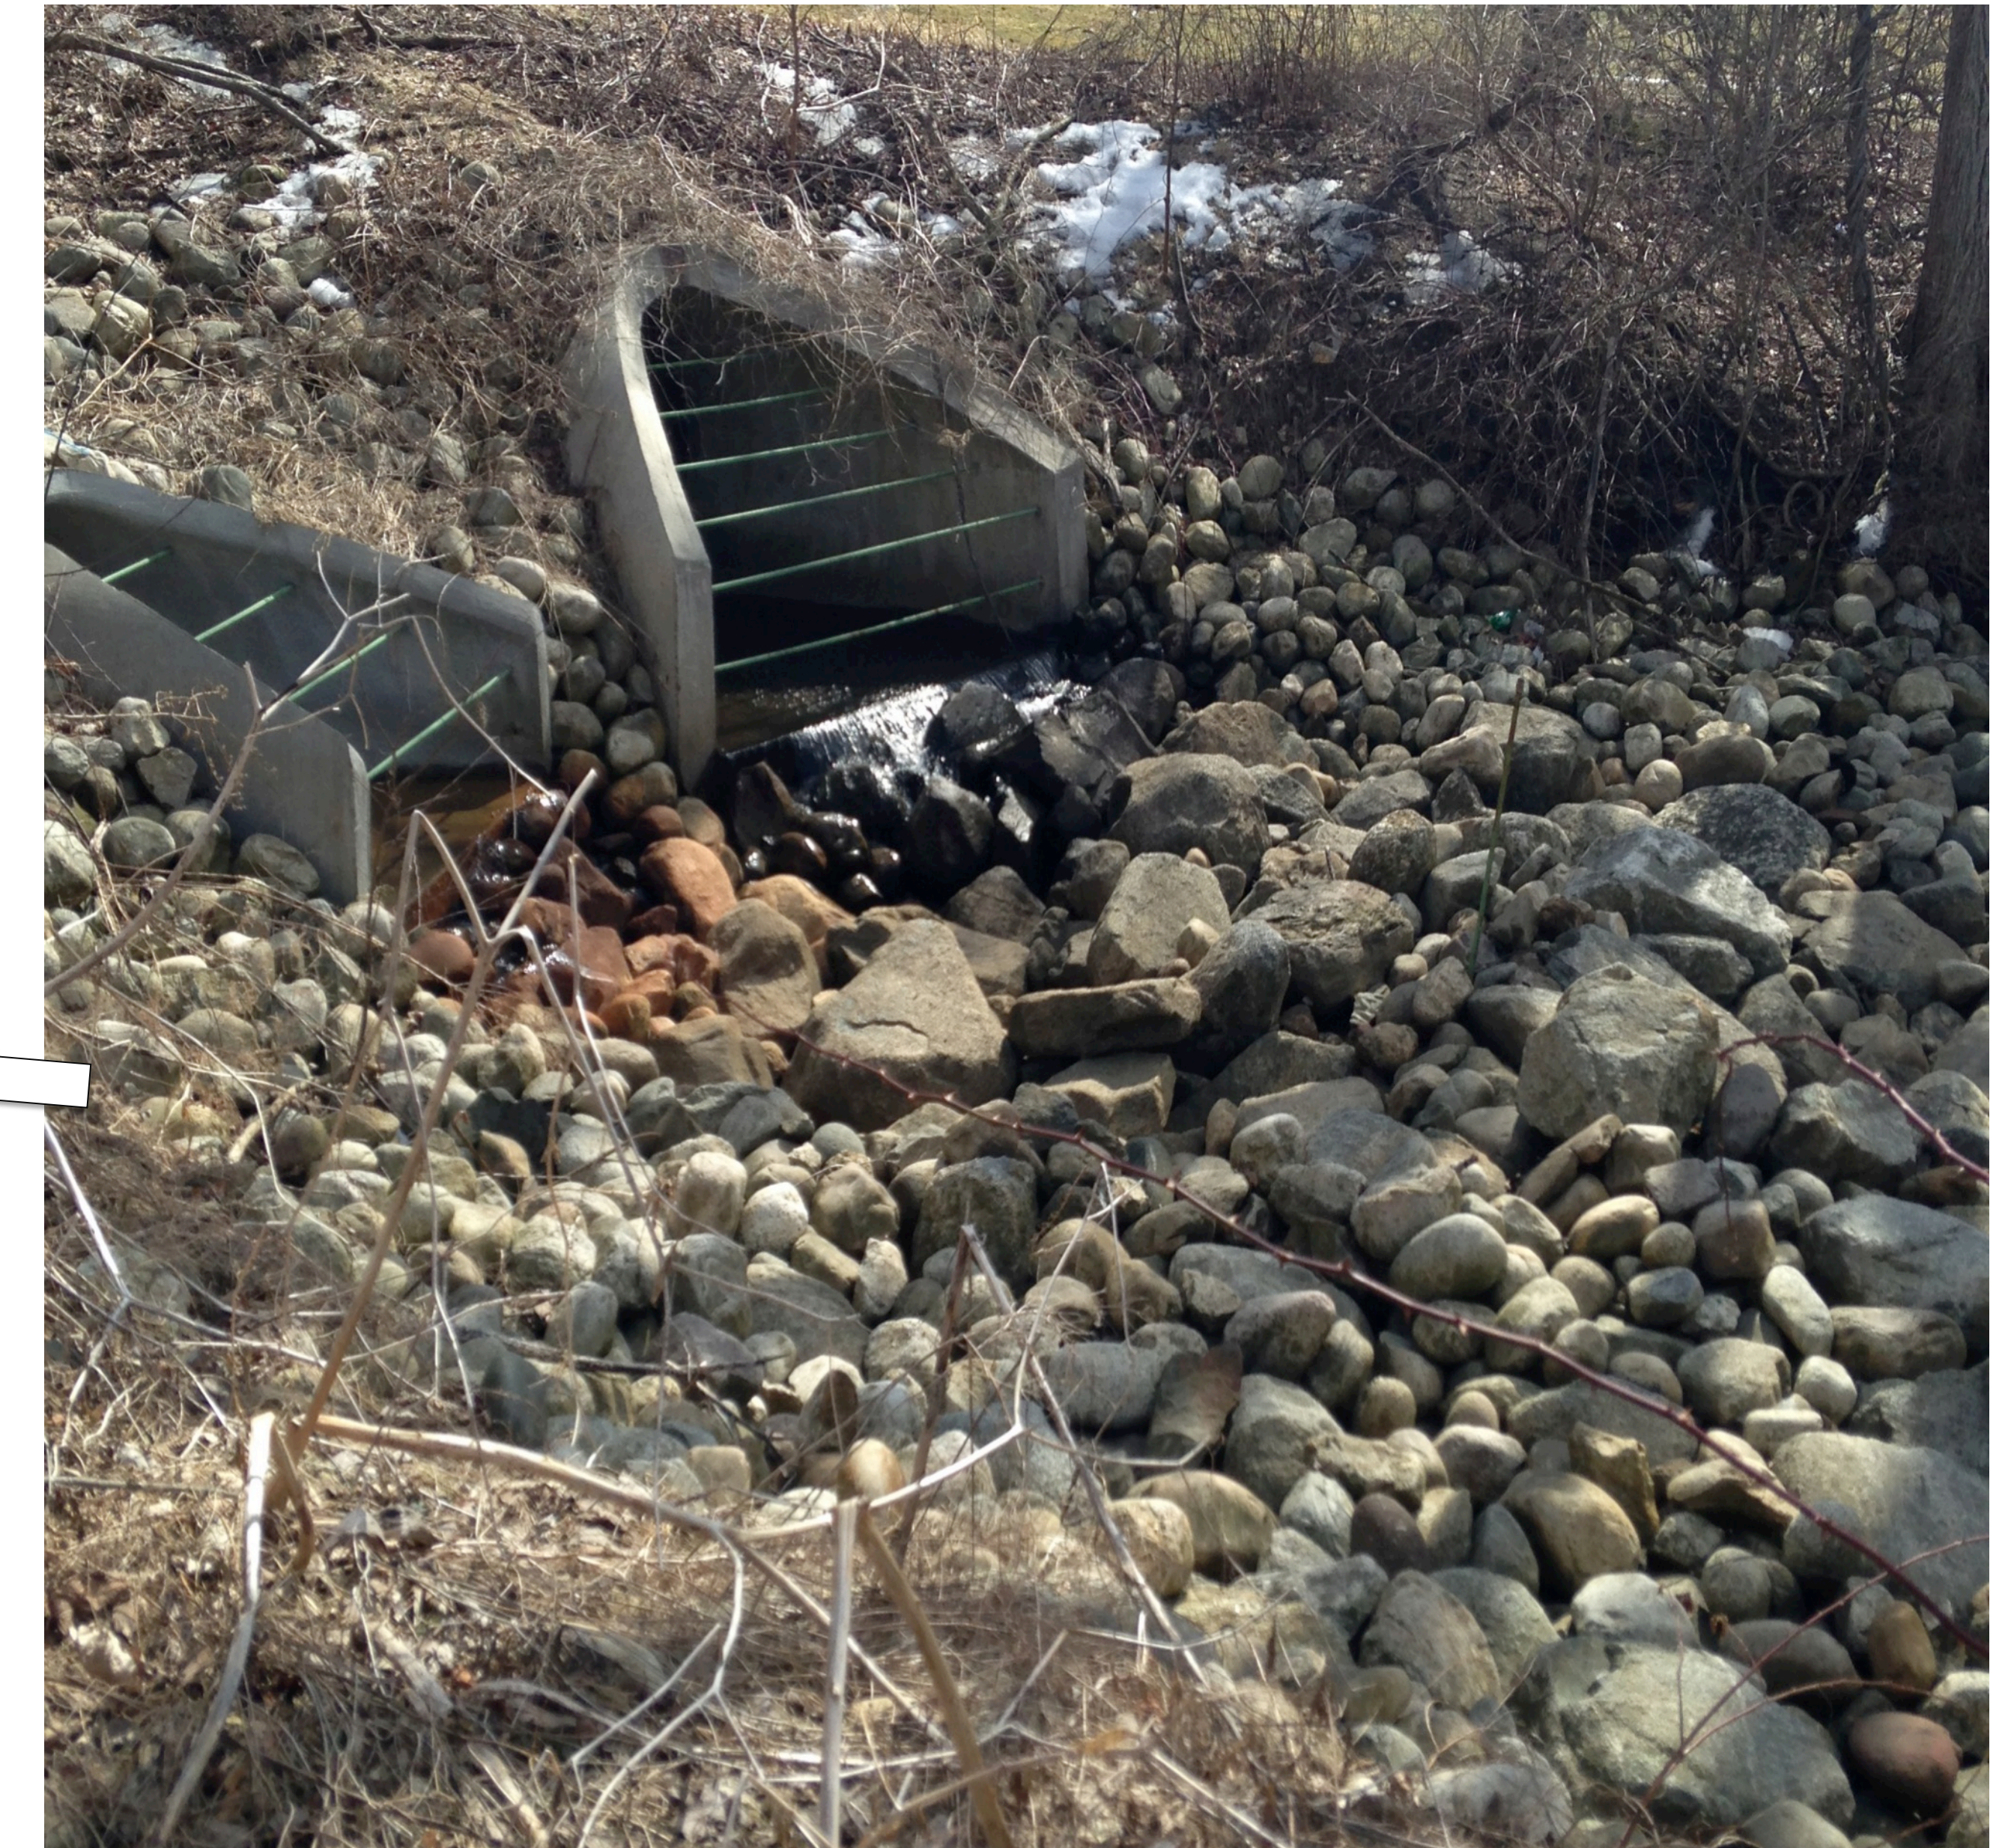
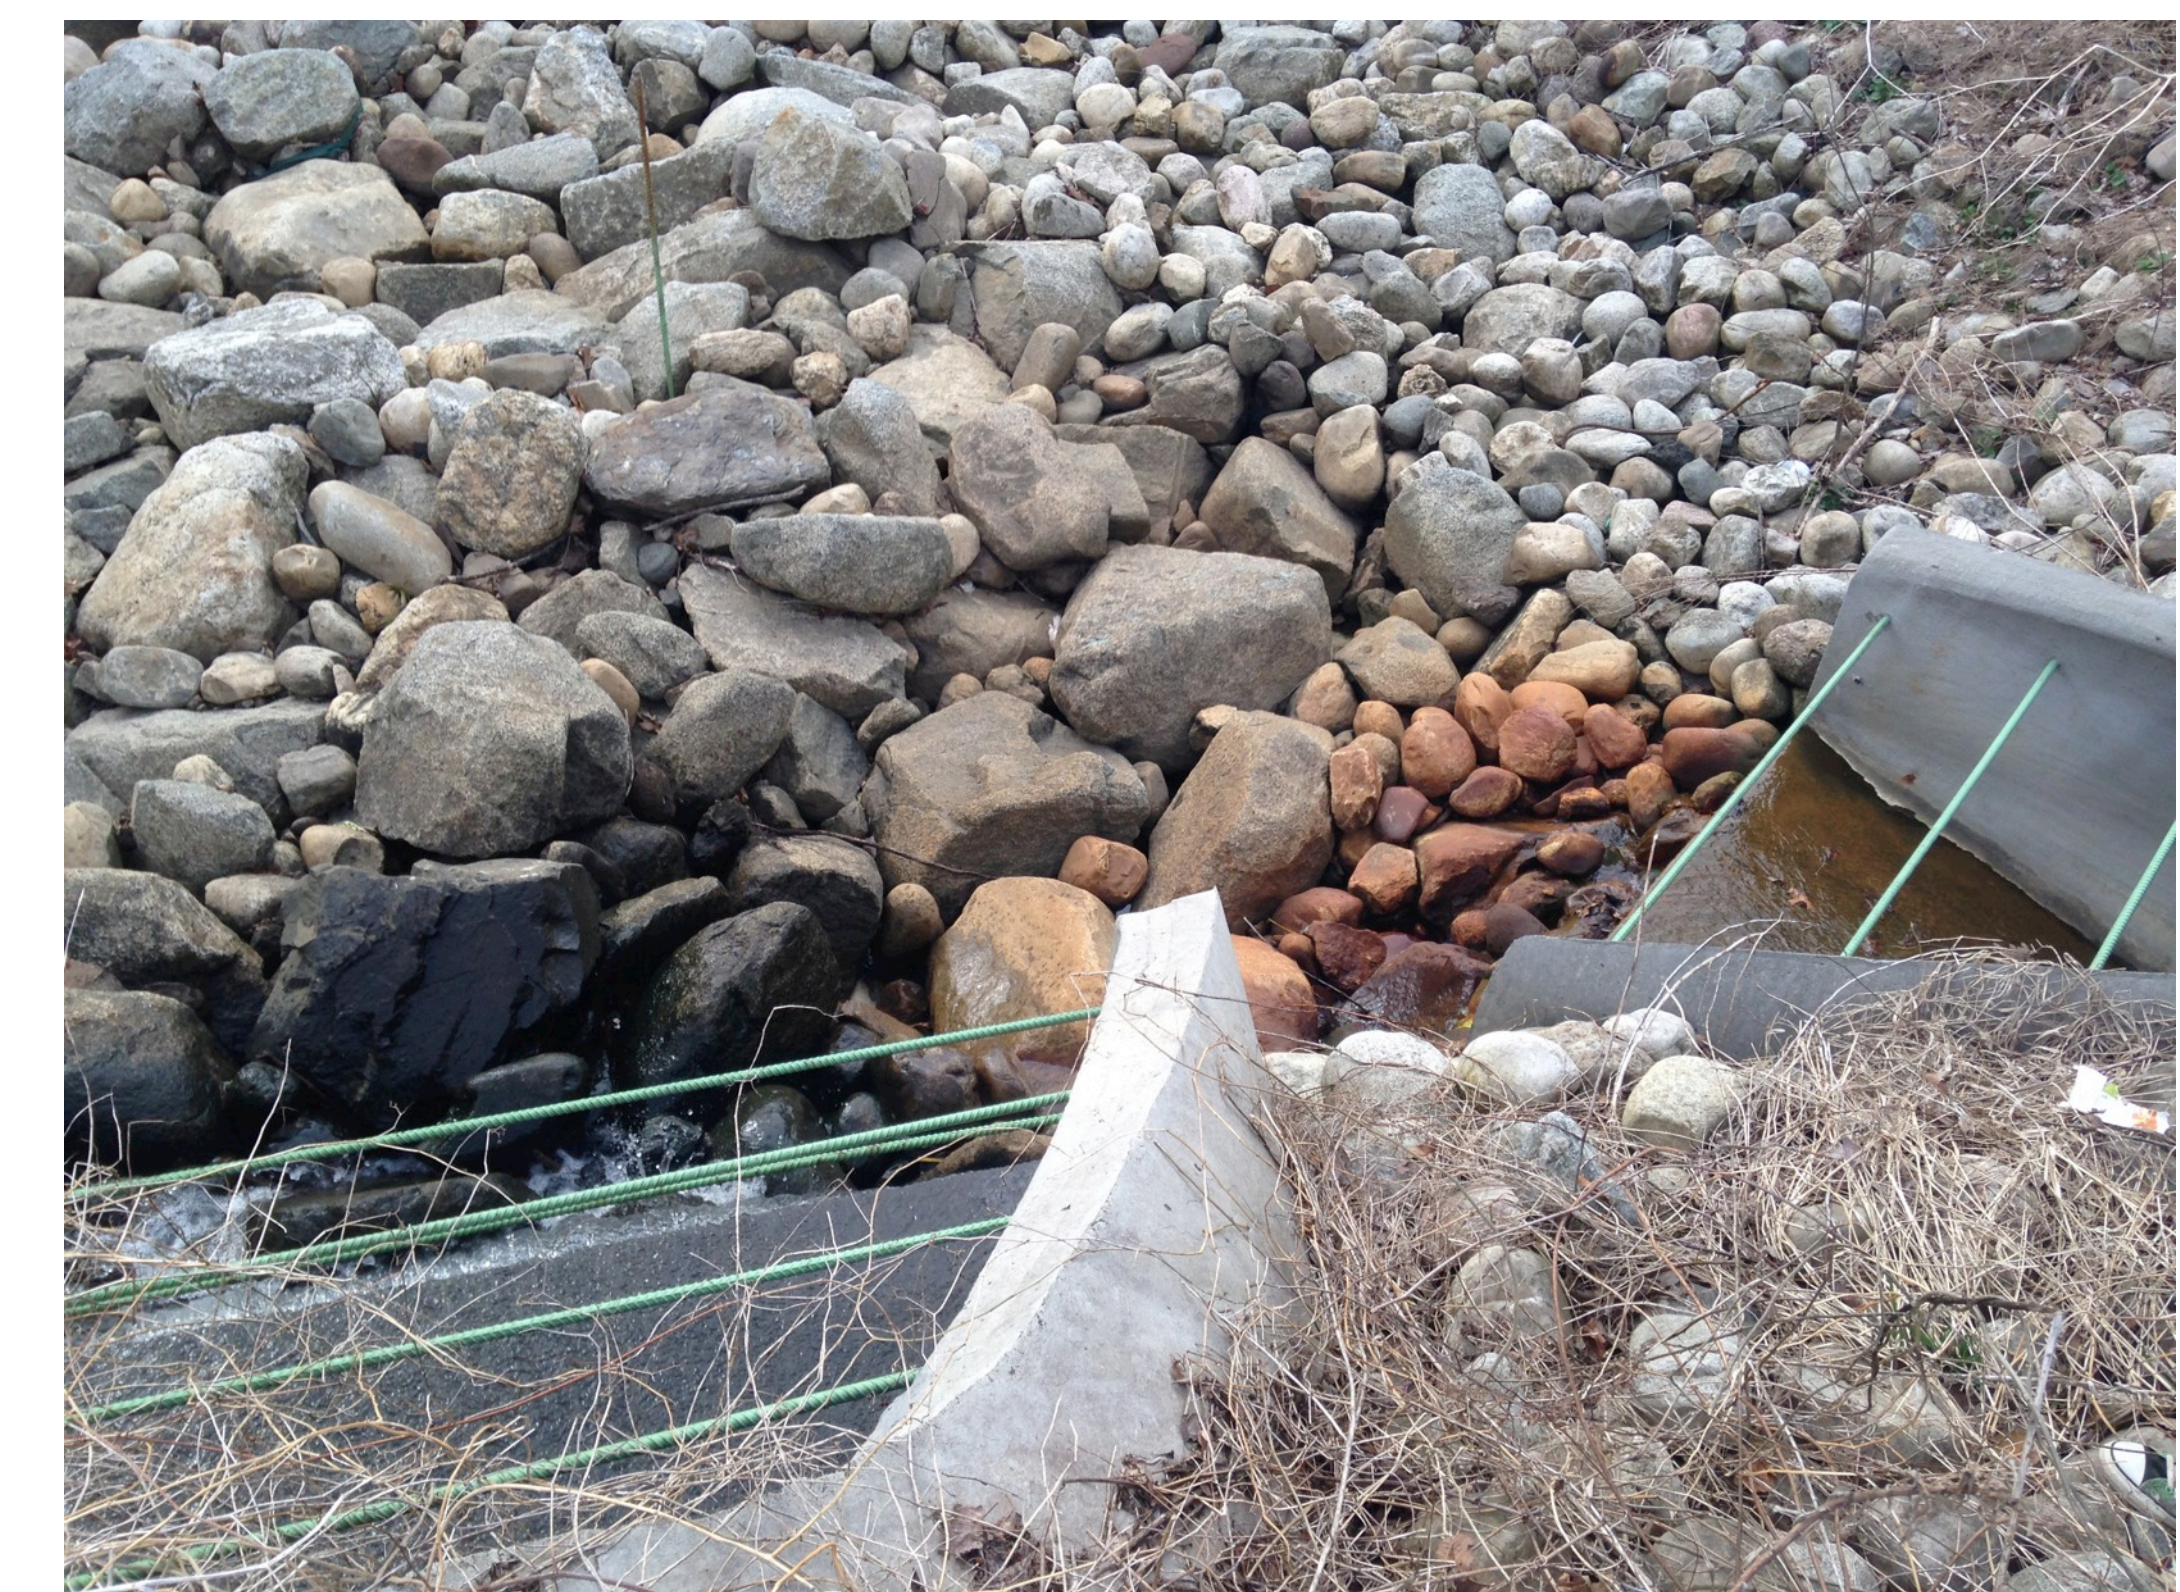
Institutional Site: University of Massachusetts Amherst

- Various manhole drainage systems collect water run-off from surrounding campus area
- Pipelined stream (Red Line) runs underneath front parking lot of the Mullins Center.
- Two outfall drainage systems bring the two stream courses together
- The stream that comes from the surrounding run-off was a bright orange color
- Rock trench infiltration system
- Flow coming from the outfall is high in velocity but slows down when filtering through the rocks

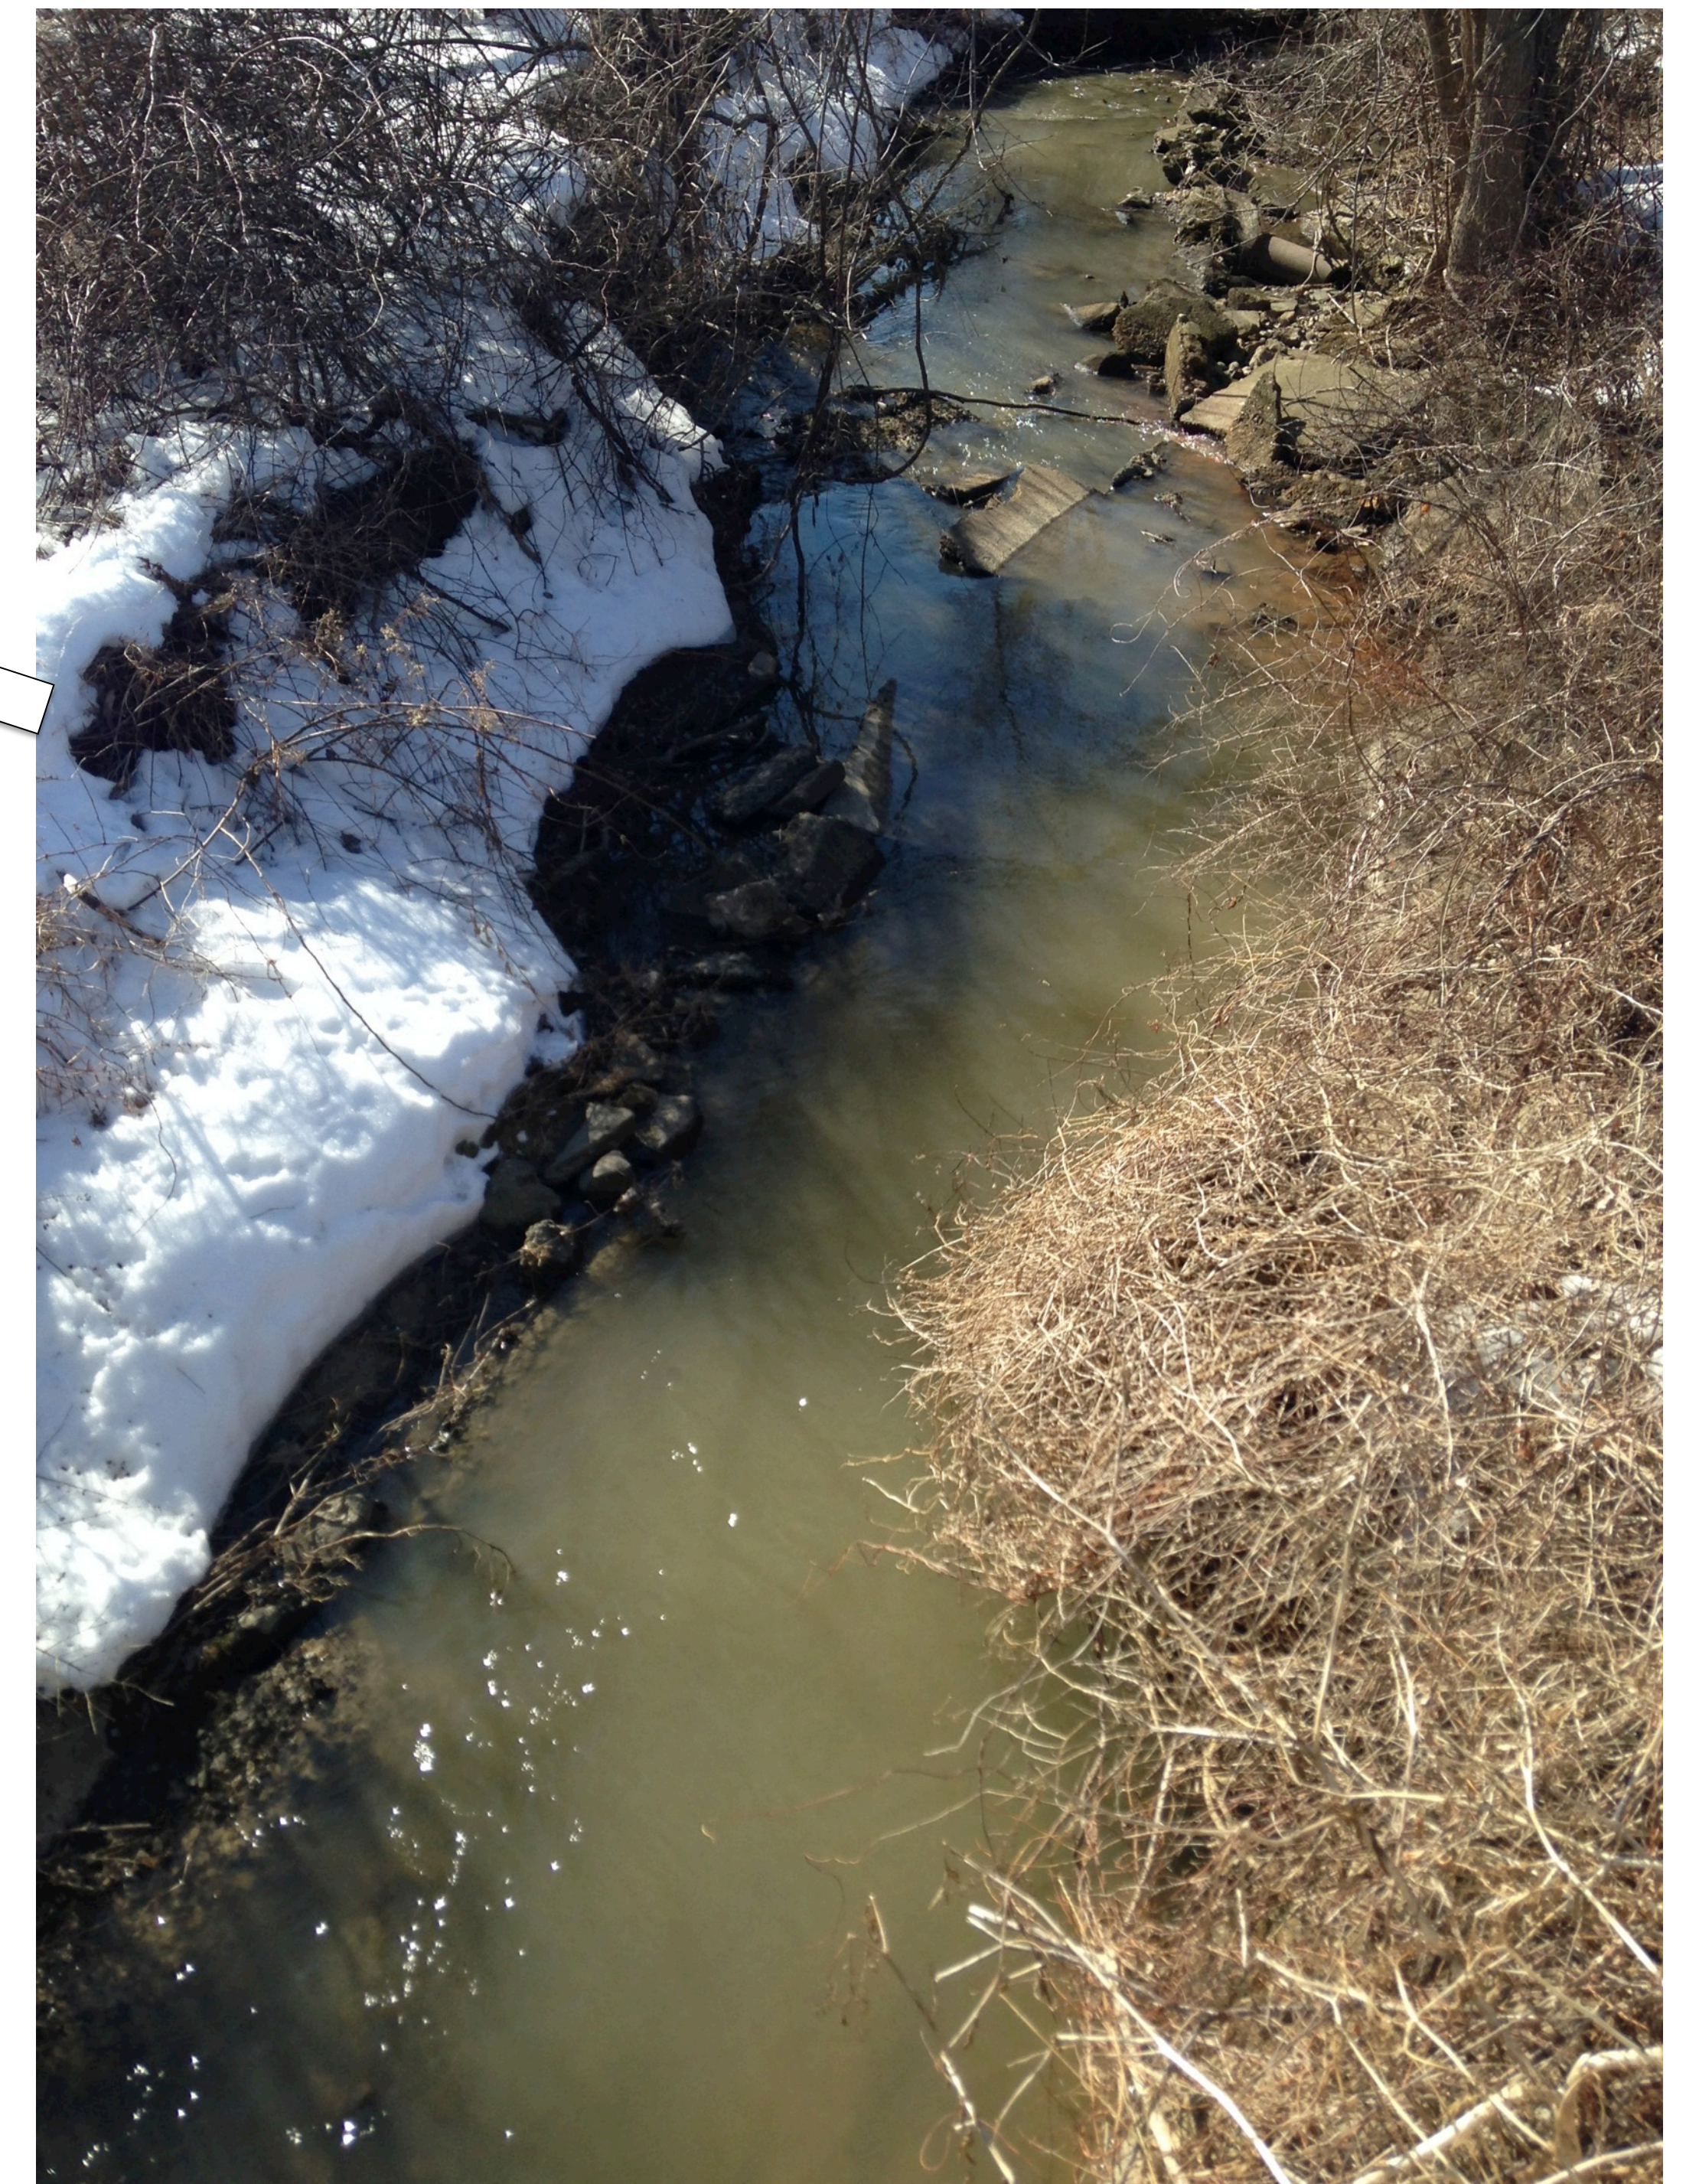
Institutional Site: University of Massachusetts Amherst

- Slabs of concrete framed either the edges of the stream or were just placed throughout the stream
- Concrete helps erosion control
- Stream was cloudy and had a lower velocity and volume, before and after snowmelt

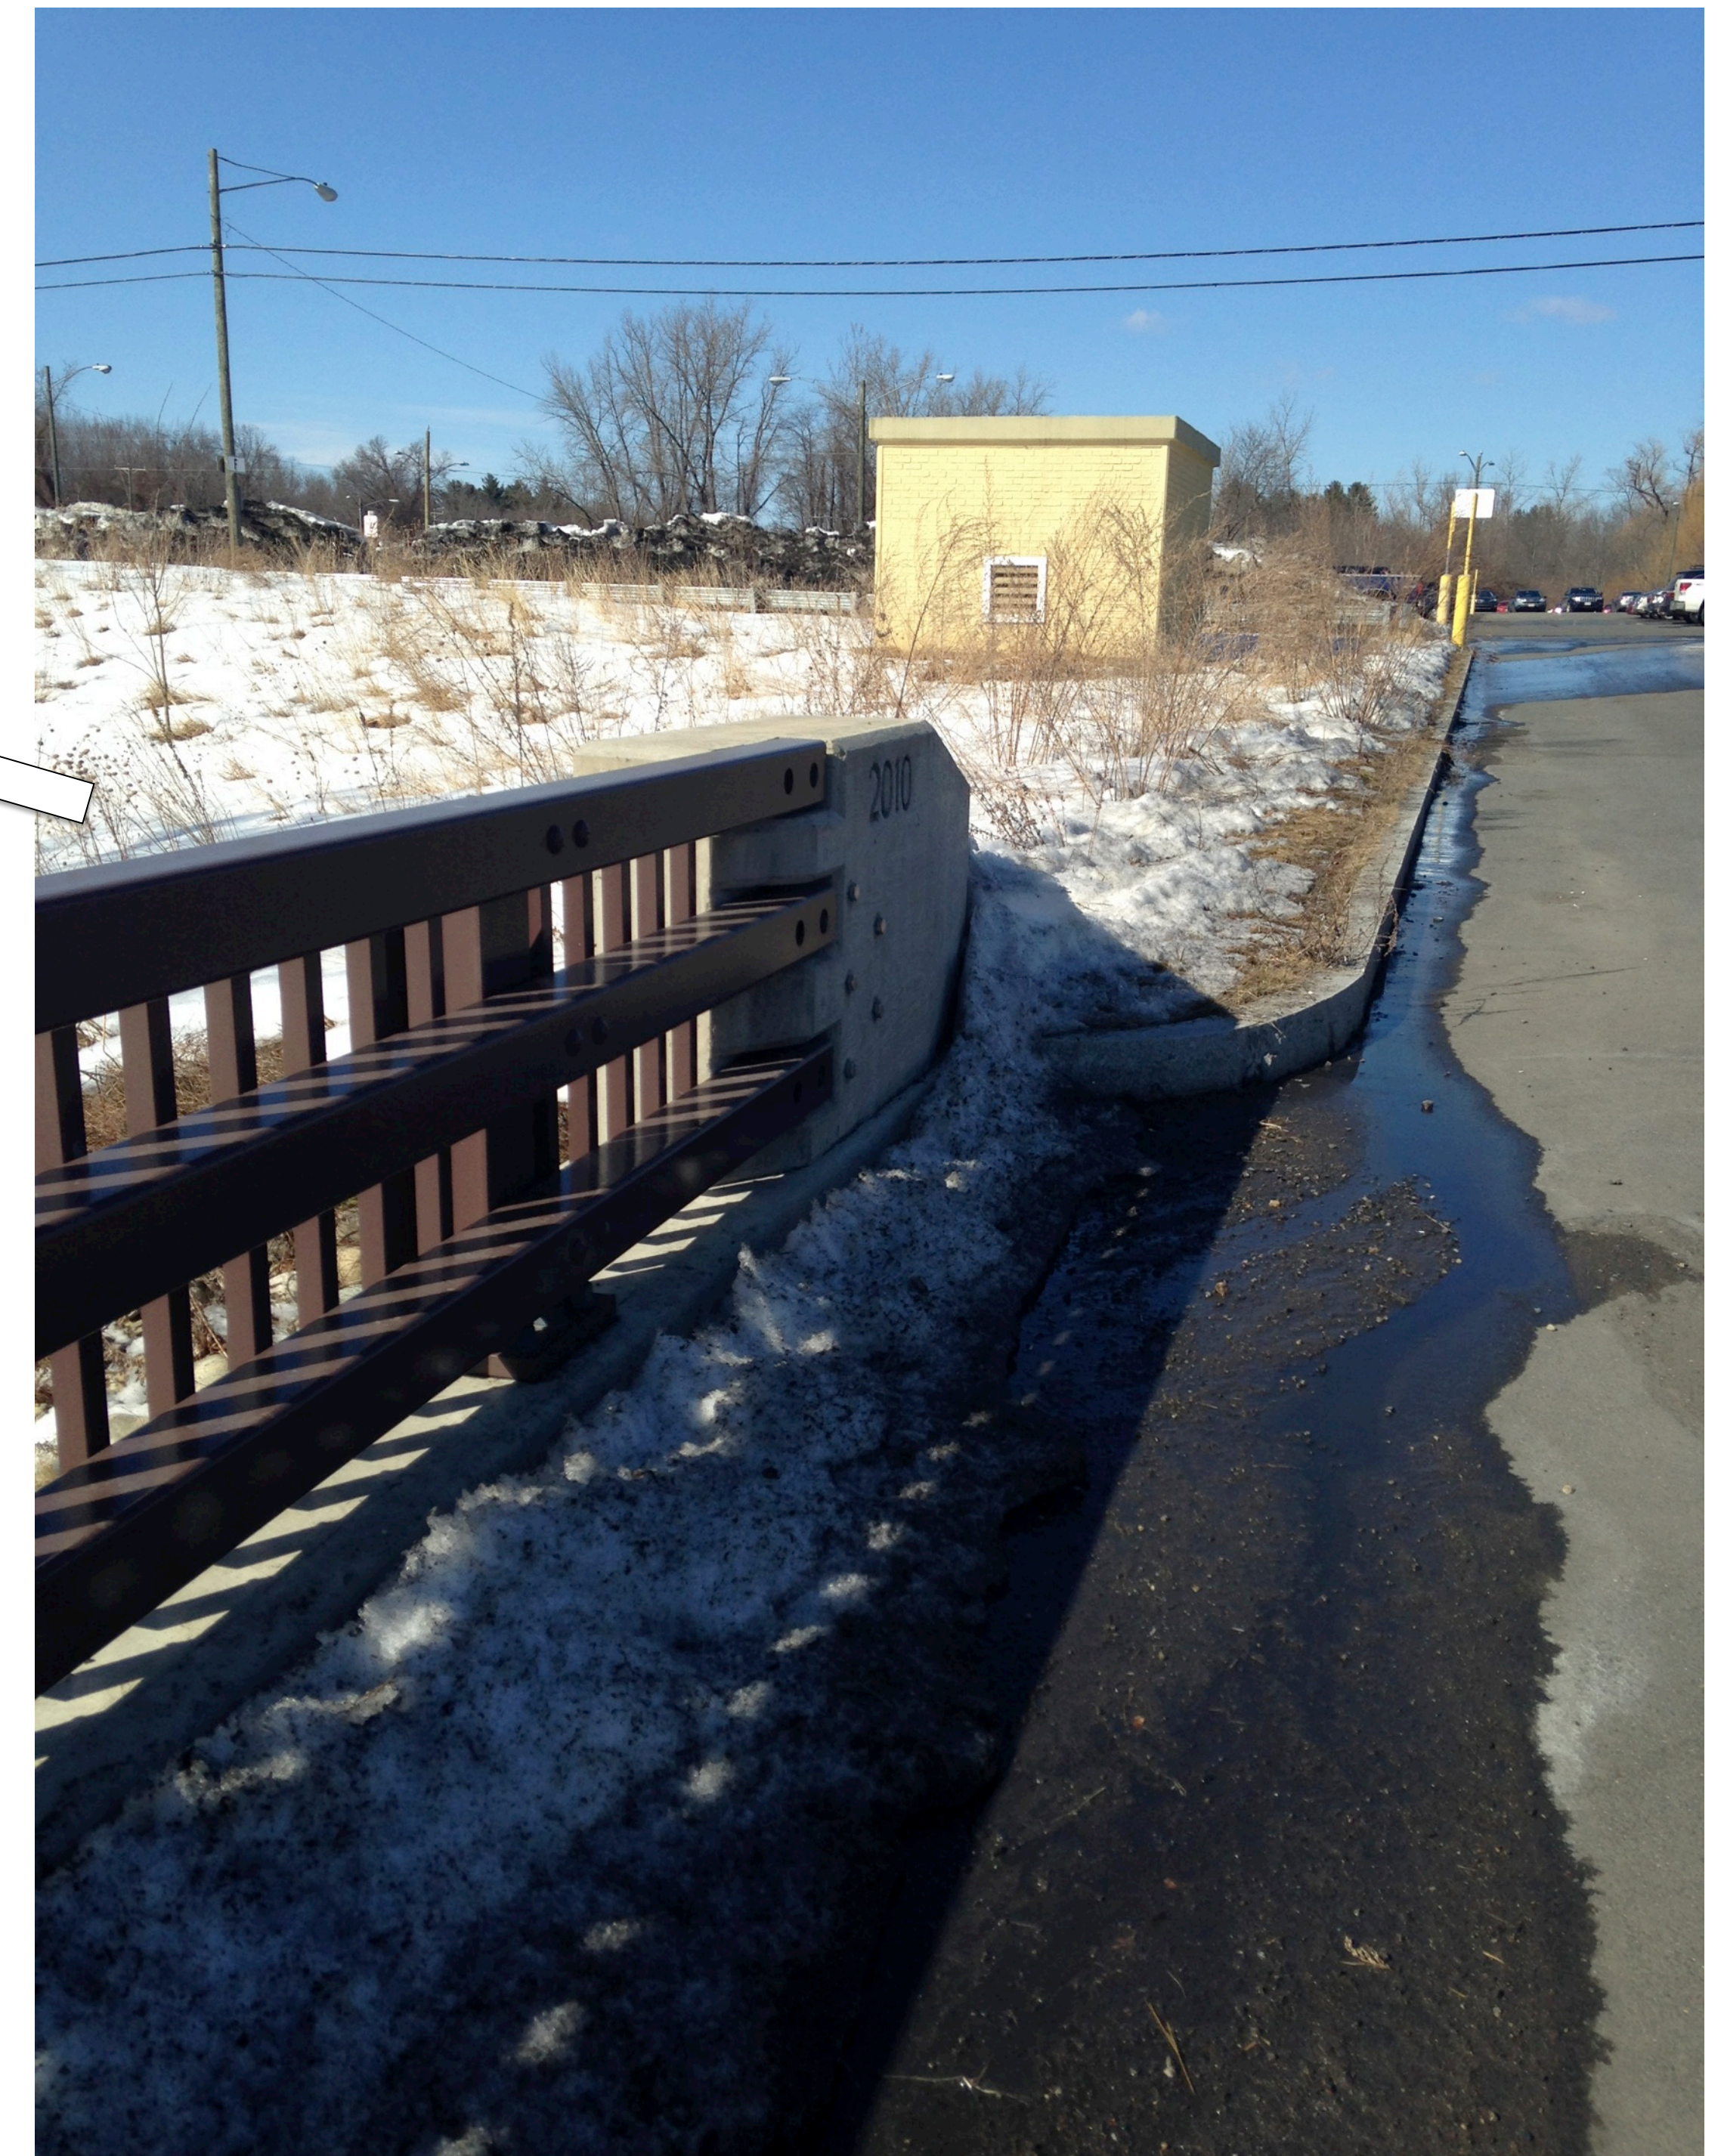
Institutional Site: University of Massachusetts Amherst

- Addition of bridge connection Power Plant to back parking lot of the Mullin's Center in 2010.
- Direct run off from parking lot (shown in picture)
- Infiltration system established on the border of the parking lot and the buffer zone of the stream

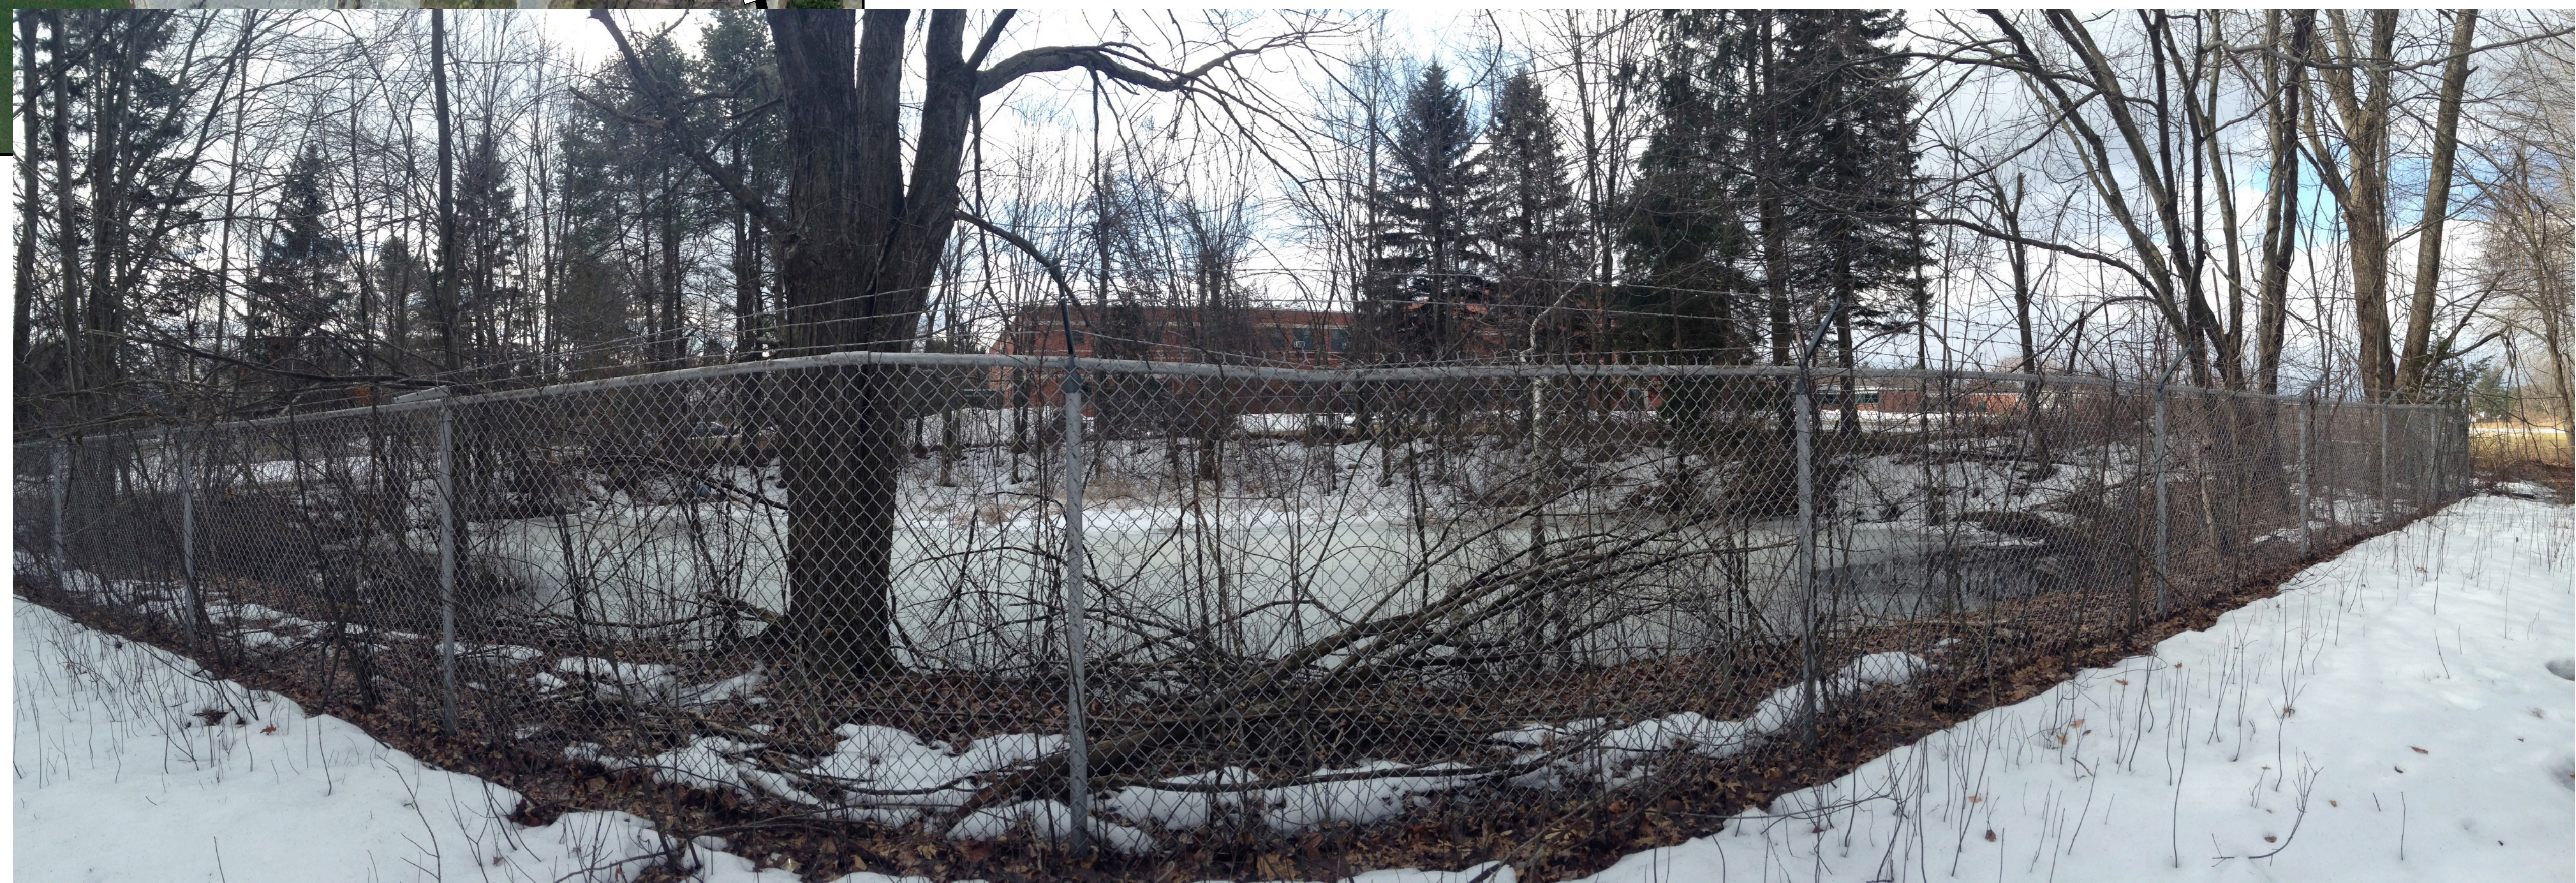
Recreational Site: Amherst Regional High School

- Retention pond (pictured below) fenced off, with 4+ culvert drainage pipes that introduce runoff from surrounding streets, vehicles, buildings, homes, etc.
- Pollution amount is very high
- Frozen over at the time of picture, but after snowmelt was overflowing which resulted in the bordering area to be over flooding
- Affected greatly by the changes in weather
- Fields adjacent were also flooded and muddy

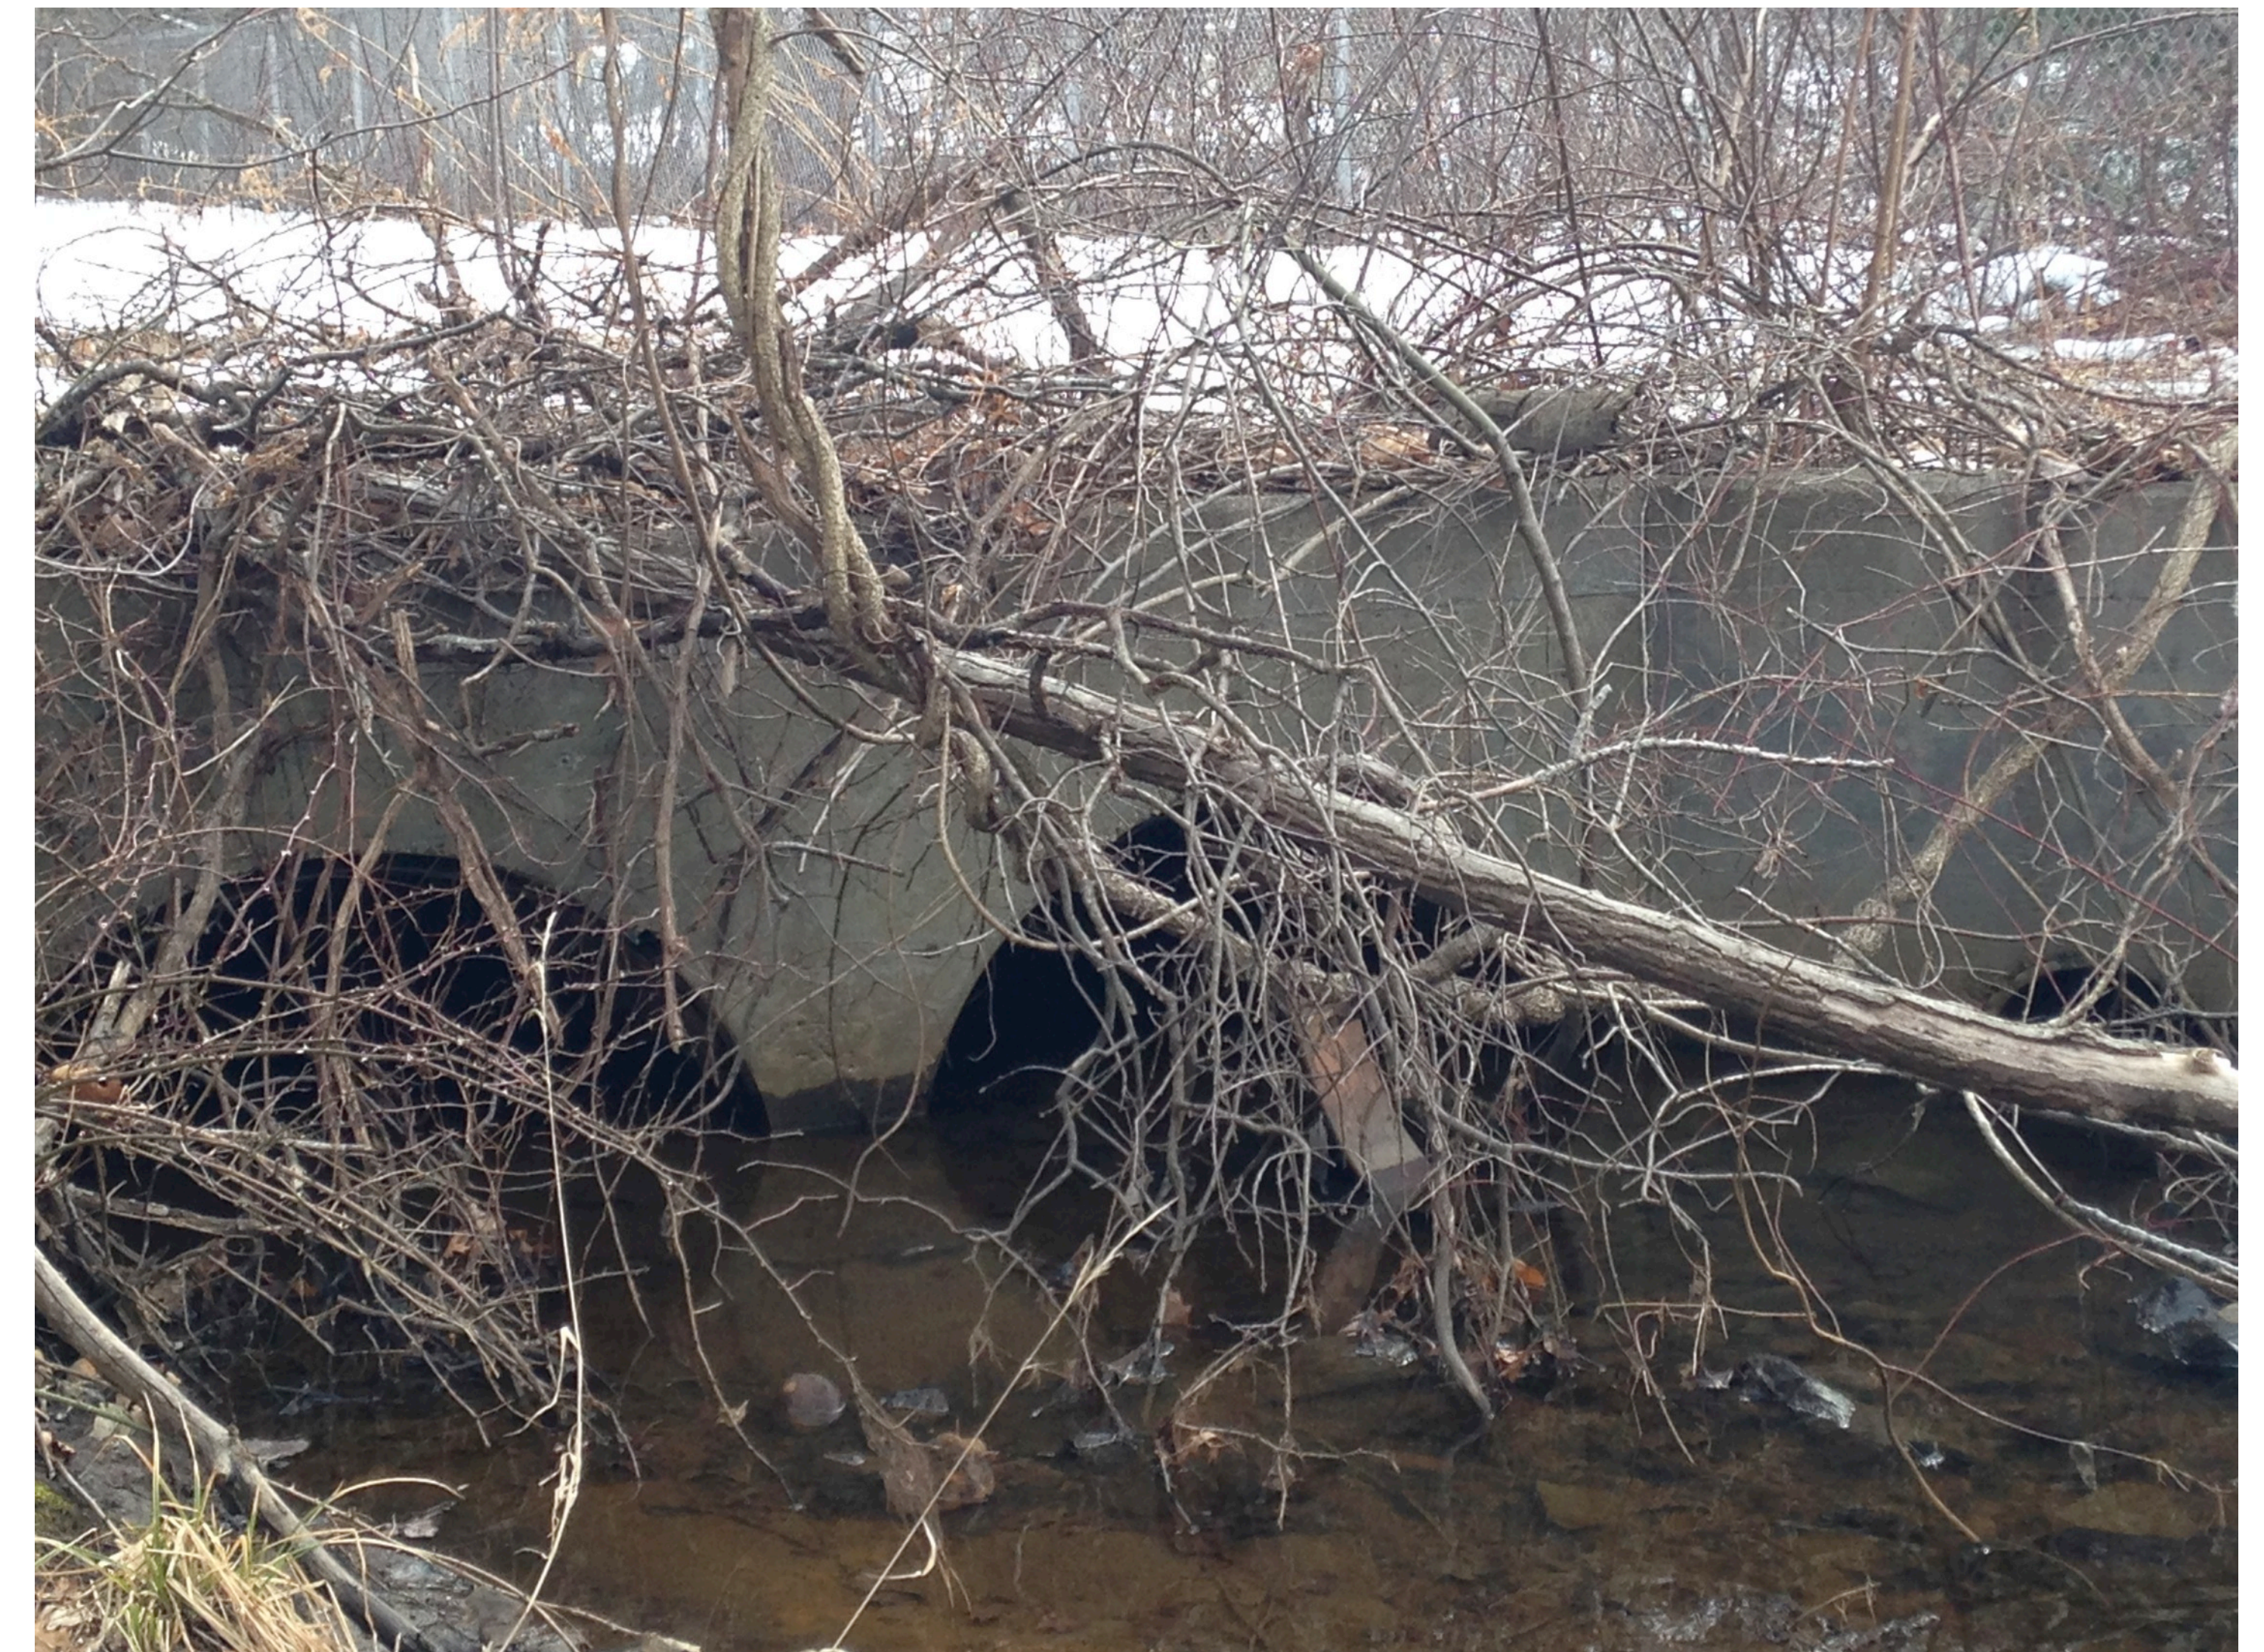
Recreational Site: Amherst Regional High School

- Wetland habitat is prominent (skunk cabbage and moss)
- Pollution is extremely high, most like because of its use by high school/middle school students
- Riffle-pool effect filters stream
- Stream is very low in both velocity and volume
- No observable aquatic wildlife
- Snowmelt resulted in flooding of surrounding area, meandering underground floor up to 30 ft+ from stream
