Qualitative and Comparative Analysis of Stormwater management in the Tan Brook Watershed

Qualitative and Comparative Analysis of Stormwater Management in the Tan Brook Watershed

Natalia von Hausen

Landscape Architecture and Regional Planning Department

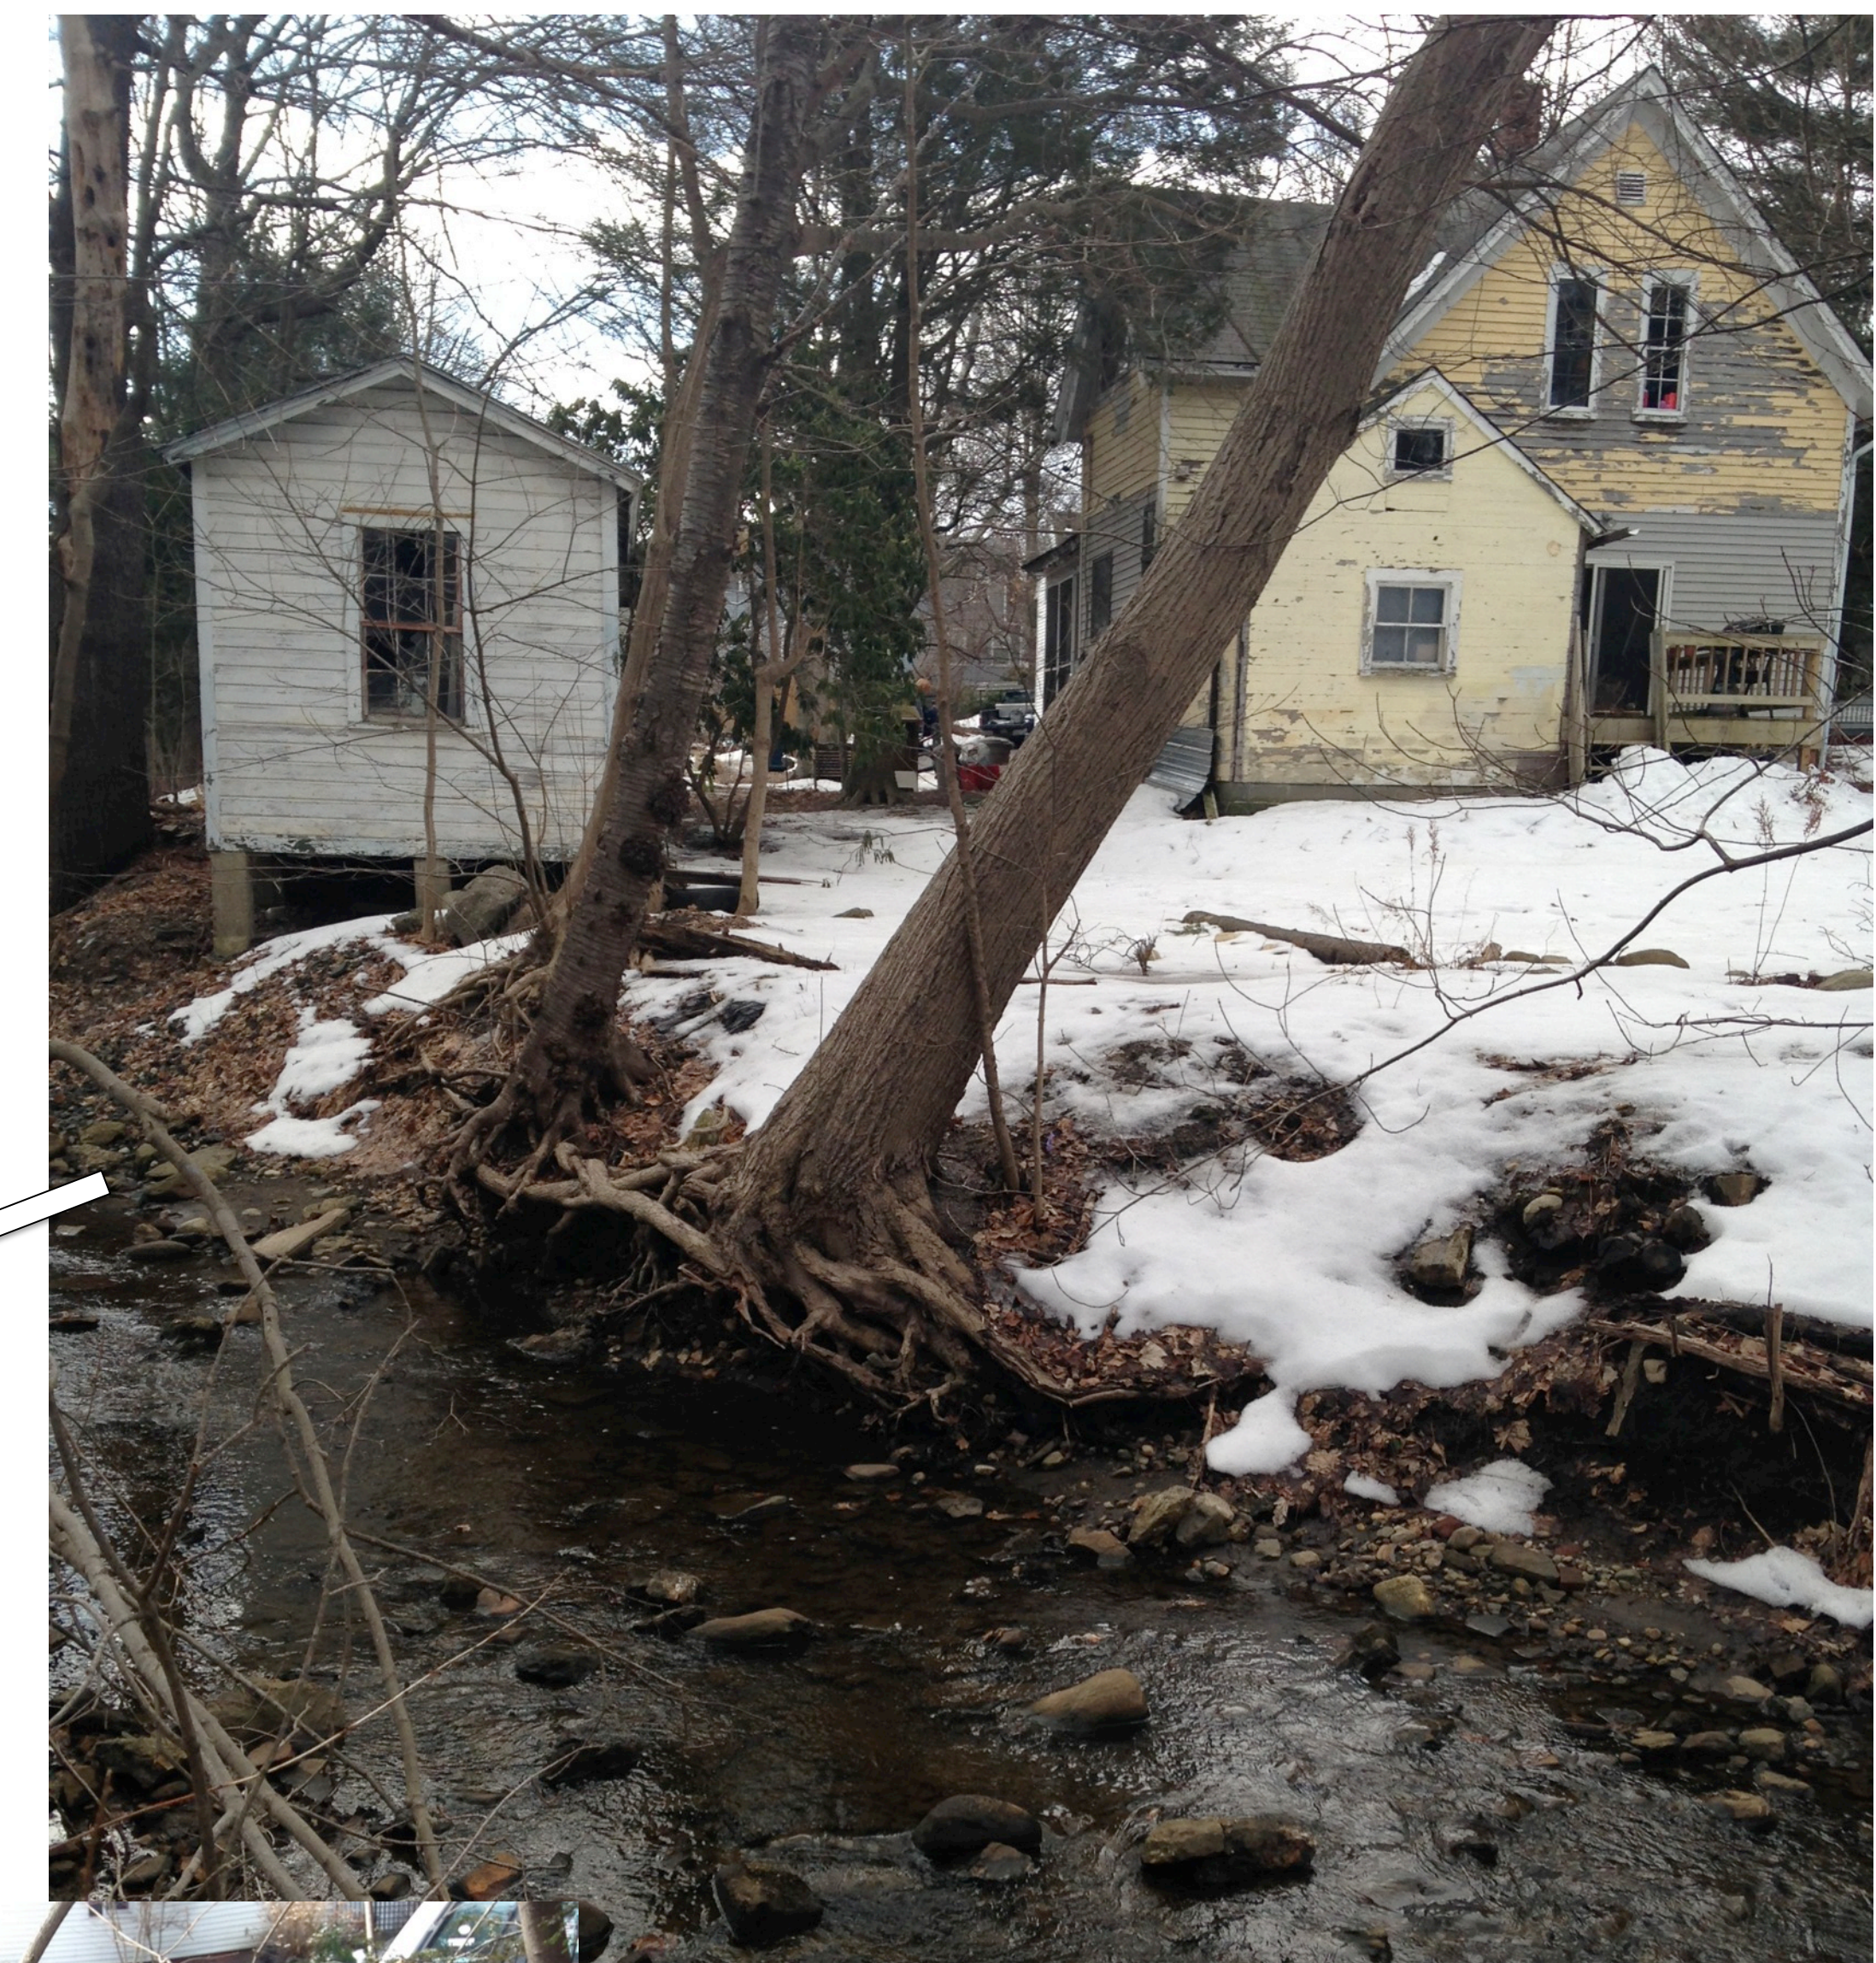
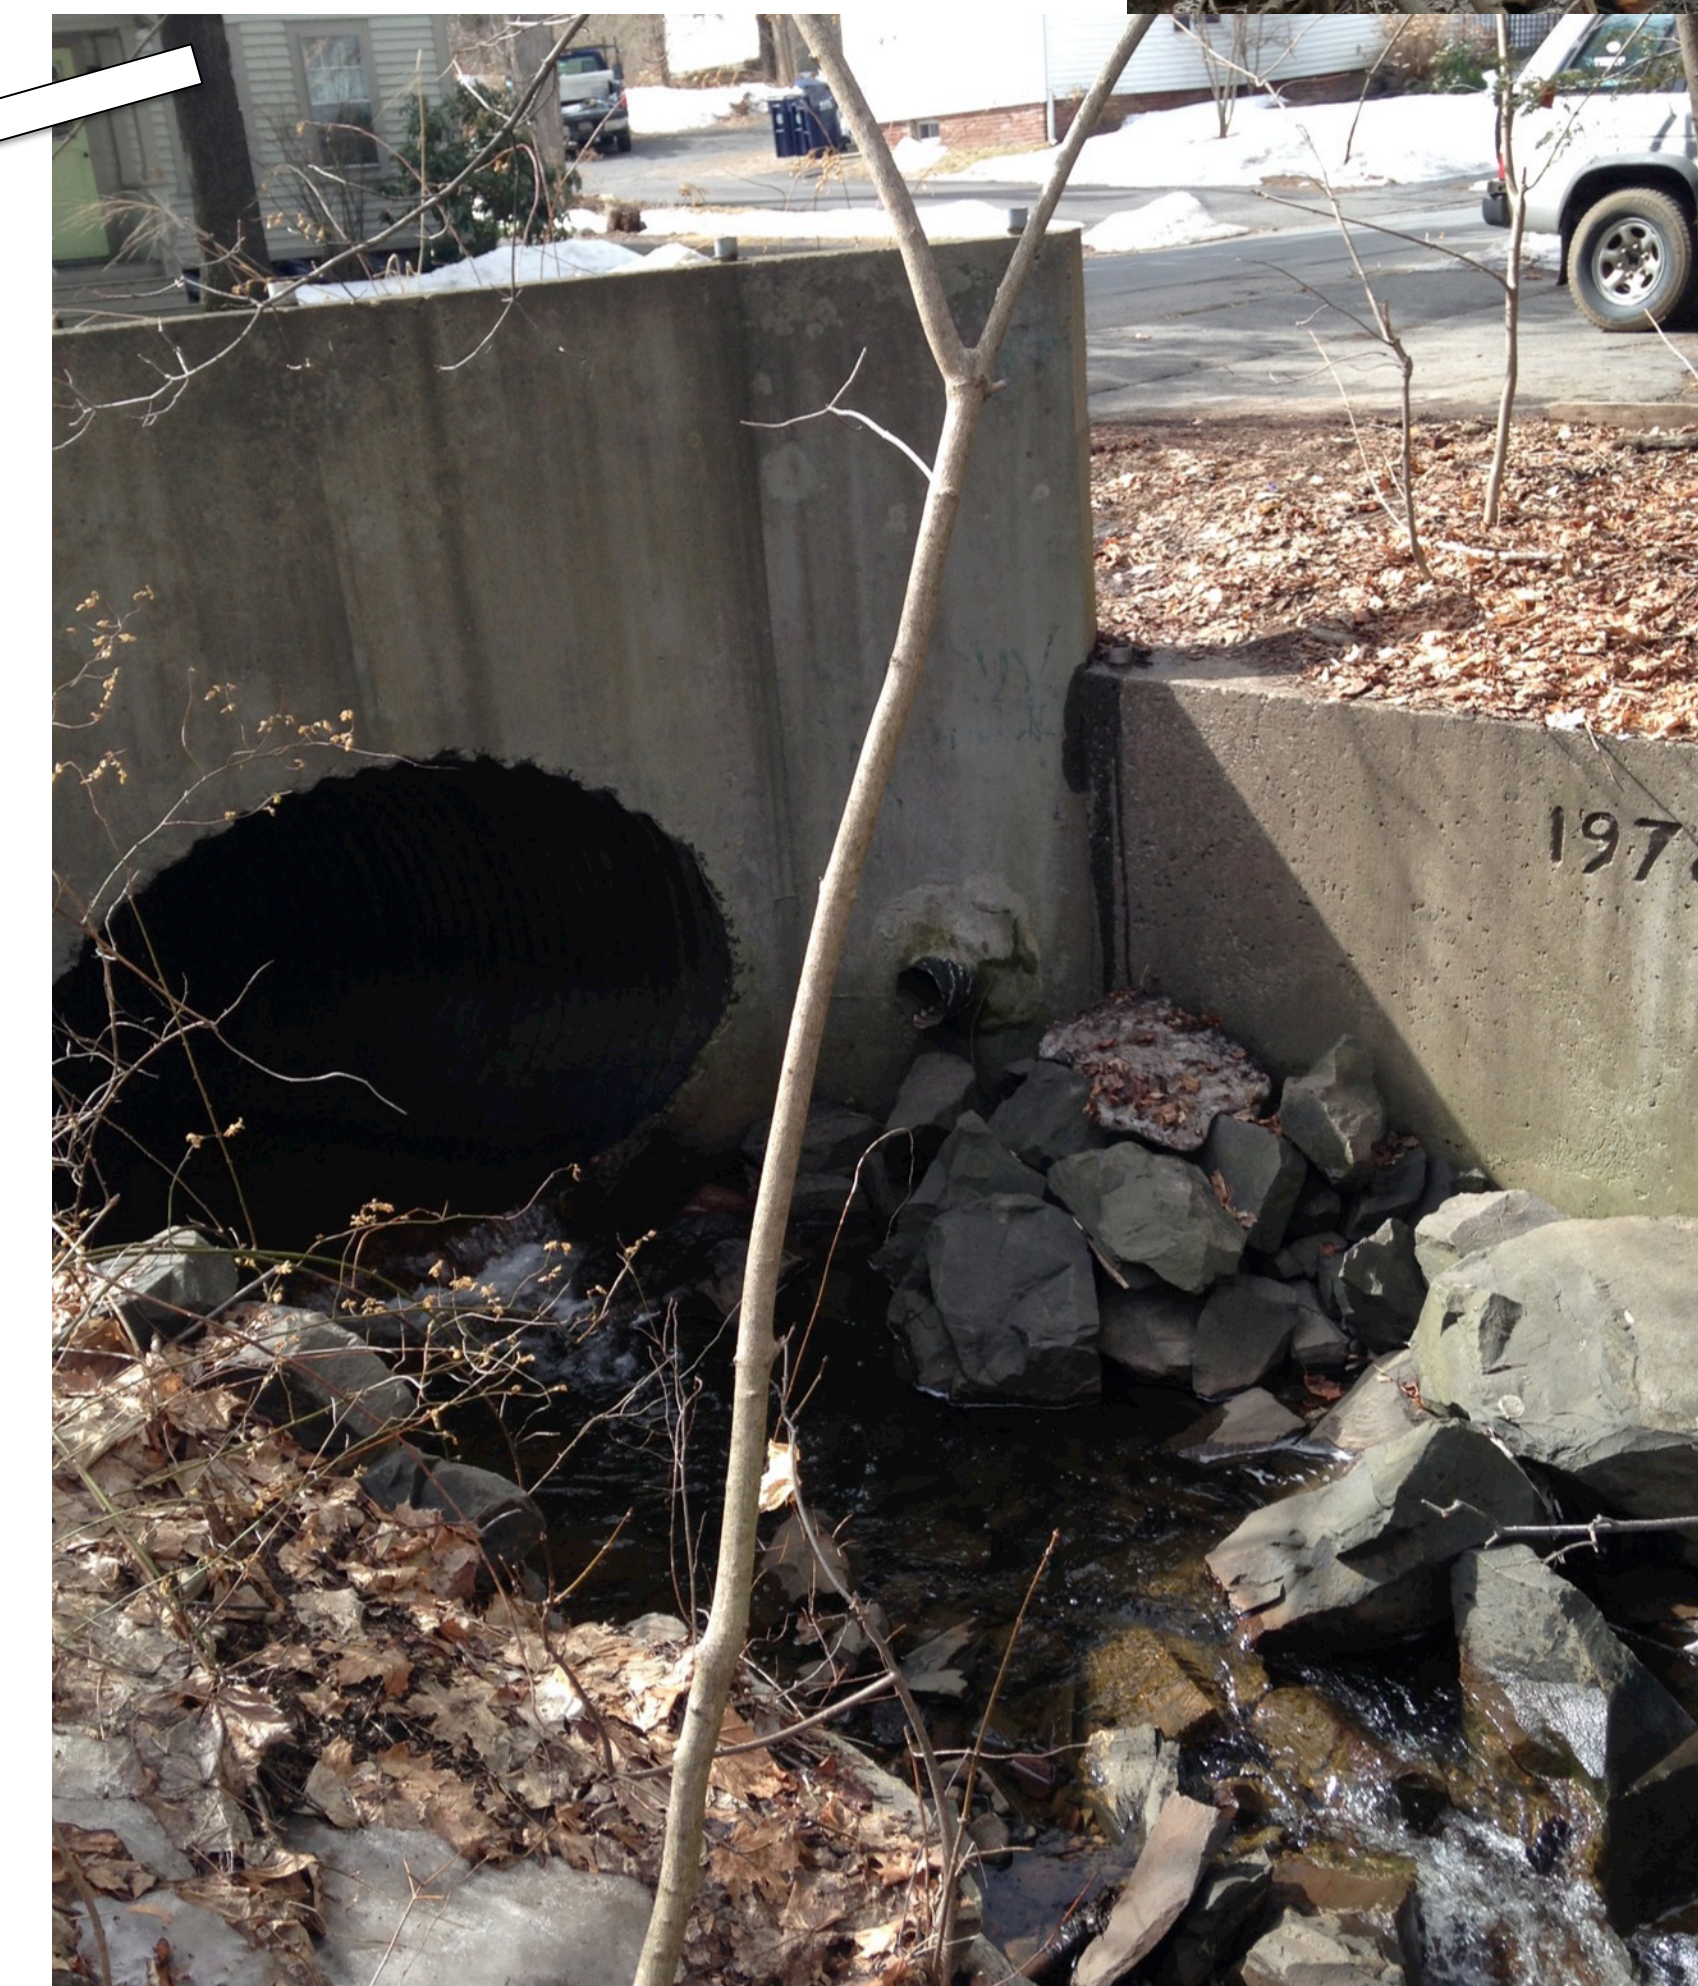
Residential Site: McClellan Street, Amherst MA

- Culvert outfall added in 1978
- Direct run-off from road into stream
- Rock trench infiltration system
- Riffle-pool effect throughout stream
- Velocity was fastest at this site
- Volume was largest
- Erosion was extremely prominent, having 10+ almost on the verge of falling
- Substantial amount of pollution
- Adjacent residential homes were less than 10 feet from direct stream

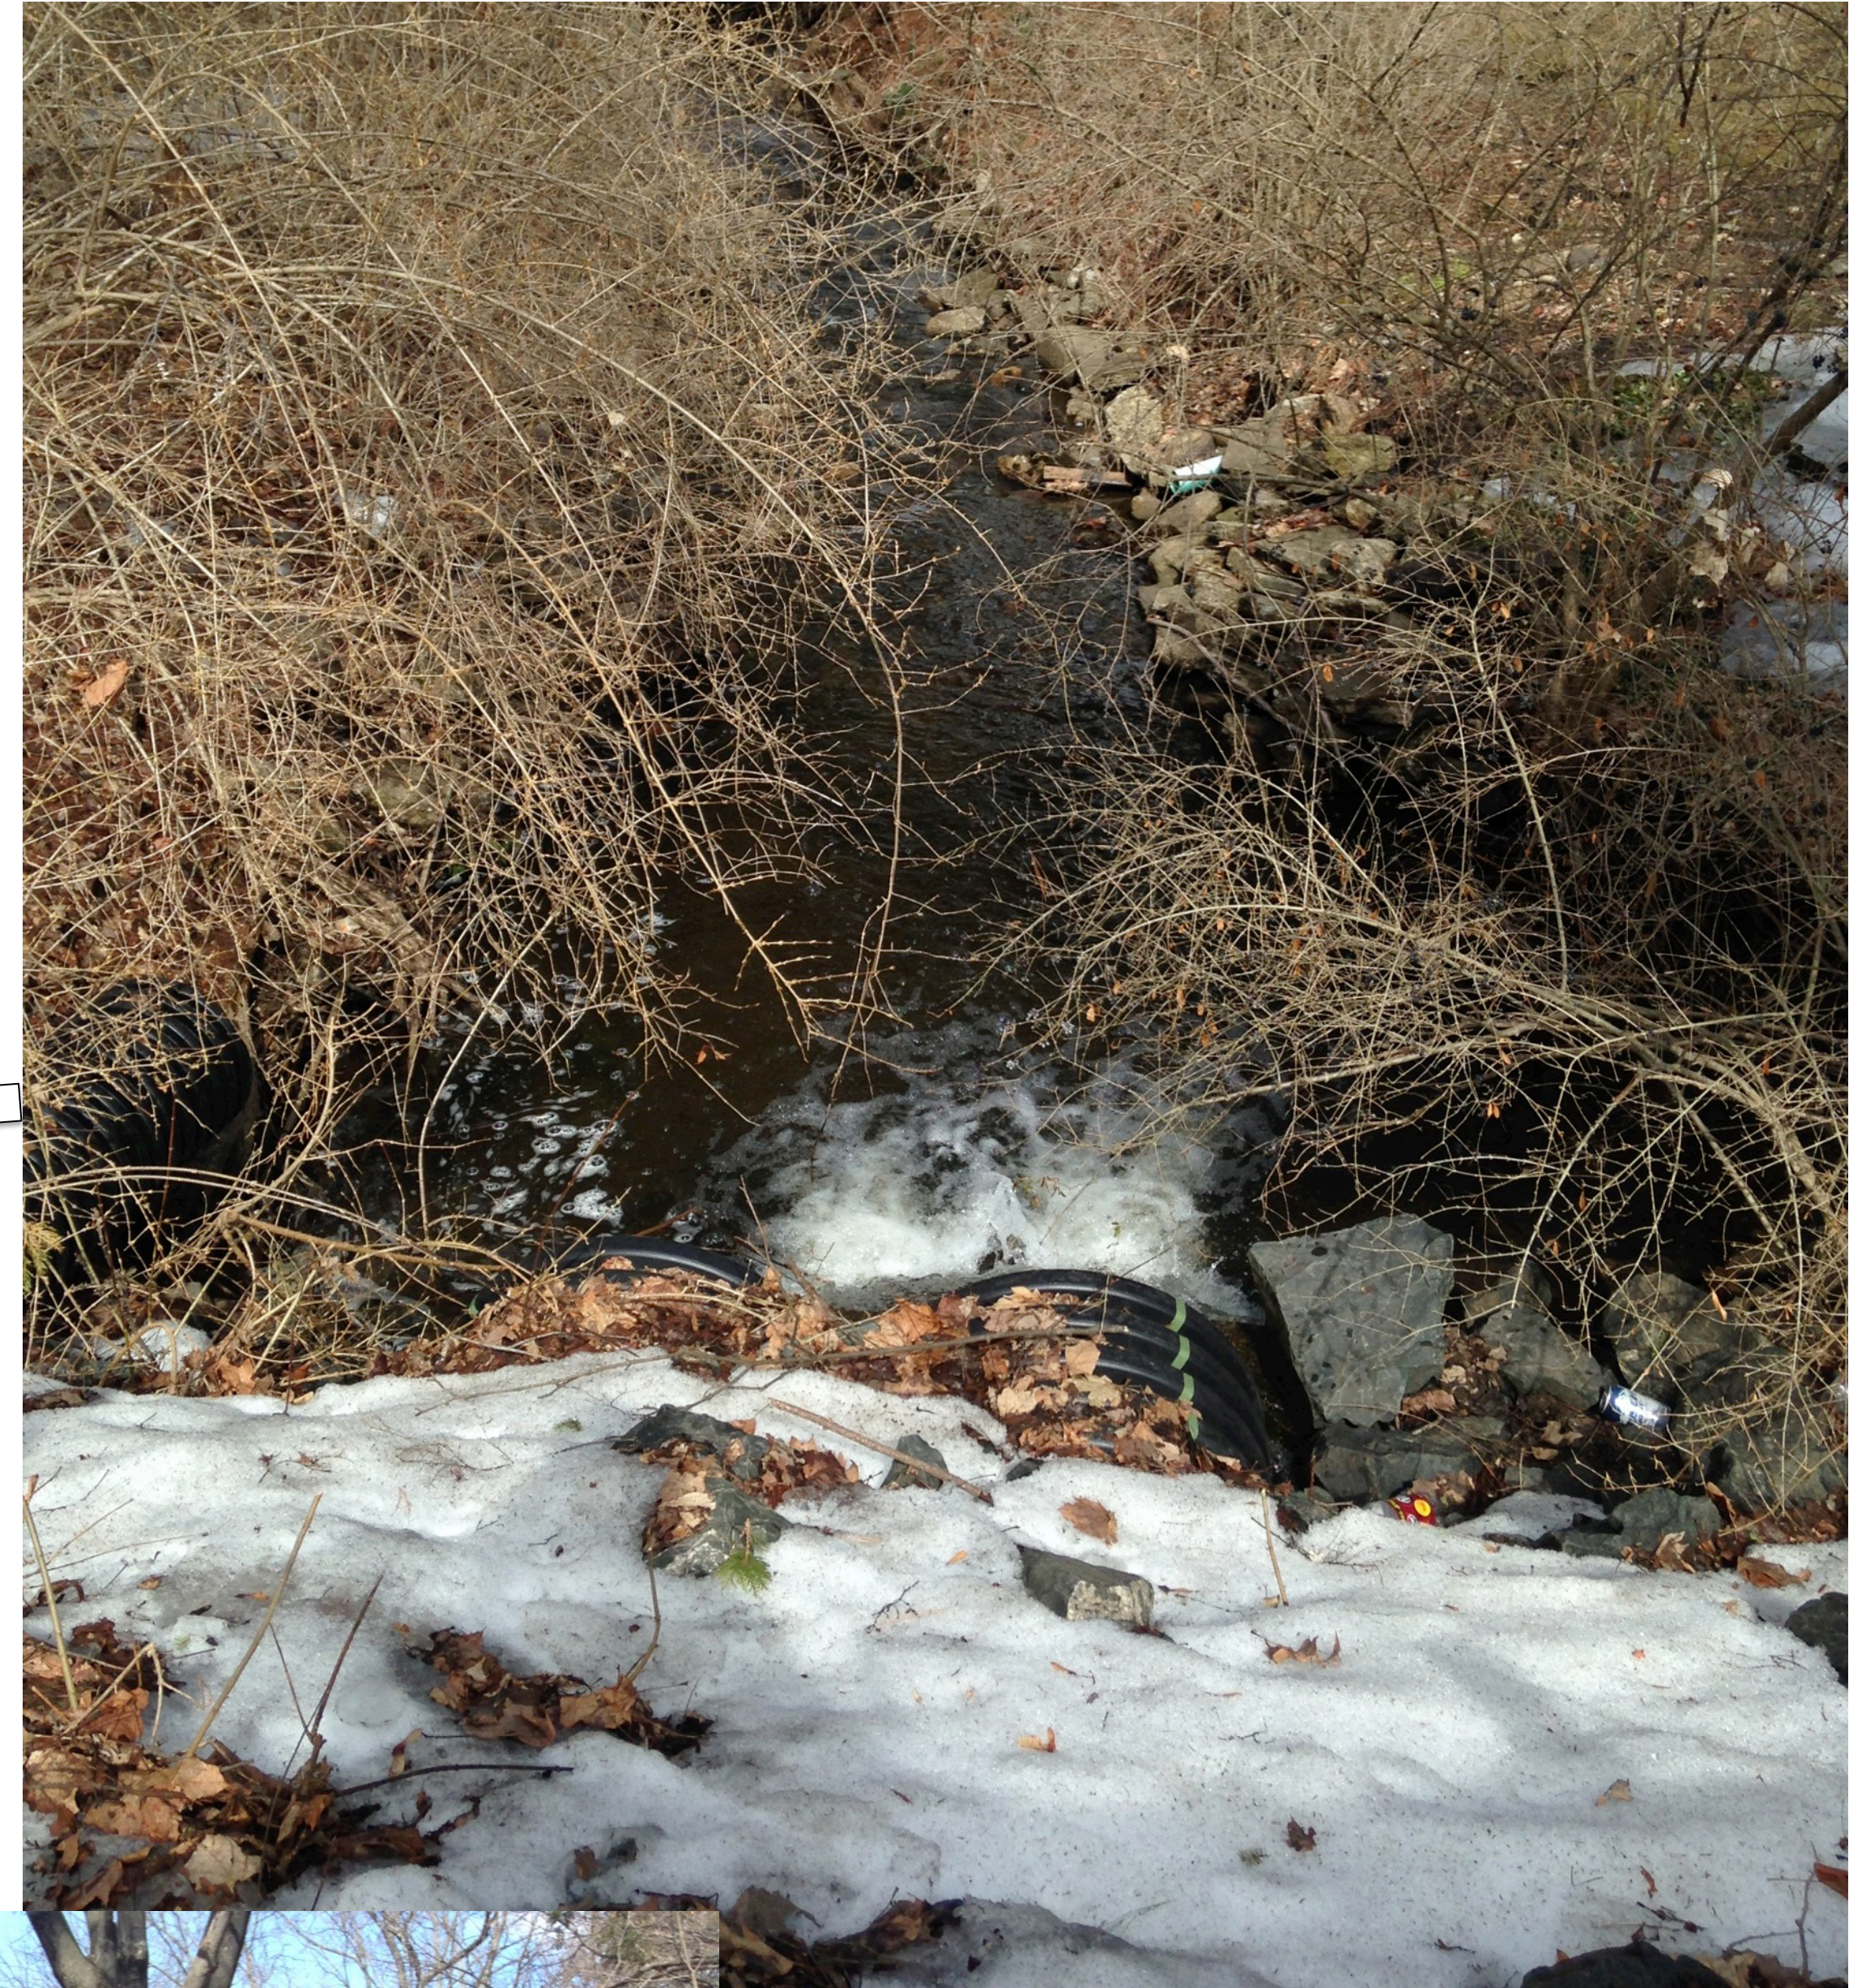
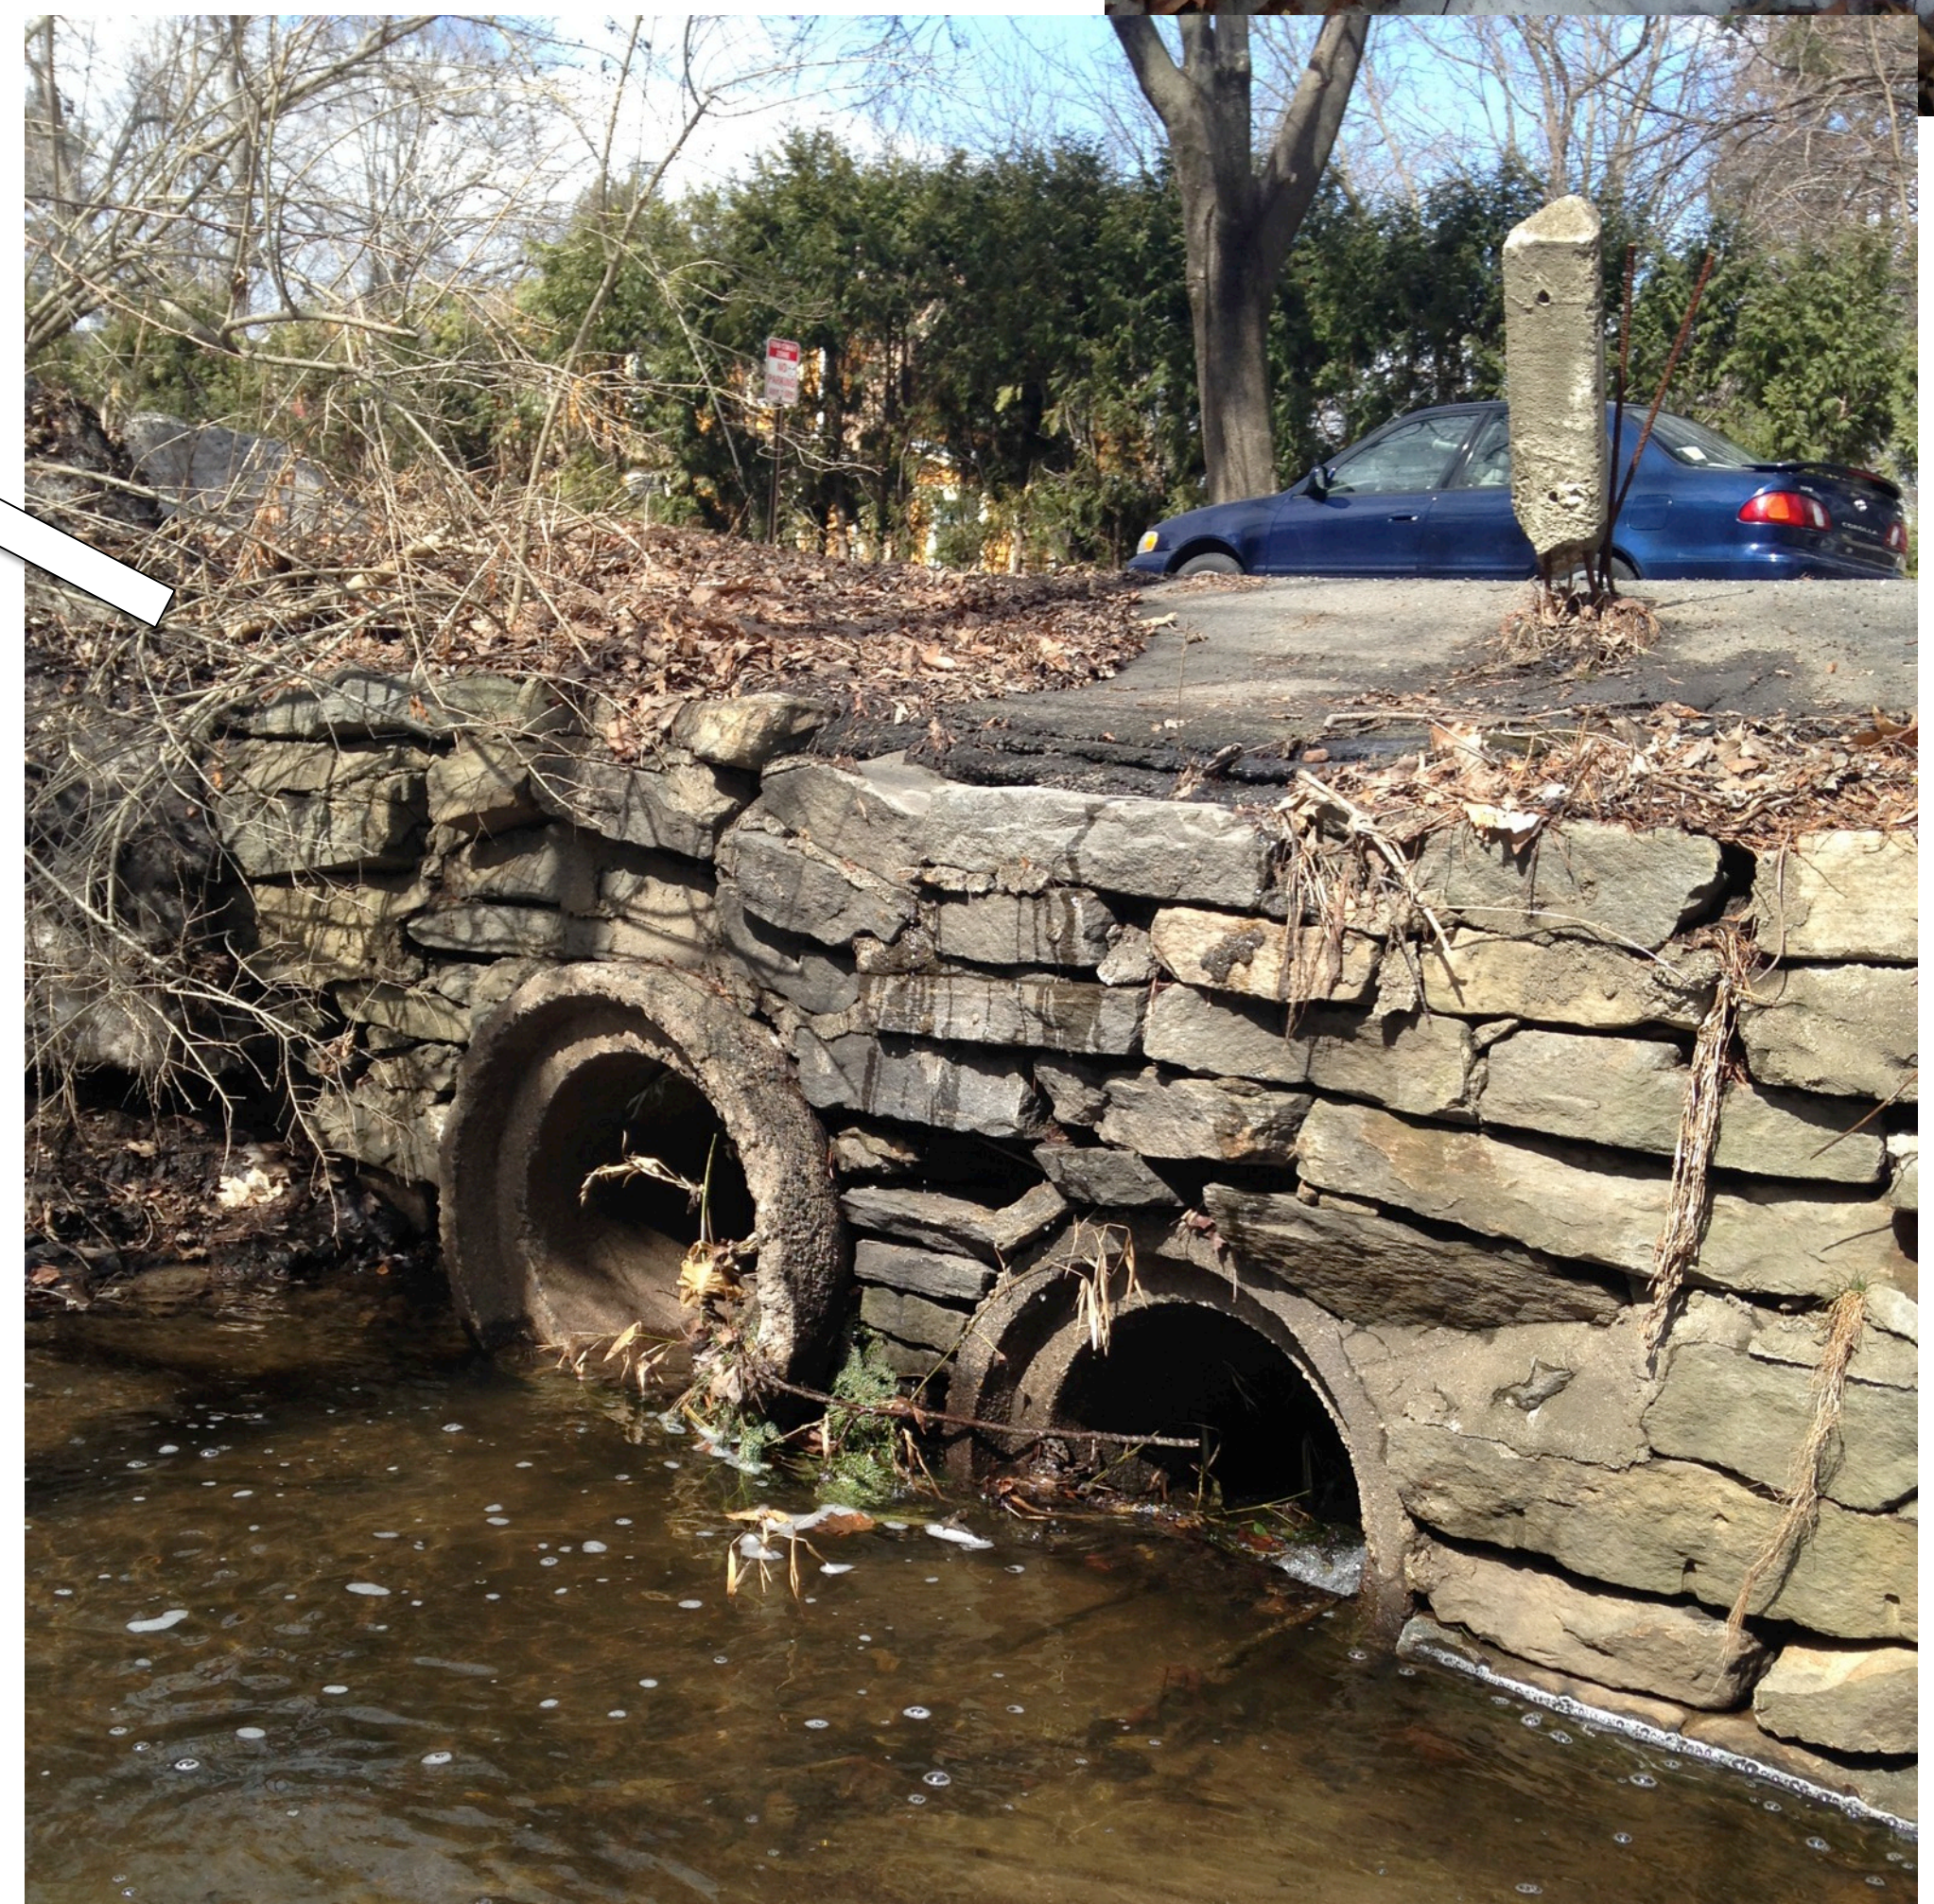
Residential Site: Fearing Street, Amherst MA

- Snowmelt uncovered high amount of litter and pollution
- Two culvert outfall drainage systems run the stream underneath the road
- Absolutely no infiltration or drainage system on south side of street (Image to the right) run-off from street was directly flowing into stream
- Wetland wildlife framed the area around the site
- Turns into a stream with two different piped streams (parking lot the stream diverges)
- Rocks border the stream and yards for slight erosion control

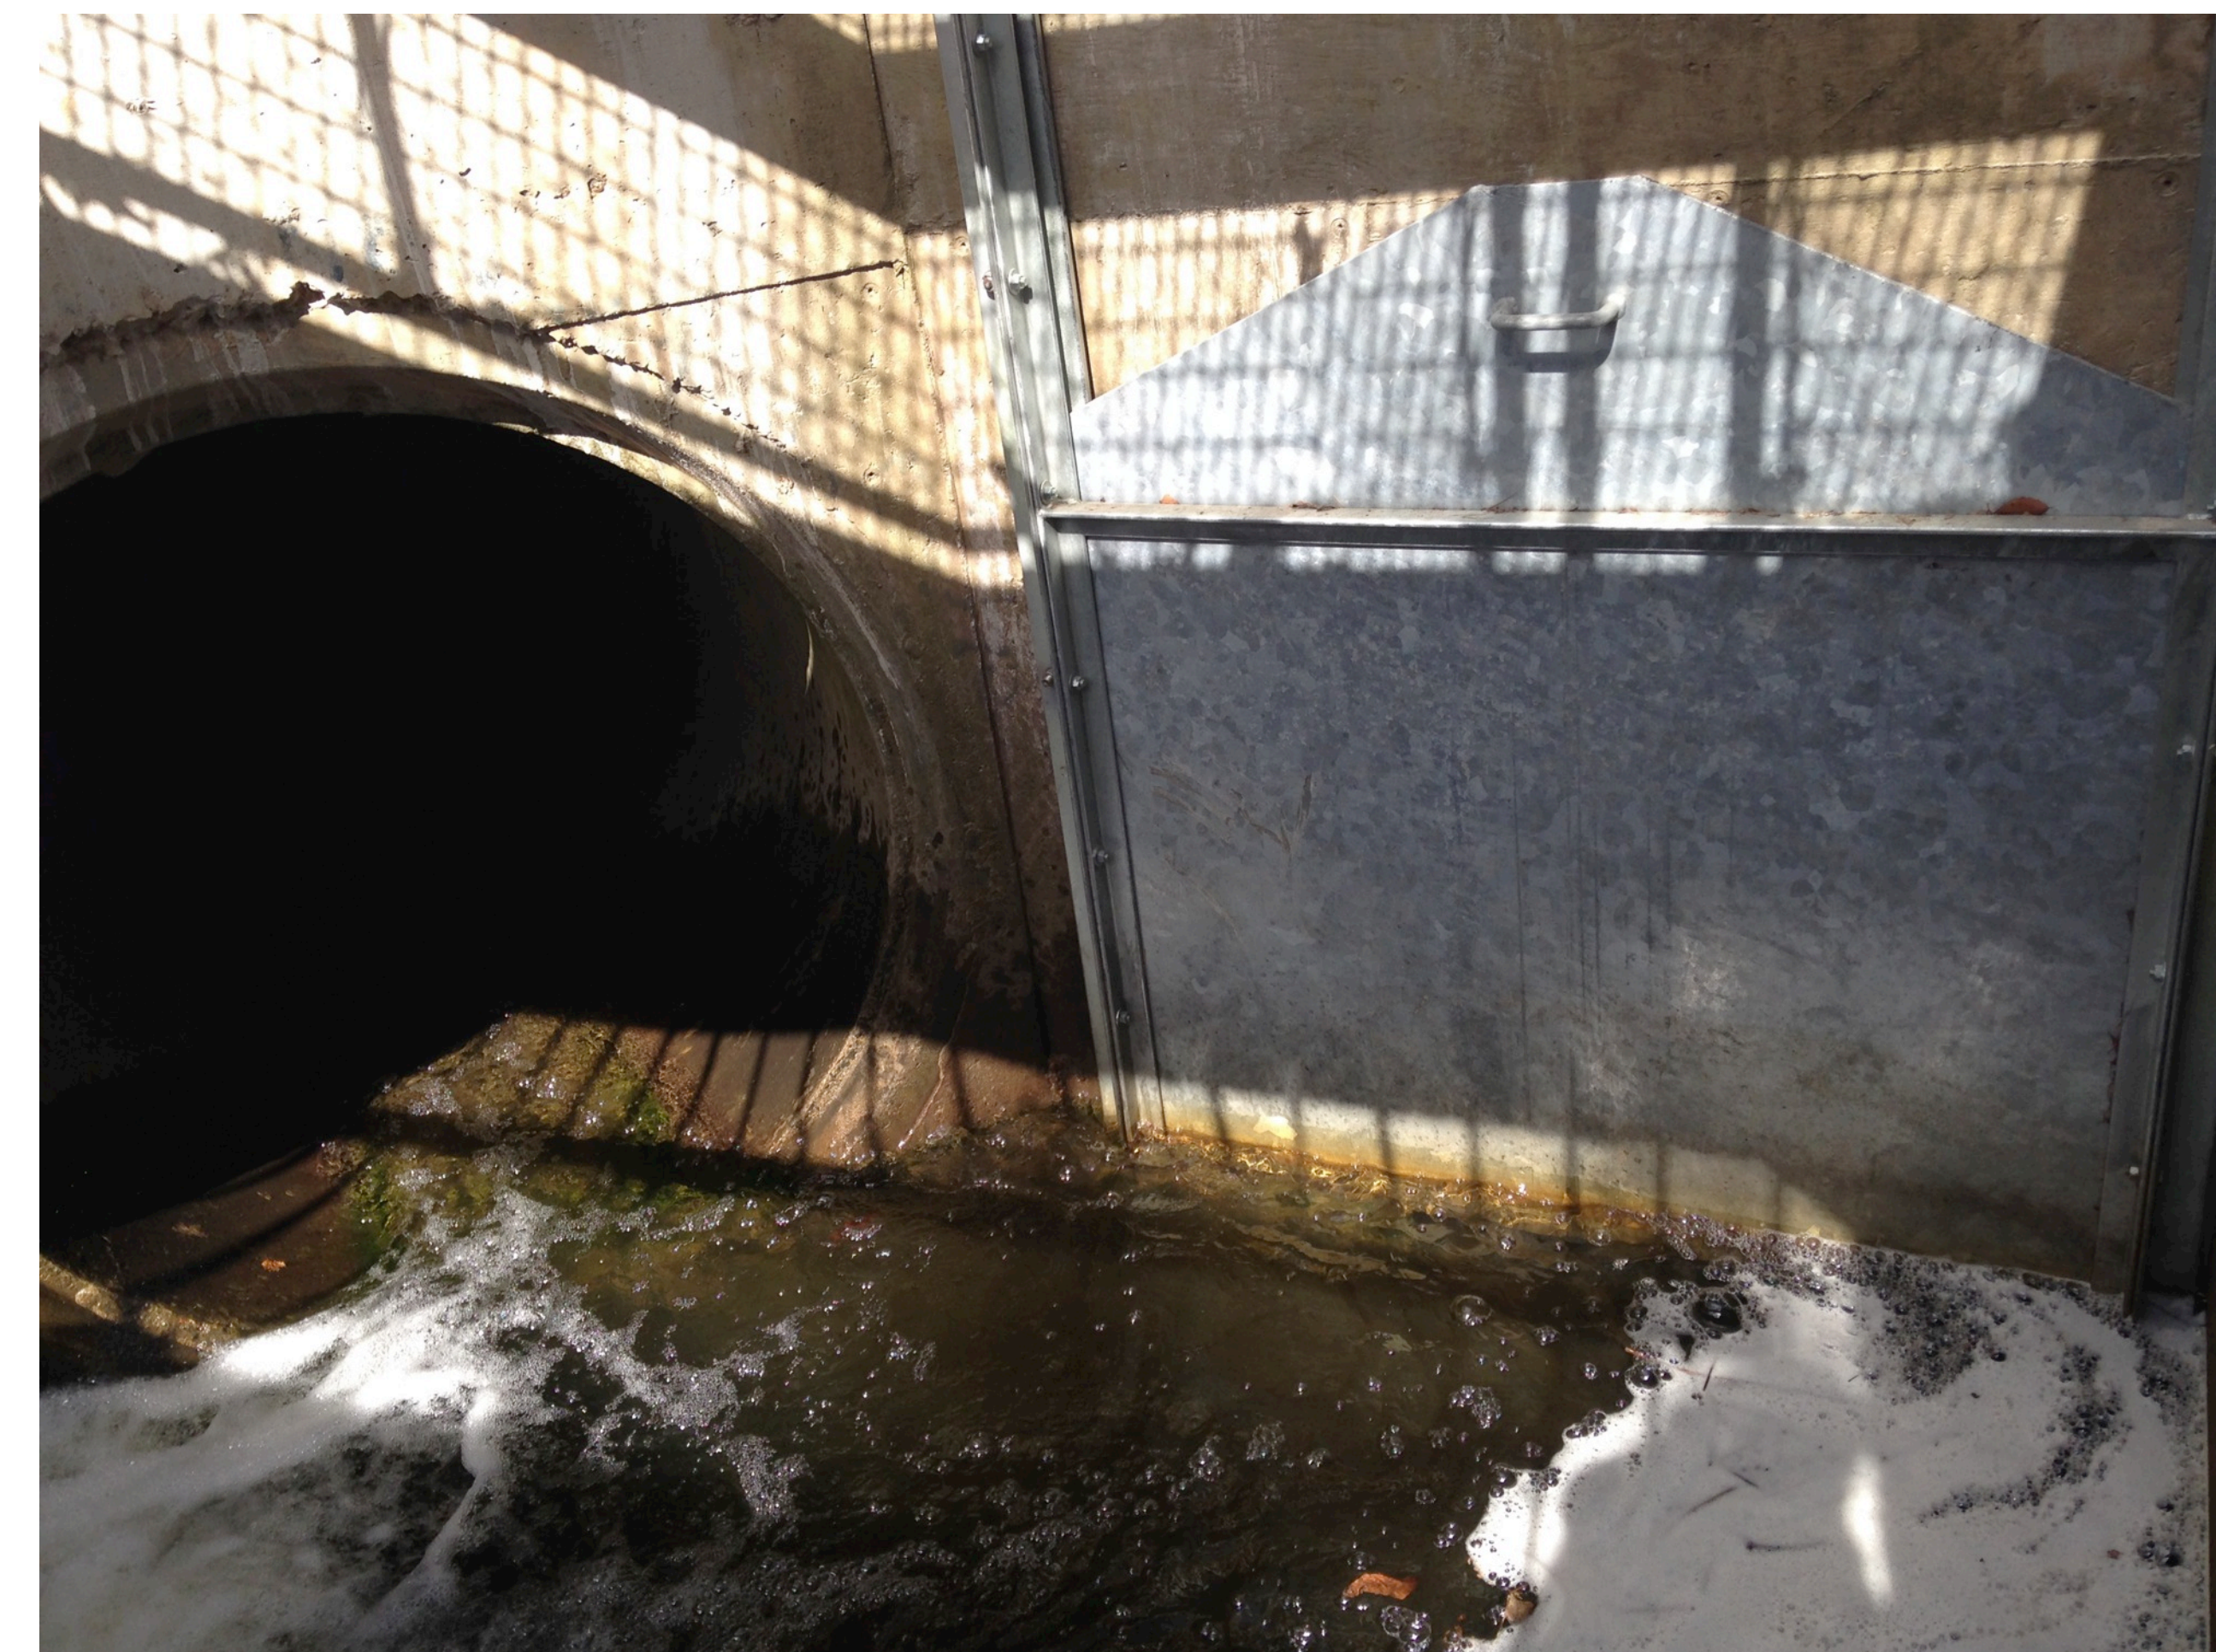
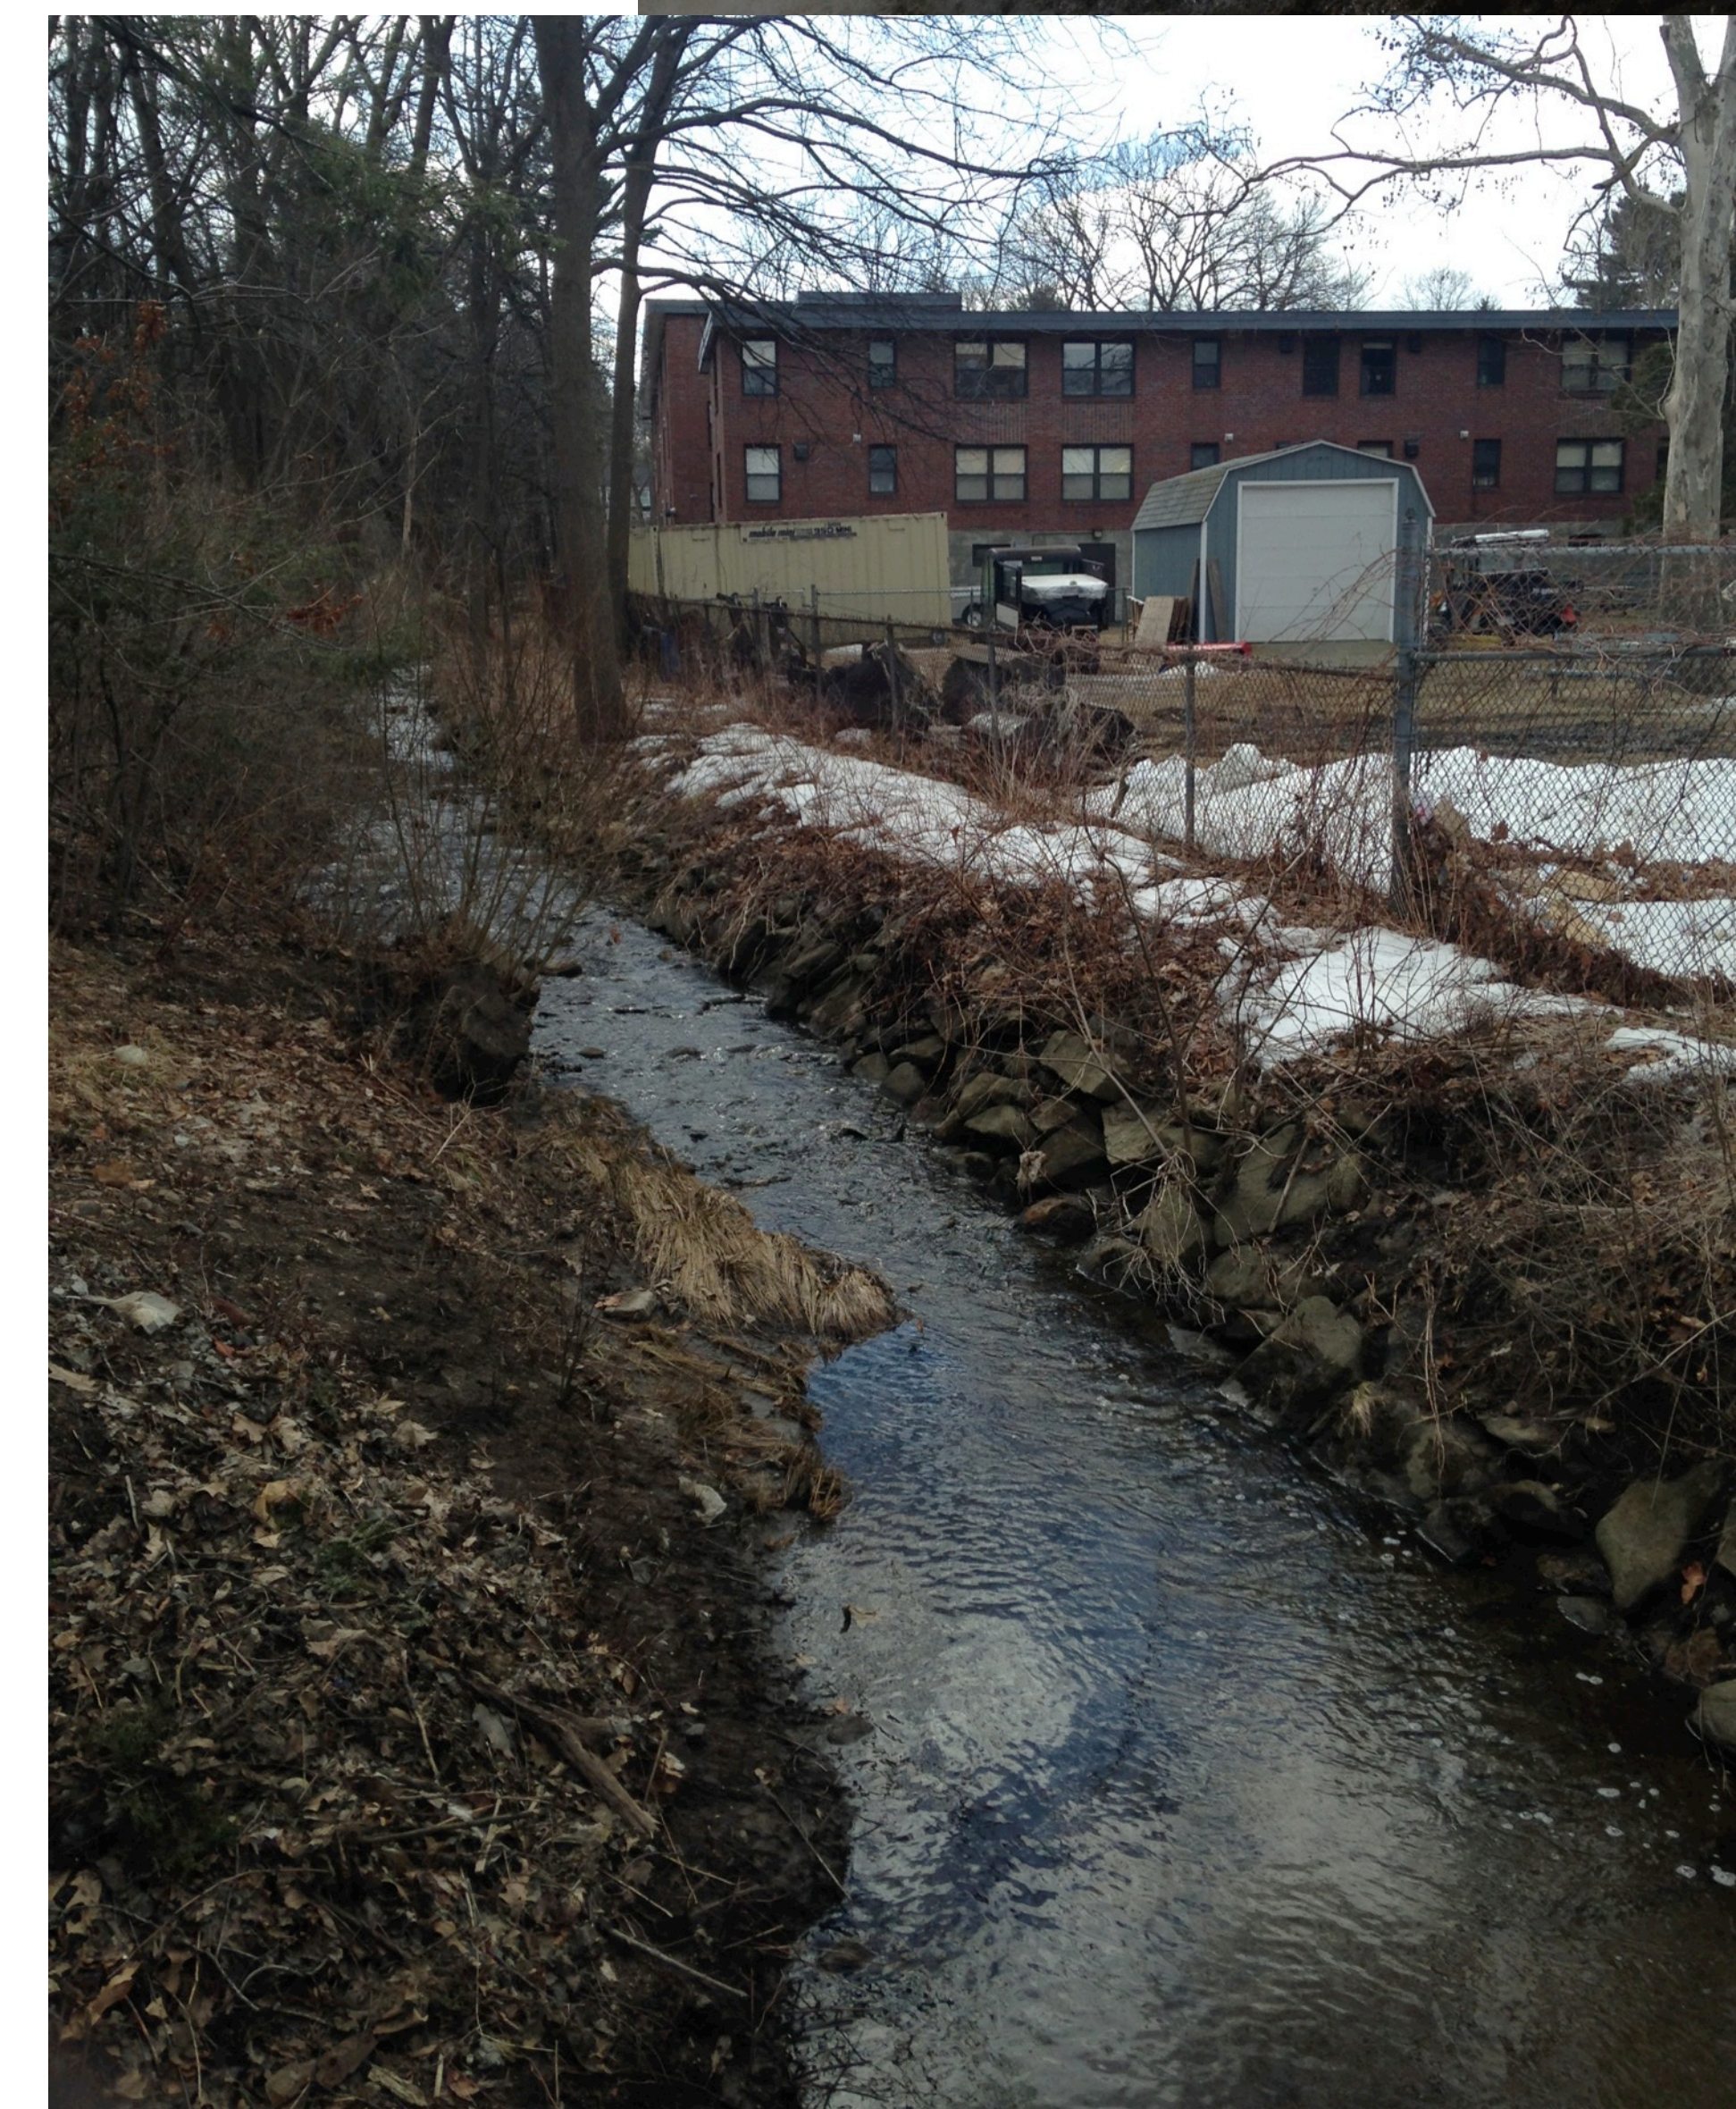
Residential Site: Visitors Parking lot Umass Amherst

- This was the end of the daylighted stream that runs through the residential neighborhoods
- Once it reaches the edge of the visitors parking lot on the Umass Campus it gets piped.
- On the image to the bottom right the right side is Umass property and the left is private property. On the left was erosion control through rip rap erosion control whereas on the other side no type of erosion control was being practiced.
- Wet land habitat was visible on private property side
- The divergent streams (top right image) are directed, one towards the sport fields by the Mullin's Center and the other towards the Campus pond (which is the direction of the stream).
- The stream that goes towards the Mullins Center has resulted in the collapse of vegetative swales
