HYRUM PROJECT - UTAH

PROPOSED
REHABILITATION
AND
BETTERMENT
PROGRAM
DRAFT

FEBRUARY 1989

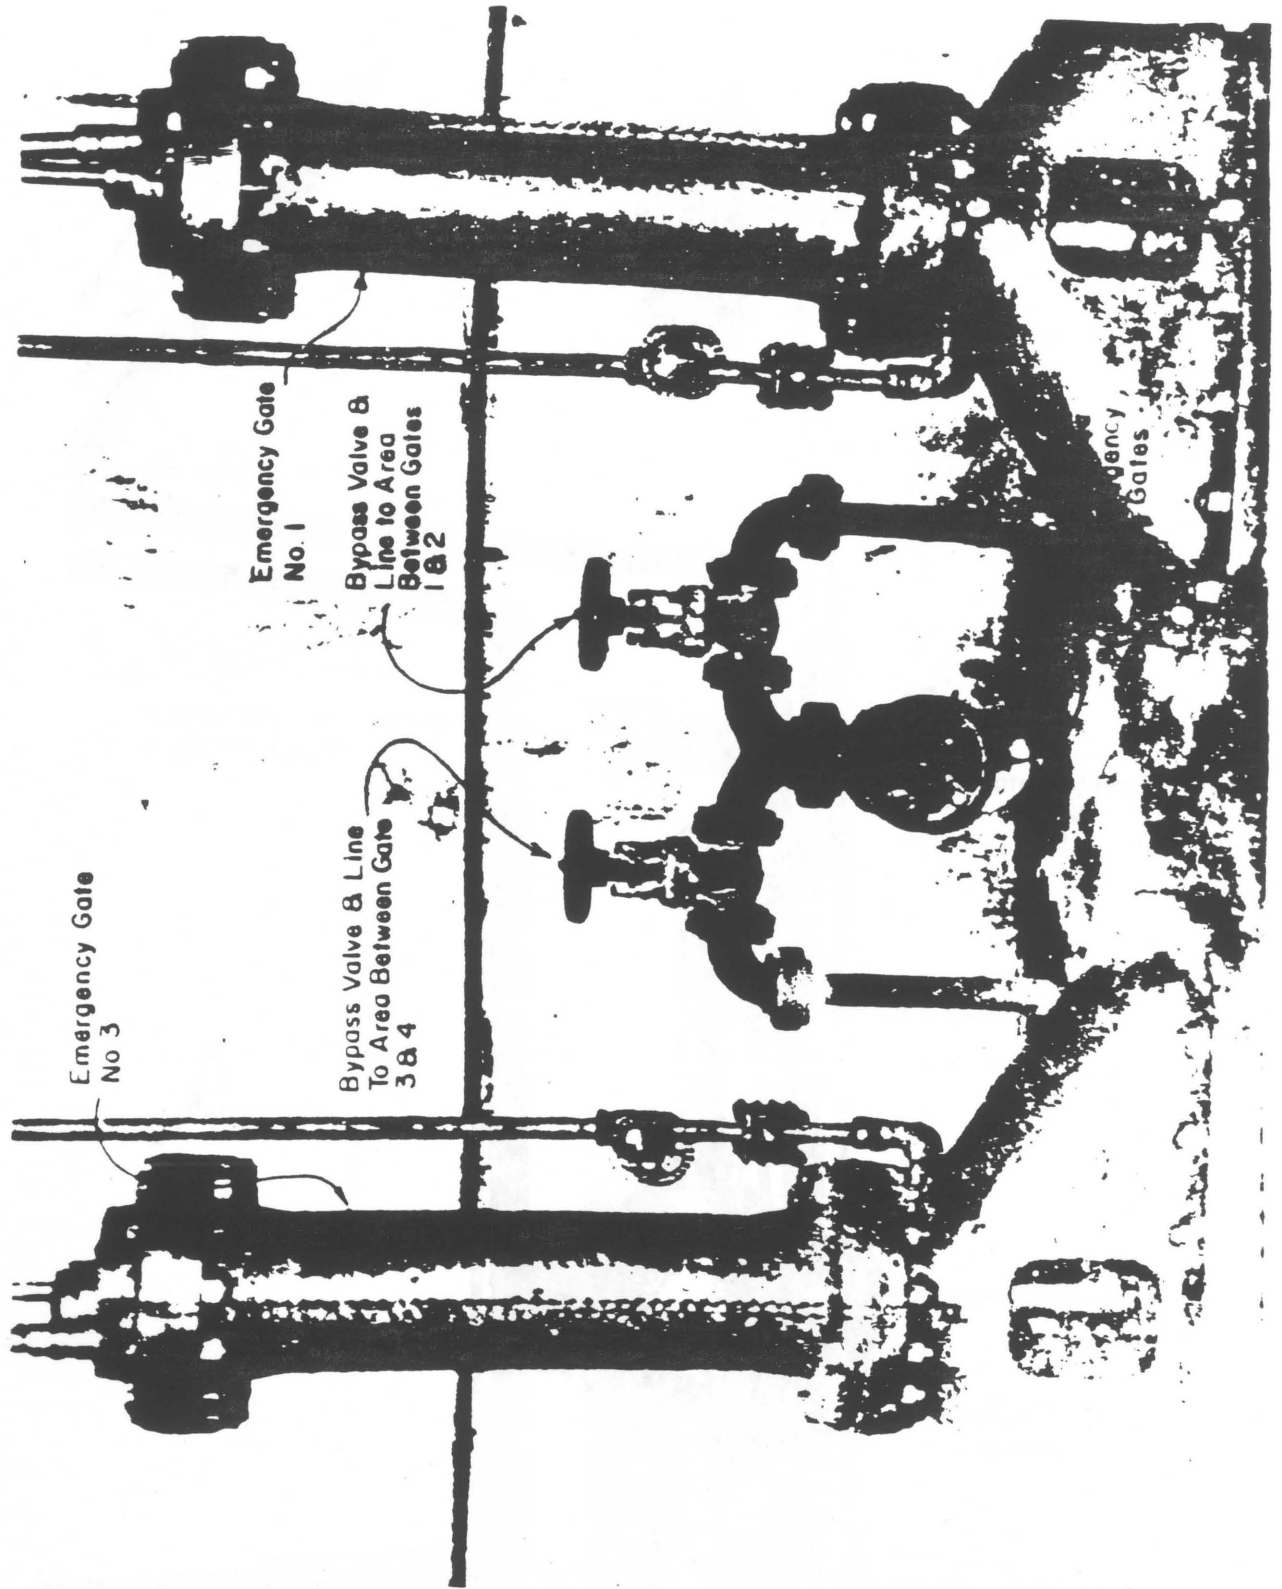
Figure II-5

4. Outlet control gates--An inspection of the control gates in April 1988, revealed that the seals and gate leaves are in need of repair or replacement. Additionally since the gates are over 50 years old, many minor items on the gates are in need of repair. There is one outstanding RO&M recommendation (81-2-A), to replace the safety studs on the semiautomatic gate-hangers on the emergency gates. Continued deterioration of the control gates will result in their failure. Figures II-5 and II-6 show the emergency gates and the semi-automatic gate hangers respectively.

View of Emergency Gates at Hyrum Dam

4. Refurbish outlet control gates--The proposed program for rebuilding the control gates would include cleaning and repainting the valves; fixing packing glands, hangers, and valves leading to the hydraulic system; and replacing the gate seals and the worn or damaged gate leaves and the safety studs on the semi-automatic gate hangers.

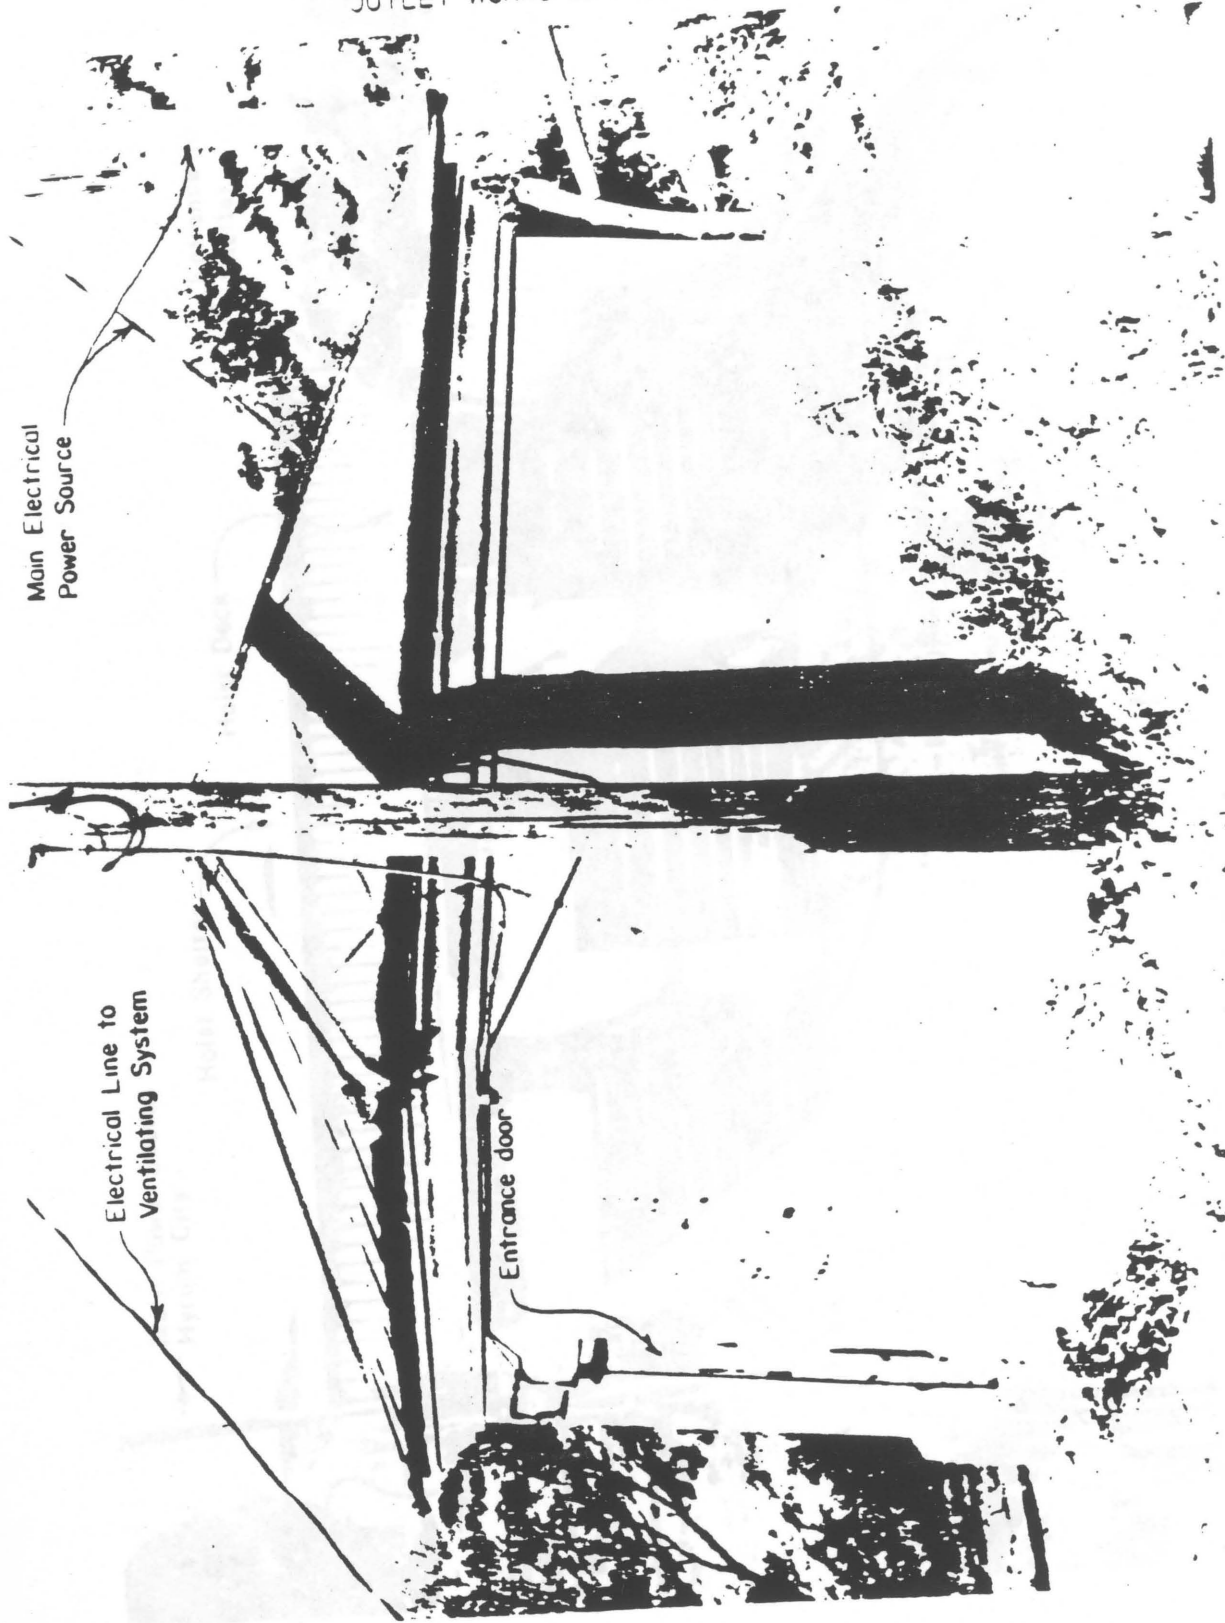
8. Miscellaneous repair work--The door and roof on the gate house are in bad repair and in need of replacement to protect the facility. Additionally, there are a number a places in which the metal work in the outlet works facility are starting to rust, such as on the spiral staircase from the gate house to the outlet works tunnel; on the catwalk in the access tunnel; on the electrical conduit; and on the hydraulic lines from the controls to the control gates. Figure II-9 shows a view of the control house looking West.

View of Control House, Looking West at Hyrum Dam

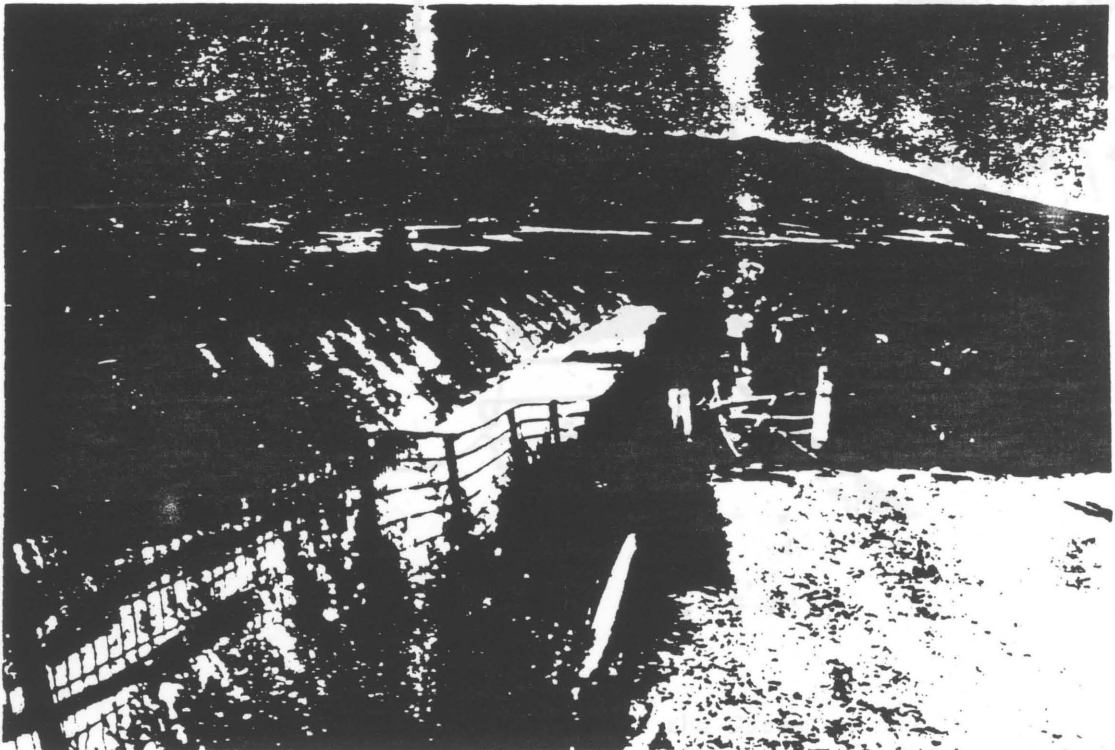
2. Spillway chute--At present there are numerous cracks in the concrete of the spillway chute and in some places, large portions of the concrete lining are displaced. This problem is identified in RO&M recommendation (87-2-F), which recommends the removal of the vegetation and sealing the cracks in the spillway chute. Figures II-11 and II-12 show views of the spillway chute looking west and a view of a typical section where the concrete lining has been displaced respectively.

Figure II-12
View of Spillway Chute Looking West at Hyrum
Dam

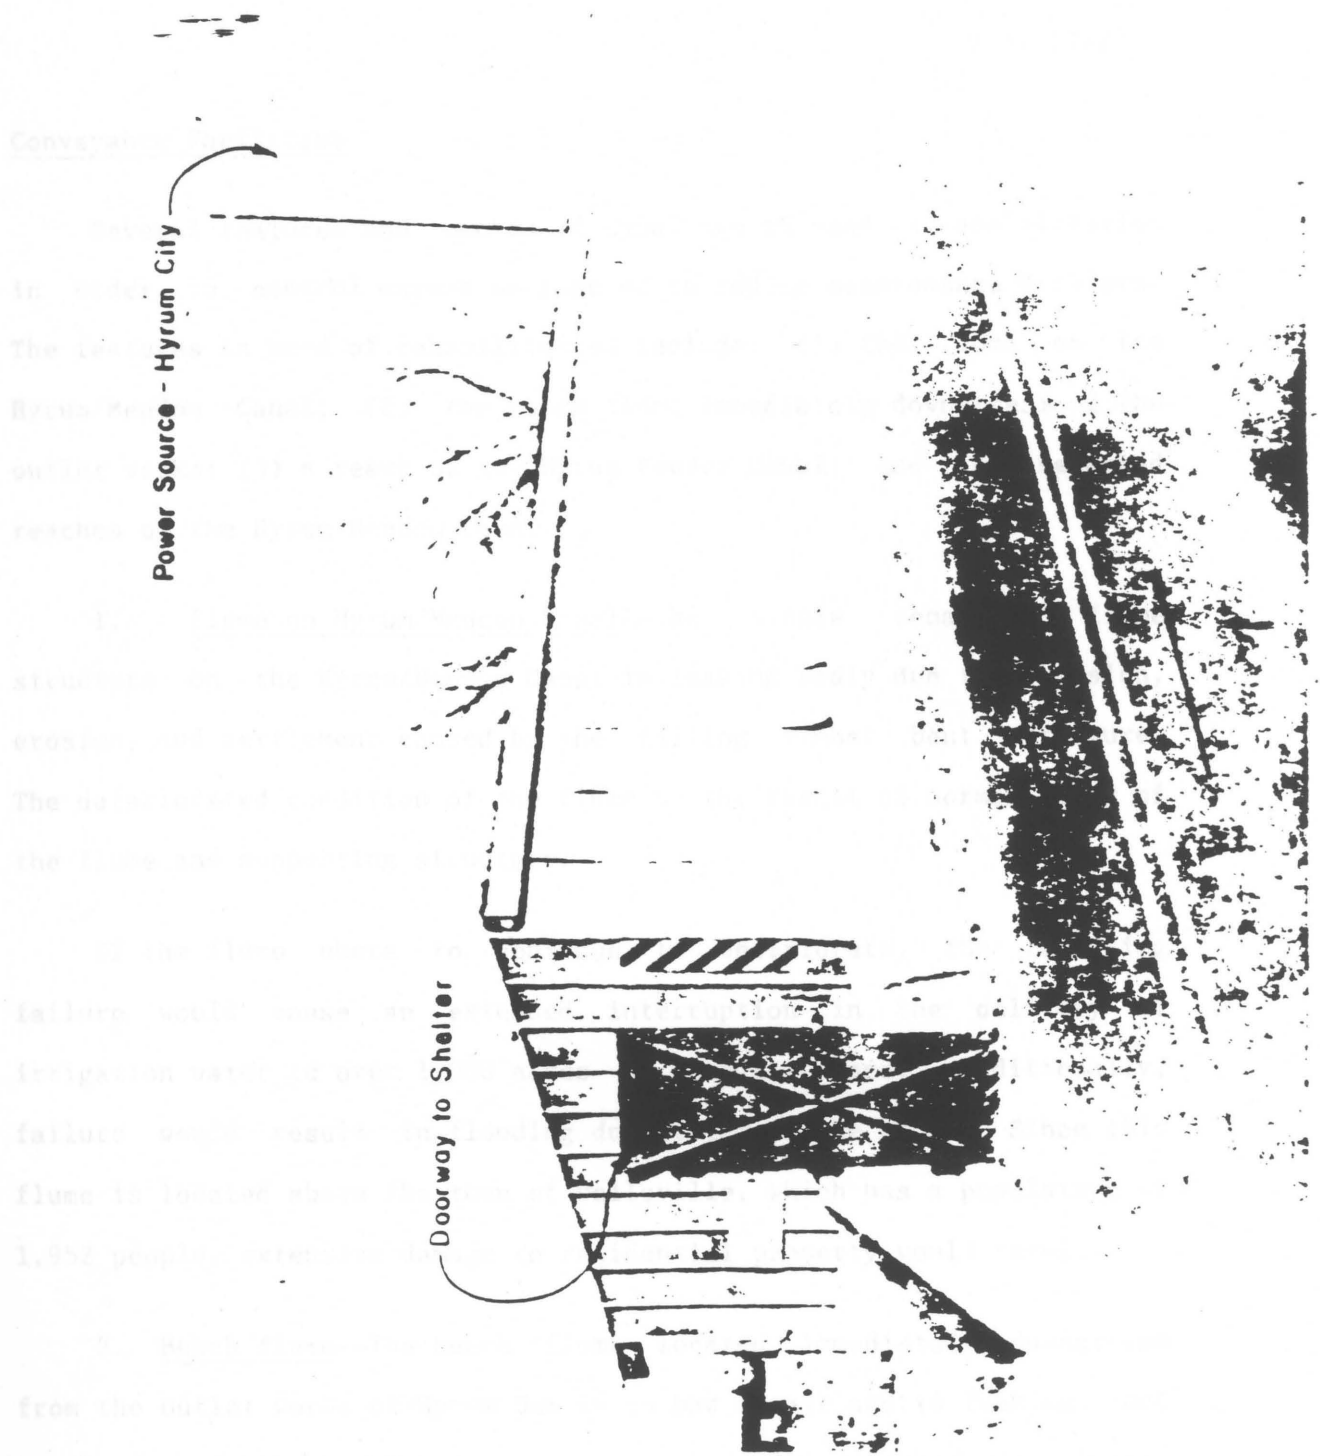
3. Electrical system--Some of the electrical system in the gate hoist house is over 50 years old and thus, does not meet current electrical standards. To reduce the possibility of electrical shock to operating personnel, the electrical system needs to be upgraded to comply with electrical codes. Also, an automatic control device needs to be installed to control the spillway gates. Installation of this device will satisfy RO&M recommendation (79-1-G). Figure II-13 shows a view of the gate hoist house for the radial gates on the spillway.

View of Gate Hoist House for the Gates on the Spillway at Hyrum Dam

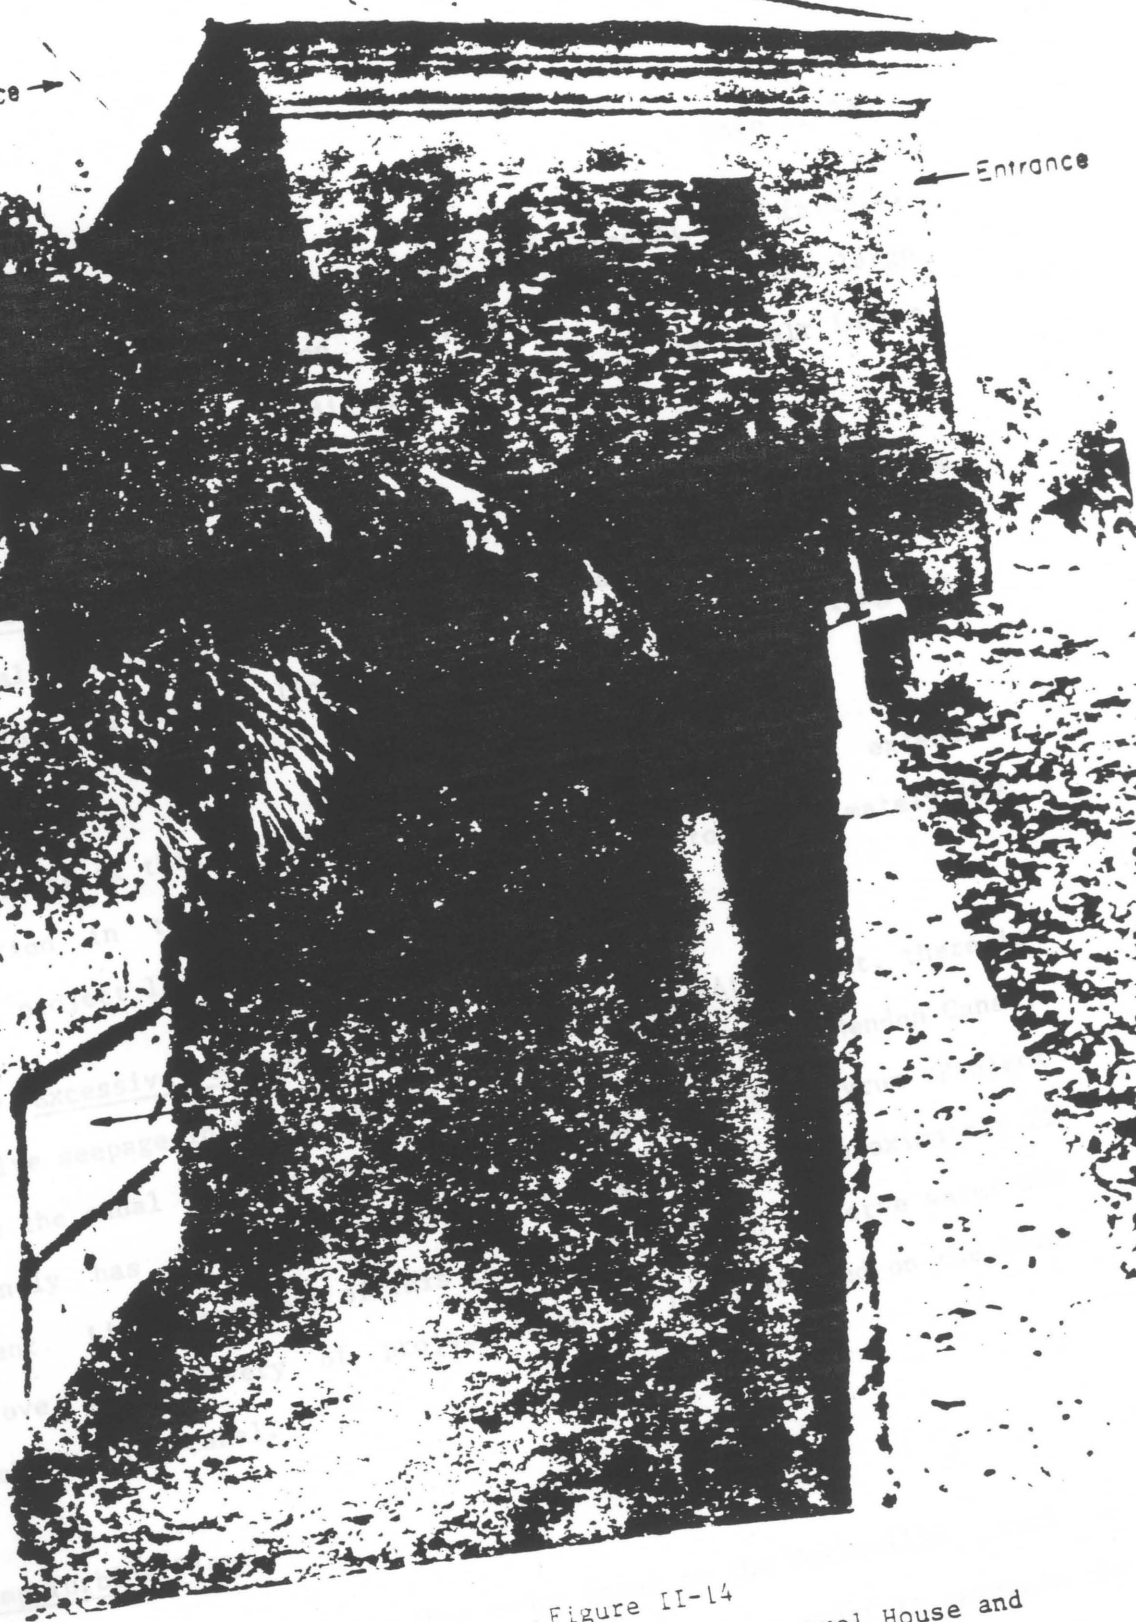
2. Bench flume--The bench flume located immediately downstream from the outlet works of Hyrum Dam is in bad repair and is leaking. Due to the age of the structure, the concrete has deteriorated in places. Figure II-14 shows a view of the north and west sides of the control house and the bench flume.

Figure II-14
View of North and West Side of Control House and
Center Line of Bench Flume at Hyrum Dam

Continued degradation of this feature will result in failure, causing an extended interruption of irrigation service to a large portion of the project lands. Additionally, failure could result in the loss of the foundation for the control house.
