Gens, A. & Alonso, E. E. (2006). *Géotechnique* 56, No. 3, 185–201

Aznalcóllar dam failure. Part 2: Stability conditions and failure mechanism

A. GENS* and E. E. ALONSO*

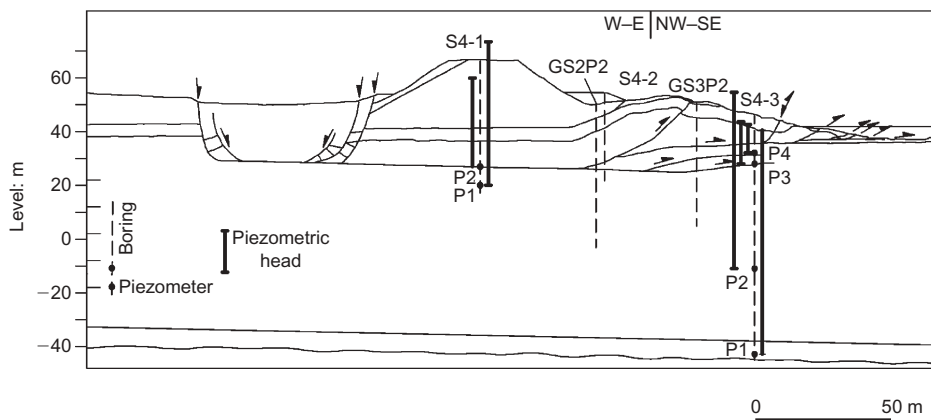
Fig. 5. Pore water pressure measured in piezometers located in Profile 4 (in borings S4-1 and S4-3). Other borings indicated helped to identify the position of sliding surfaces, shown in the plot. The graph also shows the soil profile and the geometry of the displaced dam after failure

On 25 April 1998 the embankment moved to its new position, raising the load of foundation points such as P1 in Borehole S-4-1 (Fig. 5). The point, therefore, experienced an undrained loading followed by a period of dissipation under newly formed boundary conditions. Other points, such as P2 in the same borehole, probably travelled with the moving dam, but were affected by the rapid unloading associated with the sudden decrease of the tailings level in the lagoon. This sequence of events makes any prediction exercise somewhat uncertain. Perhaps the major difficulty is the correct interpretation of the drainage boundaries after the

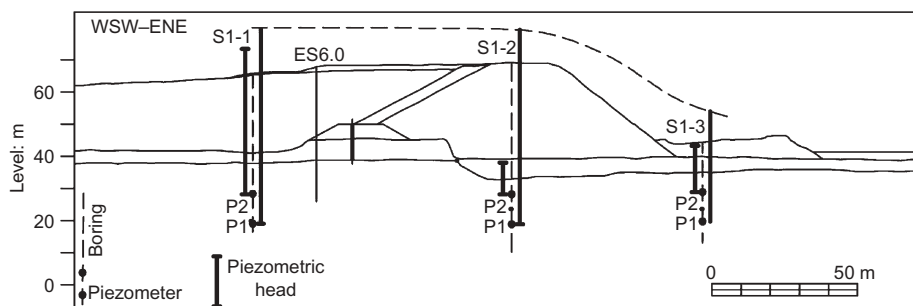
Fig. 6. Pore water pressures measured in piezometers located in borings S1-1, S1-2 and S1-3 in Profile 1 (not affected by the failure). The graph shows also the level of tailings after the failure and the soil profile

It is interesting to note in Fig. 6 that the readings in the piezometers P2, located in a shallower position within the clay, detect the boundary water pressure upstream and downstream of the cut-off wall. Water pressures in the alluvial granular soil downstream of the embankment appear to have a low value, close to the original ground surface, similar to that measured in open tube piezometers. Upstream of the cut-off, the water level in the alluvium is given by the water level in the lagoon, and this explains the reading in piezometer P2 in borehole S1-1. It is also clear that strong vertical pressure gradients exist below the embankment in the vicinity of the position of the sliding surface (in the failed embankment) as a result of the consolidation process

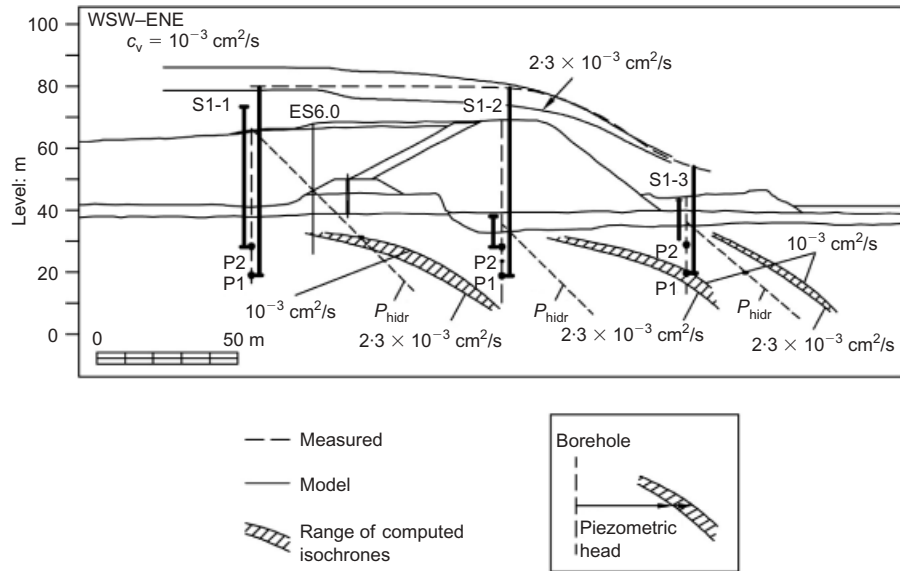
Fig. 8. Calculated and measured distributions of pore water pressures under Profile 1

The level of tailings after failure is shown in Fig. 8. It implies an unloading (which was assumed to be undrained) with respect to the tailings level immediately before failure. Fig. 8 shows the calculated pore pressures along the failure plane for two values of c_v (10^{-3} cm²/s and 2.3×10^{-3} cm²/s) and a comparison with measurements in piezometers P1. Also shown in the figure are the calculated and measured vertical profiles of water pressure at the location of boreholes S1-1, S1-2 and S1-3. They show a strong pore pressure gradient in the upper part of the clay deposit. The agreement between calculated and measured pore pressures is very good for a value of c_v close to 10^{-3} cm²/s. Remarkably, this back-calculated value is very close to the c_v values derived from consolidation tests on specimens of blue clay (Alonso & Gens, 2006). This agreement is a further indication of the massive and homogeneous nature of the foundation clay. The back-calculated values are of the same order of magnitude as those derived by Vaughan & Walbancke (1973) from observation of cutting slopes in London clay.

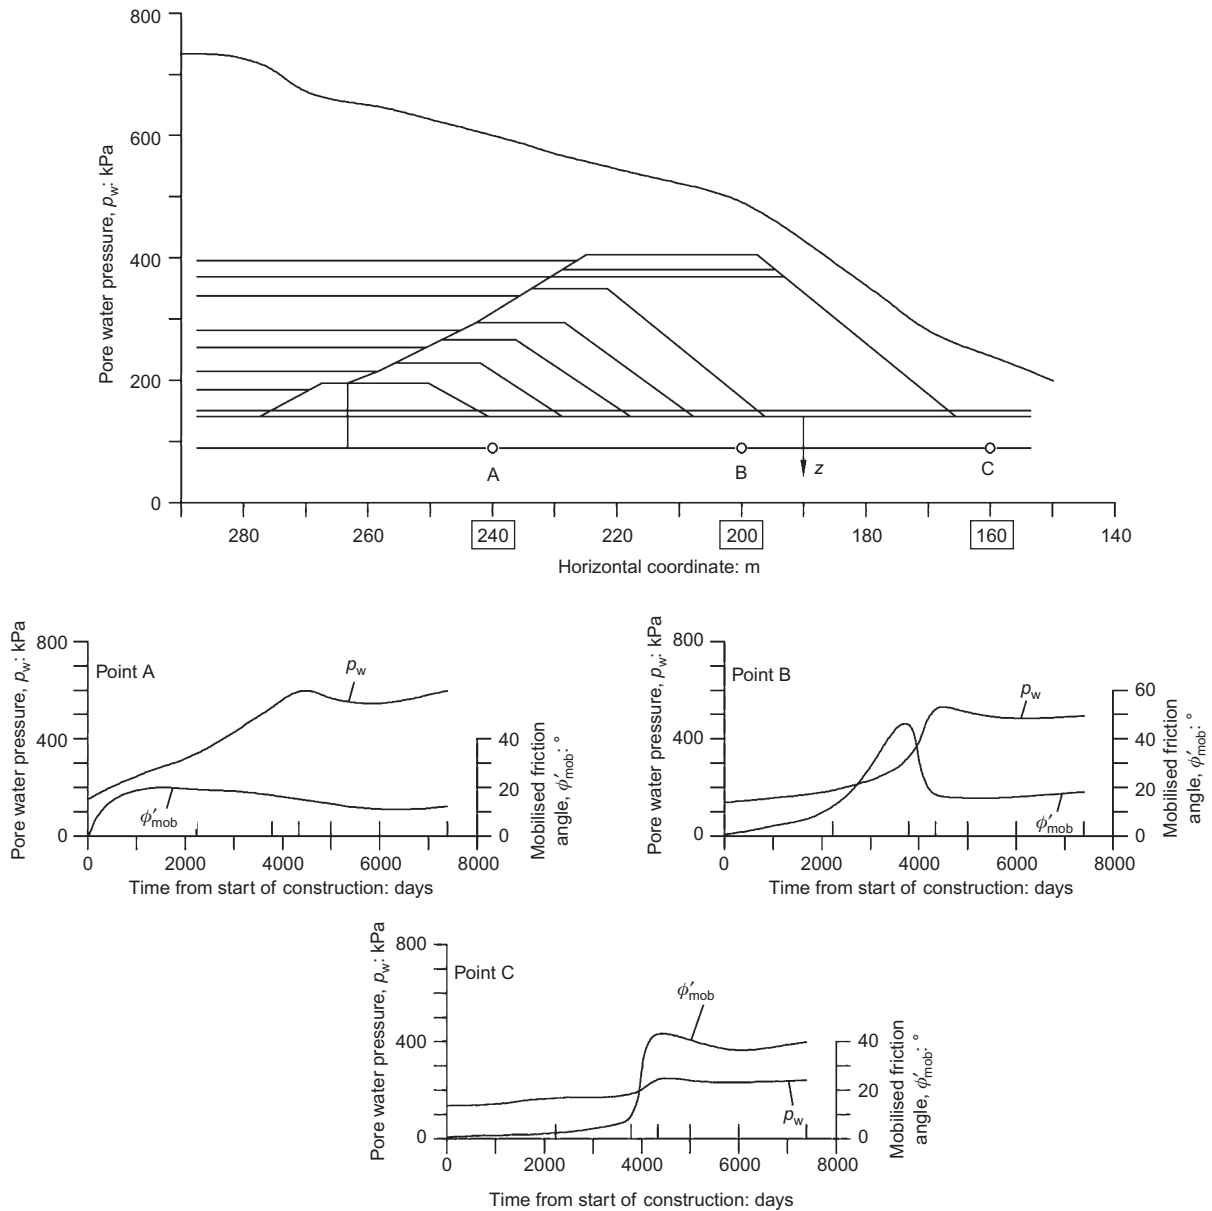
Fig. 9. Calculated water pressures and stress ratios under dam and lagoon at points A, B and C in representative profile of failed southern part of east embankment

The plots in Fig. 9 also indicate that pore pressures reached a peak at $t = 4500$ days, around 1990, at the end of a relatively rapid increase in embankment height (Figs 3 and

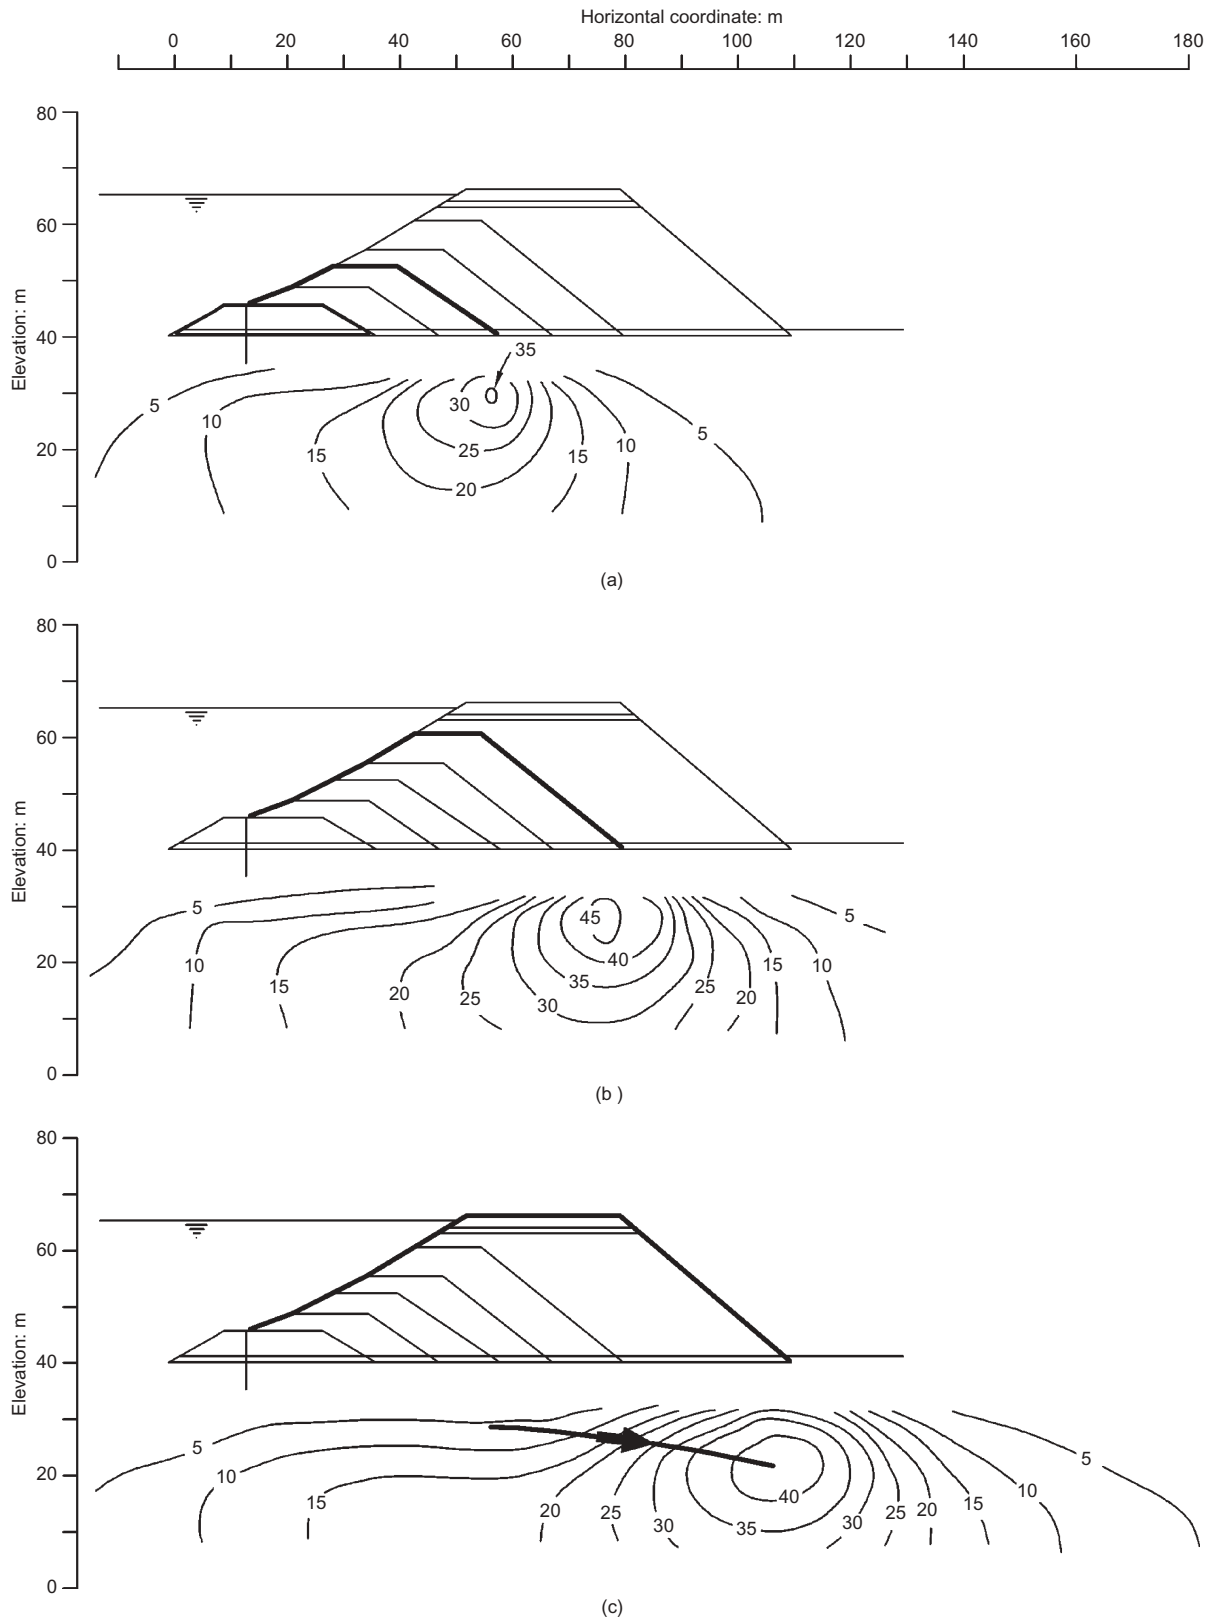
Fig. 11. Contours of equal mobilised friction on horizontal planes for three phases of construction, in terms of dam height: (a) $H = 10$ m; (b) $H = 19$ m; (c) $H = 27$ m. The line with the arrow in (c) shows the locus of the maximum mobilised angle of shearing resistance

A remarkable result is that the stress ratio reaches a peak at a certain depth within the clay. This is a consequence of the variation of pore pressures, controlled by the clay consolidation, and the distribution of shear stresses below the embankment toe. The depth of the maximum τ/σ'_n increases as the height of the embankment increases. For $H = 10$ m the maximum τ/σ'_n is found for $z = 10$ m. It increases to $z = 12$ m and $z = 17$ m when $H = 19$ m and $H = 27$ m. This result indicates the position of the sliding plane, which developed later, as the peak in mobilised friction generates the maximum damage in clay strength. In fact, the brittle behaviour of the clay, and the strength data already reported (Alonso & Gens, 2006), can be now invoked to advance a qualitative interpretation of the failure mechanism. If bedding planes do not exhibit any effective cohesion, a maximum effective friction angle of around 25° may be assumed for them. Then, in view of Figs 9, 10 and 11, the strength on a critically located bedding plane was exceeded for the first time, when the embankment had a height of 8–10 m. This initial critical point was located at a depth of about $z = 10$ m under the downstream toe of the embankment.

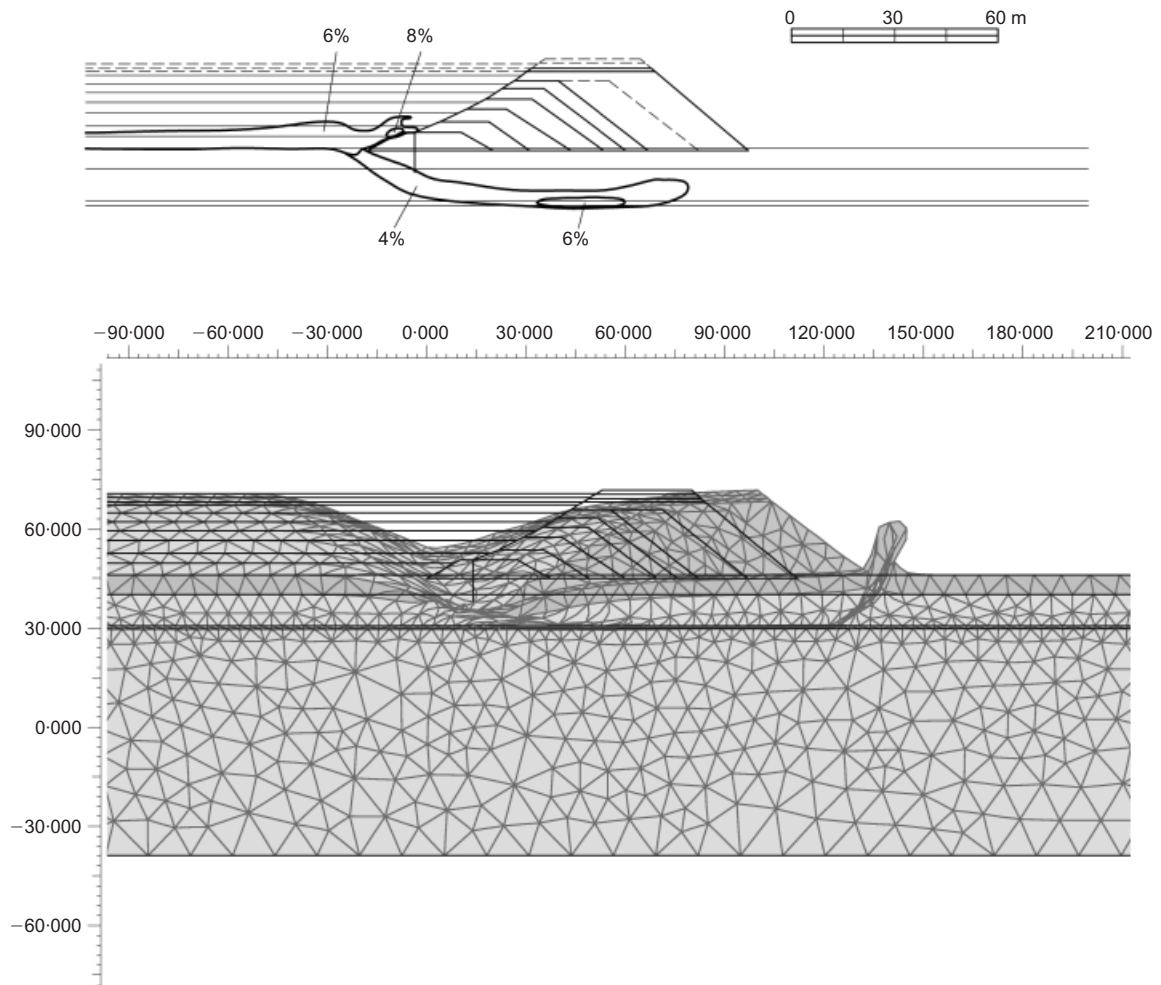
The analysis also confirms that the shear deformations accumulate on the potential failure plane, and they extend as the embankment construction advances (Fig. 17(a)). The rupture mechanism, identified by means of the mesh deformation (Fig. 17(b)), is similar to the actual failure mechanism described in the companion paper (Alonso & Gens, 2006). The failure phase was induced by a final reduction of strength parameters. Fig. 17(b) shows the passive wedge developed at the distal end of the slide, and a classic

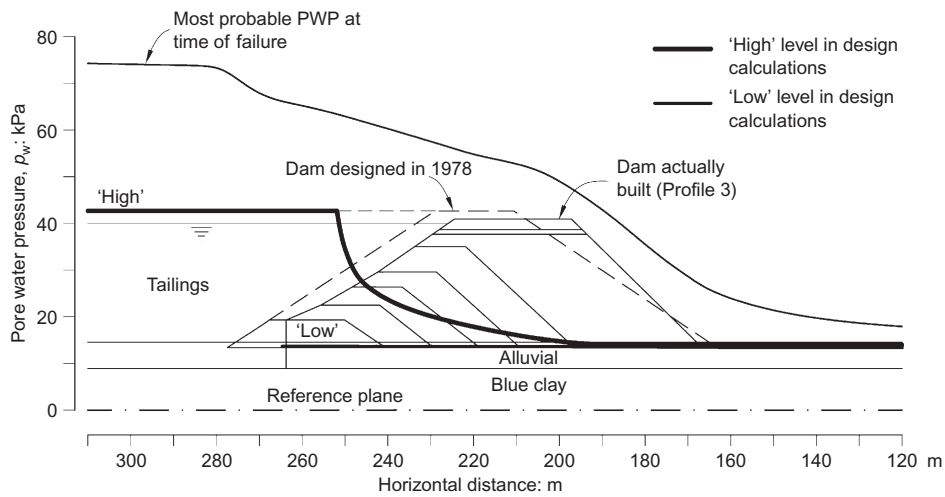
Fig. 22. Phreatic surface used in design calculations and best estimate of pore water pressure existing on sliding plane at time of failure

granular terrace layer. Limit equilibrium calculations using this phreatic level indicated a safety factor against downstream sliding of 1.40 for the dam configuration existing in 1998 (27 m above ground level). The two phreatic levels used in design calculations are compared in Fig. 22 with the best estimate of water pressures prevailing on the sliding surface at the time of the failure.
