## **Collapse Scene Investigation (CSI) Carmel River Bridge Failure**

Avila, Catherine M. C. (2008): Collapse Scene Investigation (CSI) Carmel River Bridge Failure. In: Sekiguchi, Hideo (Hg.): Proceedings 4th International Conference on Scour and Erosion (ICSE-4). November 5-7, 2008, Tokyo, Japan. Tokyo: The Japanese Geotechnical Society. S. 707-711.

# Collapse Scene Investigation (CSI) Carmel River Bridge Failure

Catherine M.C. Avila, P.E., D.WRE, MSCE, MBA

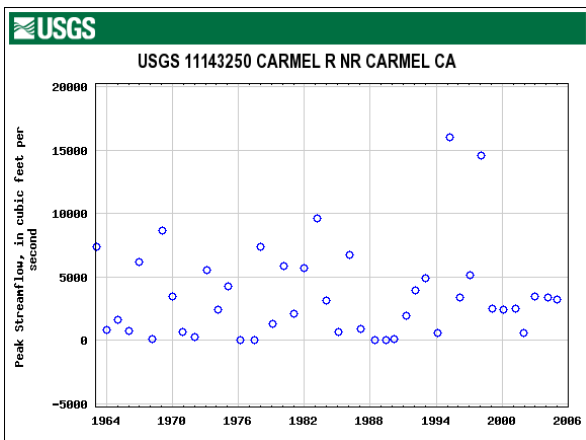
The gage upstream of the bridge (Carmel River near Carmel, Gage #11143250) has been in place since 1964. The highest recorded discharge was 453 cubic meters per second (cms) on March 10, 1995 when the bridge failed as shown in Figure 4.

Figure 4: Discharges at the Carmel River Gage near Carmel (note discharges in cubic feet per second)

The FEMA study estimated the 50-year discharge to be 651 cms and 100-year discharge to be 824 cms (FEMA, 1991). The March 10, 1995 discharge of 453

cms equates to approximately a 30-year discharge assuming the above hydrology is valid. The proposed pedestrian and bicycle bridge over the Carmel River provides an excellent opportunity to see if the forensic clues that led to the March 10, 1995 Carmel River bridge failure can be used to enhance the longevity and survivability of the new bridge under a variety of flood events.

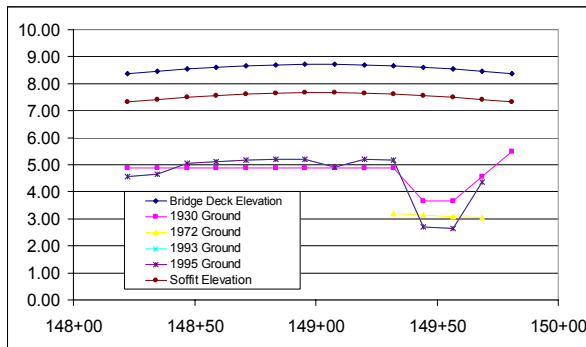
The 1934 bridge was designed for a 75-year discharge of 496 cms – only slightly larger than the 453 cms that destroyed the bridge. At the time of the bridge design, there were no dams on the Carmel River, and the “high-water” was estimated to be at elevation 6.1 m. The soffit elevation was recommended at 6.7 m while another portion of the report notes that the “elevation of high-water taken from contour map on data by Mr. Mitchell, 22.0” (State of California, 1931).

The bridge which was designed was made longer (158.5 m instead of the proposed 146.3 m) than the preliminary recommendations. In addition, a vertical curve with a maximum soffit elevation of 7.9 m and minimum soffit elevation of 7.6 m was added provided as shown in Figure 5.

**Figure 5:** Ground Elevations and Profile of the 1934 Bridge (meters)

A cross section was taken on March 2, 1995, just 8 days before the bridge failed. According to the cross section information (see Figure 5), the river degraded approximately 1-meter between 1931 and 1995. The degradation decreased the pile embedment from its original 5 m at Pier 12 and 5.4 m at Pier 11 to 4 m at Pier 12 and 4.4 m at Pier 11. The original estimated pile penetration was 5.5 m according to the 1931 Preliminary Investigations Report (State of California, 1931), which is greater than the actual penetration achieved in construction.

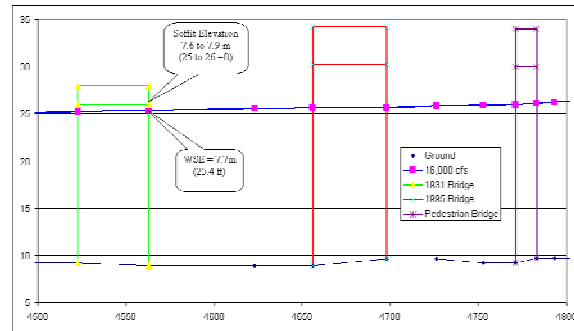
A hydraulic model (HEC-RAS) set up by Balance Hydrologics, Inc. was utilized to estimate the hydraulics at the bridge as it was in 1995. Although the model utilizes the 2007 topography, if the record discharge of 453 cms is contained in the channel, it provides an estimate of the water surface elevation and velocity for the old Highway 1 Bridge as shown in Figure 6.

**Figure 6:** Output from HEC-RAS Hydraulic Model

Debris pummeling the bridge was caught on amateur video late Friday afternoon just hours before the bridge collapsed by a local resident who commented that it “felt like an earthquake.” The documented debris included debris rafts and large trees, which were over 30.5 m long with 1.8 m diameter root-balls. The water was at or near the soffit of the bridge with significant debris catching on the piers. Debris lodged on a pier can increase local scour at the pier by increasing the pier width and deflecting a component of flow downward. HEC-18 recommends estimating the scour depth by assuming the pier width is larger than the actual pier width and notes the problem is determining the increase in pier width to use in the pier scour equation. According to HEC-18, limited studies of pressure flow scour indicate that pier scour can increase 200 to 300% for a bridge under pressure flow (Richardson et. al., 2001).

With relatively small piers (0.46 m), the pier scour is 1.1 m. This leaves 3 to 3.3 m of pile embedment. If the pier width is assumed to double due to debris, the pile embedment is decreased to 1.8 to 2.1 m. Likewise, if the pier scour depth is doubled or tripled, the pile embedment is dramatically decreased.

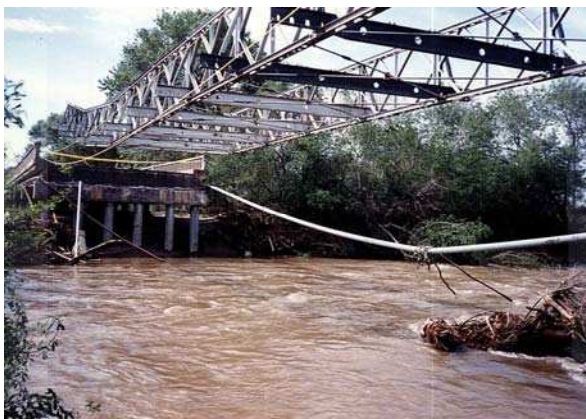
**Figure 7:** Looking downstream at Bailey Bridge Launching in March, 1995 (photo by Steve Ng, Caltrans)

In order to open the route to traffic as quickly as possible, a Bailey bridge which was stored at the Caltrans Maintenance yard at the San Francisco Oakland Bay Bridge was trucked down from Oakland to Carmel. The turnaround was fast: the 1934 bridge failed late Friday March 10<sup>th</sup>. The Bailey bridge was “designed” and loaded on trucks on Saturday, March 11<sup>th</sup>. The new bridge erection started on Sunday and was completed Thursday, March 16<sup>th</sup> (see Figure 7).

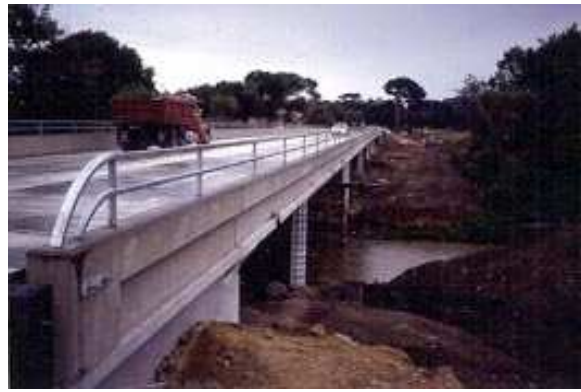
**Figure 8:** New Highway 1 Bridge with Pier Wall Construction under way (photo by Author, 1995)

The new bridge was designed while the Bailey bridge was under construction. The recommendations were 0.9 m of freeboard over the estimated water surface elevation during the 1995 storms with 30.5 m spans. Work started on the permanent bridge on April 1, 1995. It was opened to traffic on May 5, 1995 and was completed by September 1995 (the training walls were installed after traffic), as shown in Figure 8. The bridge cost almost \$3.5 million U.S. dollars (Caltrans, September 1995).
