## **Some Problems of Reconstruction, Remedial Works and Maintenance of Dams in Slovakia**

Dresdner Wasserbauliche Mitteilungen

Prof. Ing. M. Lukáč, CSc., (SK)  
Slovak Technical University Bratislava,  
Faculty of Civil Engineering

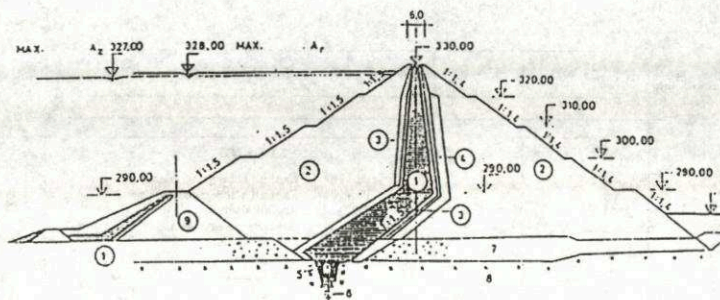
Fig. 5: Cross-section of Ružín I dam

The problem of excessive settlement of the dam body is typical for the rockfill dam Ružín I (completed in 1968,  $H_{\max} = 64$  m - the highest Slovak dam). Cross-section of this dam is given in the Fig. 5. The settlement of dam crest and clay core was more than 0,6 m after 10 years of operation and the process of dam body settlement is not finished, yet. Sealing core has been raised to the dam crest by means of cut-off wall. New calculation of design flood brought about the necessity to raise the spillways capacity. New additional spillway with diversion tunnel was constructed in 1994 - 1995.

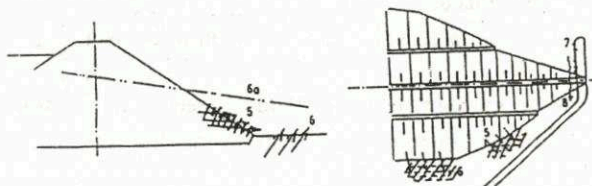
Fig. 11: The most frequent failures of small dams

- seepage through dam or dam underground;
- excessive settlement in the places of contact between earth dam body and concrete structures
- failure of upstream slope protection, caused by the wind waves action;
- inadequate free-board of dam crest, etc.

The typical failures of small dams are given in the Fig. 11.

- 1 - danger of dam crest overflow
- 2 - failure of dam slope protection
- 3,4 - cracks and dam crest settlement
- 5,7 - seepages

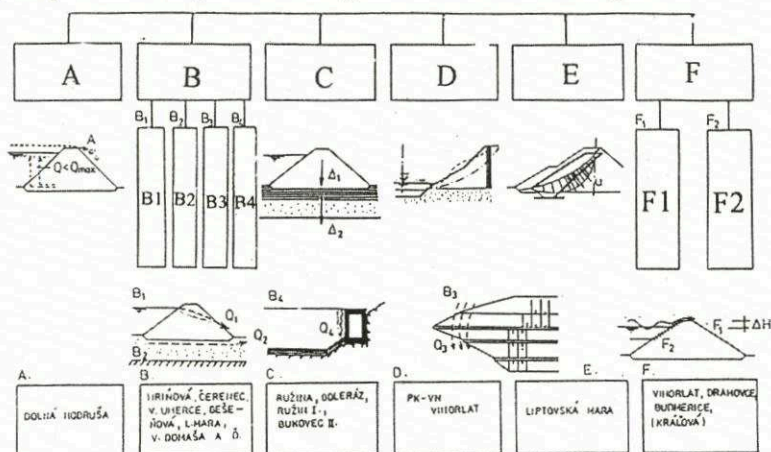
Fig. 12: The most frequent problems in the operation of dams

No serious failures or catastrophes occurred in the past in this category of dams in Slovakia, also thanks to measurements and observations. Some of the measurements indicate problems and anomalies in the behaviour of these dams. The most frequent problems in operation of large dams can be seen in Fig. 12.

| A-overflow of dam crest | B-excessive seepage: | B1-through dam body |
| B2-through dam underground | B3- in dam blanket | B4-in contact with concrete structures |
| C-excessive settlement | D-dam slope failure | E-unfavourable pattern of pore pressure |
| F-impact of wind waves | F1-dam crest overflow | F2-jeopardizing of slope protection stability |

The typical problem in the category of earthfill dams is excessive seepage through the dam body, or its underground. Excessive settlement of the dam body ( $\Delta > 1\%$ ) and high pore pressure in the clay core have occurred at some rockfill dams. Frequent problem of dams, situated in the lowland regions is the impact of wind generated waves.

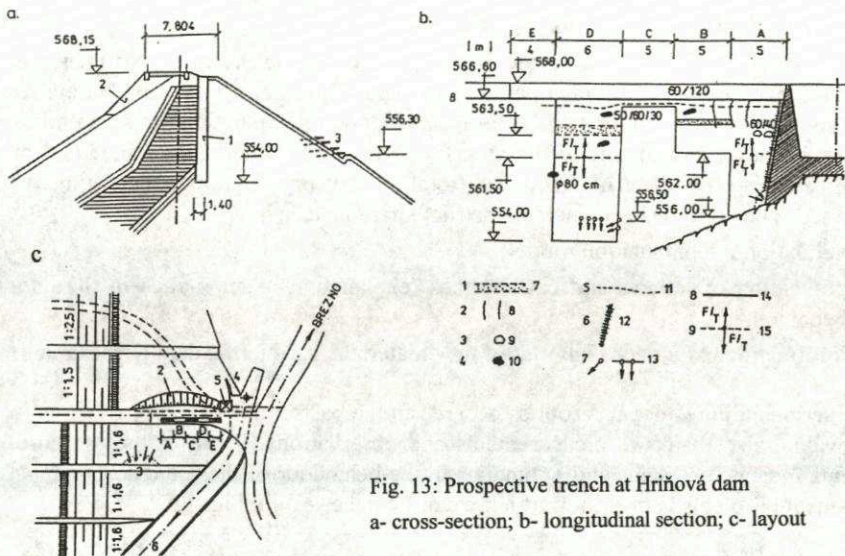
Fig. 13: Prospective trench at Hřiňová dam  
 a- cross-section; b- longitudinal section; c- layout

Long-term anomalies in the seepage regime have been typical for the operation of the Hřiňová dam. It was necessary to dig out the prospective trench (see Fig. 13) and to lower the water level in reservoir for long period, because of the risk of dam failure. Three failures are indicated in Fig. 14: P1 - P3, which occurred in the years 1966, 1968, 1971. The maximum seepage exceeded value of 100 l/s (in 1966). Earth-rockfill dam Hřiňová ( $H_{max} = 51$  m;  $L = 243$  m) with clay core creates the reservoir, which is used for the drinking water supply (total  $V = 7 \cdot 10^6$  m<sup>3</sup>).

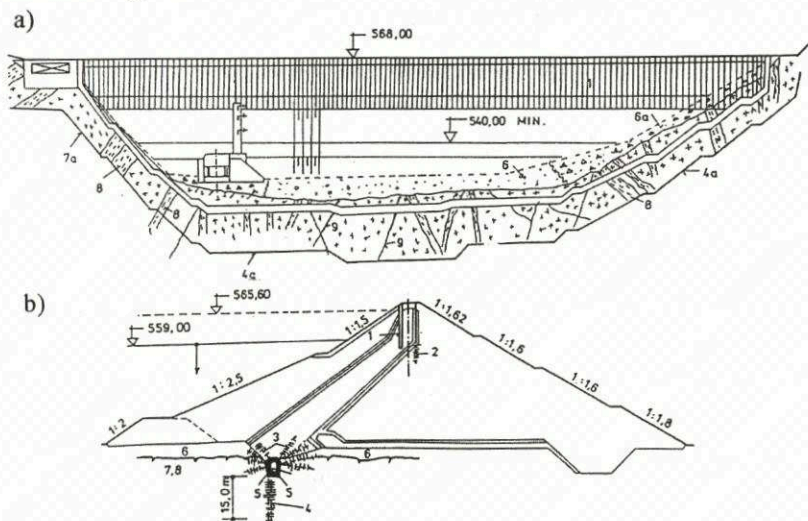
Fig. 15: Proposal of the Hriňová dam remedial measures

a- longitudinal section; b- cross-section; 1- cut-off wall; 2- grouting of filters; 3 grouting

Remedial measures, realized in 1989 - 1991 at lowered water level in reservoir (559,00 m a.s.l.) consisted from:

- construction of cut-off wall and grouting of filters from the dam crest;
- grouting of clay core in the contact with rock and injection gallery.

The longitudinal section and cross-section of the above mentioned measures is given in the Fig. 15.
