## **Foreshore erosion and scour induced failures of sea dikes**

Mai, C. V.; Pilarczyk, K. W.; Gelder van, P. H. A. J. M. (2006): Foreshore erosion and scour induced failures of sea dikes. In: Verheij, H.J.; Hoffmans, Gijs J. (Hg.): Proceedings 3rd International Conference on Scour and Erosion (ICSE-3). November 1-3, 2006, Amsterdam, The Netherlands. Gouda (NL): CURNET. S. 424-433.

**Abstract:** This paper aims at investigation of sea dikes failures and its mechanism due to foreshore erosion and scour in front of coastal dikes. The case of Namdinh sea dikes in Vietnam is introduced and selected for analysis. Some methods to estimate scour dimensions will be reviewed and applied for the Namdinh case in determination of suitable dimensions for dike's toe and bed protection. Namdinh coastal zone is a low-lying area which has been protected by sea dikes. In the region typhoons arrive on average four to six times each year at the coastline and the typhoons generate storm surges and waves, both attacking severely the sea dikes along the coast. As the result the sea dike system frequently suffer from damages and failures. One of the main reason for failures of the sea dikes is due to co

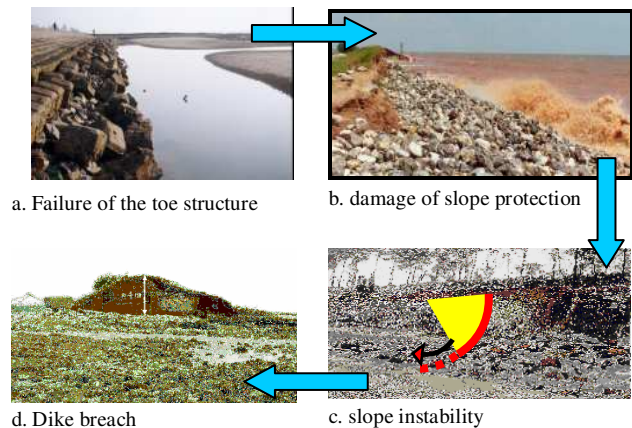
Figure 4. Failures presented at NamDinh sea dikes [Namdinh 1996]

These consecutive failure mechanisms may leads to collapse of the dikes. The series pictures in Figure 4. can be a practical expression.

Figures 4. shows the heavy damage of the dikes at Hai Chinh section 1996. First scour occurred at the toe of the dikes (Fig. 4.a) cause toe instability, after that riprap revetments was collapsed at lower and upper parts (Fig. 4.b) . After a design storm, the situation was getting more seriously. Then the dike body and revetment were collapsed after some days. The remained dike body was washed out under impact of waves and currents. Referring to the situation it is possible to say that the final failure occurred under sliding mode of outer slope

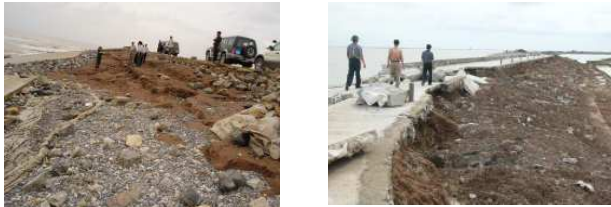
Figure 5. Failures of Hai Phong sea dikes 2005

Figure 5. shows the impression of failures at sea dikes in Hai Phong 2005 due to action of waves, wave run-up and wave overtopping. The damages of the dike in that picture included failures of crest wall and upper parts of revetments.

a. damage of armour layer and erosion upper part of outer slope      b. Damages of crest-wall and erosion of inner slopes

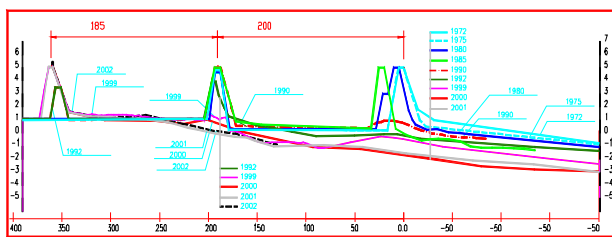
Figure 9. Overlap cross shore profiles from 1972 to 2003

Since 1972 the sea dike system in Namdinh had 2 defensive lines (see Figure...). The first line was in good condition with crest level of +5.0 CD, and outer slope of 1 over 3 and inner slope of 1 over 2. Composition of dikes cross section was sandy clay body and moderated clay for outer armour layer. The toe of the dike was protected by extending under part of the outer slope with a flatter slope of 1 over 10. Foreland and beach in front of the dike was at level from -0.5 to +1.0 and around 150 m wide. The second line stood at 200m landward of the first line. The dimension of cross section was smaller than that of the first line. The crest level was at +4.5 m CD, outer slope is one over 2 and inner slope is one over 1.5. The profile of cross section is shown on Figure 9. *line label 1972.*

Three years later, in 1975, the erosion of near shore zone started. The foreland and beach along the dikes was lowered approximately 40 cm annually. The erosion depth was even more near the toe of the dikes, about 65 cm a year. Due to this erosion the toe was in danger of instability. The erosion of the lower part of outer slope was started. The first line of defensive system was in

threatened. The profile (line label 1975, Figure 9. ) was deeper offset in comparison to 1972's.

During period of next 5 years, from 1975 to 1980, the erosion became more heavily. Continuous erosion occurred near water line due to the actions of waves dike body's material was taken away and washed out. In front of the toe the sand was also taken away forming scour holes. The cross section of the dikes was getting smaller and thinner. Instantly, the first line was upgraded by the local people by widening the cross section at inner side. There was no recognisance of occurring of foreshore erosion and scour. The cross section then looked like *line label 1980* in Figure 9. .

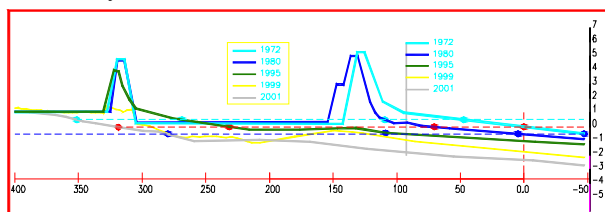
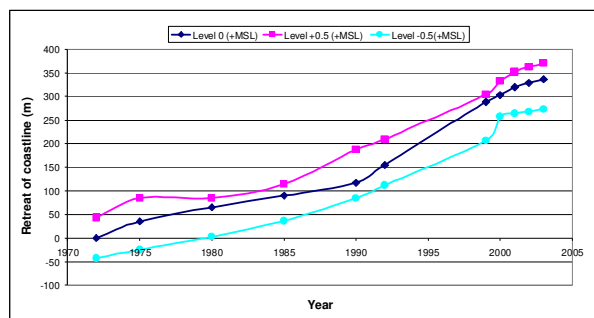
Figure 10. Retreat of coastal defences from 1972 to 2003

The retreat of coastline during the period of 30 years is shown in Figures 4.3. In this Figure, the retreats of foreland levels of -0.50, 0.0, +0.50 meters (+MSL) are indicated. The based point is the position of foreland level 0.0 in the year 1972.

Based on the above analysis, if no proper measures for upgrade and protection of the dikes are undertaken, the situation will go on by similar trend of the last period. After every 10 years the retreat of coastline will be around 150 meters inland, see also Figure 10. According to the current trend, the location of the dikes will shift 200 meters landward after every 10 years.
