Winter Season Repairs of the Oder Locks

Prof. Dr.- Ing. habil. R. Rogala, (PL)
Dr.- Ing. W. Rędownicz, (PL)
Wroclaw University of Technology,
Institute of Geotechnics und Hydrotechnics

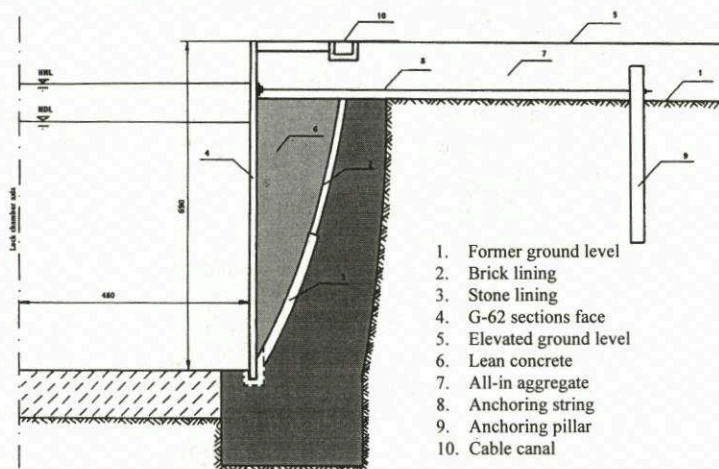
The main parameters of the lock include: length — 187.8 m, width — 9.60 m. The sloping on the lock is 2.40 m. The ordinates of the upstream and downstream heads were 125.65 m and 124.20 m above sea level, respectively, and the ordinates of the thresholds — 119.96 m and 118.50 m, respectively. The level at which navigation is still possible is 124.53 m above sea level at the downstream stand. Such a condition hindered navigation remarkably as water flooded the lock platform at higher water levels (Fig. 1).

Fig. 1: Lock chamber's cross section

The lock walls were made of concrete and shaped appropriately to the loads evoked by ground pressure (Fig. 1), which minimised the structure's weight in this way. The face of the wall downstream part was made of granite cut-stone and the upstream — of clinker brick. The bottom slab, 1 metre in thickness, was made of concrete.

The repair of the lock's left wall included facing by means of G-62 steel piling sections, elevating the platform level to the ordinate 125.40 m above sea level and constructing a cable canal (Fig. 1). The scope of the repair of the two heads was identical and included the replacement of the support gates and the flow canal wedges alongside with their drive mechanisms, a reconstruction of the heads, facing them with G-62 steel piling sections and building cable canals for distributing the wiring for the feeding, drive and signalling systems. The reconstruction of the heads consisted of an elongation and elevation of the lock head top and a change of wedge shaft dimensions. The upstream head was elevated to the ordinate 126.25 m above sea level and the downstream one — to 124.40. Such an elevation of the heads allowed for the installation of typical Ib support gates, meeting the condition of the minimum elevation of the lock top over the level of normal damming, thereby eliminating the threat of flooding the platform and the servo motor's and the upper bearing's cavities. The elongation of the head by 1.22 rendered it possible to build new recesses for standardised flashboard repair closures. The increase of the size of the existing wedge shaft allowed placing a typical steel walling of the wedge shaft. The work connected with the refurbishment of the lock's wall required high working discipline and a strict technological regime. Due to the complexity and variety of the work to be performed, the effective repair of the lock's heads meant the involvement of more measures and resources offered by dedicated contractors. Since the type of repair work on the lock's wall is the same as part of the repair work on the heads, later in this paper the authors will focus on describing the refurbishment of one of the lock's heads — the upstream head.

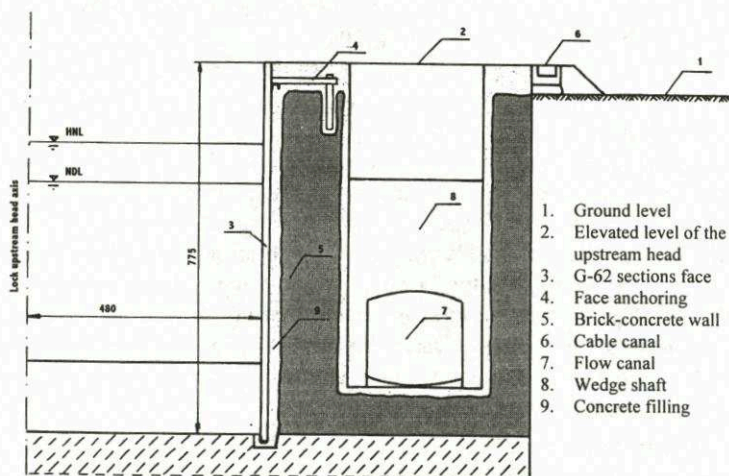
Fig. 2: The lock's upper head cross-section

The next stage of the refurbishment included assembly and reinforcement activities. In the groove hammered in the bottom and on the walls (Fig. 2), the support girts for wall facing were fixed. The lower girt was made of angle steel 200 x 200 x 20 and the structure of the upper girt — of a 160 c-bar and 120 x 120 x 20 angle steel, fixed in the lock's head. Then, in the wall face, wall upstream elongation reinforcement anchoring bars were fixed. After the groove under the lower girt was filled with concrete and when the concrete had hardened, the wall face was put up. The G-62 sections, which were supposed to make the facing, had been pre-cut to the appropriate length, sand-blasted and coated with an anti-corrosion paint. The inner side of the sections was fitted with — appropriately bent — welded reinforcement bars ensuring a better fastening of the facing. The sections, put up sequentially, were welded to the girts and then joined together with a butt joint along their entire height. The top of the lining was finished with a girt made of 200 x 100 x 12 angle steel. While putting up the facing, the walling of flow canals inlets and outlets, on-wall bollards and repair needle closure recesses were made. The subsequent work included: putting up the wedge shaft in the flow canal, insertion of the gate recess and upper bearing casings, putting up the reinforcement, recess furniture, all necessary boarding, fixing the servo motor bases and pillars, as well as all necessary steel markers. After all the work specified above had been done, concrete work started.
