## **Fallstudien zur Kolkbildung - Scour Case Studies**

# Fallstudien zur Kolkbildung

## Scour Case Studies

GEORGE W. ANNANDALE, ENGINEERING & HYDROSYSTEMS, HIGHLANDS RANCH, COLORADO, USA

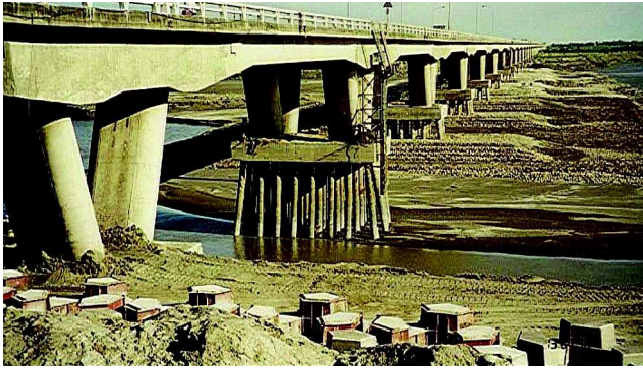
Degradation is the general lowering of bed levels over a significant length of the river channel and typically over relatively long time periods, contrasting the kind of scour that often occurs over shorter reaches during individual floods. Degradation can proceed in upstream and/or downstream directions. There are various causes of degradation, including the lowering of a downstream control; gravel and sand extraction from a riverbed or floodplain, and reduction in sediment transport as the result of sediment deposition behind dams. Degradation at a bridge in Taiwan caused by gravel extraction from the river is illustrated in Figure 1.

Figure 1: The impact of river degradation at a bridge in Taiwan resulting from gravel mining

Kies- oder Sandentnahme aus dem Flussbett oder aus dem Vorland und die Verringerung des Sedimenttransportes als Ergebnis einer Sedimentablagerung oberhalb von Talsperren. Bild 1 zeigt die Sohlrosion eines Flusses in Taiwan infolge von Kiesentnahme.

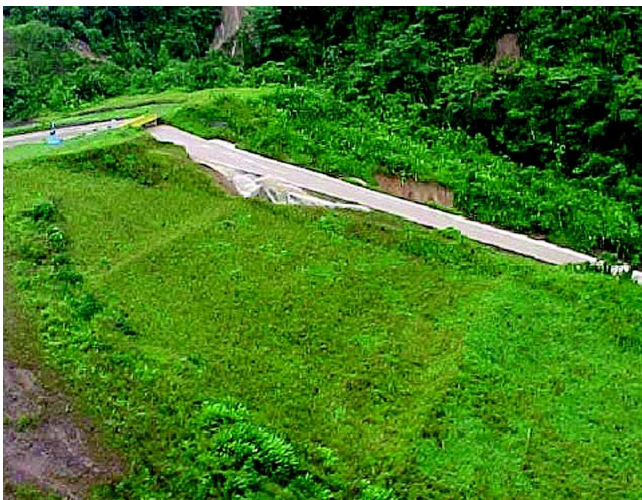
Figure 2: Lined spillway channel failure commences (Source: Hidroven)

Failure of lined and unlined spillways often occurs because of head-cutting. An example of the failure of a lined spillway is shown in Figures 2, 3 and 4. Overtopping of this spillway channel caused scour of the earth supporting it, which was followed by failure of the concrete channel. Once the concrete lined channel failed, erosion by head-cutting occurred, eventually completely removing the spillway.

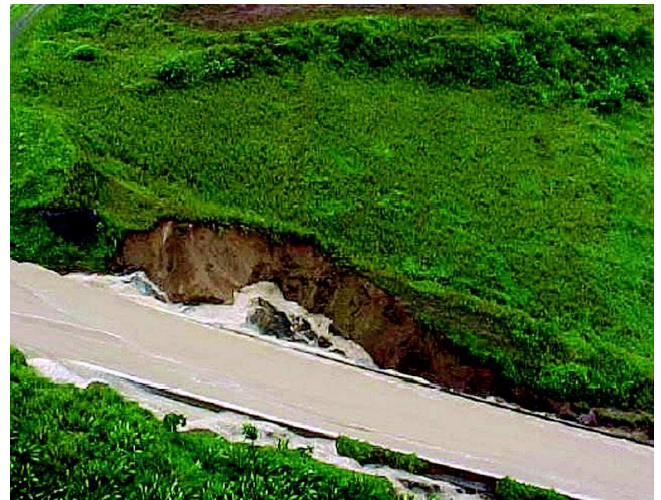
Figure 3: Close up view of principal failure area (Source: Hidroven)

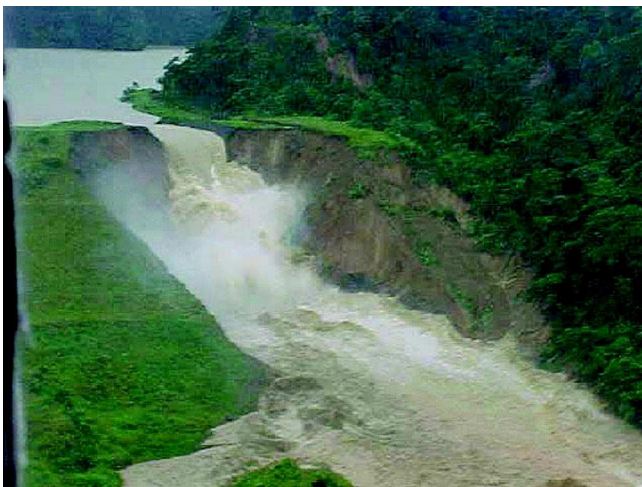
Figure 4: Advanced level of failure, showing headcutting mechanism (Source: Hidroven)

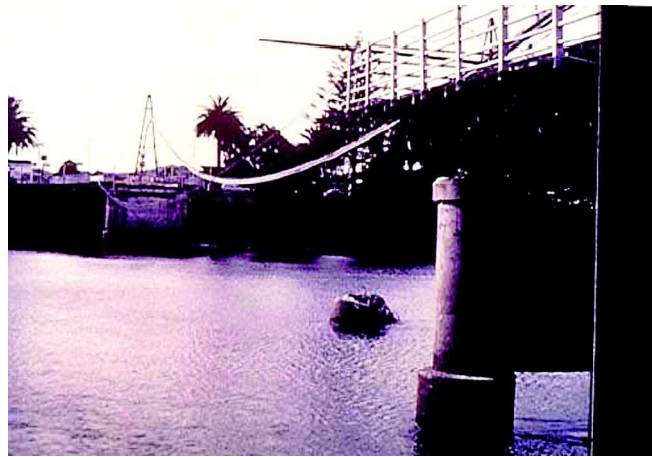
Figure 6 shows the damaged bridge. The piers comprised a barbell-shaped concrete slab supported on twin 1.8 to 2.1 m diameter concrete cylinders. The cylinders extended about 6 m below the original bed levels, and were founded on clusters of five octagonal concrete piles. The piles were 0.35 m diameter. The piles for Piers D and E extended to about 16 m below mean sea level, while the piles for Piers F to H extended to about 22 m below mean sea level, as shown.

Figure 6: The damaged Wairoa River Road Bridge, flow from left to right, after Melville and Coleman (2000)

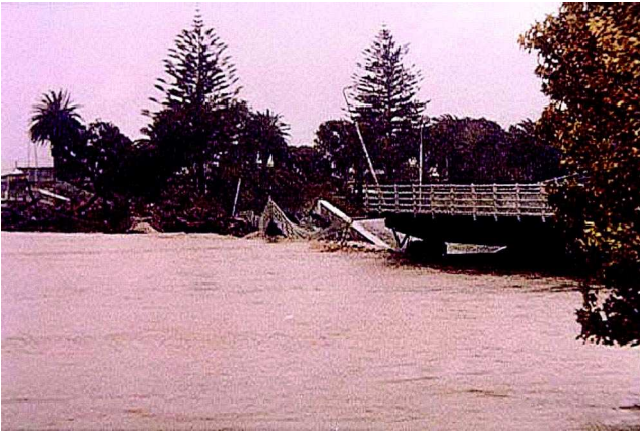
Due to the high flood level and the short bridge spans, the large volume of debris being carried by the river could not pass the bridge. The debris formed an extensive raft against the piers and bridge superstructure, as shown in Figure 7. It is postulated that the raft diverted the flow towards the riverbed, thereby increasing scour

Figure 7: The bridge failure, flow from left to right, after Melville and Coleman (2000)

around the foundations. The failure of the bridge can be attributed to this scour, as well as the loads due to the debris raft.

Six spans of the bridge collapsed, with Pier D being swept downstream. Piers E to H, which were also damaged, were separated from the respective cylinders. Four of the dislodged spans were not located. The bridge failure severed the roadway link, along with all services carried by the bridge.

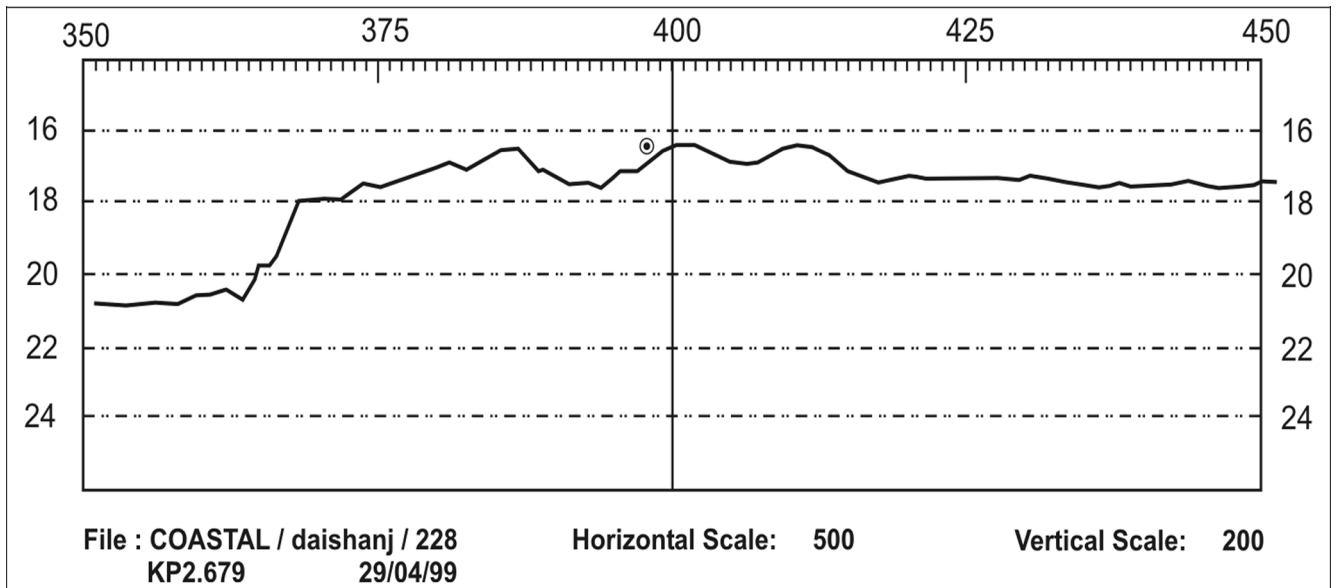
Figure 9 shows another section of the pipeline (not far from that in Figure 8) where the two large scour holes are no longer present. Instead the pipeline is completely exposed and the rock layer appears to have been washed away too. When subjected to the hydrodynamic forces caused by both wave and current, tunnel scour (Chiew 1990, 1991) can form beneath the pipeline in Figure 9. When this occurs, spanning may develop causing the pipeline to vibrate. This would seriously undermine the integrity of the pipeline, for example, it may cause spalling of the concrete over the pipeline. It is anticipated that the large scour holes in Figure 8 is a prelude to the pipeline exposure shown in Figure 9.

Not long after the measurement of these data in Figures 8 and 9, the portion of the pipeline in the vicinity of the two sections above was ruptured. The cause of the failure was attributed to vortex-induced vibration, a phenomenon that can only occur when tunnel scour beneath a pipeline has taken place.

Figure 9: Exposure of buried pipeline

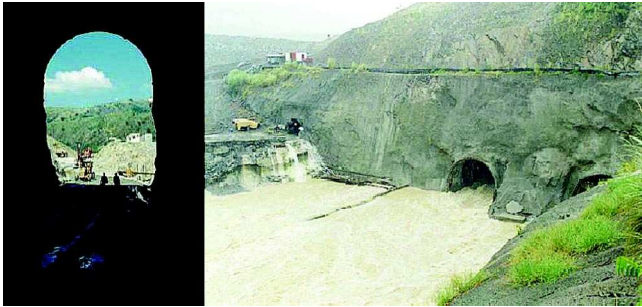
During the course of construction floods occurred that substantially filled the tunnels with water, up to 3,500 m<sup>3</sup>/s, which is equivalent to approximately the 10-year flood. Observations after the floods confirmed the recommendations. No significant scour of the tunnel floors was observed, with the tunnels remaining intact to perform their function. Figure 10 shows the inside of the tunnel and its exit during flooding, and its floor after the floods respectively. Figure 11 shows the floor of the tunnel after the flood event, remaining essentially intact.

Figure 10: Interior view of tunnel entrance and flood passing at exit

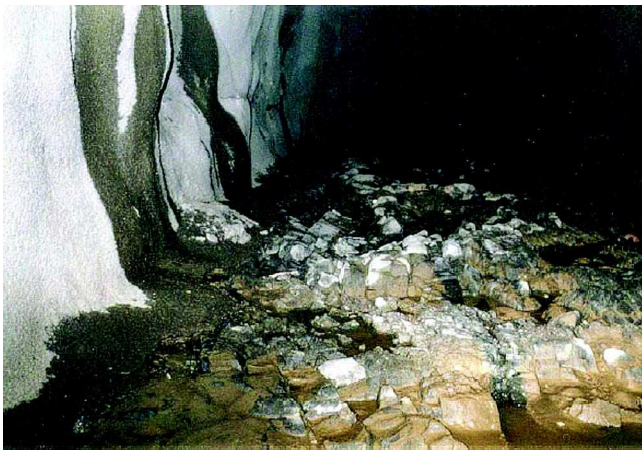
Figure 11: Unlined rock floor of tunnel after flood, remaining essentially intact
