Conference Paper, Published Version

Scour at a Submerged Rock Dike, Willapa Bay, Washington

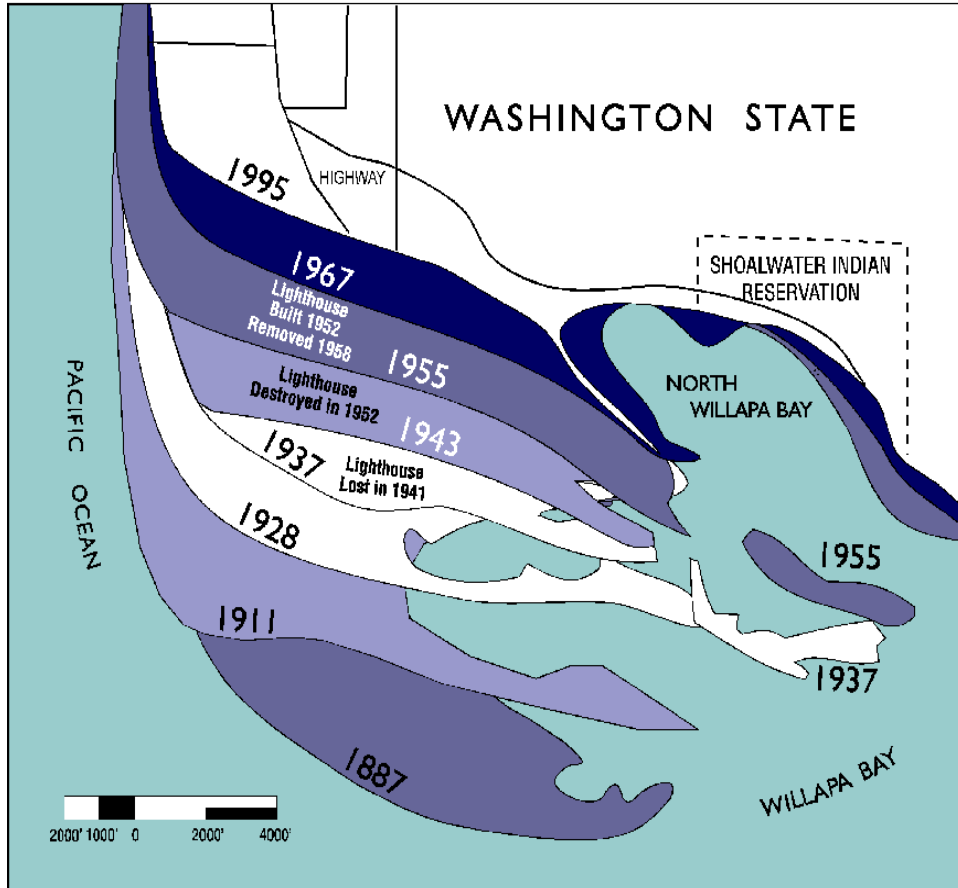
Figure 2. Erosion History at Project Area, 1887-1995

deep north tidal channel and wave action. The majority of the tidal current flows through the north channel, immediately adjacent to the shoreline. The shoreline erosion rate recently has been up to 150 feet per year. The historical rate has been observed to be greater than 250 feet per year (Figure 2). Recently, erosion threatened a 2,000-foot stretch of State Highway 105 (SR-105) near the town of North Cove, Washington. Relocation of the highway (for the second time this century) was not economically feasible.

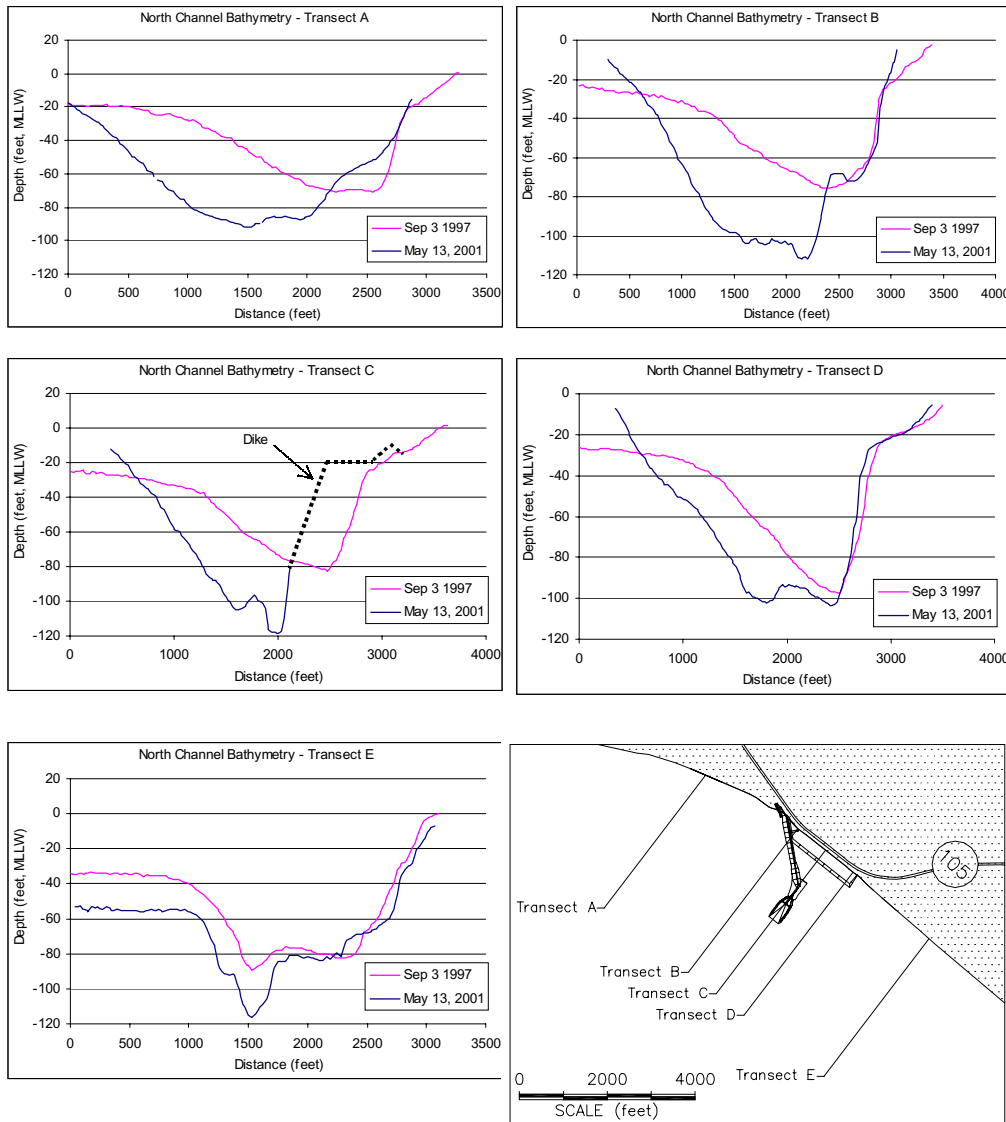
Figure 7. Hydrographic Survey Data

Hydrographic survey results show that the North Channel has moved south, 500 to 2000 feet, in response to project construction. The dike and groin have acted as a tidal current deflector and prevented further northward migration of the channel. North bank slopes in the vicinity of the project have generally accreted and moved southward. Figure 7 shows before and after hydrographic surveys taken across the north tidal channel.

Local scour in the vicinity of the structure is shown in Figure 7-Transect C. Also, the scour is shown in plan view in Figure 8, and in a section through the dike in Figure 9. The local scour induced by the groin appears overlapped, or superimposed, on a larger channel migration. The channel movement away from the north slope is caused by deflection of the tidal current by the groin. Some of the scour is likely due to a general channel migration away from the north bank. Figure 7-Transect C shows that the cross sectional area of the channel has increased more than the cross-sectional area of the dike and groin extending into the channel. The overall cross-sectional area of the north channel in the vicinity of the project has increased, as shown in Figure 7. This is consistent with velocity measurements showing a decrease in tidal current speeds near the shoreline along the north channel.

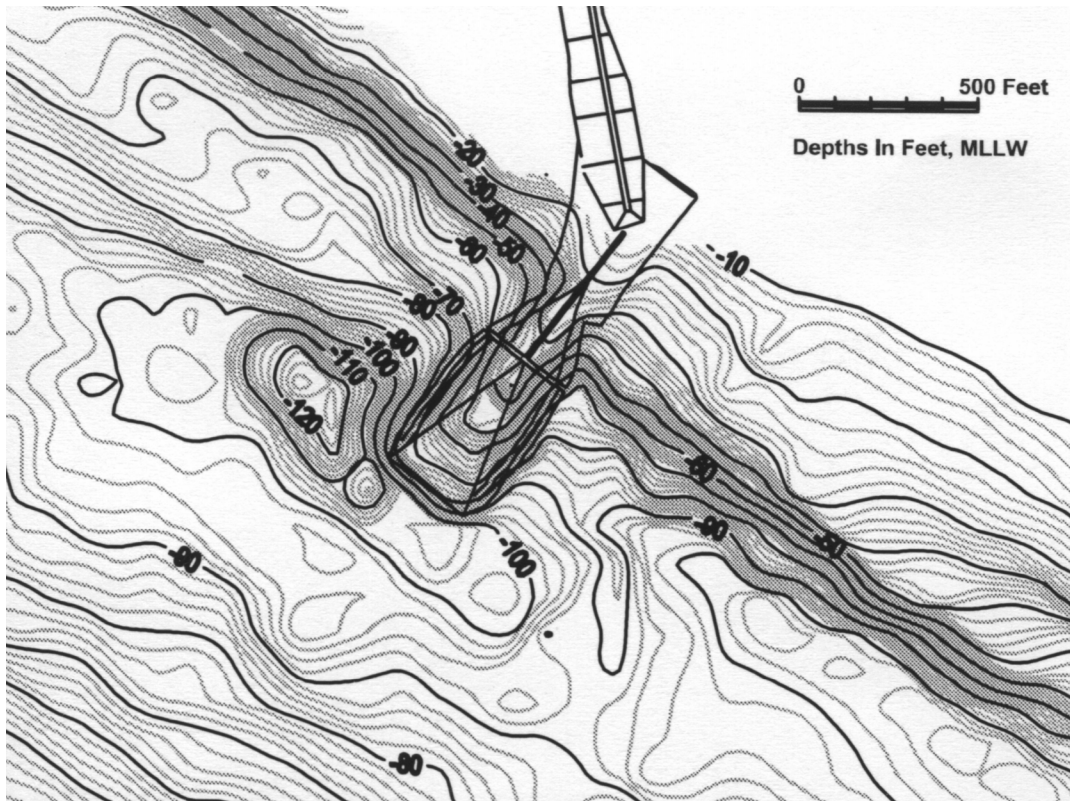
Figure 8. Scour Hole Bathymetry, April 2000

The scour hole immediately adjacent to the dike is approximately 40 feet deeper compared to pre-construction bathymetry. The scour hole forms a classic kidney shaped depression around the toe of the rock dike. The scour on the seaward side of the structure is deeper than the landward side. This may reflect the fact that ebb tide currents are stronger than the flood current. It may also be a consequence of the seaward side of the dike being generally more exposed to wave action than the landward side.

Comparisons have been made between the measured scour dimensions and predictions based on methodologies in Przedwojsk et al. (1995). The predicted scour hole dimensions are larger than that predicted from analysis based on sediment size and a steady current speed. One possible reason is the influence of waves combined

with a steady current. Another possible reason is that the scour hole is reacting in part to the overall migration of the tidal channel away from the dike and groin. It is probable that the scour hole is caused in part by large eddies generated in the vicinity of the dike, including eddies about a horizontal axis formed over the top of the dike. However, the current meters deployed in the field do not have sufficient temporal or spatial resolution to measure macro-turbulent eddies.
