Conference Paper, Published Version

Scour effects on Coastal Defense Structures Examples from the Portuguese West Coast

F. Taveira-Pinto*, F. Veloso-Gomes* and P. Rosa-Santos*

* Faculty of Engineering of the University of Porto – IHRH, Porto, Portugal

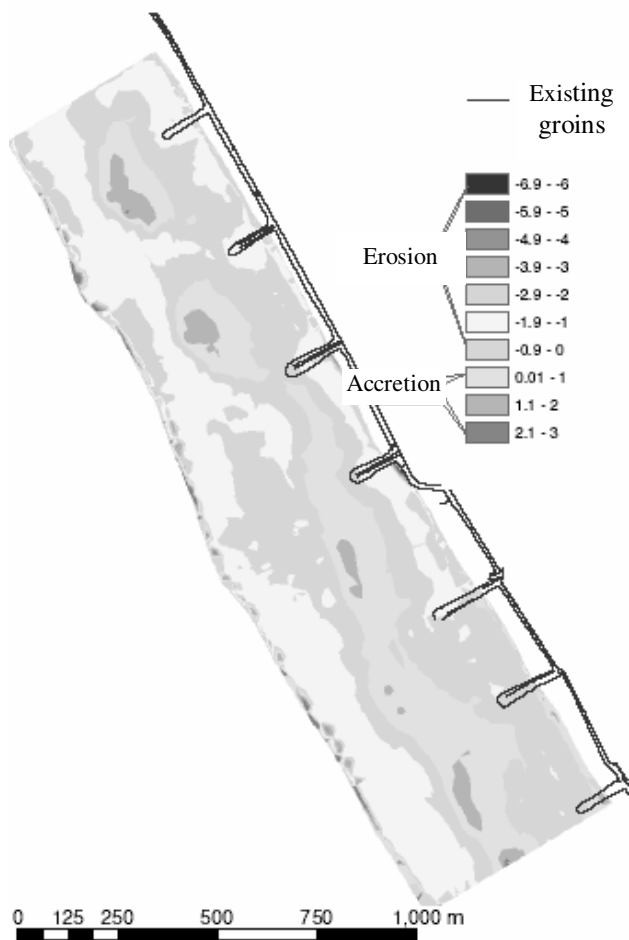
Figure 5. Bathymetric changes between Sept. 2001 and Sept. 2005 at Costa da Caparica groin field.

A scour depth of -11m has been measured in 2005 near the head of groin EV2 at Costa da Caparica. The bathymetric changes in the vicinity of the Costa da Caparica groin field, between September 2001 and September 2005, are presented in Fig.5.

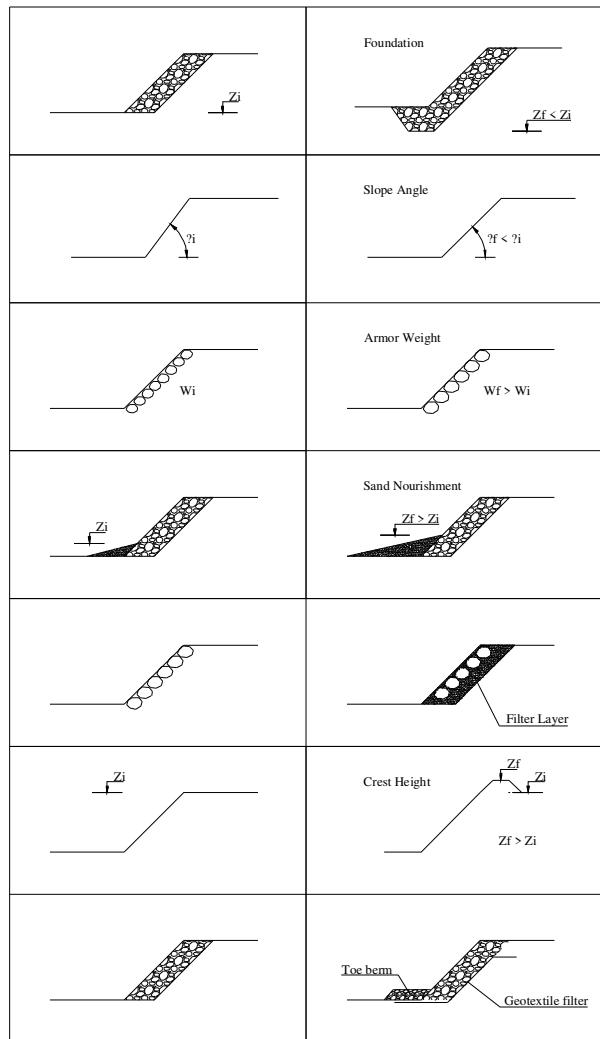
Figure 6. Situation before and after technical actions on damaged coastal defense structures [5].

Along the most critical waterfronts of the Portuguese West coast several coastal defense structures have been built through the years. Despite the care taken in their design and construction, and the repairing actions that have been carried out, some important damages on these structures can be observed. Interventions that were carried out on the Portuguese coastal defense structures are summarized in Fig.6.

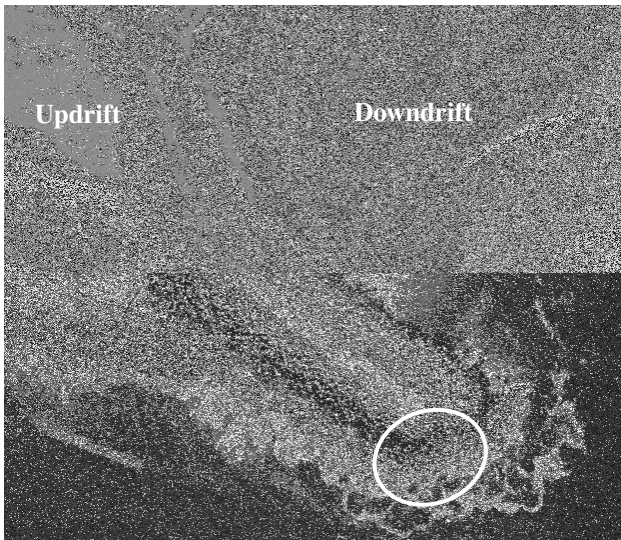
Figure 8. North groin of Espinho, 2005.

Despite the repairing actions that were carried out on the two S shaped groins of Espinho, some damages can be observed in Fig.8 and Fig.9, which present the conditions of these structures in the year of 2005. Both groins present damages at the structure head. However the damages were more severe on the central groin, whose head almost disappeared completely.

Damage on a groin structure with an armor layer composed of relatively fragile concrete blocks can be worsened by the breaking of these units. This often occurs with tetrapod concrete blocks exposed to severe wave conditions (Espinho case).

Either the sliding down of the armor layer tetrapod blocks due to scour effects at the toe of the structure or the dynamic actions induced by waves can break these units into smaller parts. These tetrapod fragments, with a reduced weight, are then projected by wave action against intact units leading to their breaking. Fragments of broken tetrapods are often observed at the head of the structure.

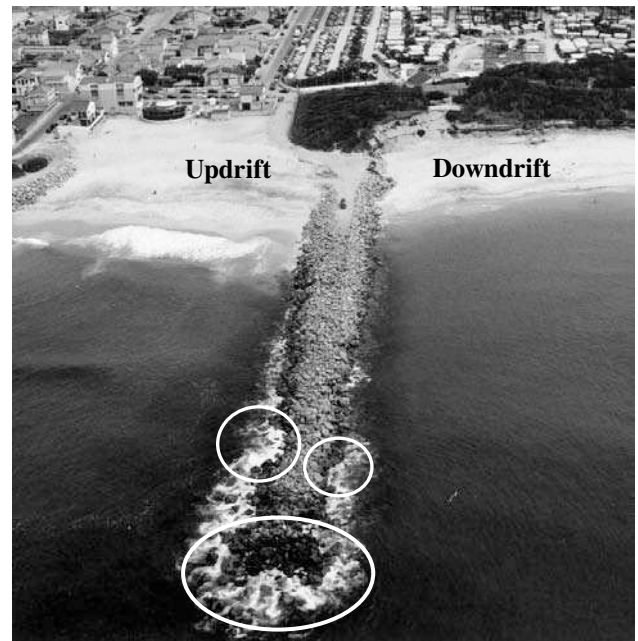
Figure 10. Groin of Cortegaça.

The groin presented in Fig. 10 is located near Cortegaça. The structure armor layer is composed by stone blocks with weights up to 12t and the length of the structure is approximately 170m. The photograph shows important damages at the structure head and at some localized sections along the trunk, either in the updrift side or in the downdrift side of the groin.

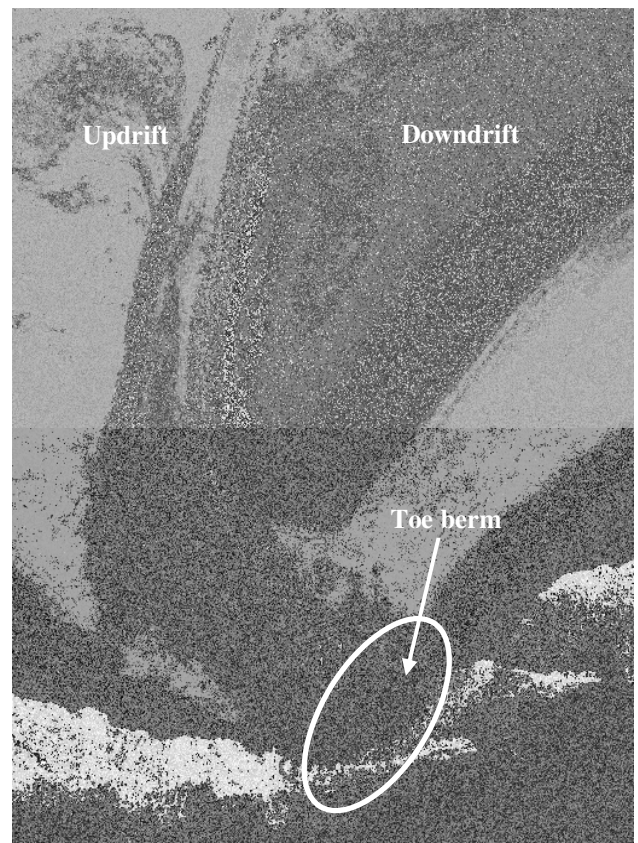
Figure 11. New groin of Poço da Cruz, 2005.

The new groin located in Poço da Cruz, Fig.11, presents a curved plant configuration and is approximately 230 m long. The armor layer is composed by stone blocks of 12t. At the head of the structure a toe berm, partially covered by sand, can be observed and in the downdrift side of the groin a diffraction beach has been created. There is no evidence of damages on this structure.

The toe berms of groin structures are clearly visibly during the first years after construction. This can have some negative visual impacts on the beach users; however these impacts will disappear with time. Fig.15 presents the elevated toe berm protection of a groin structure located near Costa Nova. Fig. 11 shows a toe berm partially covered by sand.

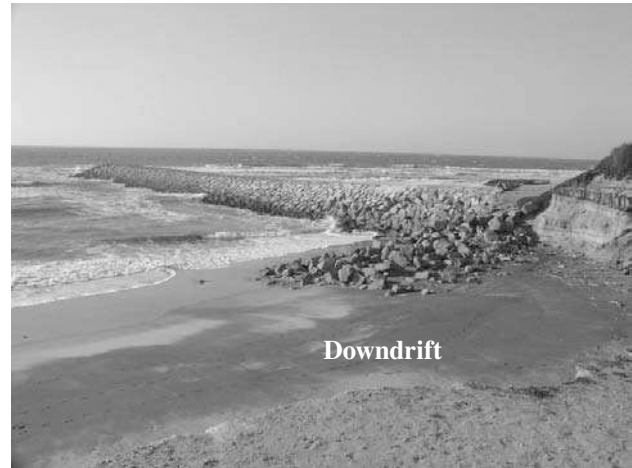
Figure 12. Groin of Maceda, 2005.

The shoreline retreat and the beach lowering can also lead to the situation presented in Fig. 12, in which the root of a groin structure located near Maceda, Portugal is being flanked in the downdrift side. The groin has been extended landward about 60m. This situation is a cumulative impact of shoreline retreat due to an overall negative sediment balance along the coastal zone and the local impact induced by the structure itself.

Short term prevention against flanking of the groin root, Fig.12, can be assured, to some extent, by the extension of the downdrift rubble-mound slope of the structure, following the coastline alignment as presented in Fig.16.

Additionally the groin superstructure can be constructed with a reduced crest elevation in order to allow the transposition of sand material from the updrift side to the downdrift side of the structure.
