Dr.- Ing. L. Satrapa, Dr.- Ing. P. Valenta, (CZ)
CTU Prague, Faculty of Civil Engineering,
Department of Hydrotechnology

Foundation of the Mseno Dam; Analysis and the Study of Remedial Measures

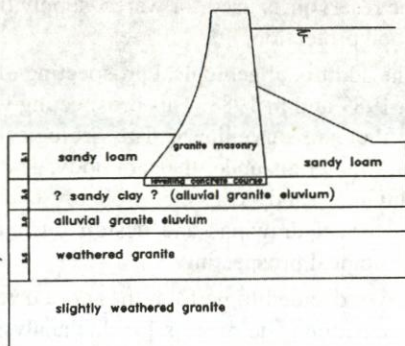
Fig. 3: Mseno dam subgrade

The archive materials (design documents, drawings) do not probably correspond to the real situation as for the subgrade of the dam. The solid rock under the dam is mentioned in old documents and drawings.

The thickness of soil layers between the dam and the bedrock varies from 7 to 11 m. The main part of the non rock subgrade consists in alluvial granite eluvium. Some parts are filled by sandy clay and sandy loam (Fig. 3).

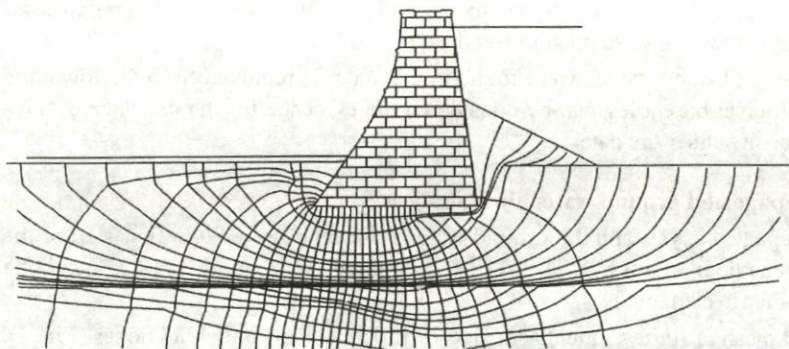
Fig. 5: Seepage analysis - equipotential lines and path lines (full reservoir)

The 2D mesh of finite elements consists in 1305 elements and 4088 nodes (Fig. 4). Some results of seepage analysis are presented in Fig. 5. The drawing presents path lines and equipotential lines in the case of full reservoir.

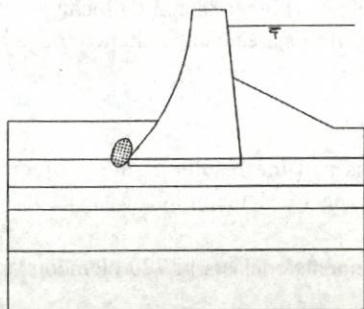
Fig. 6: Seepage analysis - hydraulic gradients higher than 1

Hydraulic gradients were the most important part of obtained results. Fig. 6 presents the large area of high hydraulic gradients (higher than 1.0) located near the downstream part of the dam toe. The shape of this area can be characterised by the width of 4 m and the height of 2.5 m.

The high hydraulic gradients concentrated in the area adjacent to the downstream toe of the dam are considered to be the warning that the dam is not safe enough from the hydraulical point of view. The external impulse can cause the rapid piping erosion of the nonrock layers under the base of the foundation. The following restrictions were applied to reduce the dangerous effects of high hydraulic gradients:

1/ the operating water level was lowered by 2 m,

2/ it is forbidden to operate heavy vibrating machines at the downstream face of the dam (in the strip 20 m in width along the downstream face) and open any excavation at the same area.

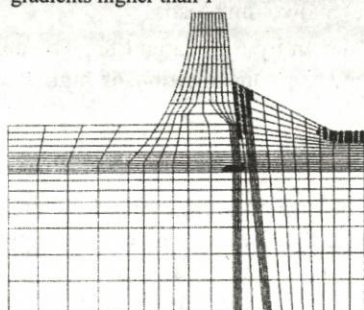
Fig. 8a: Statical analysis - present state, full reservoir (area of high tensile stresses)

Some results in the case of full reservoir are shown by Fig. 8a and 8b. The concentration of high tensile stresses (Fig. 8a) and the concentration of high shear stresses (Fig. 8b) is presented.

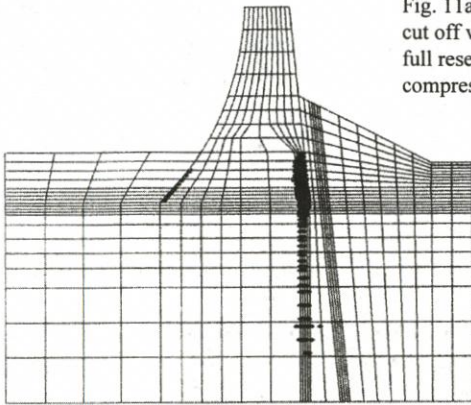
Fig. 11a: Statical analysis cut off wall under the upstream toe, full reservoir (area of high compressive stresses)

Figures 11a and 11b present the results in the case of full reservoir (concentration of high compressive stresses - Fig. 11a, the concentration of high shear and tensile stresses - Fig. 11b). The cut off wall is located under the upstream toe. This alternative is considered to be dangerous for the dam.

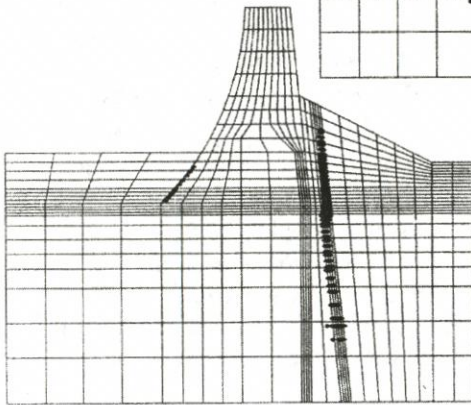
Fig. 12a: Statical analysis cut off wall in front of upstream face full reservoir (area of high compressive stresses)

Figures 12a and 12b present the results for the case of full reservoir (concentration of high compressive stresses - Fig. 12a, the concentration of high shear and tensile stresses - Fig. 12b). The cut off wall is located in front of the upstream face. This alternative is considered to be convenient for the design of remedial measures. The strip between the dam and the top of the cut off wall can be sealed by flexible membrane.
