Conference Paper, Published Version

Scour of Railway Embankment Foundation Located on Sea-Cliff in Japan

Hiroto Suzuki¹, Makoto Shimmura²

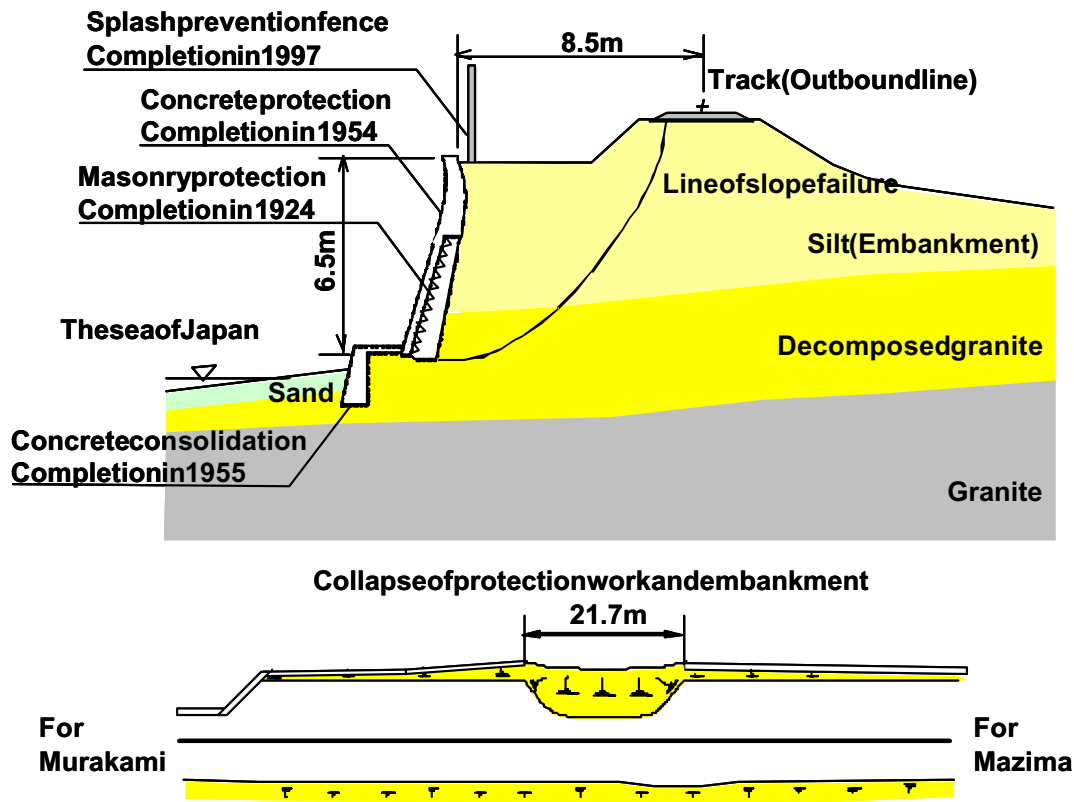
Figure2 This section and plan diagram of the collapse site

Photo 1 is a photograph of the collapse site. Figure 2 shows the section and plane diagram of the collapse site of the outbound line. The basement rock in and around the collapse site is granite formed from the latter term of Cretaceous period to Paleogene period. Upper layer of it is decomposed granite. The embankment made of silt was constructed on it. This site has 137m long and from 5m to 7m high wave protection work of the railway embankment. The masonry protection work was constructed in 1924, when the present outbound line was laid. In 1954 the front of the masonry protection work was reinforced by concrete and the concrete parapet was constructed, and moreover in 1955 the concrete consolidation of foundation was constructed at the foundation of the wave protection work. In 1997 the splash protection fence was built at the top of the wave protection work, because splash can easily go over the top of the wave protection work, when it was high waves.

The wave protection work and the embankment with 21.7m width and 6.5m height collapsed due to scour of the wave protection work foundation. The slope failure reached up to the track ballast layer. The volume of the soil collapsed was about 450m³. Moreover about 30m section each of both sides of the wave protection work collapse was out of the perpendicular.

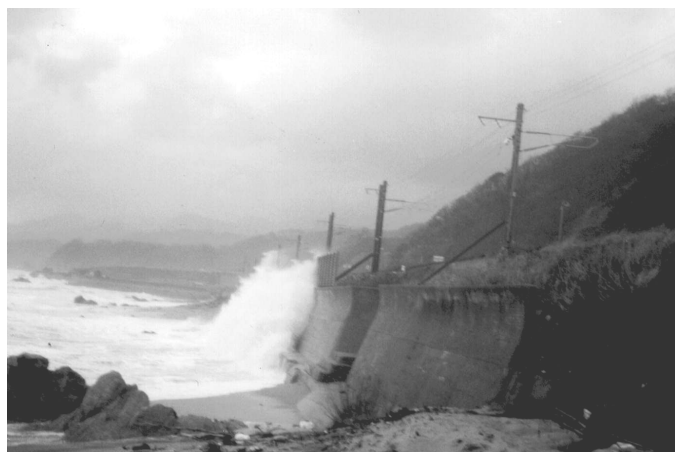
Photo 2 The waves condition of the collapse site before 2 hours of the collapse occurrence

Photo 2 shows the waves condition of the collapse site before 2 hours of the collapse occurrence, at about 17 o'clock on December 19. The sea was rough and splash covered on the railway track. These high waves seem to be the immediate cause of the wave protection work collapse.

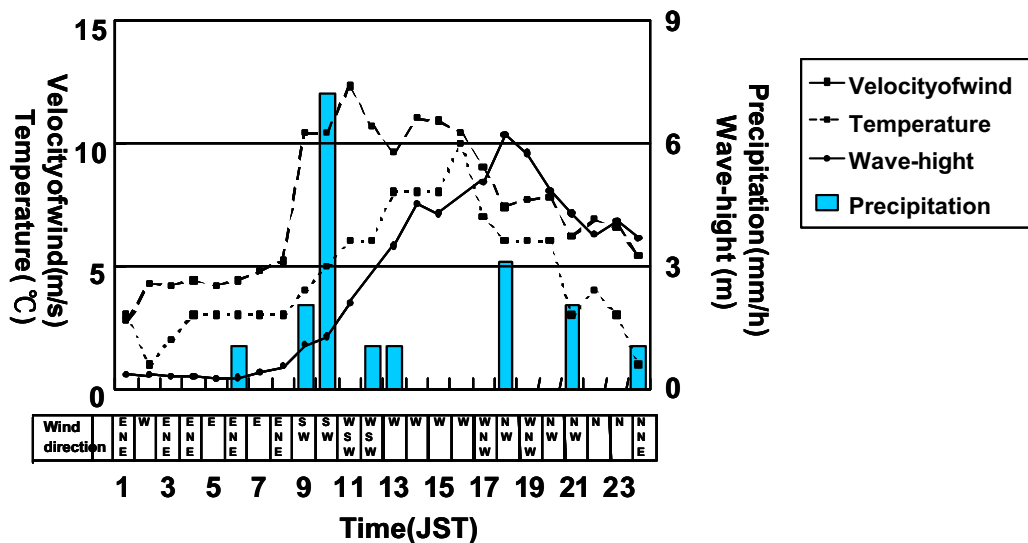
Figure 4 Time history of wind velocity, precipitation, and temperature at Murakami, and significant wave height at Atsumi on December 19, 2000

Figure 4 shows time history of wind velocity, precipitation, and temperature at Murakami (Figure 1), where is the nearest meteorological observations site of Japan Meteorological Agency (JMA) from the collapse site. The wind direction changed from east-north-east to south-west, and temperature rose at about 9 o'clock. At that time the low passed over near Murakami. After this the wind velocity grew gradually strong, and

the maximum wind velocity which is 10 m/s was recorded at 16 o'clock. 0 to 12 mm hourly rainfall was observed, but it was not a heavy rain to cause of the wave protection work collapse.

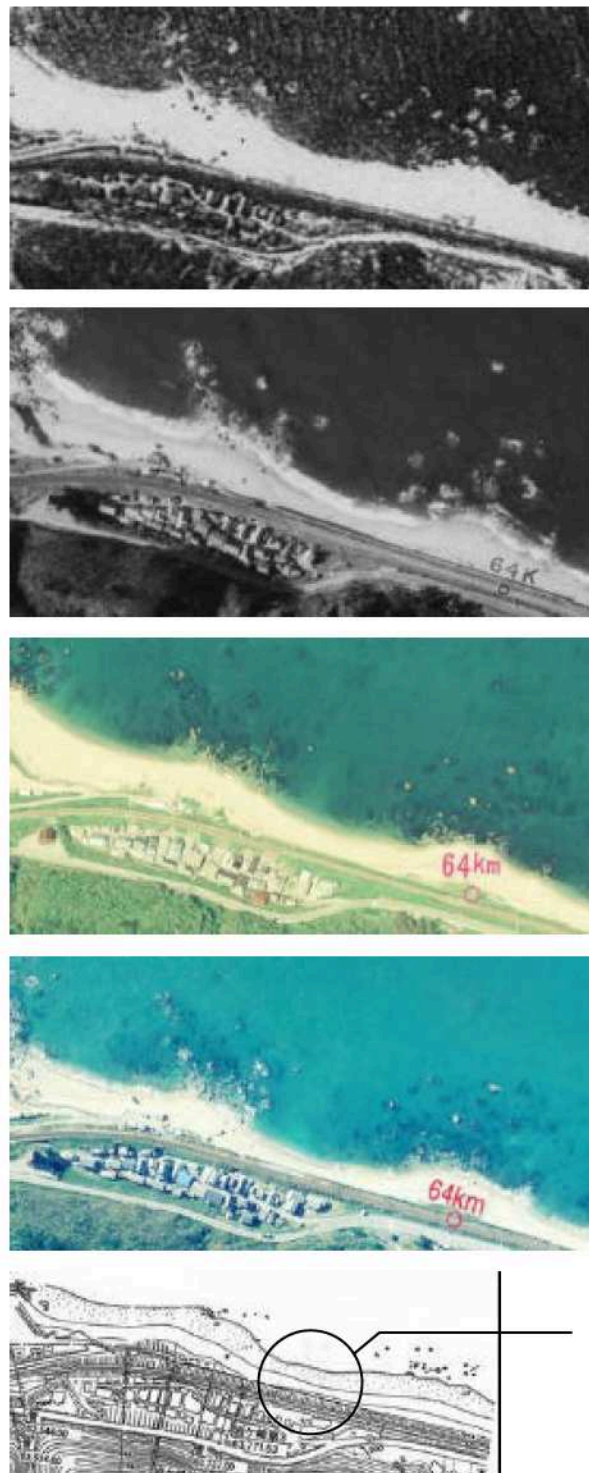
Figure 6 The aerial photographs and plane diagram in and around the collapse site.

Figure 6 is aerial photographs and plane diagram in and around the collapse site. In some place of seashore there are outcrops of granite. But there is no outcrop in front of the collapse site. The length of sandy beach of no outcrop site is shorter than one of outcrop sites. According to photograph decipher, the length from the wave protection work to beach line was 40 m in 1959. However, it gradually decreased, in 1976 it was 20 m, and in 1988 it was 18 m, and in 1996 it became 13 m.

The cause of the seashore retreat seems to be the decrease in sand supply from Miomote river. There is the mouth of this river at a distance of 1 km from the collapse site. At the upper reach of this river, Miomote dam and Saruta dam were built in 1953 and 1957. It is most probable that the decreases in supply of sand from rivers were

Wave energy hitting the wave protection work gradually increased with the progress of the seashore retreat. From about 1996 splash became to easily go over the top of the wave protection works, when it was high waves, as a result, in 1997 the splash prevention fence was built at the top of the wave protection work. Therefore the seashore retreat seems to work as the indirect cause of the scour and collapse of the wave protection work.

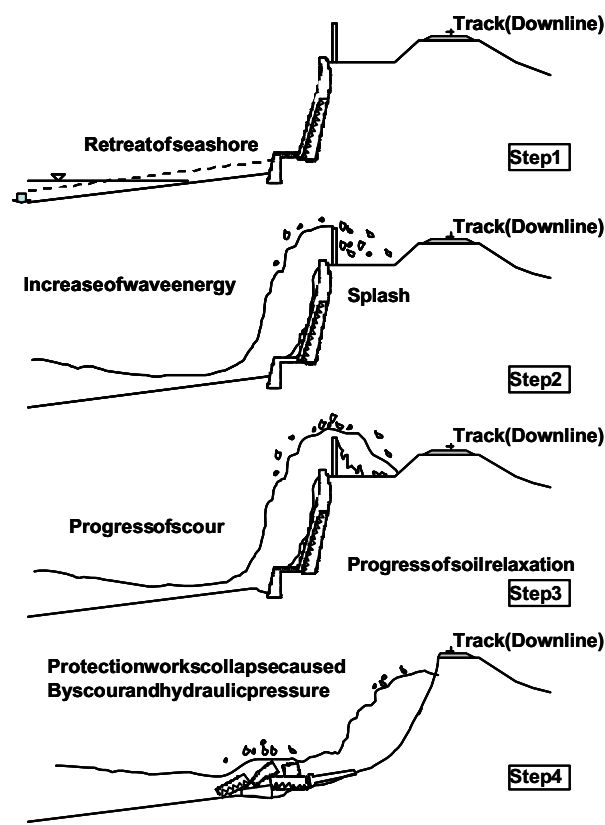
Figure 7 The process of the wave protection work collapse

According to the meteorological data analysis and aerial photograph decipher, the immediate cause of the collapse is the attack of high waves reduced by strong wind, and the indirect cause is the seashore retreat at the collapse site. The presumption mechanism of the damage process is as follows (Figure 7):

1. The seashore in the front of the collapse site gradually retreated by decrease in sand supply.
2. Wave energy hitting the wave protection work increased by the seashore retreat. Moreover splash became to easily go over the top of the wave protection work.
3. The foundation of the wave protection work was gradually scoured by high waves. Moreover soil relaxation progressed with seawater by splash.
4. The wave protection work and embankment collapsed by the scour of the wave protection work foundation reduced by high waves attack on December 19, 2000. Moreover the increase of hydraulic pressure in embankment with sea water supplied by high waves is presumed to affect the slope failure.

3. We investigated all wave protection works of railway tracks in East Japan Railway company area. As a result of the investigation seashore retreating is progress at three sites. We make plan to reinforce foundations of there wave protection works.
