## **Piping Failure in Subway Construction due to Internal Erosion of Silty Sand**

Ishihara, Kenji; Lee, Wei F. (2008): Piping Failure in Subway Construction due to Internal Erosion of Silty Sand. In: Sekiguchi, Hideo (Hg.): Proceedings 4th International Conference on Scour and Erosion (ICSE-4). November 5-7, 2008, Tokyo, Japan. Tokyo: The Japanese Geotechnical Society. S. 505-512.

# PIPING FAILURE IN SUBWAY CONSTRUCTION DUE TO INTERNAL EROSION OF SILTY SAND

Kenji ISHIHARA<sup>1</sup> and Wei F. LEE<sup>2</sup>

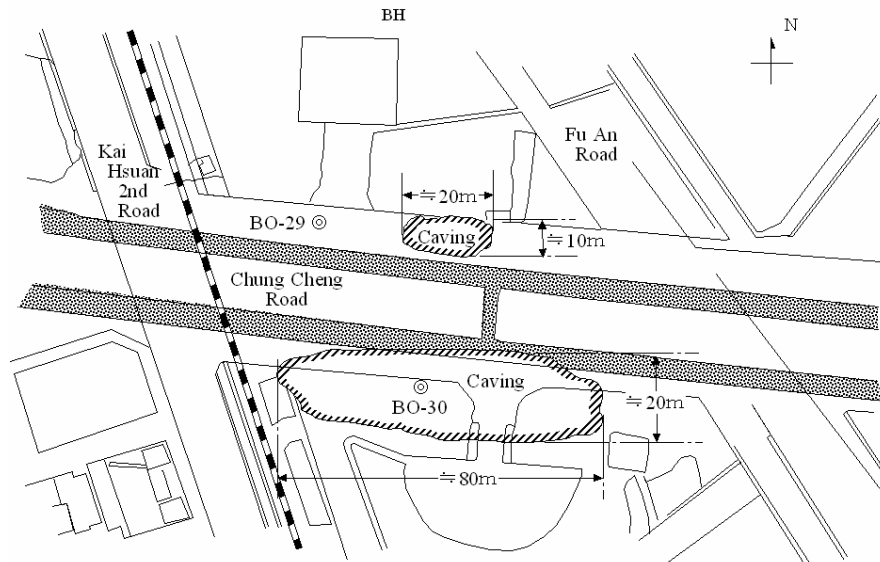
and water from the rips opened on the ceiling at the junctions between the shield segments. This breakage culminated eventually in a large scale collapse of the tunnel structure involving formation of two cave-ins on the ground surface.

Fig.1 Features of the cave-in in plan view.

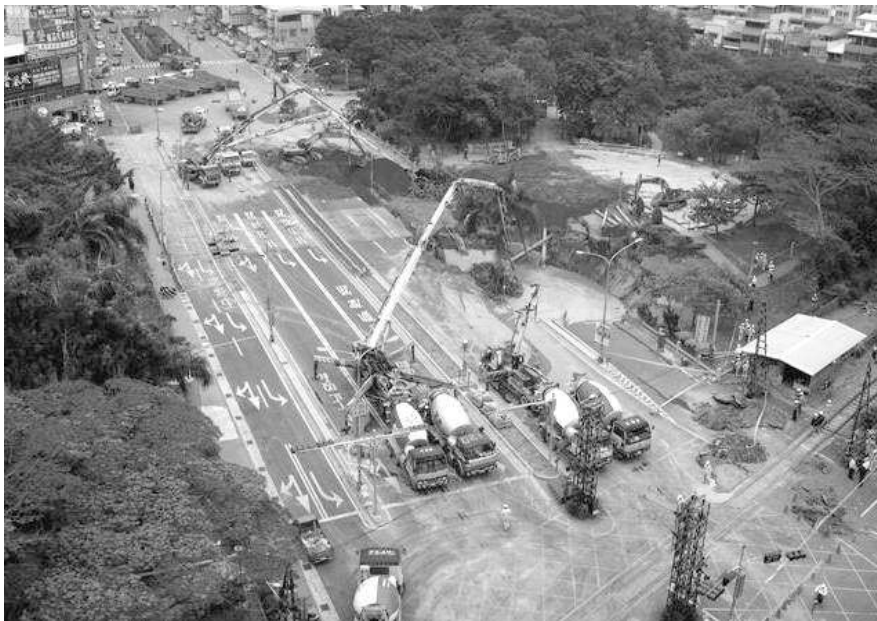
Fig.2 A bird-eye views over the cave-in in Kaohsiung.

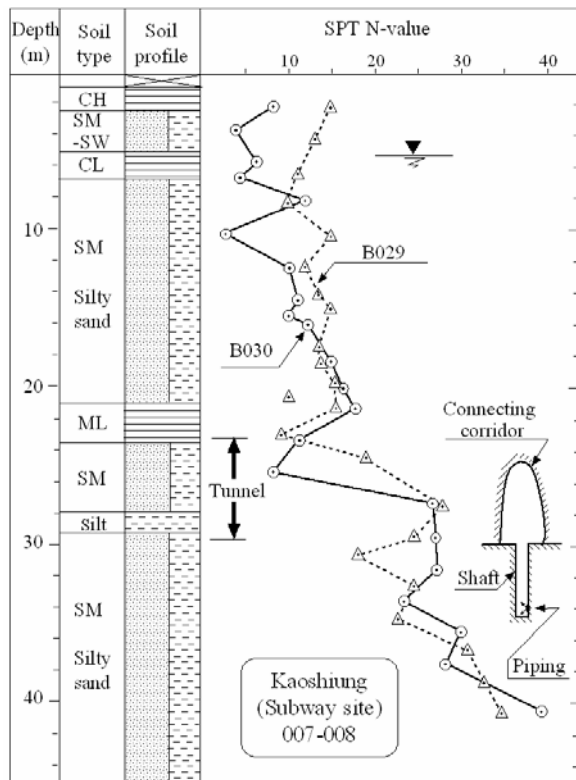
Fig.4 Soil profile at the site of collapse.

The soil profiles at the locations BO29 and BO30 in Fig. 2 are indicated in Fig. 4, where it can be seen that the deposits are comprised predominantly of silty sand with occasional layers of low-plasticity clay (CL) to a depth of 40m. The blow count, N-value, in the standard penetration test is shown to increase with depth and to have a value of 20 to 30 at the depth where the sump for water collection was excavated.

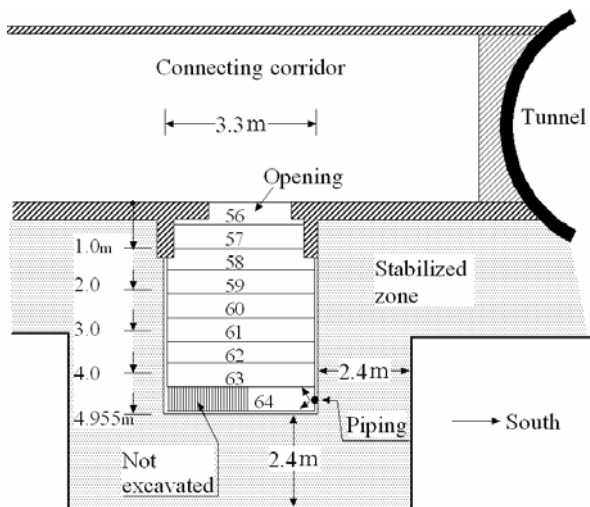
Fig.5 Details of the excavation for the sump and initiation of piping.

On December 4, 2005, the piping occurred at 3:30p.m. at the very last stage of excavation of the sump. A block of silty sand was detached from the south wall at the bottom of the excavation which is located at a depth of 35m from the ground surface. The circumstance at this time at the bottom of the sump excavation is illustrated in details in Fig. 5.

It is believed that the mud water flowed into the sump from the bottom through a single hole probably with a diameter of about 30cm. This assumption would hold true in the light of the fact that the zone stabilized by the jet grouting could not so easily broken down in the horizontal direction, and a weak zone might have existed in the vertical direction.

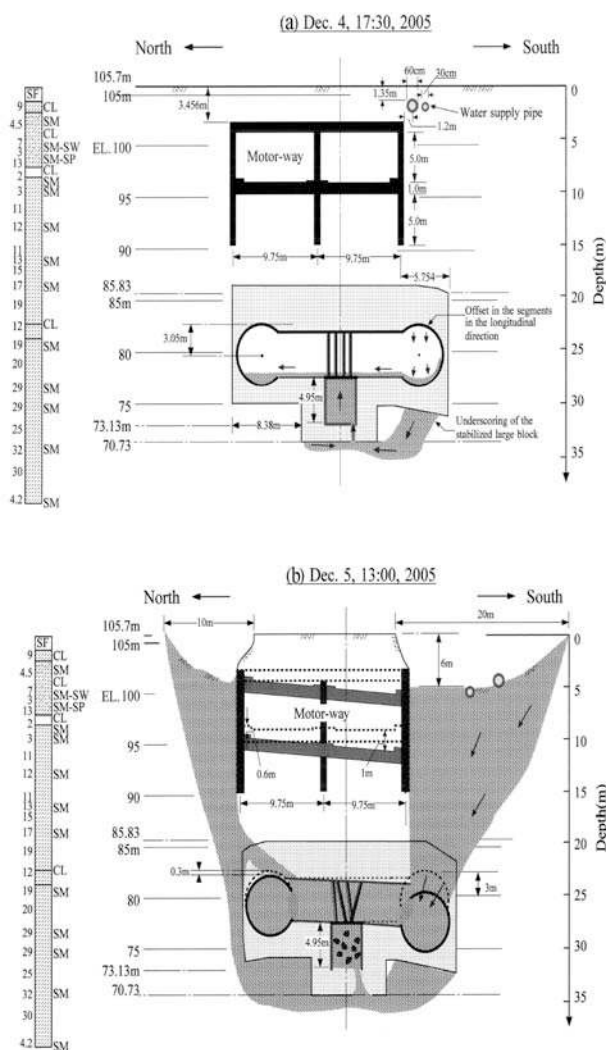
A sequence of the events after triggering the piping which are likely to have occurred is illustrated in the cross sections in Fig. 6. The blackish mud water continued to come out in the sump with increasing volume. Two men at work at the bottom strove in vein to clog the hole by dumping sand bags from the corridor. About two hours later, the workmen closed the entrance to the sump by placing a steel lid and several bars for its support (Fig. 6(a)).

About a few hours after the initial collapse, engineers at spot heard squeaking sounds of breaks at segment joints of the tunnel on the south, accompanied by mud water cascading from the ripped joints of segments at the ceiling. It appears likely that because of the underscoring of the bottom portion, the stabilized zone subsided together with the tunnel body, resulting in the stepwise settlement in the longitudinal directions illustrated in Fig. 6(a).

Around 10:20p.m., the fall-off of the soil above the ceiling had spread upwards and, assisted by the slipping along the vertical wall of the motorway structure, soil mass fell down into the tunnel. This resulted in creation of a large cave-in on the ground surface on the south side as illustrated in Fig. 6(b). At this time, two mains 60cm and 30cm in diameter for water supply were broken releasing a large amount of water for a prolonged time. This breakage of the buried pipes appears to have transferred the collapsed soil deposits into more flowable debris.

Fig.6 A sequence of likely scenario for progressing the piping failure.

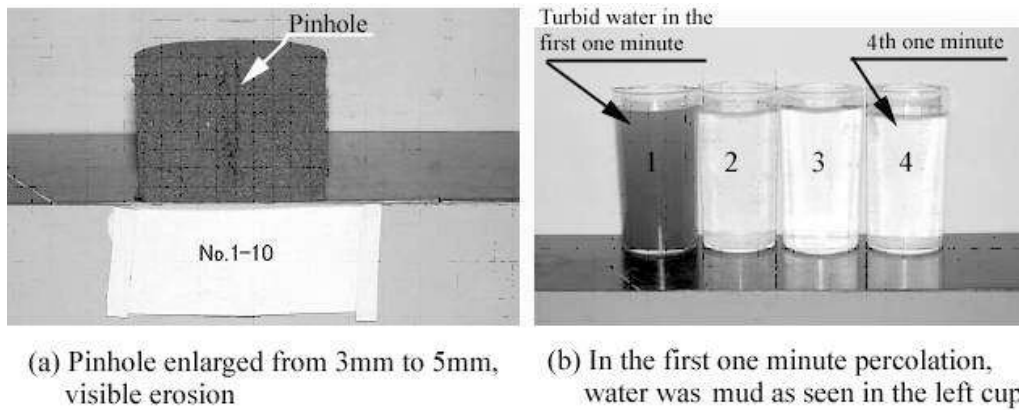
**Fig.10** Silt-contained sample from Kaohsiung.

In the first series, the tests were conducted on disturbed samples, one from Kaohsiung and another from Japan. The result of the pinhole tests on a disturbed sample is presented in Fig. 10. For the disturbed silt-containing sand sample from Kaohsiung, the pinhole is seen enlarging to a diameter of 5mm from 3mm as displayed in Fig. 10(a). Correspondingly, the drained water from the bottom was muddy for the first one-minute period of water percolation as seen in the water colour in the left-side cup of Fig. 10(b). The result of the pinhole test on the Japanese silty sand is shown in Fig. 11. In contrast to the Kaohsiung soil, the circulation of water through the Japanese soil did not exhibit any appreciable change in colour in the first one minute of percolation as seen in Fig. 11(b).

There was no change in the pinhole diameter for the Japanese soil before and after water permeation except for a local collapse at the top. Thus, it may be conclusively mentioned that the silty sand from Kaohsiung is potentially susceptible to internal erosion as compared to the soil from Chiba, Japan, although they had almost the same grading.

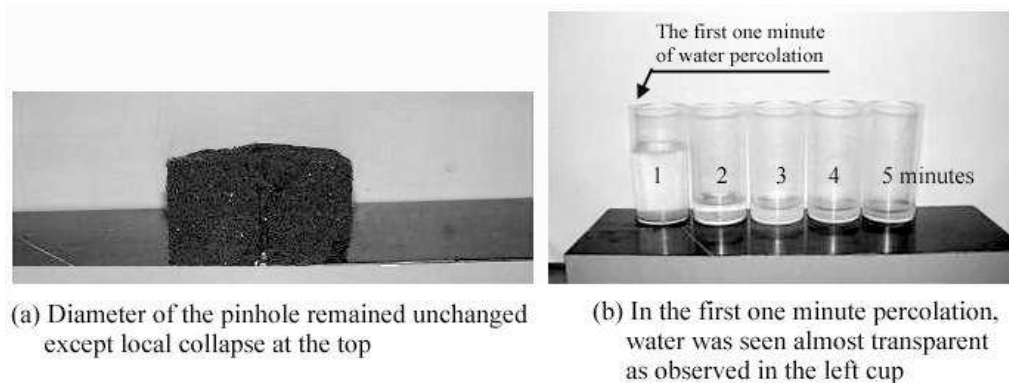
**Fig.11** The results of the pinhole test on the Japanese silty sand.
