Damages of the Roads-Bridges by Erosion and Remedical Measures in Albania

Muceku, Y.; Bozo, L. (2002): Damages of the Roads-Bridges by Erosion and Remedical Measures in Albania. In: Chen, Hamn-Ching; Briaud, Jean-Louis (Hg.): First International Conference on Scour of Foundations. November 17-20, 2002, College Station, USA. College Station, Texas: Texas Transportation Inst., Publications Dept.. S. 884-895.

Damages of the Roads-Bridges by Erosion and Remedial Measures in Albania

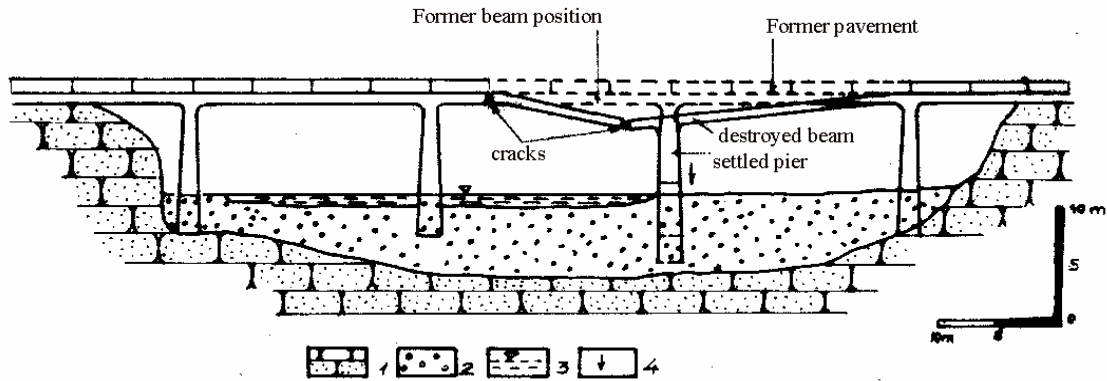
Fig. 1 Cross section of Peshkatari bridge

From a period of 60 year old of erosions activity, on 1990 year the foundation depth was 2,5m down dip. Whereas, the last ten years the erosion caused by man-made activity discover about 1.0 m of bridge foundation. So, during a rainfall storm (1999 year) the river water discharges (great flowing) was very much increased and in consequence a intensive erosion on river bed occurred, which caused a sinking from 1,98m one of bridge pier (foundation) (Fig. NR. 1, Photo NR. 1, 2,). Also from above phenomenon, is break down the central part of bridge and it is bent, as well as along of it are created many cracks enabled the destruction of it and put out of use (Fig. NR. 1, Photo NR. 1).

1. Sandstones, 2. Alluvial deposits, gravels, sands, silts and clays, 3. River water level, 4. Sinking direction

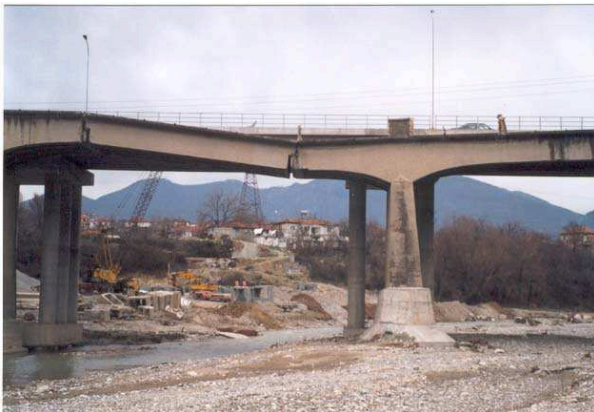
Photo nr. 1. Peshkatari bridge. It's looking to east, and shows, cracks, destroyed beam and a sinking of pier.

- Grouting with pile against other movements.
- Covering with concrete for reinforcement of damage foundation.
- Covering with stores blacks (gabion).
- Stopping of exploitation of raw material on river bed.
- Construction of provisional metallic bridge over existent one.

- Construction a new bridge with three ways highway.
- Static scheme -system beam column.
- Foundation with molded piles with 1m diameter and support on sandstone's rocks.
- Piers with concrete column.

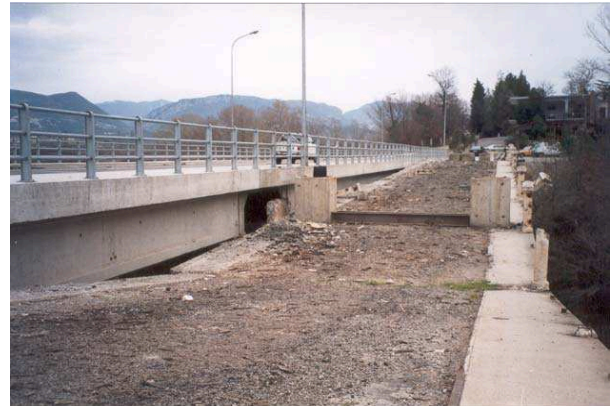
Photo nr. 2. Peshkatari bridge. It's looking to south, and shows, the new bridge and the destroyed bridge (right side) which is sunken 1.98 m compared with the new bridge.

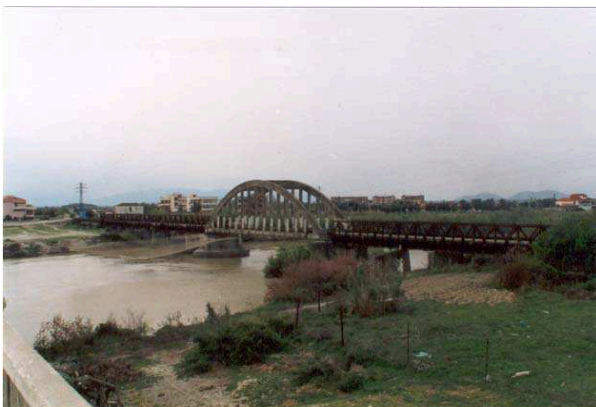
It has a combined structure, concrete arch with metallic beams. The foundations are made by metallic piles in tubular shape (Photo NR 3).

Photo nr. 3. Mifoli bridge. It's looking to north-east, and shows, its structure

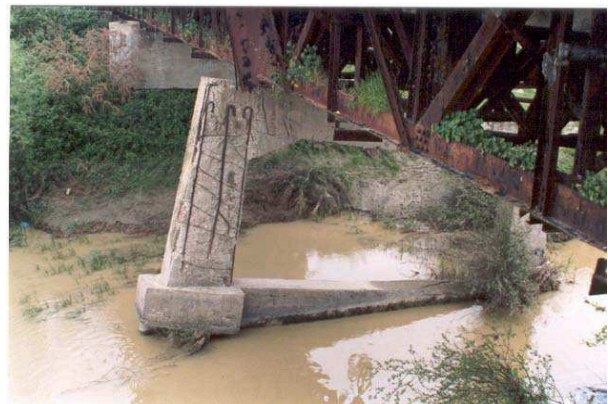
The interaction of seismic vibrations (sands liquefaction) and rivers erosion activity phenomena enabled discovering of bridge foundation (earthquakes of 1967 and 1969

Photo nr. 4. Mifoli bridge. It's looking to north, and shows, the sinking of its pier

years), from which a bridge sinking occurred (Photo NR. 4), and simultaneously a horizontal movement on one of its shoulder is done.

Consequences : It is out of use.

Construction of new bridge for the highway and railway purpose with molded pile foundation (38-42m length and 0,8-2m diameter) supported on gravel deposits.

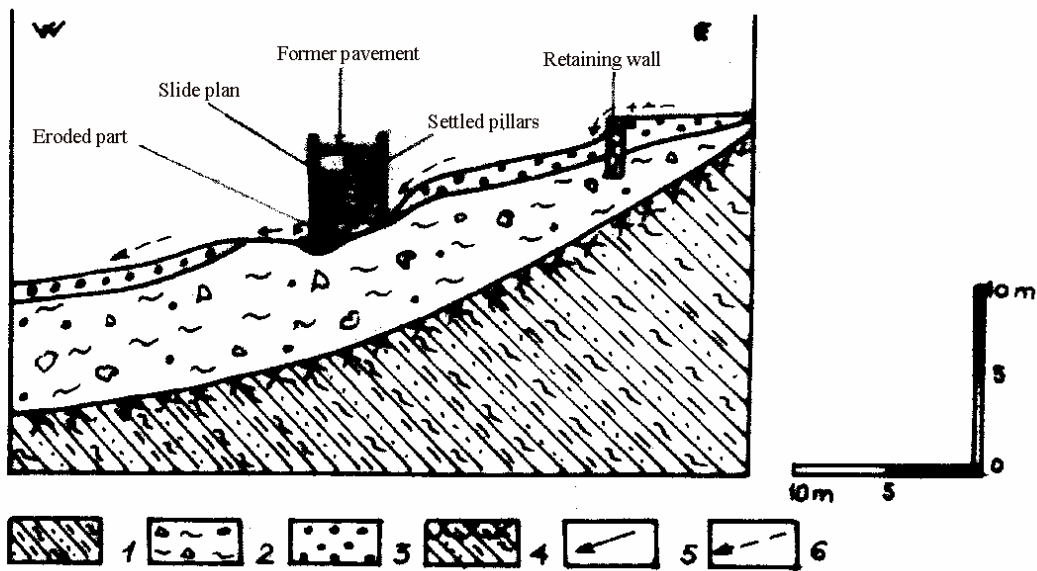
Fig. 2 Cross section of Kallmeti bridge

1. Flysch, 2. Alluvial deposits, clays, sands, gravels, and cobbles, 3. Alluvial deposits, gravels and cobbles,
4. Weathering crust of flysch rocks, 5. eroded soil movement direction, 6. Stream water flow direction

The bridge foundation moved 1,4m (Fig. NR. 2, photo NR. 7, 8) downward and simultaneously it is associated a horizontal movement, where several failures occurred on bridge pillars walls.

- Construction of weirs and groynes.
- Reinforcement of bridge foundation by its grouting.
- Filling of cavity by durable and less deformation materials.
- Construction a new bridge.

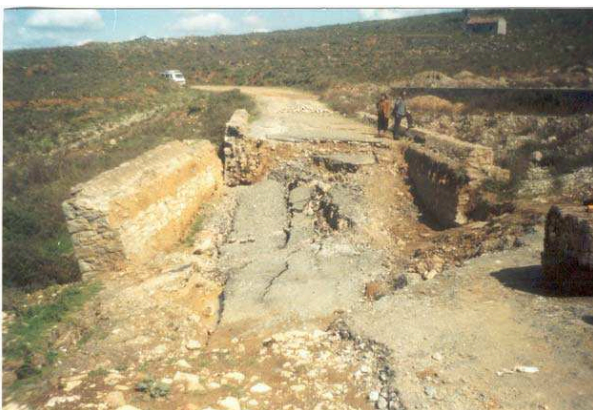
- During 1992,1994,1996 and 1998 year, as results of high quantities of precipitation and without protective measures getting in due time, on stream bed occurred a intensive erosion like a gully, which was extremely rapid. The stream bed erosion from 1992 year up to nowadays is about 1.8m, and below of bridge foundations was created a cavity with 1.4 diameter, as result of it, the bridge foundations has moved downwards (Fig. NR. 2, Photo NR.5, 6).
- The dynamic loads actions induced by motor-car traffic, when in the bridge were appeared a lot of cracks.

Photo nr. 5. Kallmeti bridge. It's looking to north, and shows, the sinking of its pillars and pavement

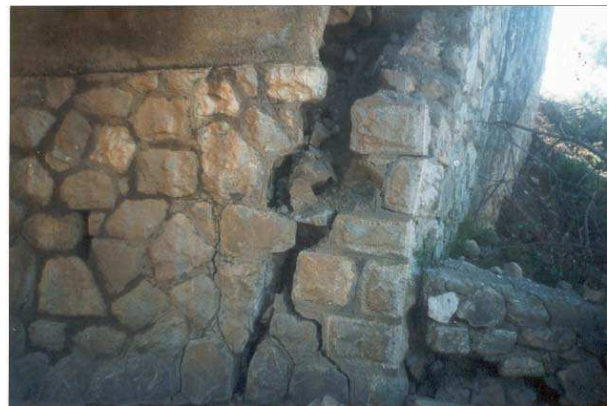
Photo nr. 6. Kallmeti bridge. It shows cracks of pillars from erosion phenomenon

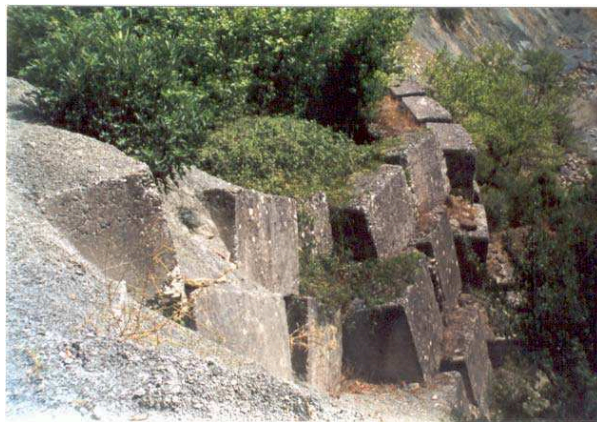
It is located on eastern part of Albania along Berati-Corovoda road, on right side of Osumi River valley. On this landslide is constructed above mentioned road, which is affected by this phenomenon. The river valley slope, where the landslide occurred (photo NR. 9), built up by flysch rocks (much weathered) with dip angle 50-60° in the same direction with the valley slope inclination, favoring it. Also on bottom of valley slope, flow the Osumi River waters, which continuously contribute to the erosion process, that is one of main factor of landslides creation. The landslide is moving slowly downwards through the valley slope to river bed (Photo 7), together with 200 m of road constructed over its body.

Photo nr. 7. Bogova landslide. It's looking to east, and shows, a destroyed retaining wall (deformed) by mass movement

- Construction of weir and groynes.
- Improving of general stability condition by installing a drainage system (2 ditches) to collect surface runoff, which reduce seepage and infiltration in the soil and this exert a positive influence on the main factor of slope stability.
- The stability of landslide by molded piles.
- Planting of trees.
- Construction of retaining wall with drainage system.
- The slope protection by using of gabions or geotextile against surface erosion.
- Protection interior erosion (systematize of two streams close of landslide).

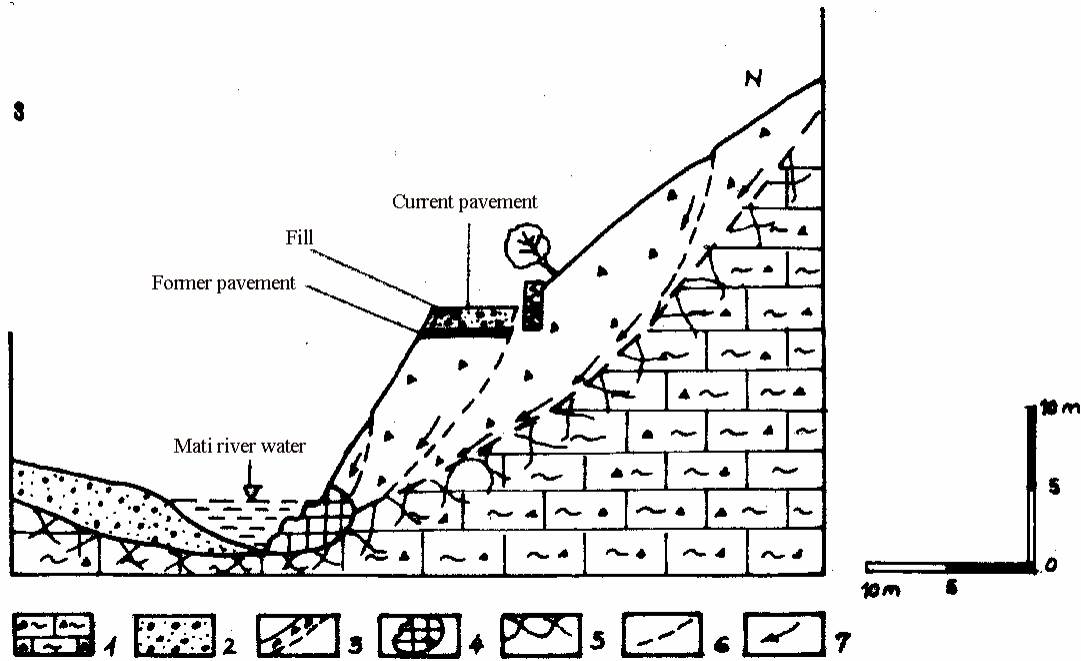
Fig. 3 Cross section of Shkopeti landslide

1. Melange deposits, 2. Alluvial deposits, sands, gravels, 3. Landslide body, 4. Erosional part, 5. Weathering crust of mélangé deposits, 6. Slide plain, 7. Slide direction

As result of lateral erosion on right side of lower part of Mati River bank slope on which is constructed the road Milot-Burreli, a landslide has occurred. It is 250-300 long, 300-350 wide and 5-10m deep.

Landslide has occurred on the boundary between of the loose Quaternary deposits (deluvions) and the melange deposits. As indicated in Fig. the landslide is developed on a steep slope and it is moving on steep slide plain. For that reason favored and from high quantities of rainfall, which infiltrate in slide plain and from bank toe erosion of river water, it begin slowly moving downwards up to reaching of a stationary equilibrium but with possibility to be reactivated from the changing of the environment conditions.

- a. Construction of concrete wall, which have to support on melange rocks.
- b. If the first one is impossible to done, then for stability of landslide needs to construct:
 - Two ditches for collect surface runoff, just there where seep and infiltrate in slide plain.
 - Construction a new retaining wall with drainage system on upper part of road.
 - The protection of the road lower part of the bank slope by using of gabion or geotextile against surface erosion.

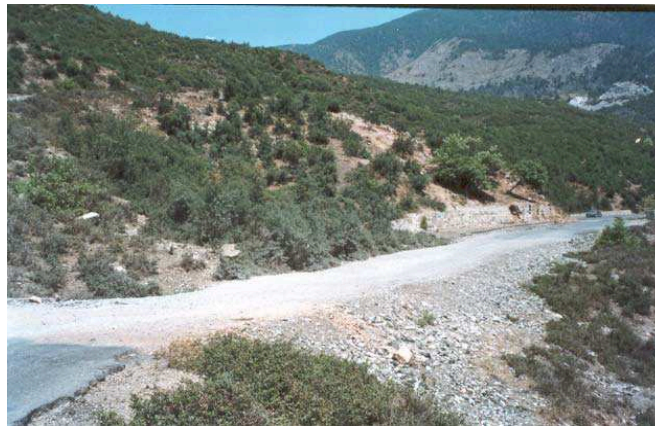
Photo nr. 8. Shkopeti landslide. It's looking to north-east, and shows, the movement of Miloti-Burreli road filled by gravels and landslide body
