Conference Paper, Published Version

**Fukui, Jiro; Nishitani, Masahiro**

## **Survey of Bridge Damages Due to a Heavy Rain in Northern Part of Kanto Region, Japan**

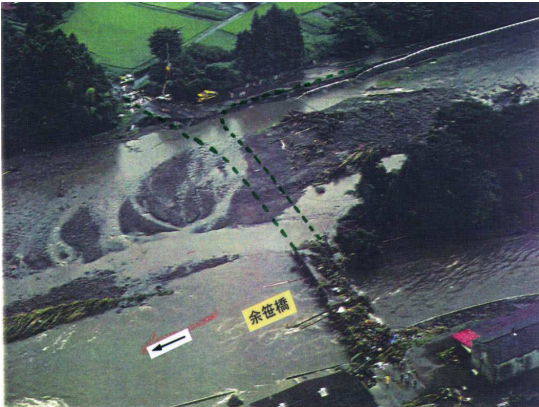
Photo 1 - Yosasa Bridge

This deluge washed away the soil behind the abutment on the right bank along with a 60 m long section of the access road (Photo 1). Moreover, on the left bank side, soil was washed away (length of 10 m) on the downstream side of access road. The examination of the superstructure revealed that part of the railing was damaged by overflow water, but no damage was found on the body of the substructure. The following process caused the damage to the soil behind the right bank side abutment.

Because the flood was much greater than the capacity of a channel section of the river, flood water overflowed at the slightly curved right bank close to 200 m upstream of the Yosasa Bridge, and as they flowed, they washed away the access road. The damage behind the left bank abutment was caused by the suction of the soil resulting from the increased flow.

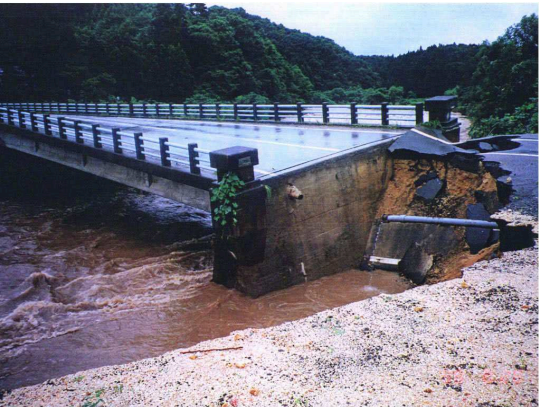
Photo 2 - Habuto Bridge

The flood tilted the abutment on the left bank side that was the outside of this curve to the downstream side and twisted the superstructure. This resulted in cracking, apparently caused by shearing, in two girders on the upstream side.

As Photo 2 shows, on the downstream side of the abutment, the soil behind the abutment washed away with even some soil on the upstream side washed away.

It is assumed that the scouring damage was caused by the direct impact of the flood water on the revetment near the left bank side abutment, and suction of the soil resulting from the vortex which were formed during the flood.

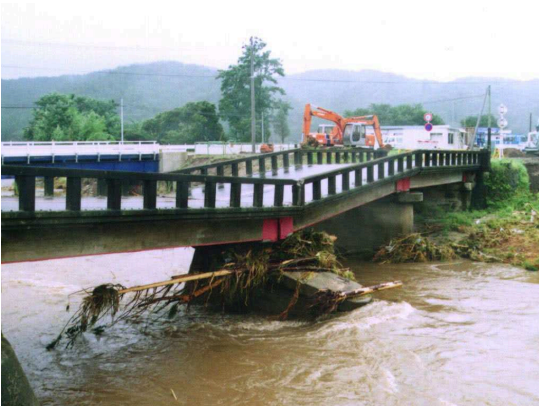
Photo 3 - Kumado Bridge

Its left bank side abutment was undamaged because it was protected by a concrete revetment and a spur dike, but the pier on the outside of the bend in the river was damaged by scouring.

As shown in Photo 3, the damaged pier settled 2.3 m on the upstream side and tilted by about 20 degrees to the upstream side. This was accompanied by serious deformation of the superstructure and damage such as pulling out of anchor bolts at the bearing, damage to the railings and so on.

For this reason, boring explorations were performed at two locations about 4 m upstream from the pier foundation, and although the results for both boring confirmed that there were a clay and a silty layer respectively that were resistant to scouring near the bottom surface of the pier foundations, it was difficult to decisively relate this to the scouring depth.

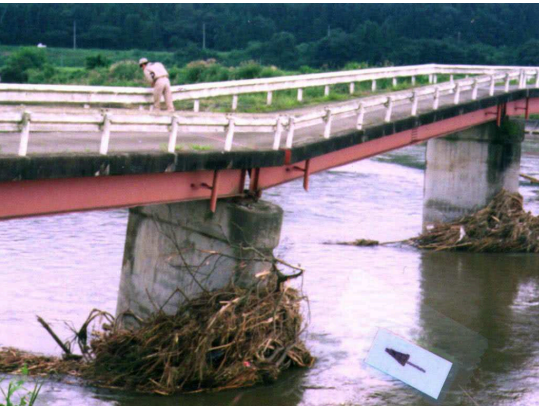
Photo 4 - Hosokura Bridge

As shown in Photo 4, it was confirmed that P1 settled and tilted and that this pulling out anchor bolts at the upstream side bearing supports on P1 and the

downstream side bearing supports on P2. The results of measurements performed at the road surface reveal that the settlement of P1 was 80 cm on the upstream side and 60 cm on the downstream side, and that this caused an angle of tilt of 4.3 degrees in the upstream - downstream direction.

It has been concluded that the damage occurred because near the left bank where the flow rate is high, the P1 has large flow resistance resulting in scouring of the streambed.

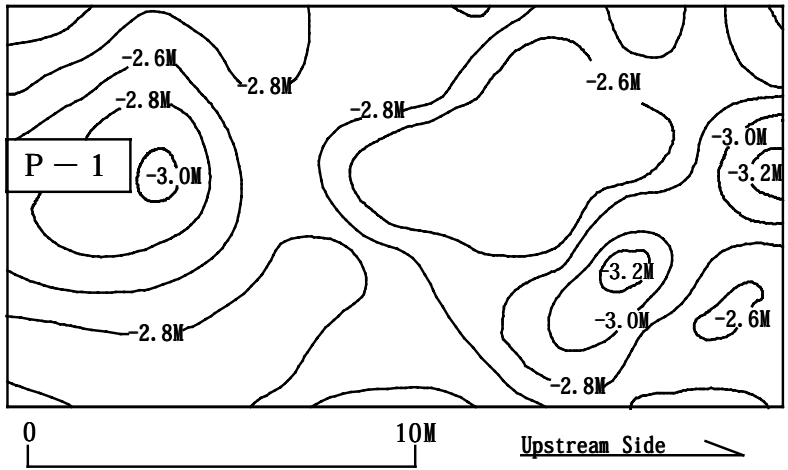
Figure 2. Contour Map of the River Bed  
at the Hosokura Bridge

In order to survey the state of scouring near the damaged P1, a radio-controlled boat was used to measure the shape of the streambed. Fig. 2 shows the results of this survey. An attempt was made to also measure the downstream side of the pier during this survey, but it was impossible to do so because the boat came up many times with numerous obstructions on the streambed.

As Fig. 2 clearly shows, the streambed is deep surrounding a location close to the upstream side of the P1, and it was possible to confirm that scouring occurred in this area.
