Gateway to the Earth

Rural water supply functionality

Survey 2 forensic assessments

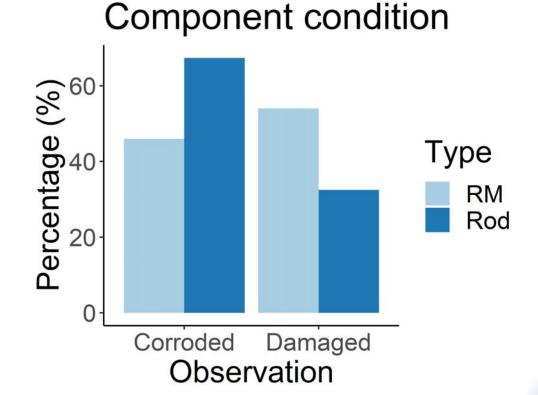
Pump component condition

Issues with India Mk 2 corrosion.

In Uganda, corrosion affects:

- 80% Rods
- 60% RM

Need to maintain and replace rising main and rods.

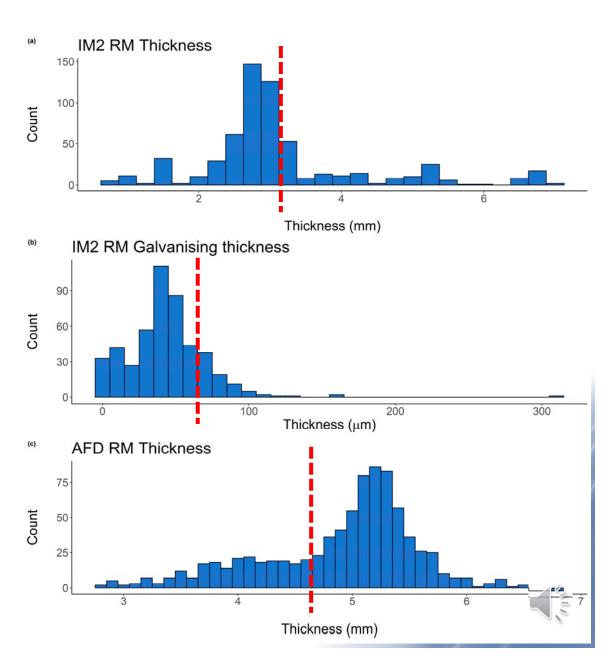
Pump component condition

<u>IMk2:</u>

>60% below spec thickness (3.2 mm)

>55% below GI spec (70 mm) (Uganda >90%)

<u>Afridev</u>

<30% below spec thickness (4.7 mm)

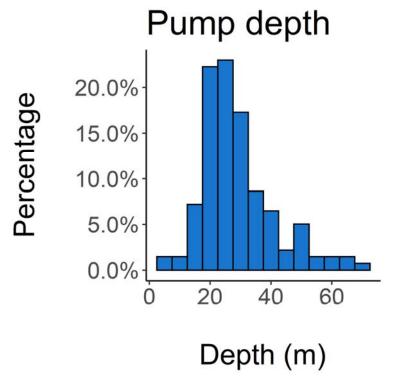
Borehole construction

Pump position, screen length and position are important

Pump >40 m in 13% of sites (Ethiopia >30%)
