Weld Solidification Cracking in a 304L Stainless Steel Water Tank

M N James^{1,2}, L Matthews² and D G Hattingh²

Abstract: Type 304L stainless steel alloy is known to be highly resistant to solidification cracking. In the present case the particular design of the welded seams in a simple 200 litre water tank, along with the likely manner in which the closing welds were made, has led to an interesting example of interdendritic hot cracking in 304L GTA welded using a 309L filler metal. The paper presents a short introduction to hot cracking in austenitic stainless steels and uses the fractographic evidence to demonstrate that this form of cracking has occurred. The cracking has occurred primarily from excessive residual restraint stresses arising from weld -fit-up and welding practice, combined with the particular sequence of welds made in finally closing the tank.

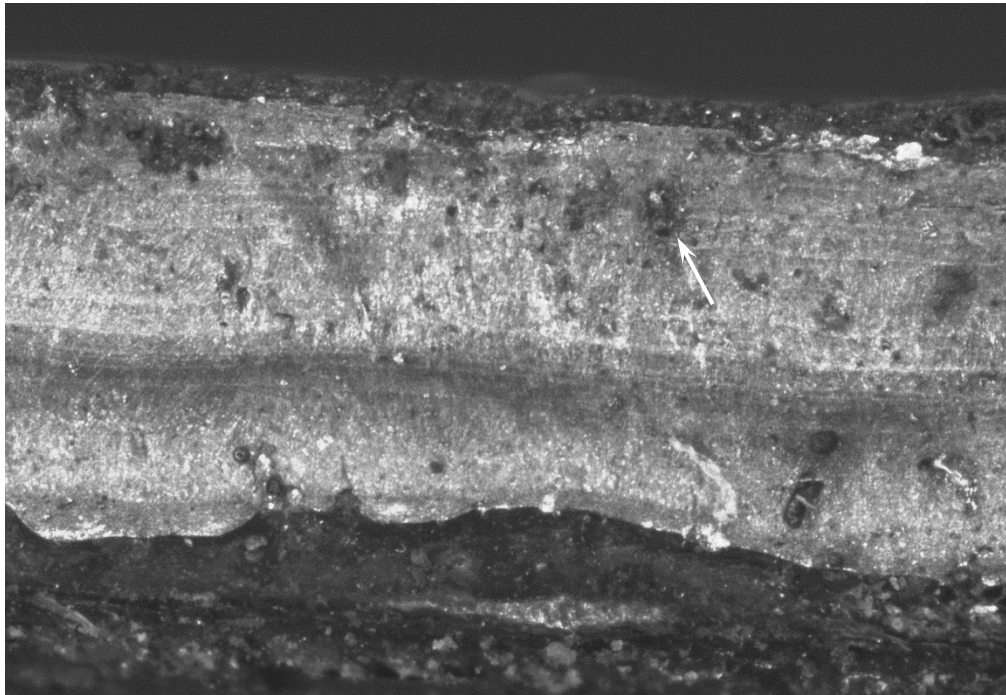
Part of the fracture surface containing the original through-thickness crack (indicated by screwdriver damage on the fracture surface – Figure 5) was sectioned from the larger specimen, cleaned and mounted for fractographic examination with stereo binoculars and with a scanning electron microscope. Low magnification inspection using stereo binoculars showed that a number of beachmarks were present both in the region of the initial water leak (Figure 5) and more generally along the fracture (Figure 6). The considerable number of beachmarks through the thickness indicates that their formation cannot be due only to a change in fracture mechanism from the pre-existing solidification crack to subsequent fatigue crack growth and/or fast fracture.

Figure 6 The beachmarks were present all along the fracture surface and therefore reflect influences other than mechanism changes.

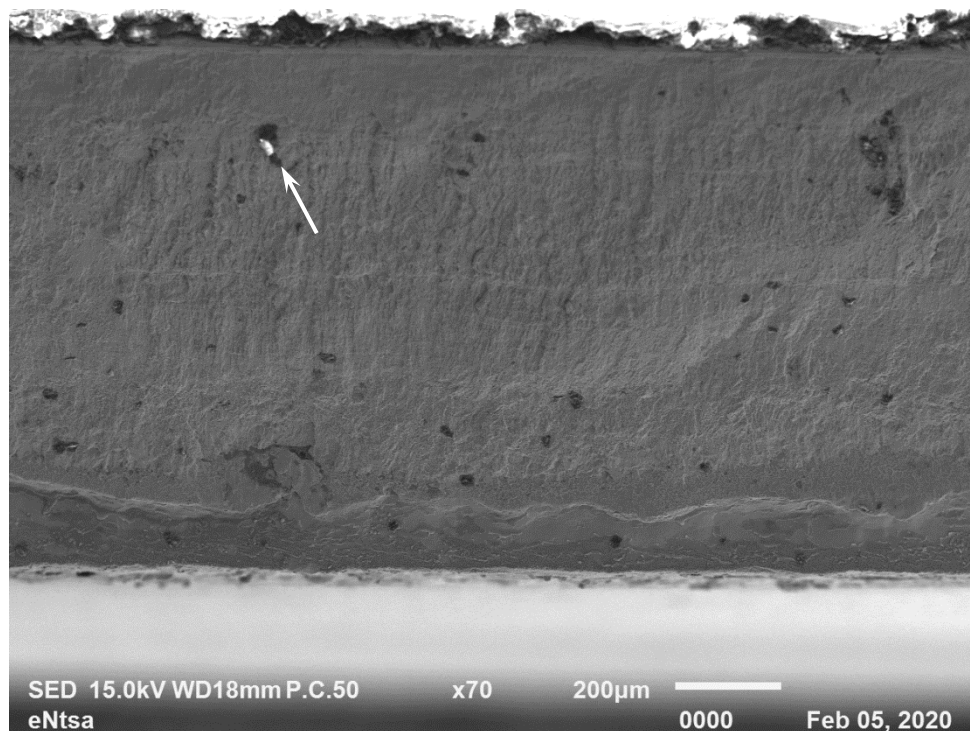
Figure 7 shows an scanning electron microscopy (SEM) fractograph of the complete fracture surface for comparison with the light fractograph in Figure 6 and to approximately locate the position of subsequent images of the fracture mechanisms. An arrow marks the same inclusion in both Figures 6 and 7. Figure 8 depicts the initial part of the fracture surface (seen in section in Figure 3) which contains the partial penetration defect, a sharp weld root intrusion

Figure 7 Low magnification SEM image of some of the region shown in Figure 5, with the weld root at the bottom of the image. The arrows in the two figures mark the same inclusion.

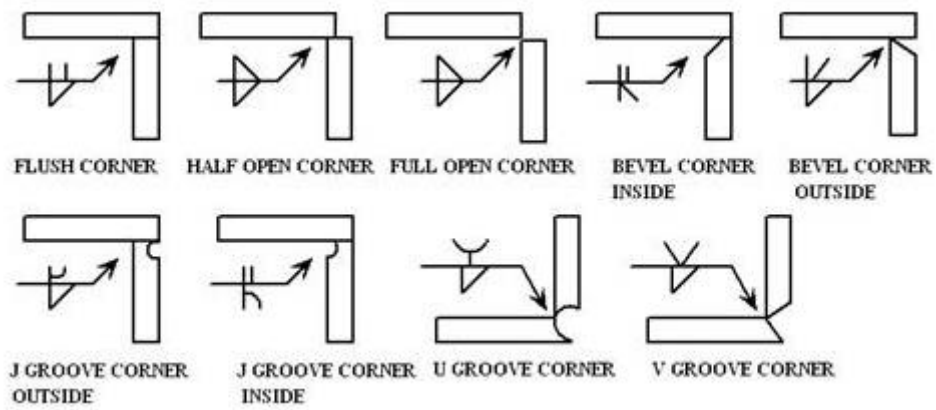
Guidance on GTAW of common welded joints is widely available on the internet, e.g. [15] and the full-open or half-open corner joint that was used for the failed seam weld (illustrated in Figure 12), although simple, requires some attention in terms of fit-up. According to the guide in reference [15] open corner joints demand precise fixturing because of the shallow joint depth and the ease with which the edge of the material melts. Stainless steel open corner joints are particularly susceptible to warping and tack welds may be required at a spacing ~50-75 mm in thin material to maintain a consistent joint. There was no evidence of such tack welds being used in the present case.

The throat of the weld should be at least the thickness of the parent plate and a fast travel speed is required to avoid melt-through to the inside corner. However, a fast travel speed is likely to result in a lower heat input per millimetre and a faster cooling of the joint which can then trigger solidification cracking. The torch angle should bisect the angle formed by the two pieces of metal to be joined in order to apply equal heat to both sides of the joint. As can be seen in Figure 2, the heat input does not appear to be uniform in the two sides of the joint and this has led to the sharp lack-of-penetration defect, associated weld root undercut and the resultant solidification cracking from a combination of high joint restraint and fast cooling (Figure 4).

Figure 12 Types of corner joint edge preparation, illustrating the full-open or half-open corner joint that was used for the failed seam weld

A change in welding practice should resolve this problem, although a redesign of the tank could also be undertaken utilising, for example, rolled plate with a single butt weld joint and a flanged approach to attaching top and bottom pieces. These could then be either bolted or employ an edge weld on the flanged corner.
